Repairing of a timber truss through two different techniques using timber elements and screwed metal plates

Keywords: Timber trusses, Repair, Timber elements, Screwed metal plates

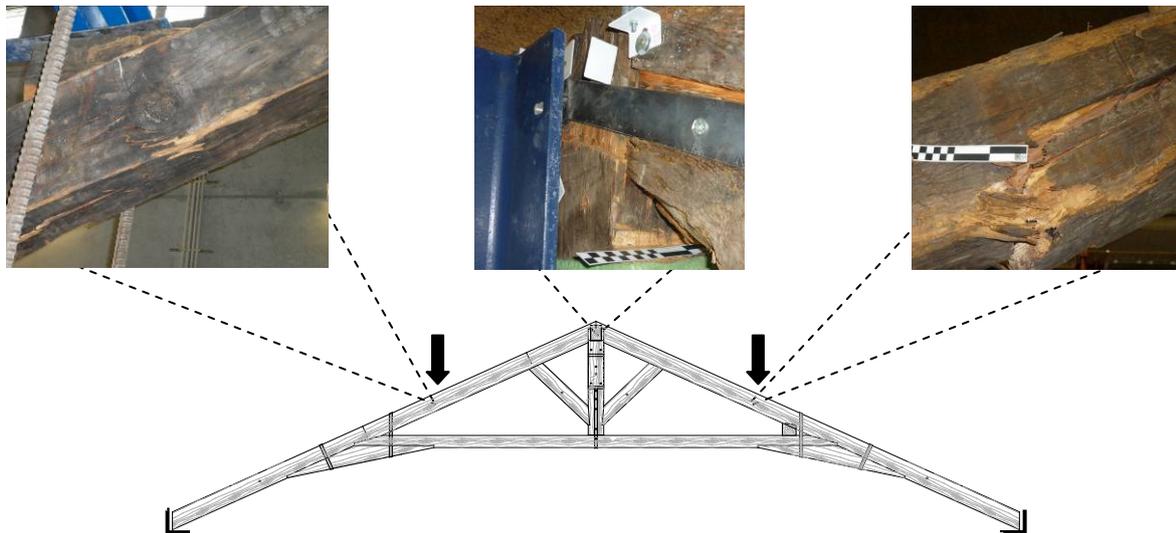
Failure of the truss was found in both rafters near the loading position and on the connection between one rafter and the post (Fig. 2). The failure of the rafters coincided with sections where significant knots were found on the tensioned side of the element. Slight crushing of the supports (bottom of the rafters) was also found (due to decayed segments).

Fig. 2 - Schematic of test setup and details of the failure of the rafters and of the post-rafter connection.

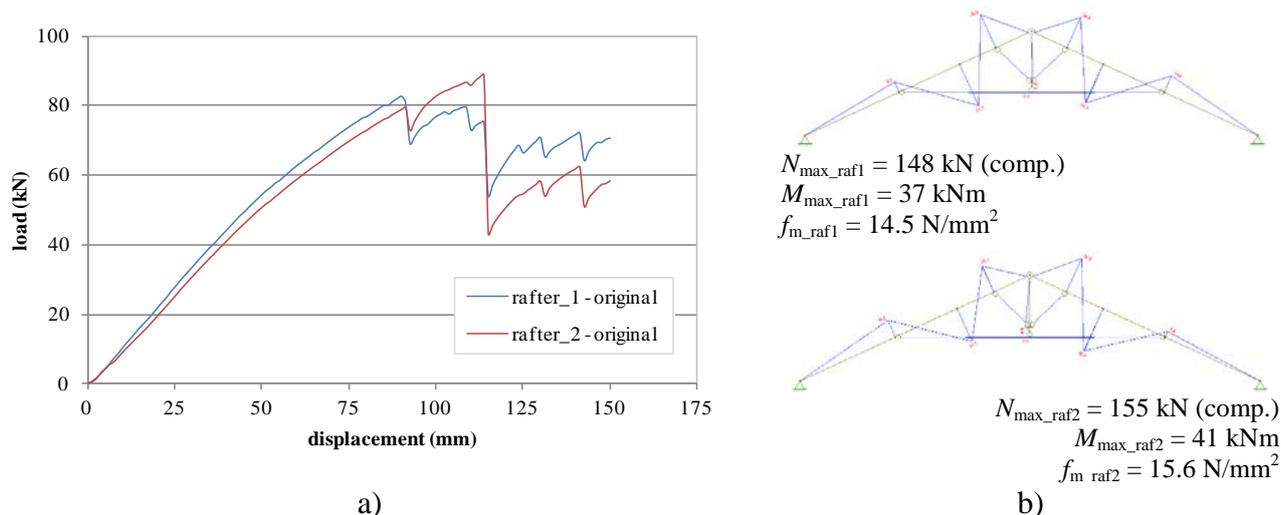
Figure 3 presents the results of the load-displacement response of the truss on the loading points, where the first load decrease, found for each rafter, correspond to the initial failure (bending) on the rafters. Considering those results, a simple truss model was calibrated to determine the ultimate stress on each failed section. The cross-section dimensions were obtained through the geometrical survey of each element complemented with the information of non-destructive tests (namely pin penetration tests and drilling resistance tests) [14]. The connection between elements was simulated by hinges and the stiffness of each element was calibrated considering the displacement of the tie-beam and of the rafters at time of failure. The stresses found for each initial failure of the rafters are presented in Fig. 3b. It is noted that the stress conditions for the failure of the second rafter (rafter_2) took into account a decrease of approximately 10% of the cross-section height of the rafter that had the first failure (rafter 1). This reduction was obtained by the analysis of the local failures of rafter 1 and calculating the height that allowed maintenance of the same ultimate bending strength of that section during the test.

Fig. 3 - Full scale test on the truss in original conditions: a) test results measured at the loading points on the rafters; b) simplified model and bending strength of the failed sections.

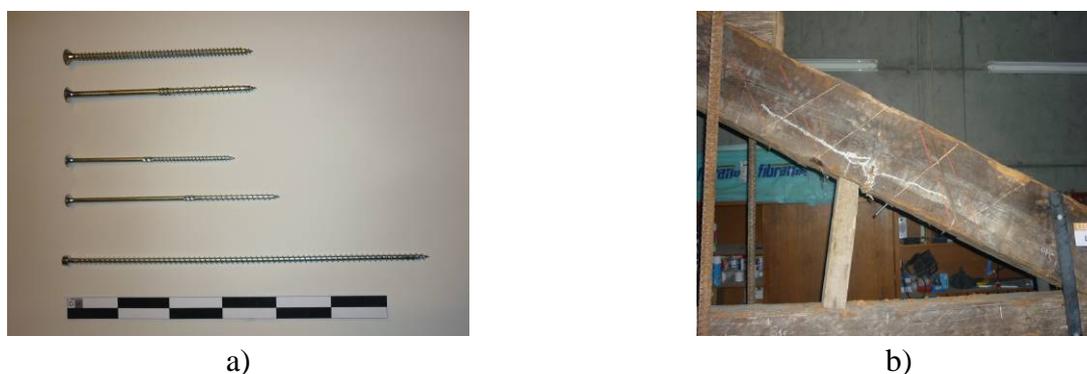
Fig. 4 - a) Metallic screws used for the repair of the timber rafters; b) exemplification of the placing of a strut and of the inserting of inclined screws to close the existing cracks.

Repair Interventions. The initial step made within the repair interventions was to reestablish the state of deformation of the rafters prior to failure. To that aim, hydraulic jacks were used and a strut was placed between the tie-beam and the rafter while screws (VGZ 7×340) were inserted in the rafters, in a 45° angle with respect to the observed crack (Fig. 4b). The objective of these screws was only to close the crack and recover the initial configuration of the truss, and they should not be considered as influencing the strength of the element. After inserting the screws the strut was removed and the repair intervention was continued. Two different techniques were considered for the intervention on each side of the truss.

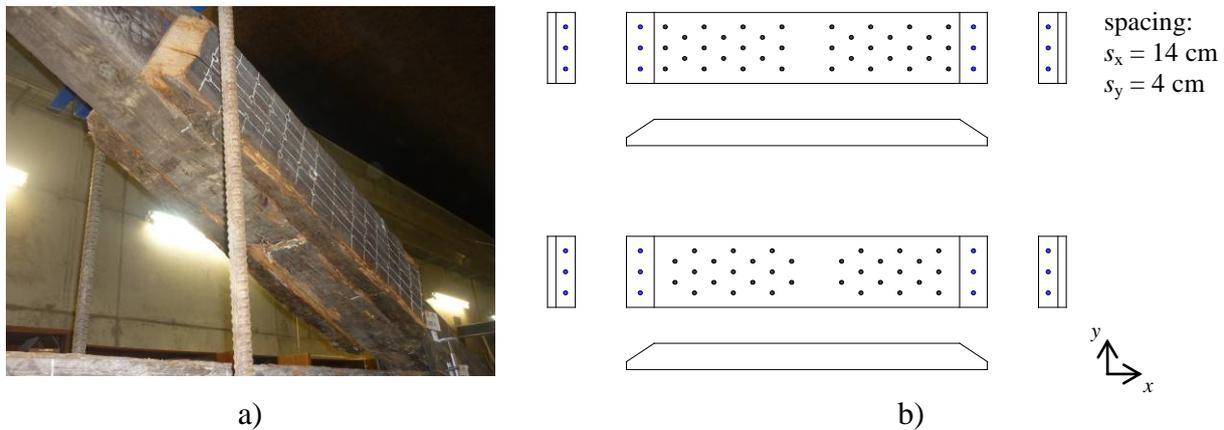
Fig. 5 - Repair intervention on a rafter using timber elements: a) repair intervention onsite; b) schematic of the location of the screw connectors.

Repair with Timber Elements. In the first case, the cross-section was reinforced with timber elements placed on the sides of the cross-section by means of screws. On the edges of the new timber elements taken from remaining elements of the same original roof, screws (HBS 6×200) were inserted to connect the new timber element to the existing rafter, while perpendicular screws (HBS 6×160) were inserted along the segment where failure occurred (Figure 5). In this case, the contribution of the timber elements to the strength capacity of the cross-section mainly concerns the increase of its geometry (increase of width) using elements with the similar mechanical properties. For this type of repair, the contribution of the existing element should not be considered when determining the cross-section load bearing capacity. The inertia and area of the cross-section is only determined from the added timber elements. In this repair configuration (Fig. 5a), the area and inertia of the repaired cross-section is equal to the original as each element had half of the width of

The maximum normal force observed during the first test was 166.3 kN. Considering the contribution of the residual cross-section, each side of the connection system should be able to sustain 58.2 kN. Attending to the configuration presented in Fig. 5b, the bearing capacity of the connections, calculated through Eurocode 5 [14] and also attending to the manufacturers the European Technical Approval [15], was equal to $F_{V,Rk} = 58.4$ kN, therefore being suitable for the this load level. Disposition of screws attended to [16] recommendations and to the manufacturers' guidelines, aiming at maximizing the performance of the effective number of screws.

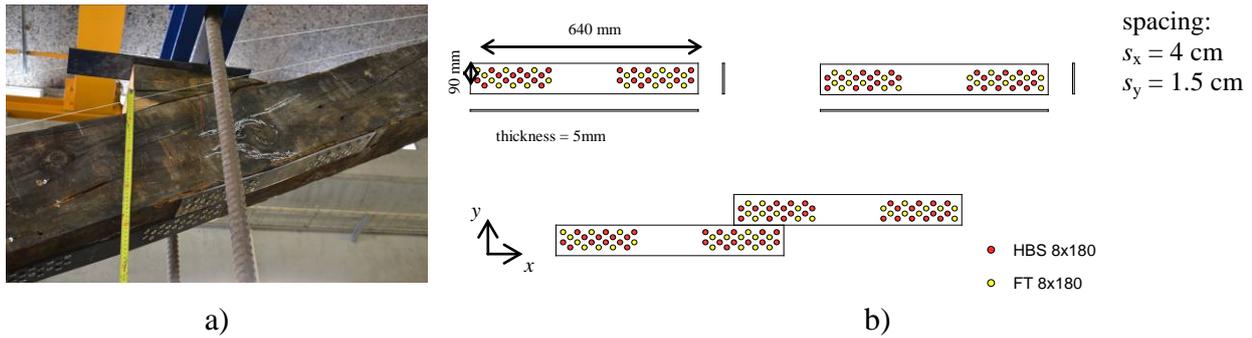
Fig. 6 - Repair intervention on a rafter using steel plates: a) repair intervention onsite; b) schematic of the location of the screw connectors.

Repair with Metal Plates. The second intervention technique considered the use of steel plates placed on the bottom face of the cross-section, which corresponded to the tension side where failure was initiated. Two types of screws were used for this connection namely screws HBS 8×180 and fully threaded screws (8×180). The screws were inserted perpendicular to the elements' bottom face fixing the metal plates to the timber element. Due to the configuration of the cracks, two metal plates (5 mm thickness) were used. In order to ensure a suitable safety level, the load carrying capacity of both connection systems was preliminarily calculated using the ultimate load, according to Eurocode 5 and ETA-11/0030 (2012) [15,16]. The distribution of bending stress found in the mechanically jointed section using the failure load level previously observed is presented in Fig. 7.

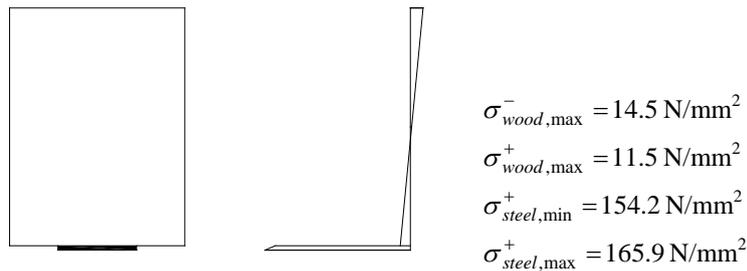
Fig. 7 - Repair intervention on a rafter using timber elements: a) repair intervention onsite; b) schematic of the location of the screw connectors.

According to Eurocode 5 [15], considering a repair solution using only normal screws (with lower characteristic shear strength compared to the chosen fully threaded screws) leads to a value of load per fastener of 4.15 kN. For the proposed repair configuration a $F_{V,Rk} = 4.18$ kN is obtained for each effective screw (using only HBS 8×180 screws). Considering the stress level on the shear plane, a total of 18 screws would be necessary to efficiently fix each side of each steel plate. Disposition of screws attended to Eurocode 5 [15] recommendations and to the manufacturers' guidelines, aiming at maximizing the performance of the effective number of screws. Taking into account the use of fully threaded screws and the required number of effective screws a total of 22 screws were used for each side.

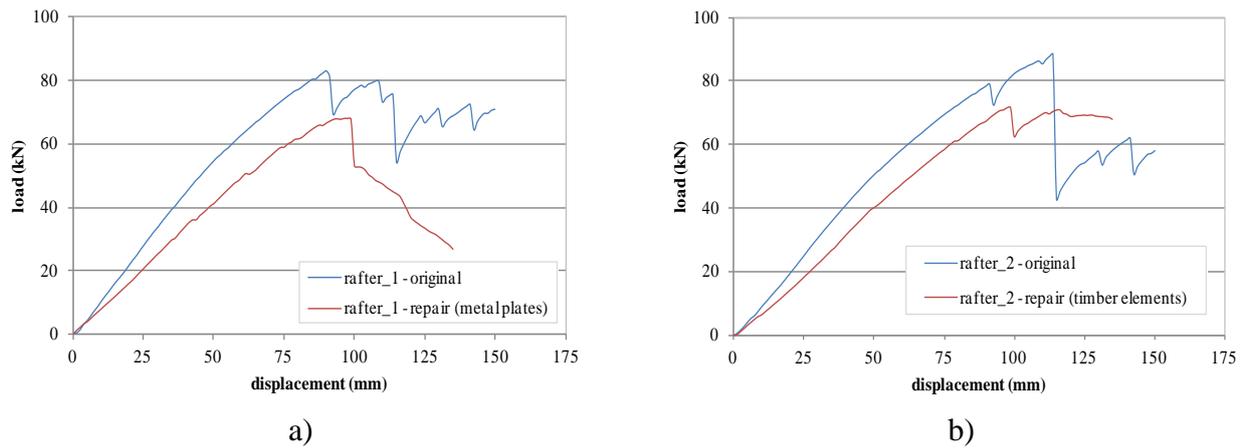
Efficiency of the repair techniques. Figure 8 shows the load-displacement graphs, before and after the repair interventions, measured at the loading points on the rafters. It is possible to note that the ultimate load achieved with the original truss was not reached with the repaired one. In fact, the maximum load (at failure) of the repaired rafters was, using both repair techniques, approximately 80% of that of the original rafters (Tab. 1). In addition, as expected, a different stiffness was observed due to loss of rigidity of the connections and also due to local failures along the elements. The screws used in both repair interventions presented no failures, but the stiffness of the metal plates was not sufficient to avoid local deformation of the timber element.

Fig. 8 - Comparison between original and repaired truss with: a) metal plates; b) timber elements

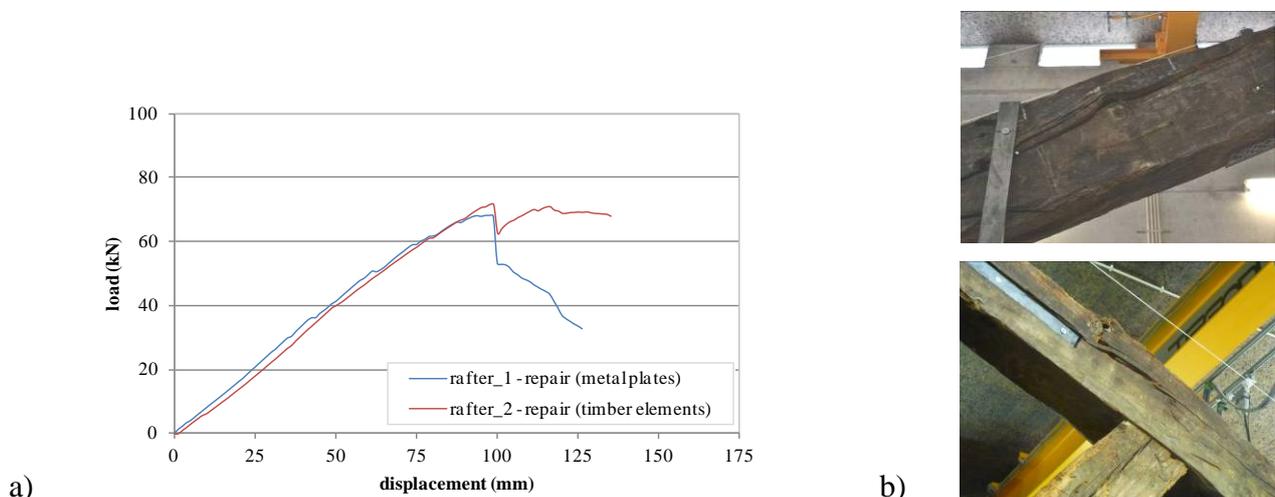
Comparison between the two repair methods. Different failure scenarios occurred between the two rafters and, therefore, between the two repair methods. Figure 9 depicts the load-displacement graph. The first drop of the load corresponded to failure of the rafter 1 (around 72 kN), where the metal plates were placed. For the repaired side with timber elements, the load after the first drop slightly rises and then maintains the same value (around 70 kN) until the end of the test; while for the rafter 1 the displacement increases without any upturn of the load. This behaviour was due to the fact that other failures occurred in different places of the truss destabilizing the structure and not allowing the same load distribution as seen in the original truss.

Fig. 9 - Rafters in repaired conditions: a) test results; b) failures on the top side of rafter 1

Once the repaired timber cross-section strength of rafter 1 was exceeded, the metal plates prevented the collapse of the truss shifting the stress distribution to other points of the structure. As a result, additional failures took place in rafter 1, namely on the top surface of the previous failed section (near the connection with the tie-beam), and after the strut (Fig. 9.b). Moreover, the truss started to have a significant out-of-plane behaviour, as the rafters began to incline around their axis, especially rafter 1. Therefore, the use of metal plates was not able to reestablish the same load bearing capacity of the original truss (due to its low stiffness). On the other side, the added timber elements allowed a better performance and are recommended in case of fire as they are less sensible than exposed metal plates. However, it was not possible to fully determine the efficiency of the connection system in the repaired sections because failures were observed in other sections.
