WIRELESS MONITORING FOR ASSESSMENT OF CONCRETE RAILWAY BRIDGES – EXPERIENCES FROM FIELD TESTS

Björn Täljsten
Ph.D., Professor
Luleå University of Technology, 971 87 Luleå, Sweden
Invator AB, Box 1093, 181 22 Lidingö, Sweden
e-mail: bjorn.taljsten@ltu.se; bjorn.taljsten@invator.se

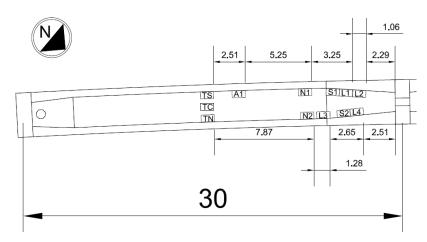
Figure 3 – Placement of sensors in section 1, see also Figure 1.

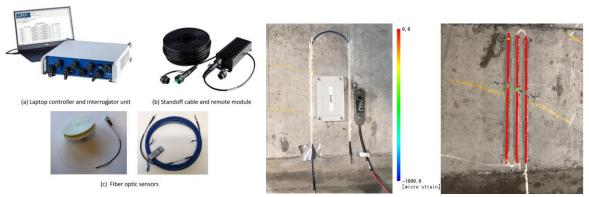
Figure 4 – a) Fibre Optic System. This platform is configured to measure standard "Rayleigh" High-Definition Fiber Optic Sensors (HD-FOS). HD-FOS operation is based on the measurement of the Rayleigh backscatter in optical fiber and delivers maximum spatial resolution for static and quasi-static applications. b) Installation of fibre optics in section where we also have a crack (LVDT) and a strain gage. c) Optical results from the FOS monitoring
