# COMPARISON OF TOR LUBRICATION SYSTEMS ON THE IRON ORE LINE

## SUMMARY

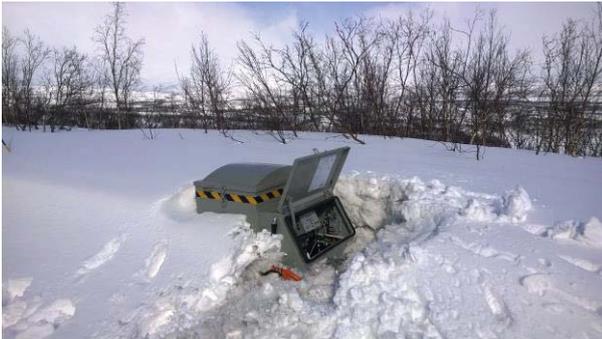
Figure 5 illustrates the influence of the precipitation during the winter season on the TOR equipment at facility 1, showing unit no. 2 in the open area. The snow influences the maintainability in that one needs to shovel snow away from the unit to be able to perform inspections and maintenance activities.

**Figure 5: TOR equipment at facility 1 in April 2014.**

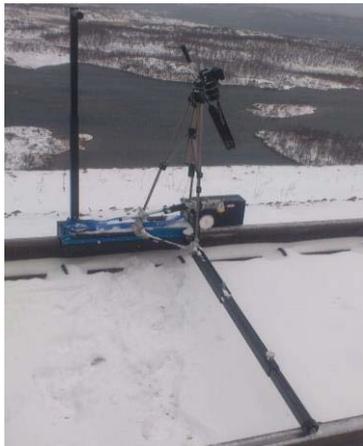
**Figure 8: The manually pushed tribometer used to determine the friction.**

The friction was measured frequently during the test period with a hand-pushed tribometer, see Figure 8 [21].

The hand-pushed tribometer shows good agreement with other laboratory equipment for friction measurement [21]. This tribometer is a conventionally used friction measurement instrument in this area and has been used in many research studies. The instrument is operated by one person, has a wheel that brakes and measures the friction between the wheel and the rail, and displays the friction value on a screen. The tribometer screen shows a new value every two seconds. The friction was measured before applying the FM and during the operational phase on the top of the rail, as well as on the GF. The extent to which this represents the real friction of a train in operation has not yet been investigated.

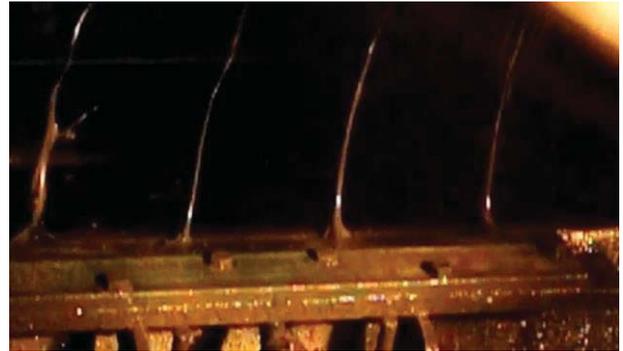
To verify if the lubricants would stick on the wheel, high-speed filming of wheels was carried out when they passed the lubrication bars. This was performed for the equipment at facility 2 in November 2013 using a high-speed camera and additional lights. The camera was a regular high-speed camera and the additional lights were three Bosch Big Knick car lights mounted on a camera stand and powered by a car battery. The film shows that the wheel is in connection with the lubricant and picks it up from all four nozzles, see Figure 14.

**Figure 14: High-speed filming of train wheel passing over the TOR unit at facility 2.**
