Condition monitoring of train wheel wear and track forces: A case study

One of the major failure modes in the railway industry is wheel wear. Wheel wear affects the dynamic characteristics of vehicles and the dynamic force impact on the rail, and can in worst cases scenario cause derailment. The wheel conditions also influences the wear and required maintenance on the rail. In this paper the correlation of wear rate and dynamic force between wheel and rail is studied to specify the most cost-effective wheel maintenance interval. Two cars, total of sixteen wheels, were selected. In order to calculate the wear trend, measurements have been performed, by MiniProfTM, for a period of 12 months with the cars in traffic. During the same time period, the trend of track forces from the two cars has been obtained from the research station, outside Luleå, Sweden. Using the trends from wheel wear and track force in combination to form maintenance planning for wheels are discussed.

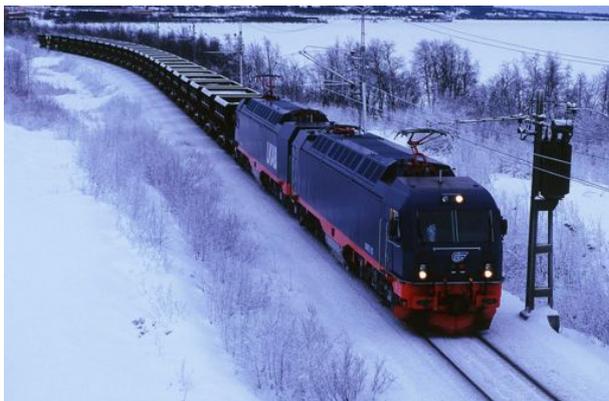
Figure 2. LKAB iron ore train.

The case study is performed on iron ore freight cars belonging to LKAB mining company. The train cars are a Fanoo wagon with a three-piece AMSTEAD bogie and UNO wp4 wheel profile. Trains are transporting iron ore pellets on the iron ore line in northern Sweden, from the mine outside Gällivare to the port in Luleå, see figure 1. This line is trafficked by both passenger and goods trains. The trains are subjected to harsh climate condition such as snow and temperatures close to -40°C in wintertime and +25°C in summer time [7]. See figure 2 for a picture of a LKAB train.

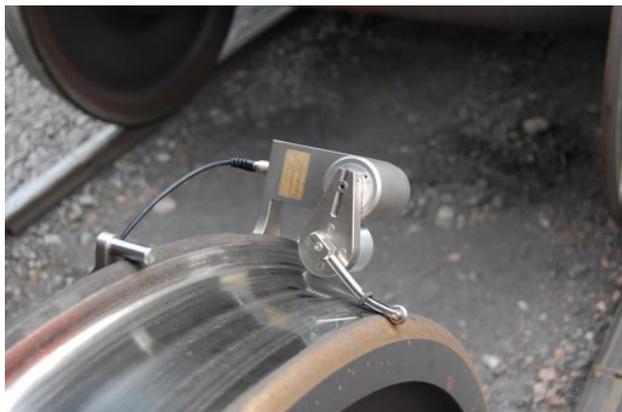
In this project, profile measurements of sixteen wheels were performed by MiniProf™ to monitor wheel profiles regarding wear trend assessment, collecting information for wheel maintenance and optimizing profiles from the service life point, see figure 7.

Figure 7. Wheel profile measurement by MiniProf™

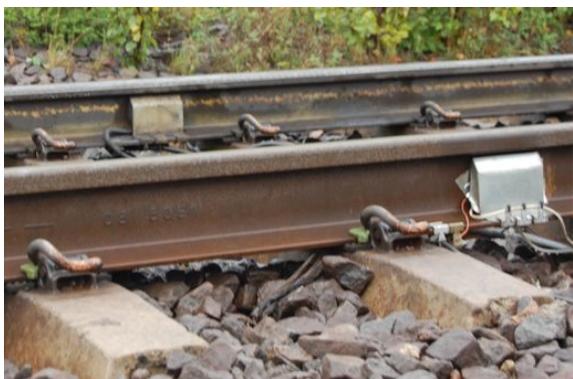
The strain-based system is composed of a series of strain gauges attached to the web of the rail [2, 12]. The strain gauges quantify the force applied to the rail through a mathematical relationship between the applied load and the strain caused to the rail web or rail foot. High-impact wheels are wheels that have an impact force of 400 kN or greater and most often they have a flat spot on the tread surface [12]. Other causes for high-impact forces are major defects in the tread surface and these have a higher probability of leading to catastrophic failure. The research station outside Luleå does not only measure impact forces from wheels but also lateral forces introduced by bad steering or by a non-optimal wheel-rail interaction. In figure 4 you can see how the measurement system at the research station is placed on the track. The outside rail of the track in a curve is called high rail and be seen as the closest rail in figure 8.

Figure 8. Picture of measurement system placement at the research station.
