Design of power lines poles that will be safe even when a phase has come in contact with crossarm.

Mats Wahlberg
Skellefteå Kraft Elnät AB
Sarah Rönnerberg
Luleå University of Technology

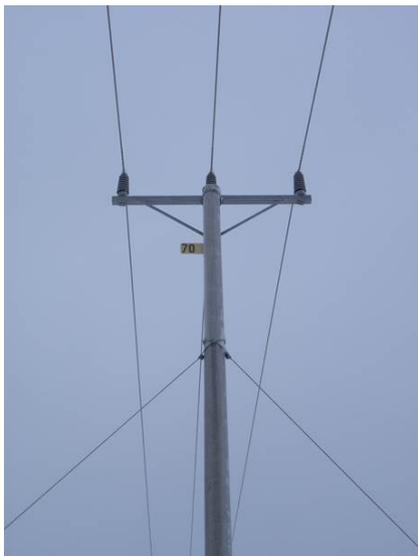
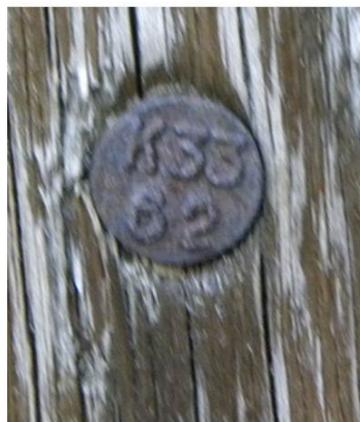
How the lines are built will have an impact as well. Sometimes the pole holds additional cables that are connected with a metal bolt through the pole. Occasionally the pole is supported by a stay wire connected to the pole or a sign used during air inspections of the line as seen on left hand side in Figure 3. The right hand side in Figure 3 shows the head of a metal nail that is used to indicate preservative and year of erection of the pole. Incidents have occurred when maintenance workers have felt a small electrical shock when touching the nail. As the nail can be reached from the ground, also the general public is exposed to this risk.

Figure 3 Pole with stay wires and metal sign (left hand side) and identification nail (right hand side)

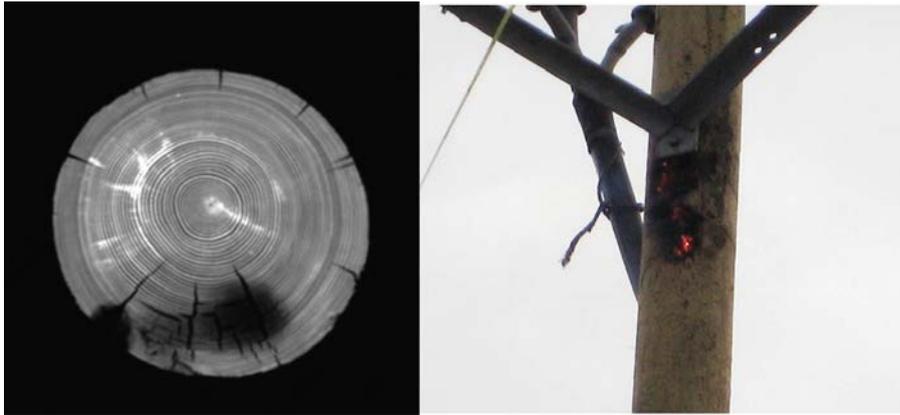
During the field measurements in Sweden a new wolmanit CX impregnated pole was equipped with an earth wire connected 50 cm below the brace. In Sweden it is not common practice to connect all metal parts in the pole to ground as it is in other countries, for instance Norway. The live wire was connected to the metal cross-arm as would be the case of a broken insulator, thus creating a voltage potential of 6 kV between the brace and the earth wire. This created a fire in the pole in less than an hour. The line was tripped manually before the fault was detected by the protection relay. On the left hand side in Figure 6 a scanned image of the pole is shown, the dark spots in the lower side of the pole indicates where wood is “missing” due to the fire.

Figure 6 Scanned image of the pole after the fire (left hand side). During the fire (right hand side)
