Tested versus code capacity of existing bridges - Three examples

Gabriel Sas

Niklas Bagge, Jens Häggström, Jonny Nilimaa, Arto Puurula, Thomas Blanksvärd, Björn Täljsten and Lennart Elfgren

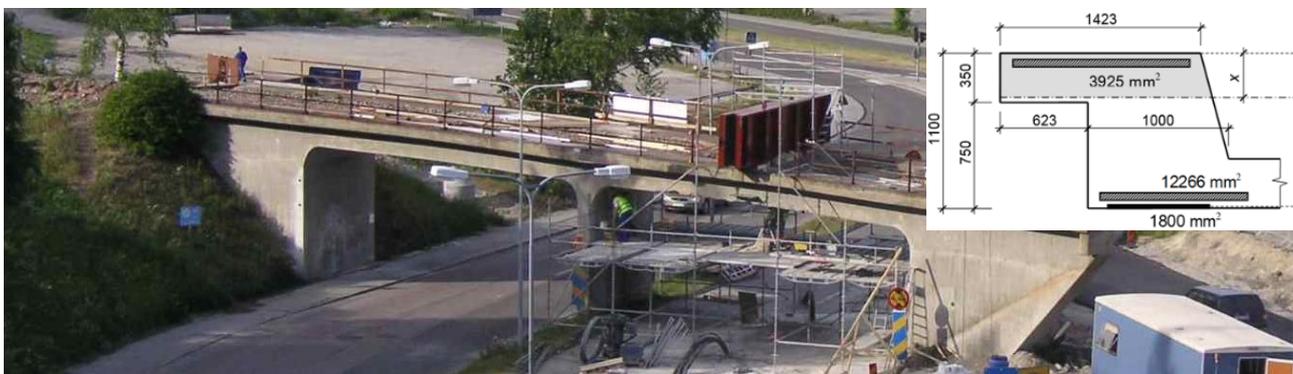
Figure 1. The tested railway bridge in Örnköldsvik, Sweden. A view from the West side showing the test setup and, as insert, a typical cross-section [4]-[6].

The studied bridge was a 50 year old RC railway trough bridge located in Örnköldsvik, Sweden, see Figure 1.

The bridge consisted of two outer beams supporting a slab in two spans (12 + 12 m), with a slight longitudinal curvature ($R = 300$ m) and supports skewed with an angle of 17 degrees. It was taken out of service in 2005 when a new high-speed railway line, the Bothnia Line, was built [4]-[6]. The bridge was designed for a 40 MPa concrete and steel reinforcement with yield strength of 400 MPa. Tested concrete had a mean strength 68,5 MPa (8 MPa standard deviation) corresponding to a characteristic compressive strength of 57 MPa. The reason for the growth is a coarse grinding of the cement which prolonged the hydration process after the 28 days, when the original concrete was tested. The steel reinforcement tests showed yield strengths slightly above 400 MPa and ultimate strengths up to 700 MPa.

The bridge was tested with two hydraulic jacks, placed on top of a loading beam. They exerted a downward force on the loading beam by pulling on steel tendons anchored in the bedrock to a depth of 9 m. The loading beam was placed over the middle of the second span and positioned so that its longitudinal axis was oriented transverse to the longitudinal direction of the bridge, see Figure 1. The test setup was designed so that a shear failure would be obtained at the mid longitudinal section of the loaded span.

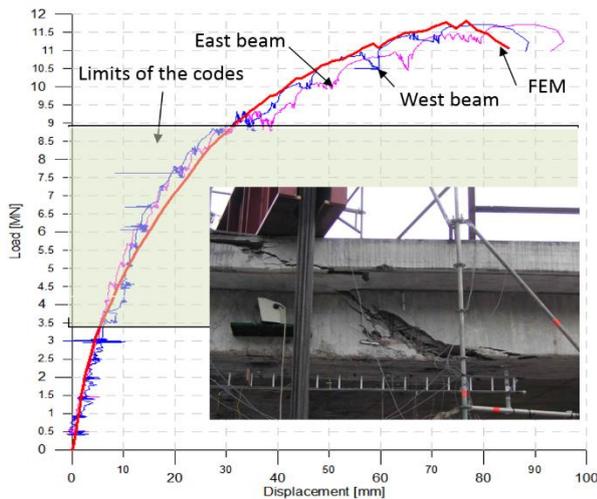
Figure 2. Load-displacement curves as recorded and as calculated with nonlinear FEM and crack pattern in the SE beam after failure.

The failure was relatively ductile, Figure 2, and the bridge was intact after the test finished. The recorded failure load P was 11,7 MN. The mechanism of failure was a simultaneous bond-bending-shear failure, resulting in the formation of flexural-shear cracks in both beams at an angle of about $\theta \approx 32^\circ$. The NSM reinforcement played a major role in the failure process. The video recorded during the test shows that intermediate crack debonding of the NSM initiated the shear-bending failure.

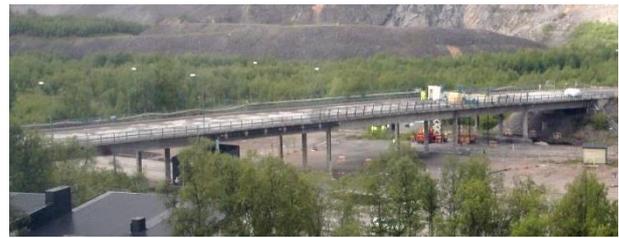
Figure 3. Photograph of the Kiruna Bridge tested to failure [12], [13].

A 55 year-old five-span prestressed concrete girder bridge, located in Kiruna, Sweden, had been monitored from 2006 due to large ground deformations, which were caused by mining activities. In 2014 the bridge, see Figure 3, was the object of an extensive experimental programme, including the performance of two types of strengthening systems using carbon CFRP materials. The complete experimental programme is reported in Bagge et al [12], [13], [17].

The bridge was a 121,5 m long and 15,6 m wide viaduct with five spans. The superstructure consisted of three parallel girders (height: 1923 mm, width: 410 mm), connected with a deck slab

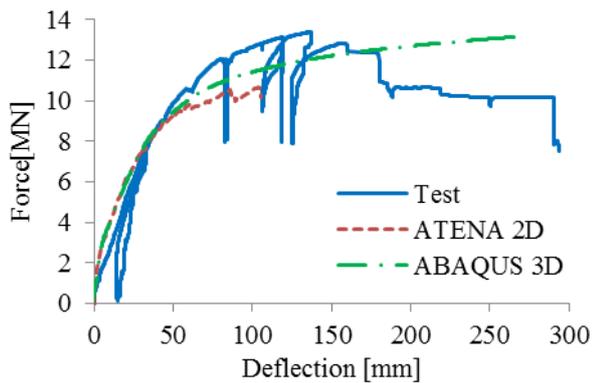
Figure 4. Load-deflection curve for the failure test of the bridge girders [13], [14].

Finite element (FE) analyses were performed in order to predict the structural behaviour and the load-carrying capacity. The softwares Atena and Abaqus with a 2D and 3D idealization, respectively, were used. Figure 4 shows the load-displacement curve for the failure test and the two FE analyses, total load versus midspan deflection of the central girder.

The first step in the test was equal loading of all three girders up to a total load of 12 MN, followed by loading the southern and the central girder to failure. At failure of the southern and central girder the total load was 13,5 MN and 12,8 MN, respectively. Predictions with linear elastic analysis in combination with an explicit check according to Eurocode [9], models for the flexural moment and shear force resistance resulted in a load-carrying capacity about half of the load given by the test.

followed by yielding of several stirrups. In both girders a combined shear and flexural failure occurred including yielding of longitudinal reinforcement, concrete crushing and ultimately stirrup rupture. The girders behaved in a ductile manner and after the test they still had an appreciable residual load-carrying capacity, see Figures 4 and 5.

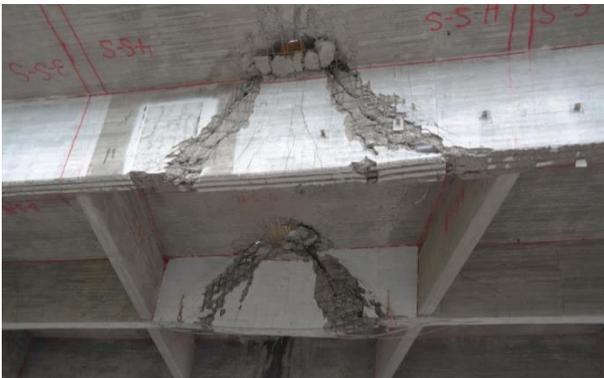
Figure 5. Photograph of the girders after test [13], [14].

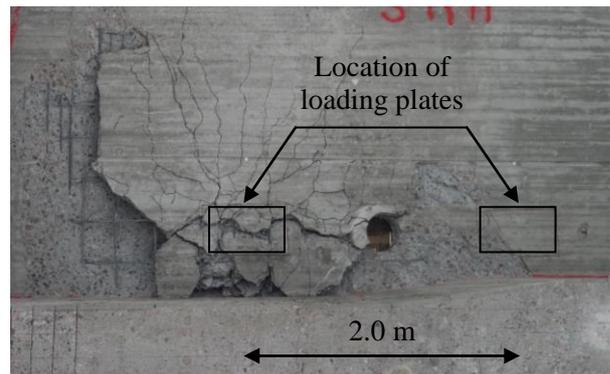
Figure 6. Photograph of the deck slab after test.

Figure 6 shows the deck slab after the test, illustrating the failure under the western loading plate. The total load was 3,32 MN (1,66 MN per loading plate) and it suddenly failed in shear and punching, without any forewarning.

The test demonstrated a load-carrying capacity two times larger than the outcome from the analytical analysis given by the punching model in the Eurocode [9]. This indicates that the analytical model did not fully predict the behaviour of the tested bridge slab. For instance, the influence of important conditions such as flexible supports, i.e. the girders, and membrane action is disregarded in the analytical model.

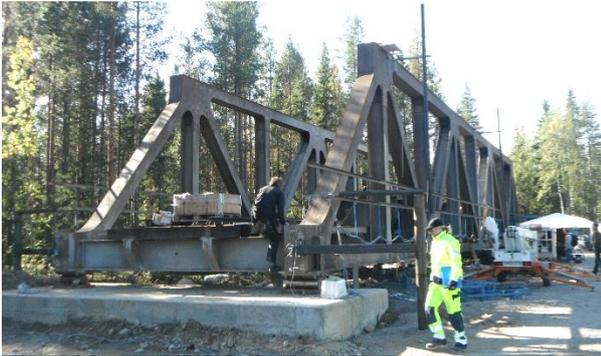
Figure 7. Test of a 55 year old 33 m long metallic bridge at Åby River in 2013. Overview of test site.

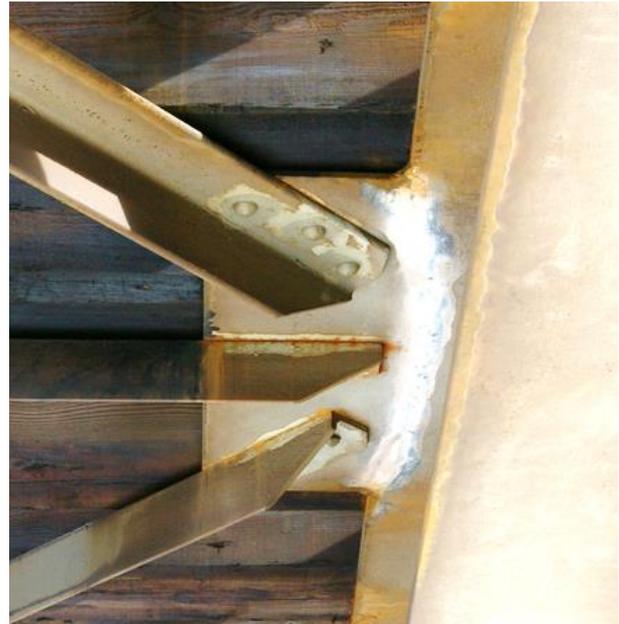
Figure 8. Connection for the horizontal bracing which makes the longitudinal stringers sensitive for fatigue [15].

The results from a new assessment performed in accordance with the Swedish standards [16] have indicated that the bridge had sufficient capacity at ultimate limit state but not at fatigue, most likely due to inexperience with fatigue in welded details at the time when the bridge was designed. A refined fatigue assessment showed that the fatigue capacity was exceeded in the connection between the longitudinal stringers and the stabilizing horizontal truss, where the connection plate is welded to the flange of the longitudinal stringer, see Figure 8. There were however no visible cracks at these details, although the Palmgren-Miner damage hypothesis shows an accumulated damage exceeding 5, which means that the designed lifespan is exceeded 4 times. This deficiency had potentially severe

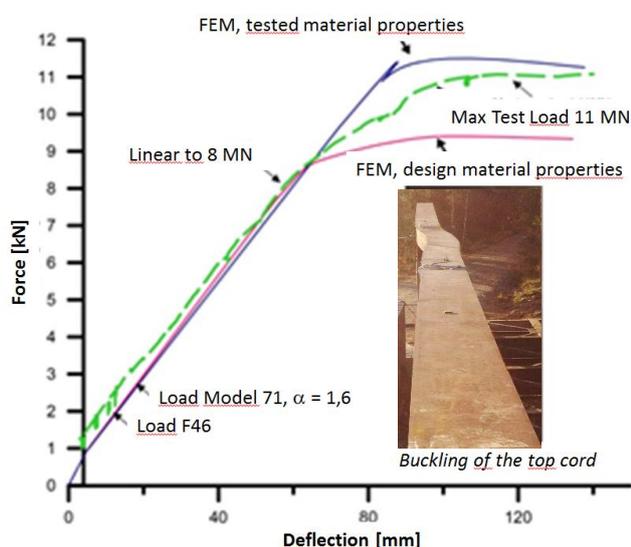
Figure 9. Deflection at mid span. The figure also shows the expected outcome based of the simulation

Non-linear deformations started at about 8 MN and continued up to 11 MN when the top cord buckled, see Figure 9.

Since the load added to the bridge only corresponded to one wagon, the load level for a whole train set is compared for a certain number of points. The loading is compared for the normal force in the top cord. Here the loading can be observed from a train set F46 (which is the train set it was designed for) and the loading according to current standards (Eurocode) for new bridges along the line subjected to the heaviest axle loads in Sweden (Load model 71 with $\alpha=1,6$). Safety or dynamic amplification factors are disregarded. The comparison shows that the bridge could withstand loading that substantially exceeds both the load it was designed for as well as the load the model in use today before failing. See Figure 9.
