Full-Scale Test to Failure of a Prestressed Concrete Bridge in Kiruna

To calibrate methods for condition assessment of prestressed concrete (PC) bridges, tests are planned for a 50 year old five-span bridge with a length of 121 m in Kiruna in northern Sweden. Both non-destructive and destructive full-scale tests will be performed. This paper summarises the test programme, which comprises evaluation of the structural behaviour of the bridge, the residual forces in the prestressed steel, methods for strengthening using carbon fibre reinforced polymers (CFRP) and the shear resistance of the bridge slab.

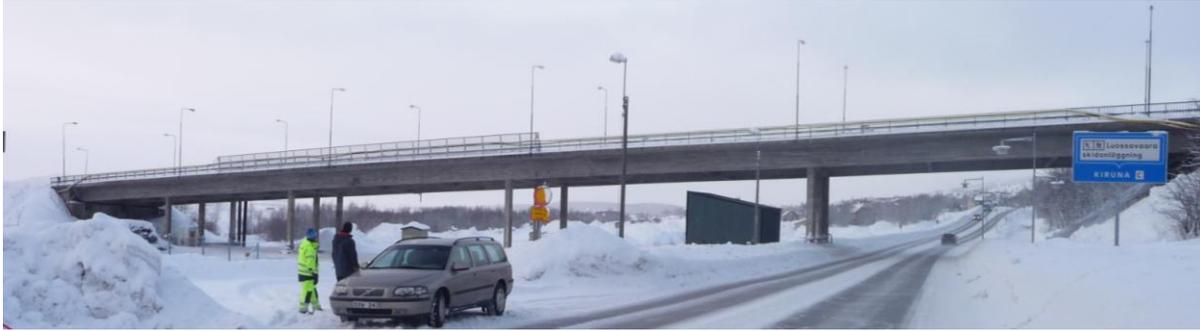
Figure 1. Photograph of the Kiruna Bridge, view from south (2014-02-19).

The bridge consists of five spans with the lengths 18.00, 20.50, 29.35, 27.15 and 26.50 m, see Figure 1-2. The western part (84.2 m) is curved with a radius of 500 m and the eastern part (37.2 m) is straight. Furthermore, the bridge has an inclination of 5.0 % in longitudinal direction and 2.5 % in transverse direction. The cross-section is 15.5 m wide with three longitudinal beams with a height of 1.92 m. The concrete quality was K 300 ($f_{ck} = 21.5$ MPa) in the substructure and K 400 ($f_{ck} = 28.5$ MPa) in the superstructure, and the reinforcing steel was Ks 40 ($f_{yk} = 410$ MPa) and Ks 60 ($f_{yk} = 620$ MPa). The prestressed reinforcing steel system BBRV was used with

The European route E10, passing under the span 5-6, will still be in use at the time of testing and therefore the tests will mainly be located in the spans 2-3, see Figure 1-2. The condition and the residual prestressed force will be investigated. Furthermore, two different techniques to increase the flexural moment resistance, using carbon fibre reinforced polymers (CFRP), will be studied in span 2-3 during the loading to failure. Finally, investigation of the shear resistance of the bridge slab is planned to take place.
