# **Age Estimation of Qara Chattan Landslide, Using Exposure Dating Method, Sulaimaniyah, Northeast Iraq**

## **Abstract**

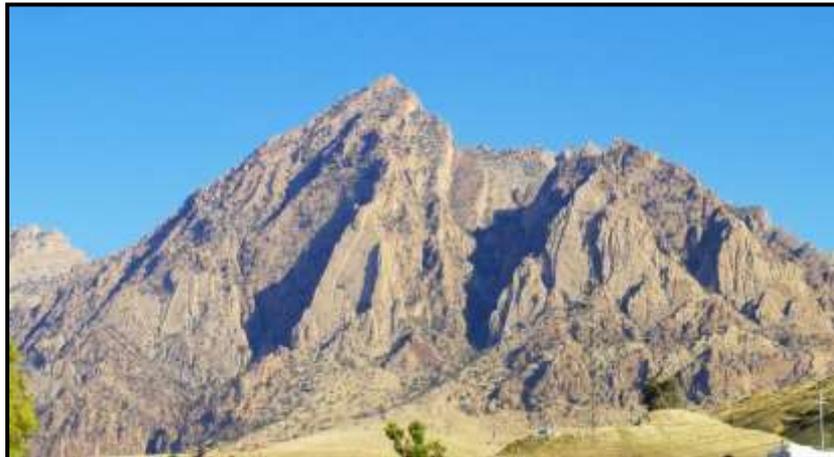
Figure 2: Giant flat irons along Pera Magroon anticline

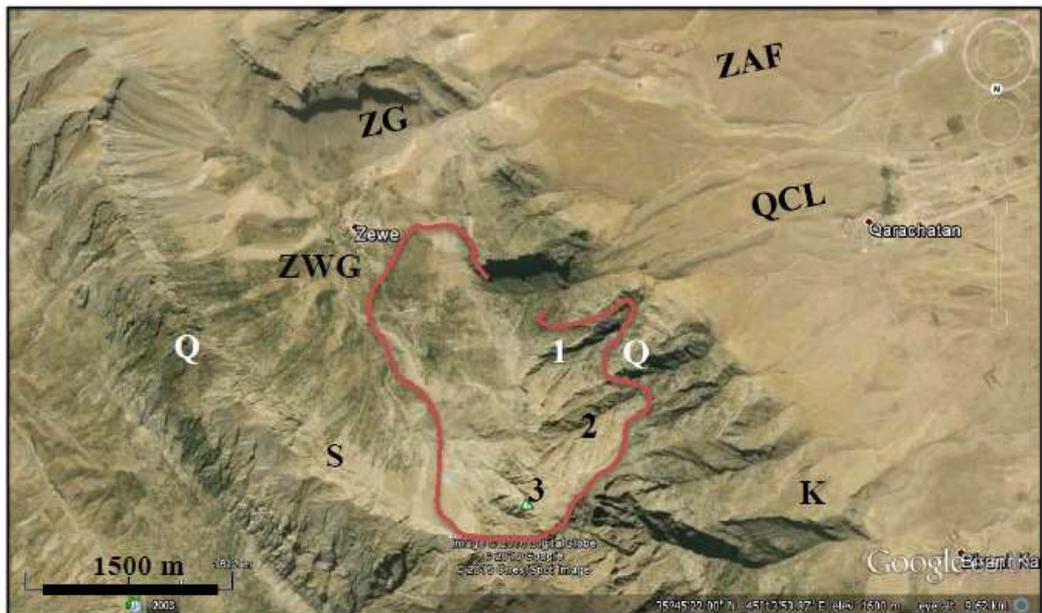
Fig.5: Google Earth image facing south showing the acute asymmetry of Pera Magroon anticline. QCL = Qara Chattan Landslide, ZG = Zaiwi Gorge, ZWG = Zaiwi Wine Glass, ZAF = Zaiwi Aluvial Fan. Formations: S = Sarmord, Q = Qamchuqa, K = Kometan.  
 = Limits of water basin of the Qara Cahttan Alluvial Fan

Among other morphological causes that have contributed in the sliding is the drainage basin of the previously existing alluvial fan in the area (Fig.5), in which 3 main valleys were draining (1, 2 and 3, in Fig.5). Most probably the amount of the collected water in the water basin was more than that can be drained out through the outlet of Qara Chattan Alluvial Fan; therefore, weight of the collected water was acted on the rocks of both sides of the outlet that was acting as a natural

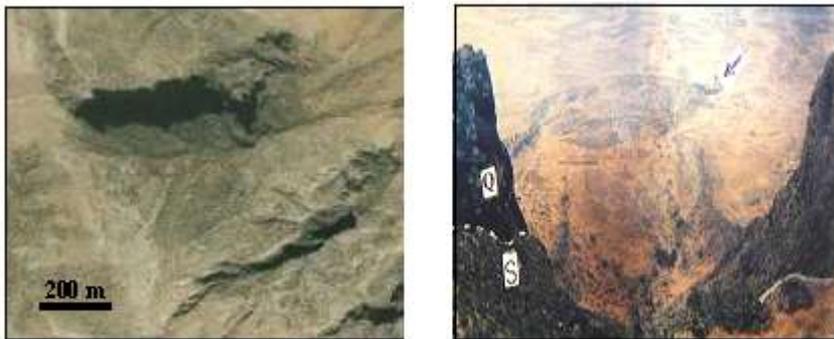
Fig.7: Left) Google Earth image facing south showing the crown area and side cliff of Qara Cahttan Landslide, Right) Photo from the crown area [3]

The crown area of Qara Chattan Landslide is large; since its length is 877 m, with two side cliffs (Fig.7). The indications for sliding on the crown area are almost vanished because it is very old landslide; however, the eastern cliff is still clear and active area for toppling and rock fall of small blocks (Fig.7, Left). When comparing the shape of the remained main cliff and side cliffs, and the developed hallow below the cliffs with other neighbouring cliffs; then it is very clear that a very large mass had slid downslope (Fig.7).

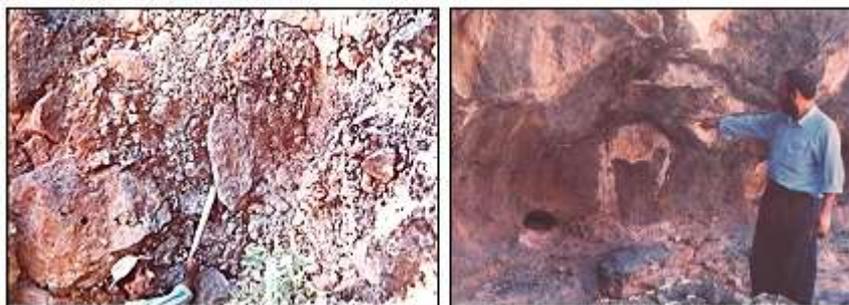
Fig.8: Left) Coarse grained sediments; most probably of an old alluvial fan, in the outlet of the fan, Right) Solution cave in the crown area (Both photos are after [3]).

In the lower part of the crown area, coarse grained well cemented clastics occur (Fig.8, Left); most probably they belong to an old alluvial fan that was radiating from a valley through which the landslide had occurred. Moreover, some solution caves occur too indicating the presence of accumulated water in the site (Fig.8, Right). This was also recognized and confirmed by [3].

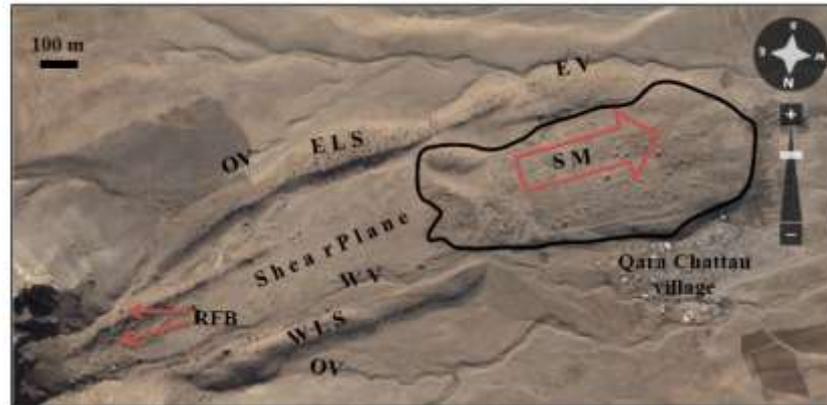
Fig.9: Flash Earth image facing south showing the slid mass (SM), the Eastern longitudinal strip (ELS), Western Longitudinal Strip (WLS), eastern valley (EV), western valley (WV), recently fallen blocks (RFB). Note the concentration of the large blocks on the top of the slid mass.

The eastern side of the slid mass is partly limited by a valley (E V in Fig.9) that runs from Pera Magroon Mountain and merges into Zaiwi valley, which flows out of Pera Magroon Mountain through Zaiwi Gorge (Fig.3). This valley is older than the landslide, since it started to erode the eastern limits of the slid mass. Along the western side of the slid mass, a small valley is developed (W V in Fig.9); it started eroding the shear plane and part of the slid mass. This means the valley is younger than the landslide.

Along the slid mass (Fig.9), some clean flat areas can be seen, these are area cleaned by the local people of Qara Chattan village and used for agricultural purposes.

When comparing the size and the depth of the old valleys along both sides of the slid mass (OV in Fig. 9) with those developed on the shear plane (EV and WV in Fig.9), it can be seen that clear differences exist. This means that the valleys developed on the shear plane of the landslide are younger than those valleys that exist on both sides of the slid mass, which are almost early Holocene in age.

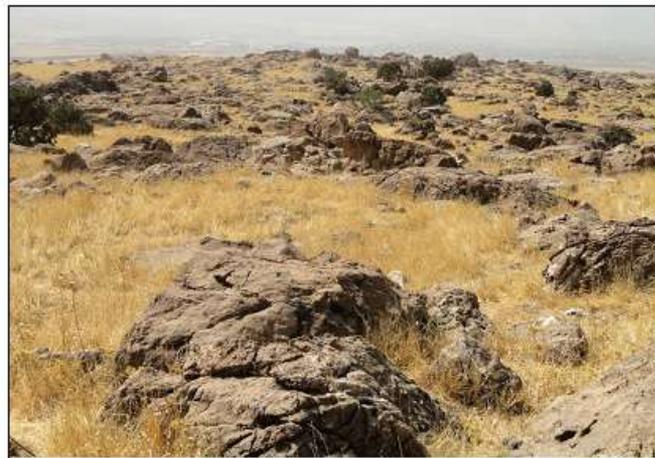
Figure 10: Top view of the slid mass. Note the status of the weathering of the blocks

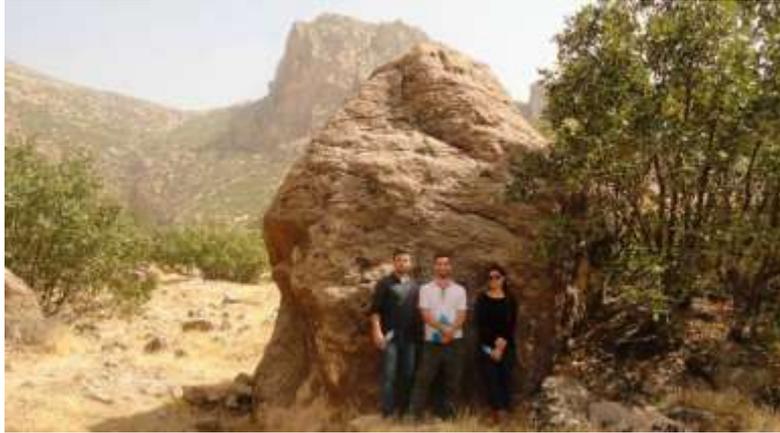
Figure 11: A recently fallen block, in the back ground the crown area and the eastern cliff can be seen

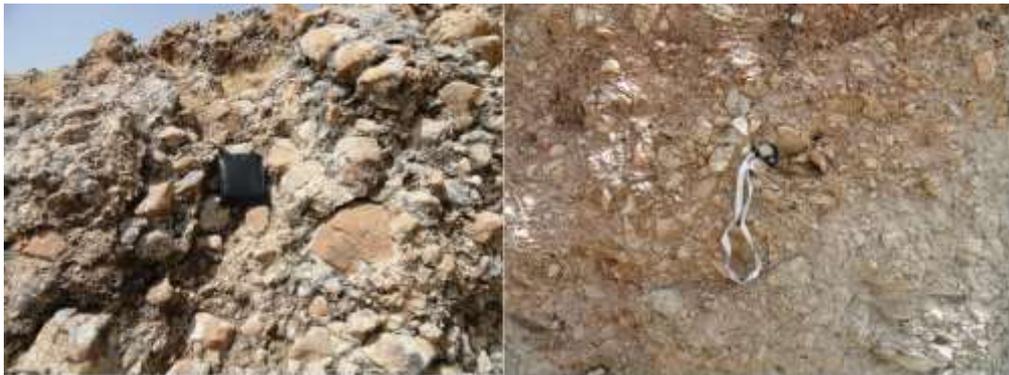
Figure 12: Alluvial fan sediments. Left) Coarse grained sediments along the longitudinal strips, Right) Fine sediments on the top of the fan (below the slid mass)

The Qara Chattan Landslide has happened; most probably above an area that was originally an old alluvial fan. The slid mass has swiped the alluvial fan sediments (Fig.12) as the large blocks were moving in very high speed down the slope during the sliding. On both sides of the landslide; however, the remnant of the alluvial fan sediments can be seen in form of longitudinal and narrow strips; like embankments (Figs. 3, 9 and 13). The length of the eastern strip is 1365 m, whereas the western one is 1002 m, the width of both strips ranges from (30 – 100) m. The height of the two longitudinal strips ranges from (3 – 7) m.

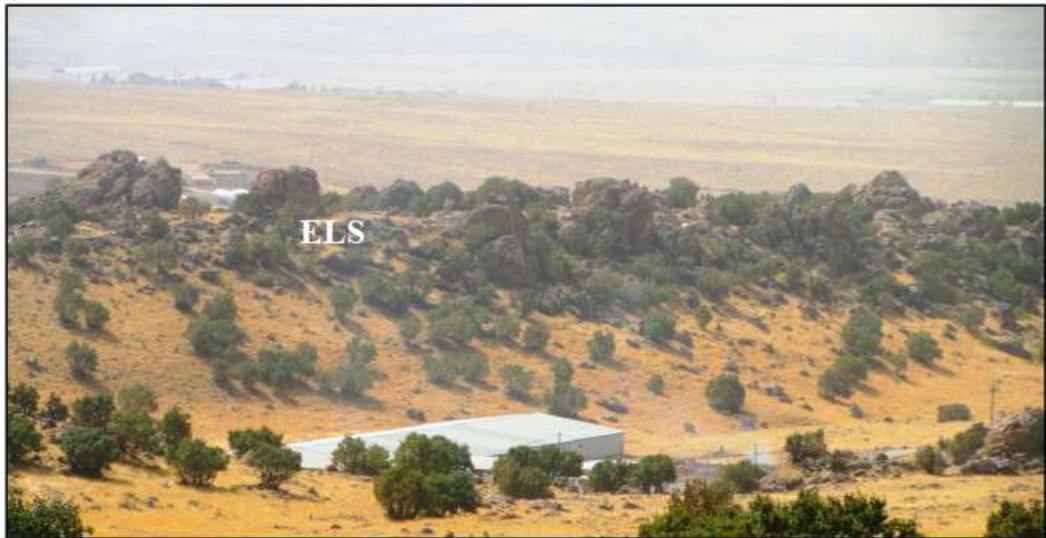
Figure 13: Part of the eastern longitudinal strip (ELS)

The shape of the old alluvial fan is still clear, especially on both sides of the slid mass (ELS and WLS in Fig. 9 and 13). The weathering status of the

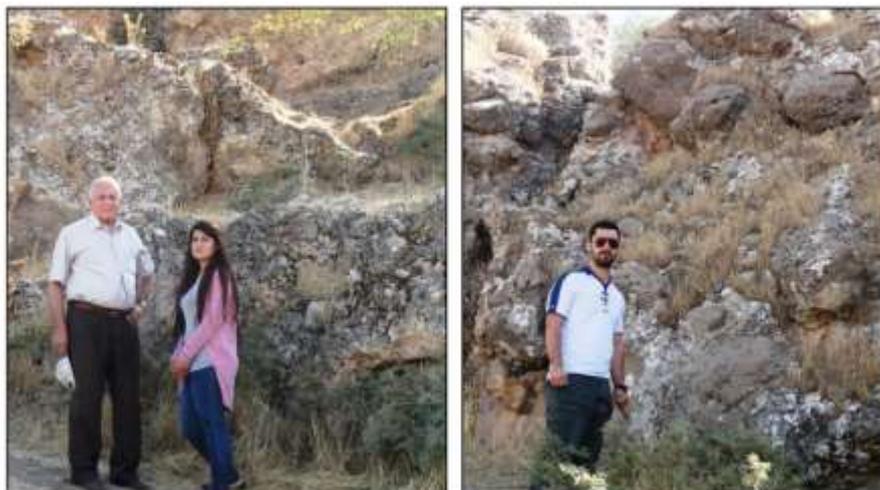
Figure 15: Toe area of the old alluvial fan, (Left) The fine fragments (FF).  
(Right) The coarse fragments (CF)

The toe areas of both the old alluvial fan and that of the slid mass almost coincide to each other (Fig.14). The blocks of the toe area of the old alluvial fan consist of coarse breccia; the fragments are either small in size of angular form or are large in size of subrounded limestone of the Qamchuqa Formation (Fig.15).

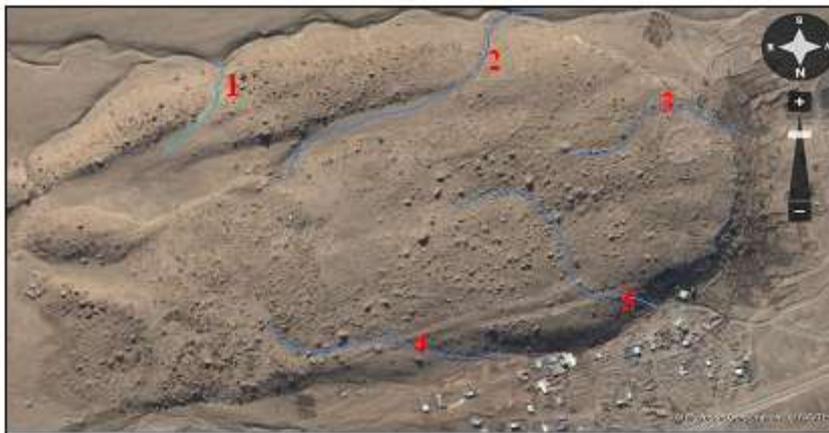
Figure 18: Google Earth image facing south showing the details of the slid mass

In reviewing thoroughly the slid mass of the Qara Chattan Landslide (Figs. 9 and 18), it is clearly seen that a new valleys started to be developed on the shear plane as well on the top of the slid mass. The shear plane as well the top of the slid mass should be free from drainage system, because in the former case all existing valleys were cleared and/ or filled during the sliding. Whereas the top of slid mass also should be clear or free from the drainage. This is attributed to the fact that the top cover of the slid mass is a recently developed mass; therefore, no drainage would be on the top. However, in both cases; the shear plane and the top of the slid mass are not free from drainage and started to exhibit fine rills (Fig. 12, example at points 1, 2, 3, 4 and 5) indicating the effect of the water erosion on both surfaces. Certainly, development such rills will need thousands of years.

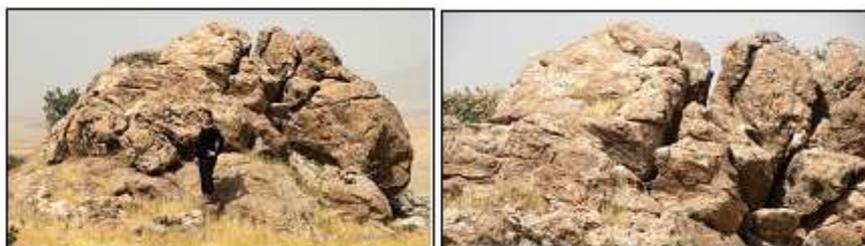
Figure: 20: A large block showing the size of the fractures

Another feature that indicates that the sliding has occurred very long time ago is the shape and opening size of the fractures (Fig.20). If those fractures were originally present in the rocks before sliding, then they will be parted to different blocks and not being exists within the slid mass as a one block.

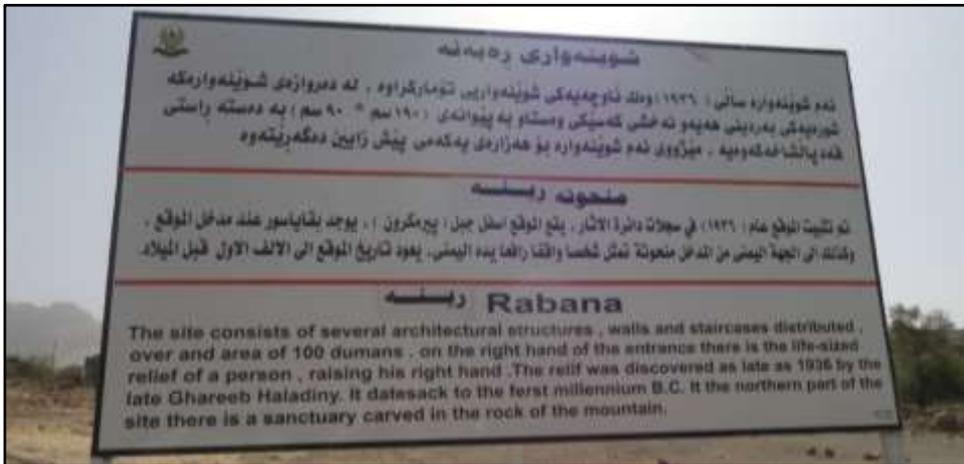
Figure 21: The shield of the archeological site that indicates the estimated age of the site.

An archeological site occurs just west of the slide area. It is dated as the first millennium B.C., which means it is more than 3000 years in age (Fig.21). According to one of the local people of Qara Chattan village many archeological indications exist even in the landslide area; like thick defence walls. This means that the site is younger than the landslide; otherwise it shouldn't exist there; it should slide down with the slid mass.

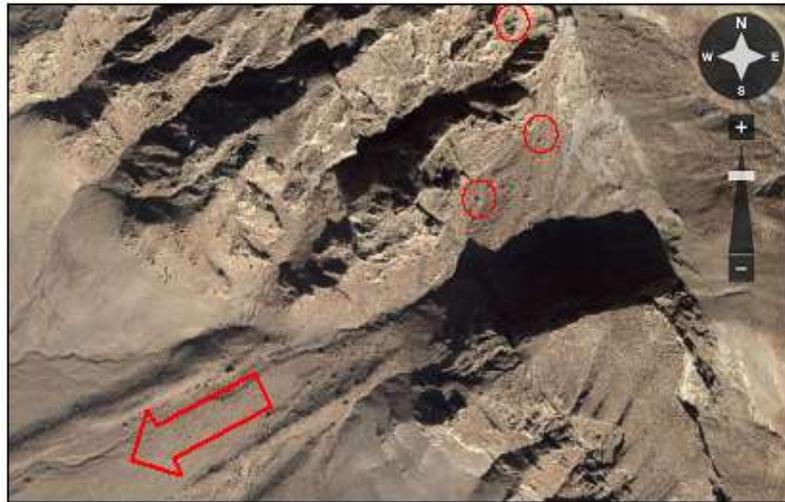
Figure 23: Google Earth image facing south. Note the karst forms on the Qamchuqa Formation; some are encircled in red colour

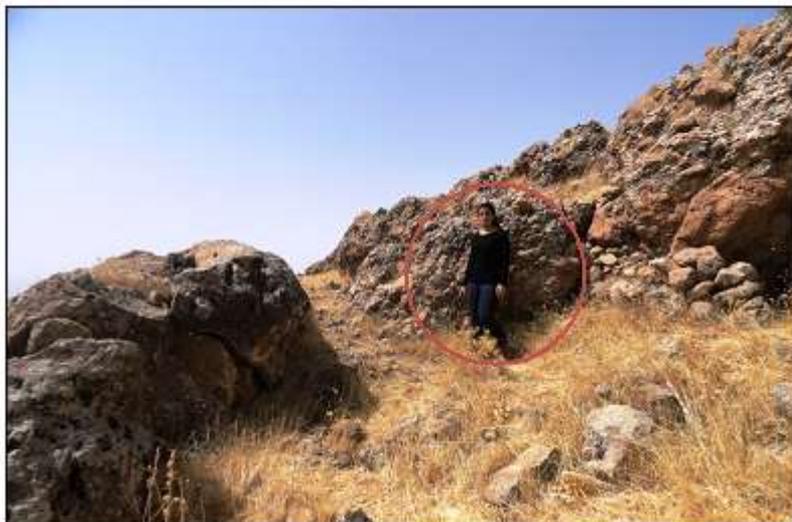
Figure 25: Brecciated sediments of the old alluvial fan; to the right and a normal fallen block from the slid mass; to the left.
