# Improved wheel-rail system of Sweden's iron ore line

**ABSTRACT:** The Swedish Iron Ore Line (IOL) is the only heavy haul line in Europe. The northern part of the line is located above the Arctic Circle, a very harsh climate. Because of the introduction of new vehicles with a 30-tonnes axle load, the track were gradually replaced between 2006 and 2009 with heavier rails, mostly with a steel grade of R350LHT. Just after the first replacement of track in 2006, the project presented herein was established with the primary goal of improving the life length of the rail, and monitoring activities started. This project now has a unique database of rail degradation data. So far, the information has been used to improve the performance of the wheel-rail system and thus extend the life length of the rail, as well as to improve our knowledge of heavy haul operations in a cold climate. The paper discusses the project progress in general and gives some examples of improvements that have been successfully implemented, such as new rail profiles and a higher grinding frequency. Finally, it discusses the challenges of future capacity improvements, such as an increase in the axle load, and how th

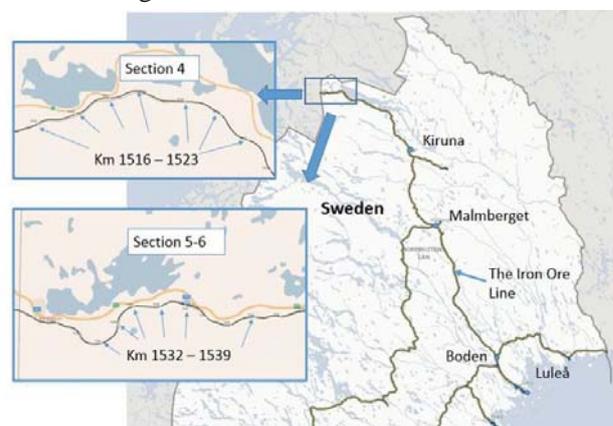
in Figure 1. The middle of the figure shows Northern Sweden; there is a harbour in the south (Luleå) and another in the north (Narvik). Situated between the harbours are two mines, one in Kiruna and the other in Malmbanan. The IOL links the mines with the har-

Figure 1. Northern Sweden with the geographic situation of the IOL and monitored sections 4-6

The IOL is the only heavy haul line in Europe. This investigation looks at the northern-most part. The IOL and the monitored areas, sections 4-6, are shown

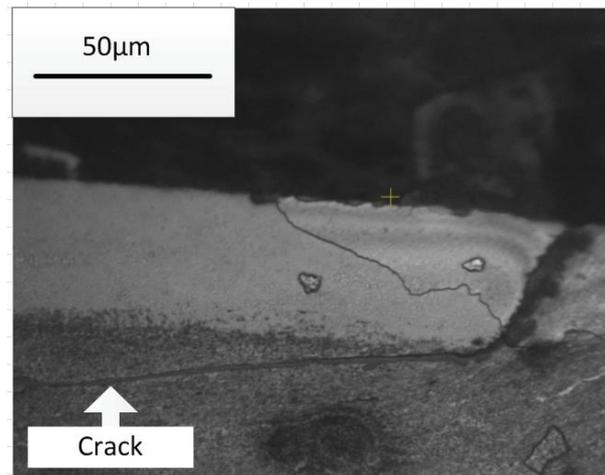
Figure 2 shows the surface of an IOL rail. The grade of this rail is R260 (CEN, 2011); it was removed from service because of RCF. At the top of the rail, it can be seen a white layer (likely a martensite layer) with a thickness of about  $50\ \mu\text{m}$ . This white layer can be produced in hard steel by adhesive slid-

Figure 2. Crack propagation on the surface of an IOL rail. ing wear without lubrication (Siposet. al., 2008) of the rails. The crack angle changes direction dramatically after passing the white layer, most likely influenced by both material properties and pressure distribution.

First, for crack propagation, the crack angle seems to get larger as it goes deeper into the rail head. At about 2 mm under the surface, the crack angle is about 70°. This can give a different crack propagation behaviour after grinding if the crack is not totally removed. This new knowledge needs to be taken into account in the planning of grinding.

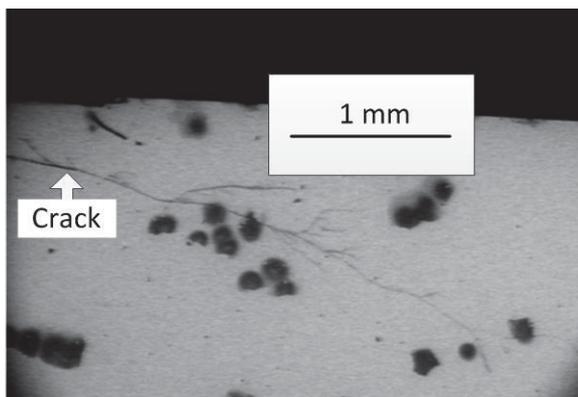
The crack is branching inside the rail during the load cycles of passing wheels, Figure 3 shows how a typical crack branches in a rail. This particular crack reaches almost 2 mm into the material at an angle of about 30° from the surface. In the end phase, the crack angle (bottom right of Figure 3) is about 70°.

Figure 3. Crack branching inside the rail.

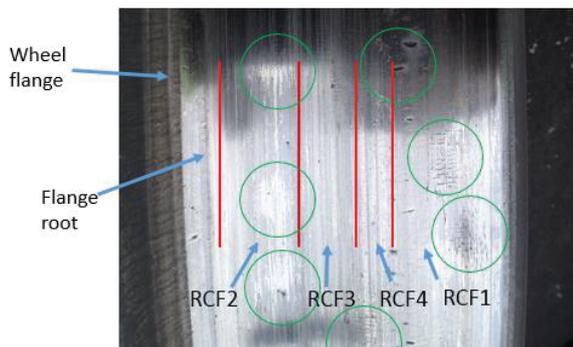
Reliability investigations of locomotive wheels show that the wheel position in the bogie has an impact on the wear rate. Studies also indicate that the most frequent failure mode is RCF on the wheel tread (Lin et al., 2013; Lin et al., 2015). Figure 4 shows the fatigued surface of such a locomotive wheel.

Figure 4. Surface fatigue on a locomotive wheel with locations of different patterns.

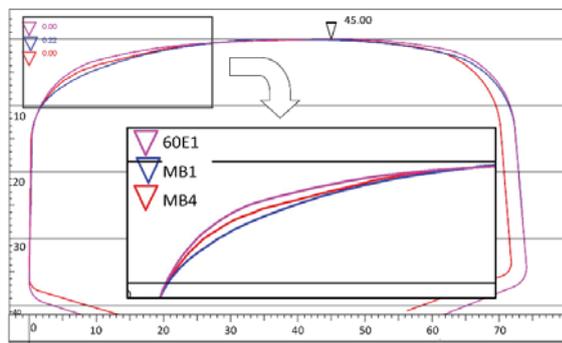
There are four main rail profiles on the main track of the IOL: 60E1, MB1, MB4 and MB5. The MB4 rail profile is used for switches and crossings and is the standard profile for tangent track. Narrow curves have MB1 on the high rail and 60E1 and MB5 on the low rail. Figure 6 shows profiles 60E1, MB1 and MB4. MB5 is a recent profile, developed for worn wheels in curves <650 m where gauge widening has taken place.

Figure 6. Three profiles used on the iron ore line.

The MB5 profile is close to the 60E1 profile, but is 0.4 mm higher on the field side and 0.1 mm higher on the gauge side. This gives a wider running surface to solve the emerging RCF problem on the low rail. Figure 7 shows the MB5 profile on the low rail; after one pass of the train with a 30-tonnes axle load, the contact band width is 30 mm.

Second, the latest developed rail profile MB5 shows good results with a wide contact band. However, it should only be applied where the track gauge is under 1450 mm because wheels with hollow wear can destroy the rail.

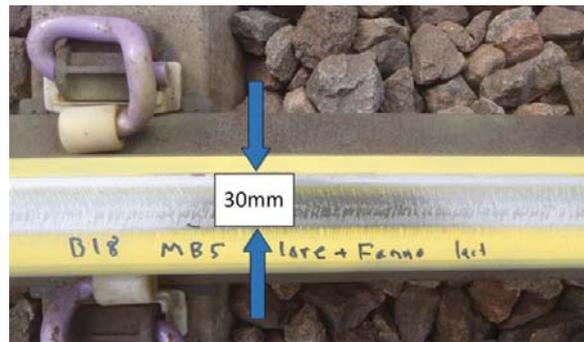
The track gauge widening needs to be managed as well, as this parameter changes the wheel-rail contact conditions. Simply stated, it leads to an accelerated formation of RCF (Asplund et al., 2017). Investigation of the IOL in test sections A to E shows that the gauge widening is about 1.6 to 0.6 mm each year, depending on the radius of the curve. In general, a smaller radius leads to faster gauge widening, and the main cause of gauge widening is worn and broken fastenings.

Figure 7. MB5 profile on the low rail where gauge widening take place.

A new type of fastener with heavier clamping force was introduced in 2012, but the results so far are not revolutionary, Figure 7 shows the new type of fastening. With these fastenings, the degradation rate in curves < 550 m in radii went from 0.0603 mm/MGT to 0.0564 mm/MGT. For curves between 550 to 650 m the track gauge widening actually increased with the new fastenings; in addition, the standard deviation (STD) was larger for these curves. However, more traffic is needed before a final conclusion can be drawn. Table 4 shows the track gauge degradation rate mm/MGT for old and new fastenings.

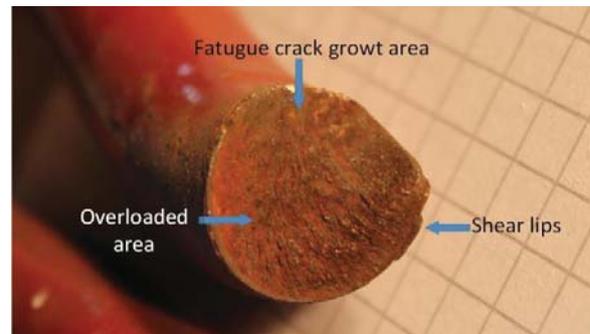
It is discovered that a certain section had a large number of broken fastenings. This was surprising, as the curve in question does not have a specifically small radius; its radius is 765 m (D-curve; see Table 1). The accumulated tonnage for this curve is 240 MGT. The broken fastenings were investigated by the manufacturer who determined that fatigue cracking caused the failure. There were too many or too large force cycles in the vertical direction.

a better gauge in narrow curves. Figure 5 shows the typical failure mode and the fractured face of a fastening clip.

Figure 5. Fractured face of a fastening clip.

The manufacturer's recommendation was to use another type of fastening, change to a stiffer pad to reduce the deflection, and change the isolators to keep

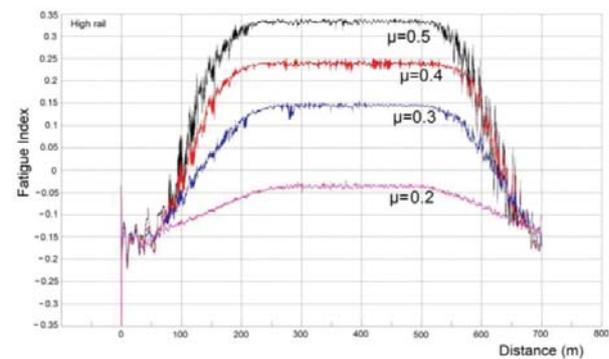
effect of friction control on the generation of RCF. The MBS used basic theory such as shakedown and energy dissipation methods to predict the generation of RCF. A sample result from the MBS is a fatigue index (Ekberg & Kabo, 2005), based on shakedown theory, for a curve of 200 m radius. This is shown in Figure 8 and Figure 9. The fatigue index reports only the initiation of RCF. If the index is positive (>0), RCF will initiate; otherwise, there will be no RCF. The fatigue index value represents the proportion of the pressure which has overshoot the limit for shakedown.

Figure 8. Fatigue index for a curve of 200 m radius and 700 m length at different friction values with respect to the distance in the curve of the high rail (Khan et al. 2016).

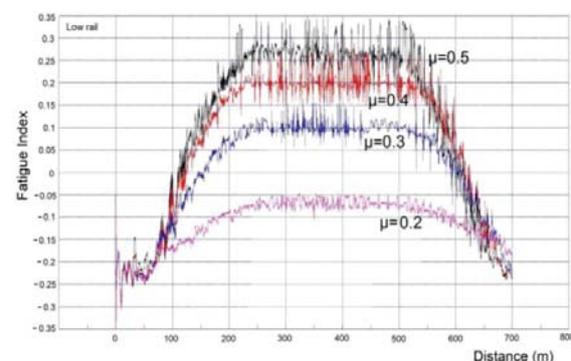
Figure 9. Fatigue index for a curve of 200 m radius and 700 m length at different friction values with respect to the distance in the curve of the low rail (Khan et al. 2016).

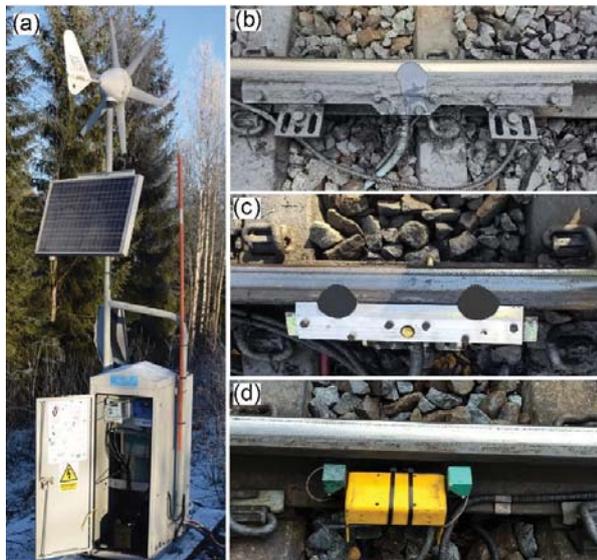
Despite the positive theoretical results, the presently installed wayside equipment (see Figure 10) does not seem a promising solution for the application of TOR–FM. The equipment is battery powered and is recharged using wind and solar energy; it is a challenge to keep the battery alive during winter, but installation of a direct power supply is costly and therefore is not possible in this project. In addition, to keep the equipment running, regular refill and maintenance are required. In an initial field test (Asplund & Nordmark, 2015) before the start of the current project, the similar wayside equipment is used, but observed no benefit. It was thought the benefits were negligible

Figure 11. The wayside TOR equipment installed at Gullträsk, Sweden (a) Main unit (b) Distributing bars used for FM-A (c) Distributing bars used for FM-B (d) Wheel detecting sensor

because of good wheel and rail maintenance practices. However, more recent experiments show that the carry distance of TOR-FM when using wayside equipment is extremely short. With an application of 1 litre/1,000 axles, four times the recommended amount, it was observed a carry distance of 20 m when using the product from one supplier and 225 m when using the product from another. Possibly different solvents are used in the products, and this may explain the difference, but this is speculative, as the contents of the FMs are unknown. The carry distance of TOR-FM on wheels was also followed; it is observed a dried FM layer on the wheel surface for up to 1 km, but there was no FM in the contact band where it is actually needed.

Fourth, with respect to TOR-FM, there are some problems in the carry distance capabilities of wayside equipment; depending on the product used, this varies from 20 to 225 m, but in all cases, the distance can be considered short. Luleå University of Technology and LKAB are discussing the installation of one or two on-board systems and calculating the life cycle cost of the on-board system.

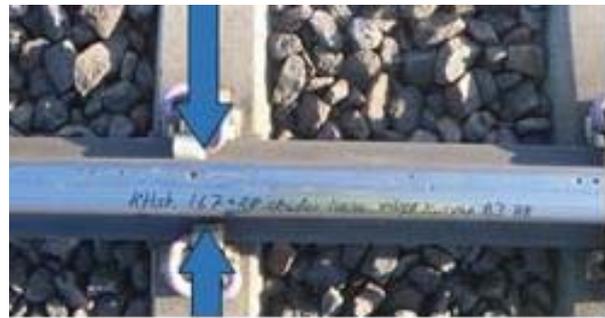
Regular grinding has been implemented since 2006 with the installation of the new track. The use of a continuous grinding strategy has resulted in good rail condition. Although the rail in tangent tracks and on curves is good, the low rail on curves with a small radius needs more investigation. Figure 10 shows the low rail and its failure mode, line spalling.

Figure 10. Low rail with spalling on the running surface.

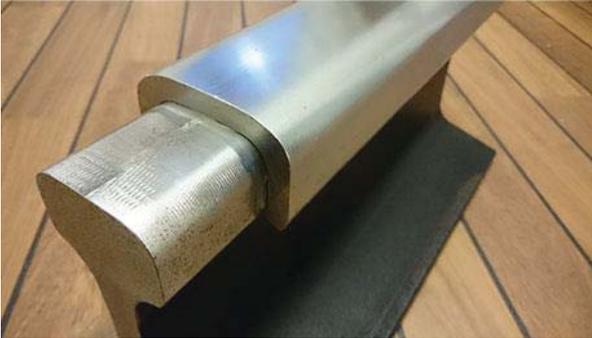
The ReRail is a totally new concept of how a rail is built up. The ReRail is a replaceable rail head made of hardened steel (martensitic micro structure) with a thickness of 10–12 mm. The concept of a replaceable rail head is shown in Figure 12.

Figure 12. ReRail is a replaceable rail head.

One advantage of ReRail is that there is less carbon emission in the rail production; another is that the material chosen can be harder than the regular rail.

A 6 m test rail is mounted as a high rail in a curve of 600 m radii on a section of the IOL. This has been in service since June 2016 and is loaded with about 10 MBT (until February 2017). This rail is carefully monitored in terms of wear, fatigue and conductivity. So far, the test shows positive results.

Fifth, the ReRail findings are promising. ReRail has been used on track with about 10 MGT with no abnormalities; the trial will continue until 2019.
