Assessment of concrete bridges - Prestress forces

Experiences from full-scale testing to failure of a bridge in Kiruna

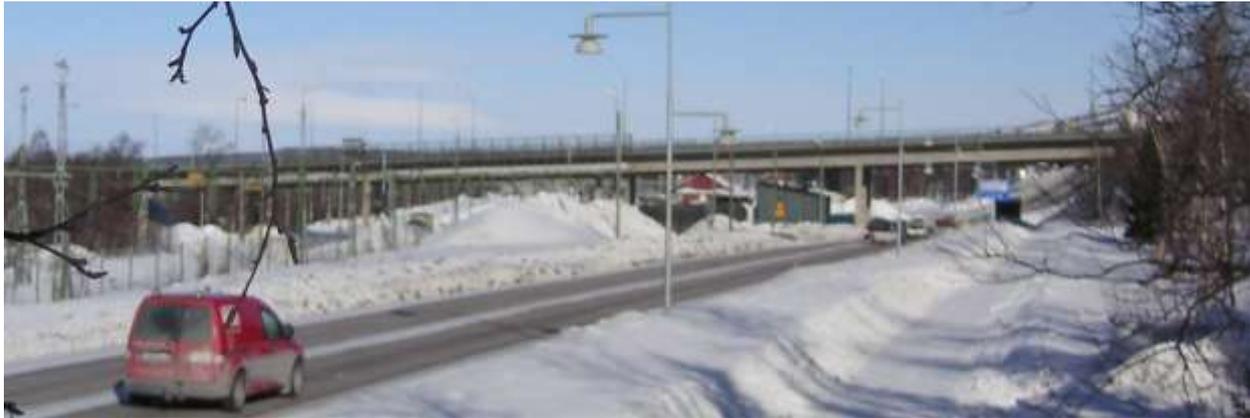
Figure 1. The Kiruna Bridge with road E10 to the right and Iron Ore Railway line to the left (2010-03-23).

The test object, located in Kiruna, Sweden, was a viaduct across the European road E10, see Figure 1. It was constructed in 1959 as a part of the road connecting the city centre and the LKAB mining area. Due to underground mining, the entire area underwent excessive settlement. The owner of the bridge, LKAB, closed it in October 2013 and planned to tear it down in September 2014. Before demolition, the bridge was tested in a research project which will be discussed below [5]-[11].
