Mystery of Mosul Dam the Most Dangerous Dam in the World: Maintenance Grouting

Nasrat Adamo⁴, Nadhir Al-Ansari¹, Issa E. Issa³, Varoujan K. Sissakian⁴ and Sven Knutsson⁵

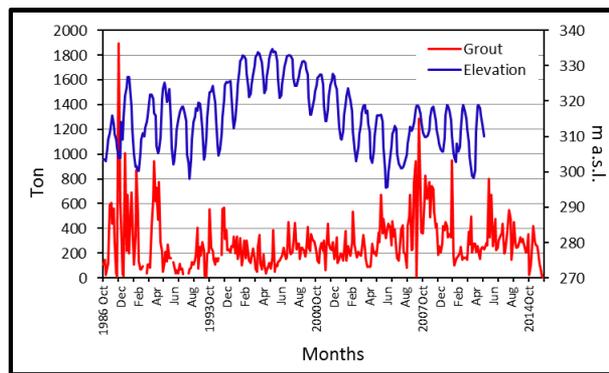
Figure 1: Monthly grouting and water level at Mosul Dam.

The Mosul Dam grouting works were completed on February 6th, 1988. Maintenance grouting works; however, has been going on since September 1986, at which time impounding of the reservoir was started and water level was rising steadily. Figure 1

shows the quarantines of grouting takes injected from October 1986 up to October 2014. Efforts at that time were going on to close the already unsealed so called “Windows”, where design criteria for acceptable residual permeability could not be reached. Meanwhile, areas of high grout takes appeared in other locations. The general accepted cause for this was the dissolution of the gypsum and/or anhydride beds resulting in the deterioration of the curtain. So, it was clear that new methods had to be found to cope with the new situation. High hydraulic heads were steadily building up resulting in increased seepage flows through the curtain. New grout mixes were tested and even methods of delivering and injecting large grout quantities were developed. Maintenance grouting works continued from September 1986 up to now. Where the quantity of grout used from 1986 to 2015 reached 95657.43 tons. Techniques of Enlarged (massive) grouting as it is called now are used in addition to normal grouting that was already in use.

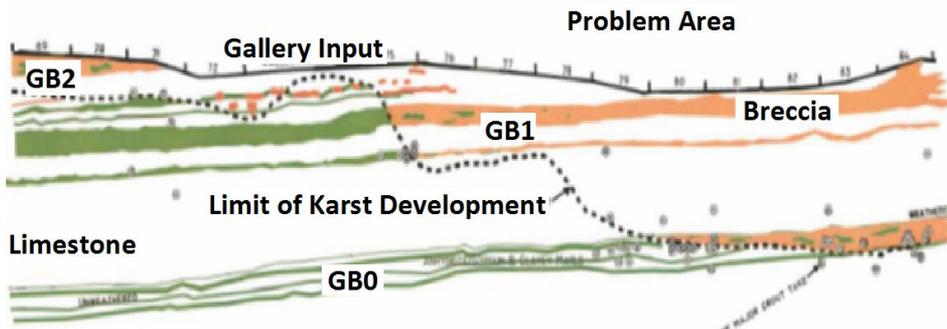
Figure 2: Major Grout takes in sections 69-84.

Continuation of the piezometric observation resulted in the repeated application of both normal and massive grouting works up to now as a repair measure. The location of the major grout takes between sections 69 and 84 is shown in figure 2.

There are other high grout take zones along the dam, but this area appears to be one of a major concern. The heavy line shown on the crest of the dam in figure 2 shows the approximate extent of this problem (high grout take) area. The green layers represent anhydride, while the orange represent gypsum breccia (nodules). The major grout takes are located close to the karst line associated with the conversion of anhydrite to gypsum (and also marking of the change from a high permeability to a lower permeability foundation), and also in the gypsum breccia(nodules). The white area between the green and orange layers consists of karstified limestone. It often contains voids, fractures, and fissures [7].
