Instrumentation and Full-Scale Test of a Post-Tensioned Concrete Bridge

Thus, in the study presented here a 55-year-old post-tensioned concrete bridge was thoroughly instrumented (with up to 141 sensors) and tested to failure. The aims were to calibrate and refine methods and models for assessing existing reinforced concrete bridges, and to assess the utility of methods using carbon fibre reinforced polymers (CFRPs) for upgrading reinforced concrete structures [23]. Since there have been few full-scale tests on post-tensioned bridges, a particular focus was on assessment of the post-tensioned system. The complete test and measuring programme is described here, and selected general results to provide insights about the tests. More detailed results will be presented later.

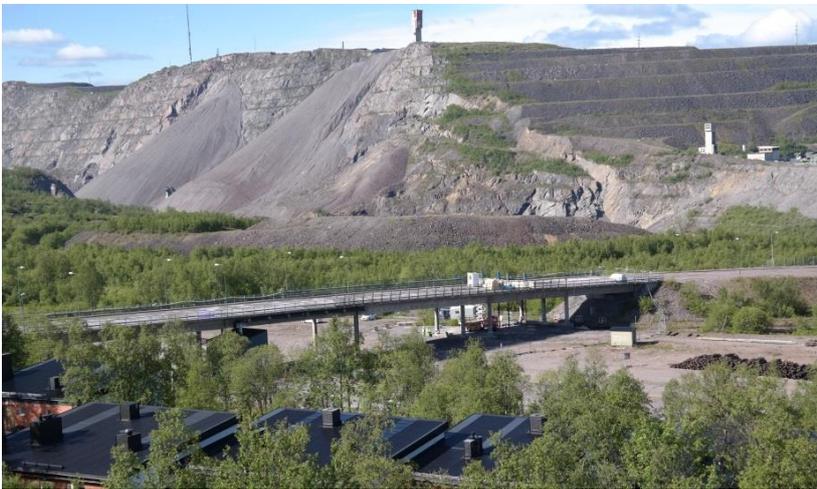
Figure 1 – Photograph of the Kiruna Bridge from the north-east, showing the slag heap from the LKAB iron ore mine in the background (2014-06-25).

The Kiruna Bridge, located in Kiruna, Sweden, was a viaduct across the European route E10 and the railway yard close to the town's central station (Figure 1). It was constructed in 1959 as part of the road connecting the city centre and the mining area owned by LKAB. The sub-level caving method for extracting the ore causes subsidence. Thus to ensure the continuing utility of the Kiruna Bridge, in 2006 LKAB initiated geodetic position measurements of the bridge supports. In 2008 Luleå University of Technology (LTU) started to monitor the bridge continuously [24]. Due to ongoing subsidence, LKAB decided to permanently close the bridge in October 2013 for demolition in September 2014, providing an opportunity for LTU to test it to failure in May-August 2014.

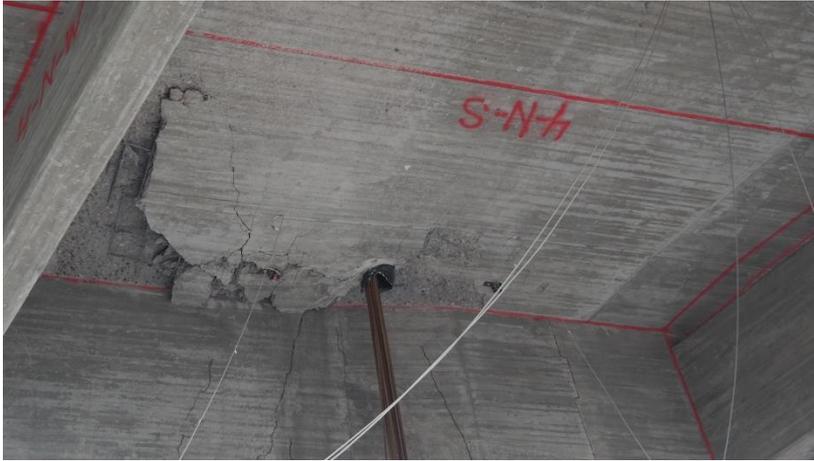
Figure 17 – Photograph of the bridge slab failure, view from south (2014-06-27).

The data acquired from the specified test setup indicate that the load-carrying capacity of the bridge slab was 3.32 MN. Thus, the load transferred in each loading plate was 1.66 MN. The slab failed only at the western load distribution plate, displaying very brittle behaviour with no

appreciable indication of the failure. In Figure 17 the final shape of the bridge slab is presented from underneath the bridge. Due to the arrangement of the test setup and type of failure it was not possible to further load the slab to achieve failure at the eastern load distribution plate.
