Experimental Testing of Anchoring Devices for Bottom Rail in Partially Anchored Timber Frame Shear Walls With Two-Sided Sheathing

Giuseppe Caprolu

Luleå University of Technology
Department of Civil, Environmental and Natural resources engineering
Division of Structural and Construction Engineering

Luleå 2012

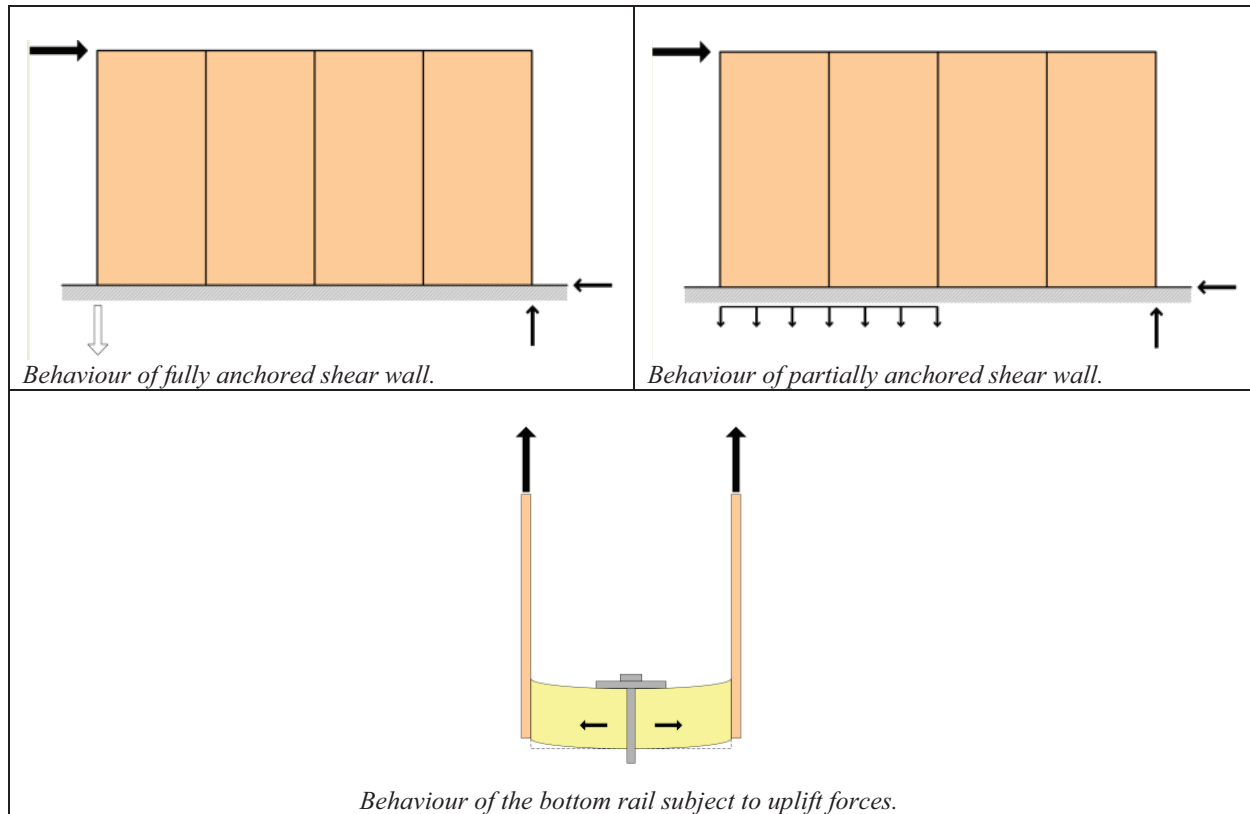
Figure 1: Behaviour of fully and partially anchored shear walls and behaviour of the bottom rail under uplift forces

In fully anchored shear walls the uplift is prevented by some kind of tying down device at the leading stud. This will result in a concentrate force at the end of the wall. In partially anchored shear walls there are no device between the leading stud and foundation. The uplift is resisted by the sheathing-to-framing joints along the bottom rail. This will result in a distributed force on the bottom rail and there is some uplift of the studs of the wall (*see Figure 1*).

In the latter case the bottom rail will be subject to uplift forces that cause a tension stresses perpendicular to the grain and crosswise bending (*see Figure 1*).

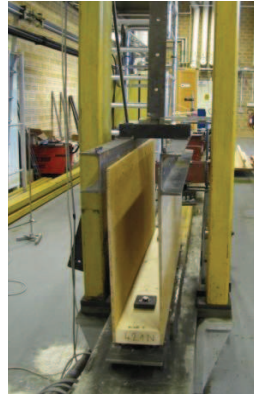
Figure 2: Test setup

The bottom rail was fixed to a steel plate simulating the foundation which in turn was welded to a steel structure. The connection between bottom rail and steel plate was made through two anchor bolts. To tighten the bolt a torque moment of 50 Nm was used. A square or rectangular washer of high rigidity was inserted between the bottom rail and the head bolt. Its size and shape varied for the set tested.

A tensile load with a rate of 2 mm/min was applied by a hydraulic piston (static load capacity 100 kN) through two load distribution C steel beams attached to the upper panels by four bolts Ø 16 for each panel (see Figures 2 and 3 for test setup).

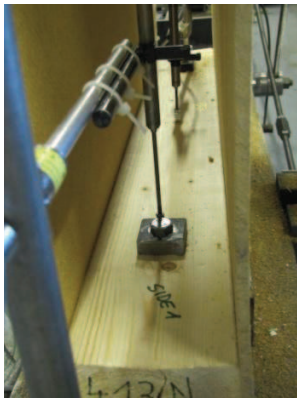
Figure 5: position of the two LVDT on the upper surface of the bottom rail

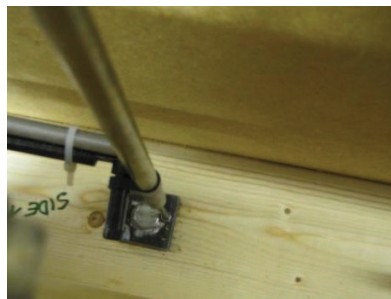
Figure 6: position of LVDT recording displacement 1

However the displacement 1 was too small to measure and this has given some problem during recording of data. Plotting the graph load vs. displacement during the post process the line plotted appears disturbed and it is impossible to understand the real curve trend.

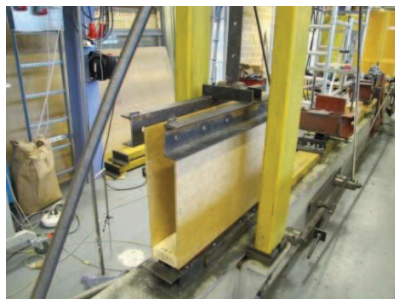
Figure 8: lifting device free to rotate during loading

The rails are free to rotate during loading, i.e. the inclined bars are removed from the lifting device (see Figure 7 and 8). This provides a well-defined boundary condition. However by mistake Set 1 was tested before cutting the inclined bars and it was retested in Set 1-BIS (see Figure 9 and 10). The results of Set 1 are also presented in this report and compared with Set 1-BIS, in order to evaluate the influence of different boundary conditions.

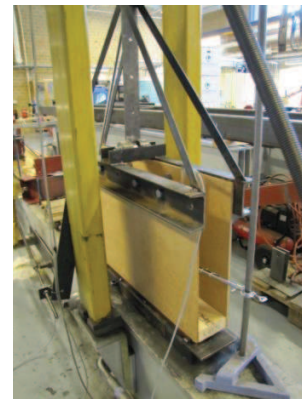
Figure 10: lifting device with inclined bars used for Set 1

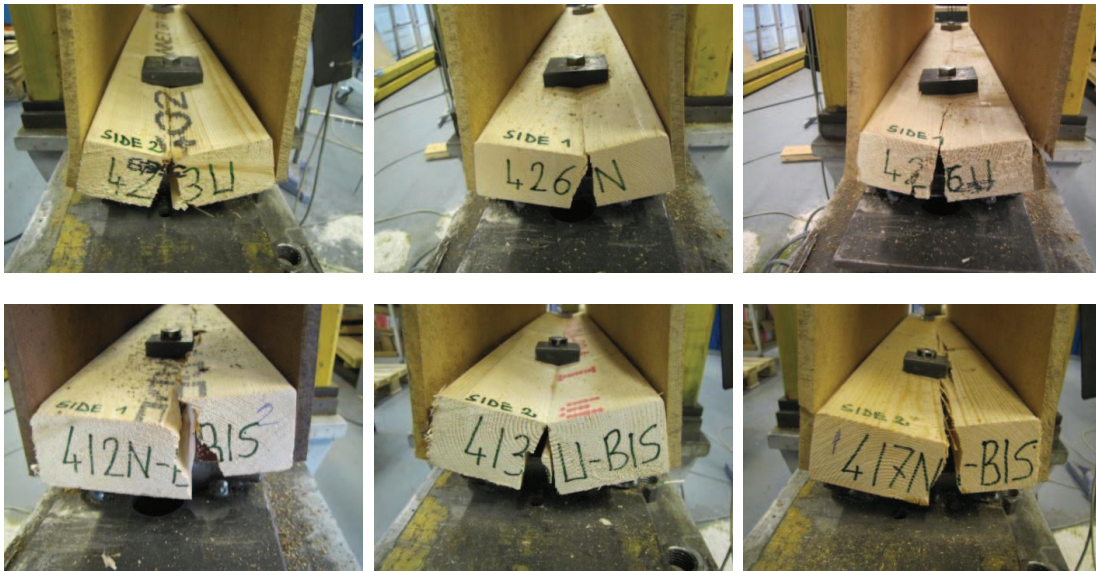
Figure 12: Some example of failure mode 1, splitting of the underneath side of the bottom rail

- **Failure mode 1:** failure due to splitting of the underneath side of the bottom rail (see Figure 12);

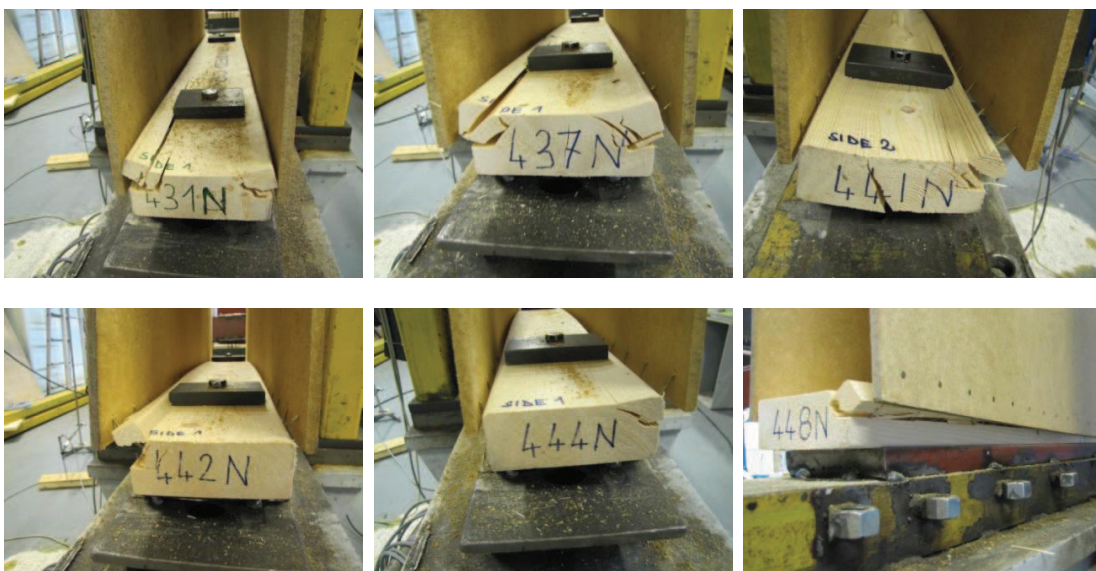
Figure 13: Failure mode 2, splitting along the edge side of the bottom rail

- **Failure mode 2:** failure due to splitting along the edge side of the bottom rail (see Figure 13);

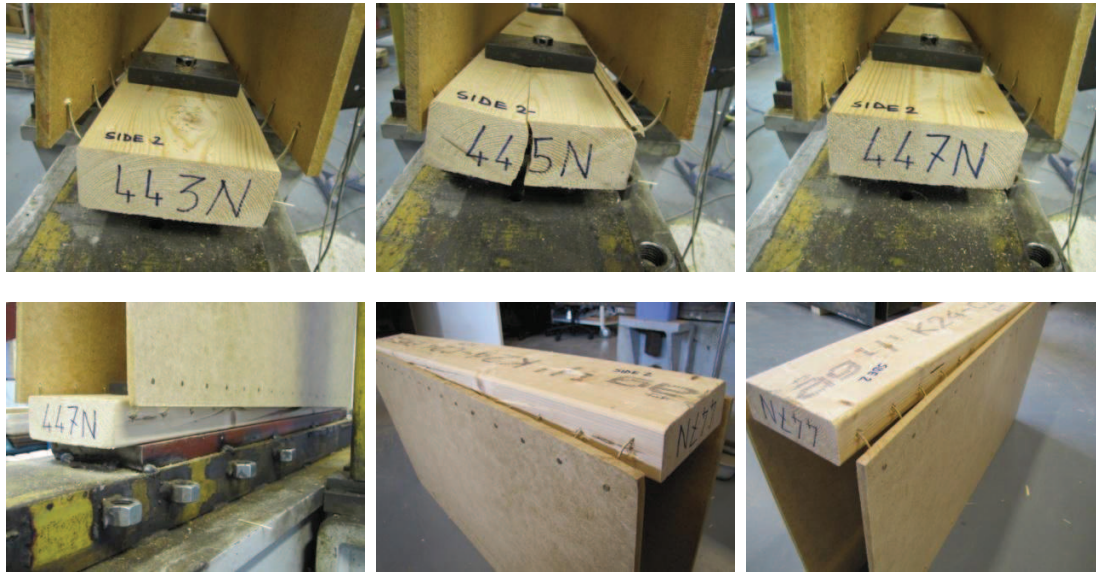
Figure 14: Failure mode 3, pull-out of nails

- **Failure mode 3:** failure due to pull-out of nails (see Figure 14);

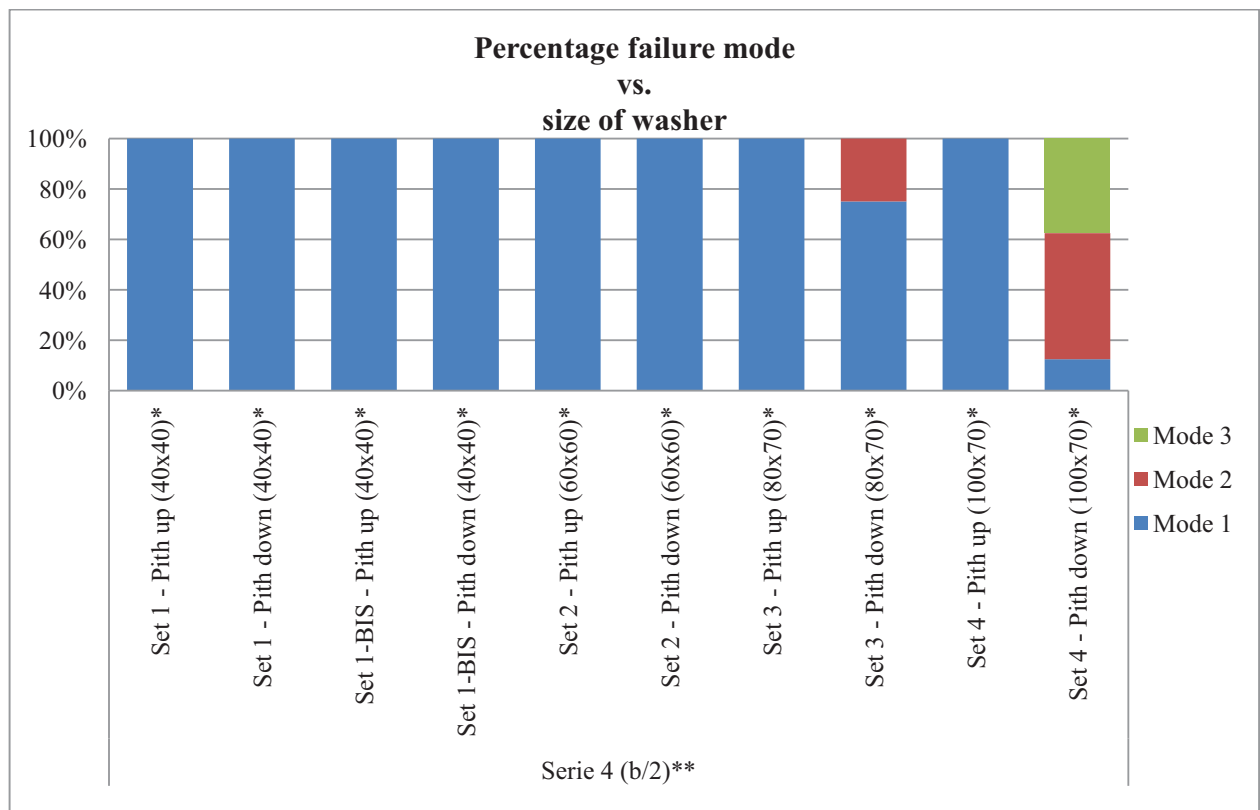
Figure 15: *Size of washer [mm], **Bolt position (where b is the width of the bottom rail, 120 mm). **Failure mode 1:** splitting of the bottom rail; **failure mode 2:** splitting of the bottom rail along the line of the nails between the anchor bolts; **failure mode 3:** pull-out of nails

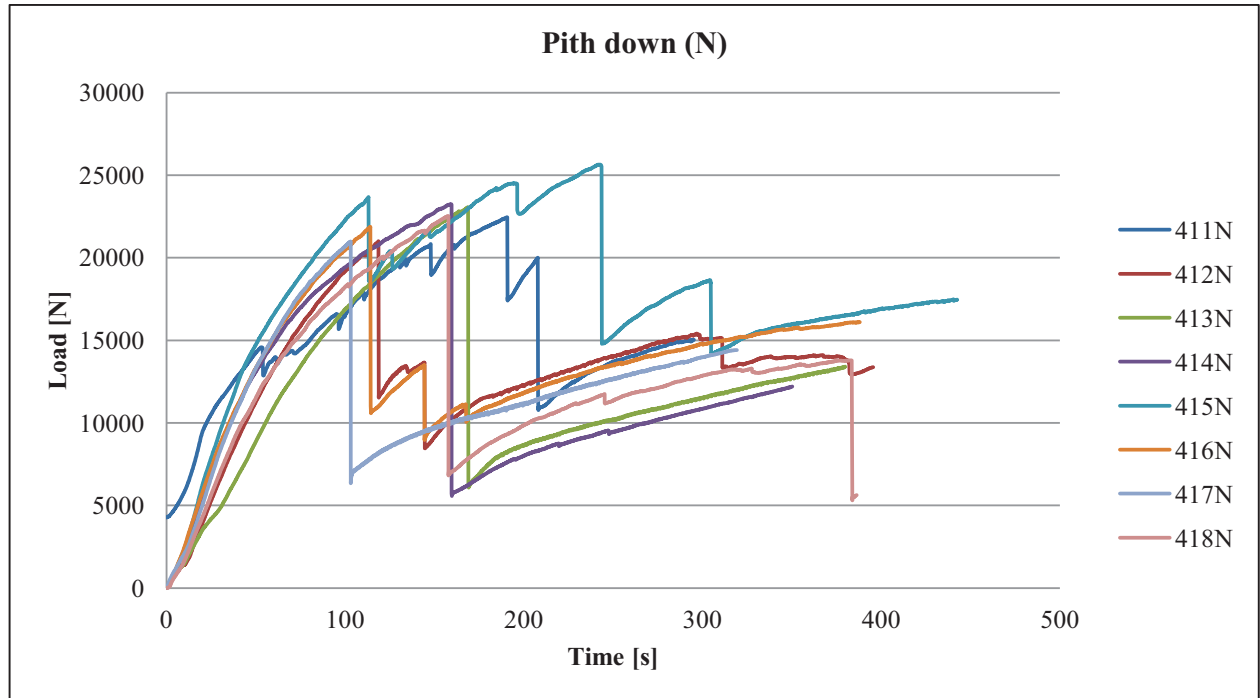
Figure 16: Load vs. time curves for bottom rail with pith down of Series 4 – Set 1.8 failure mode of type 1

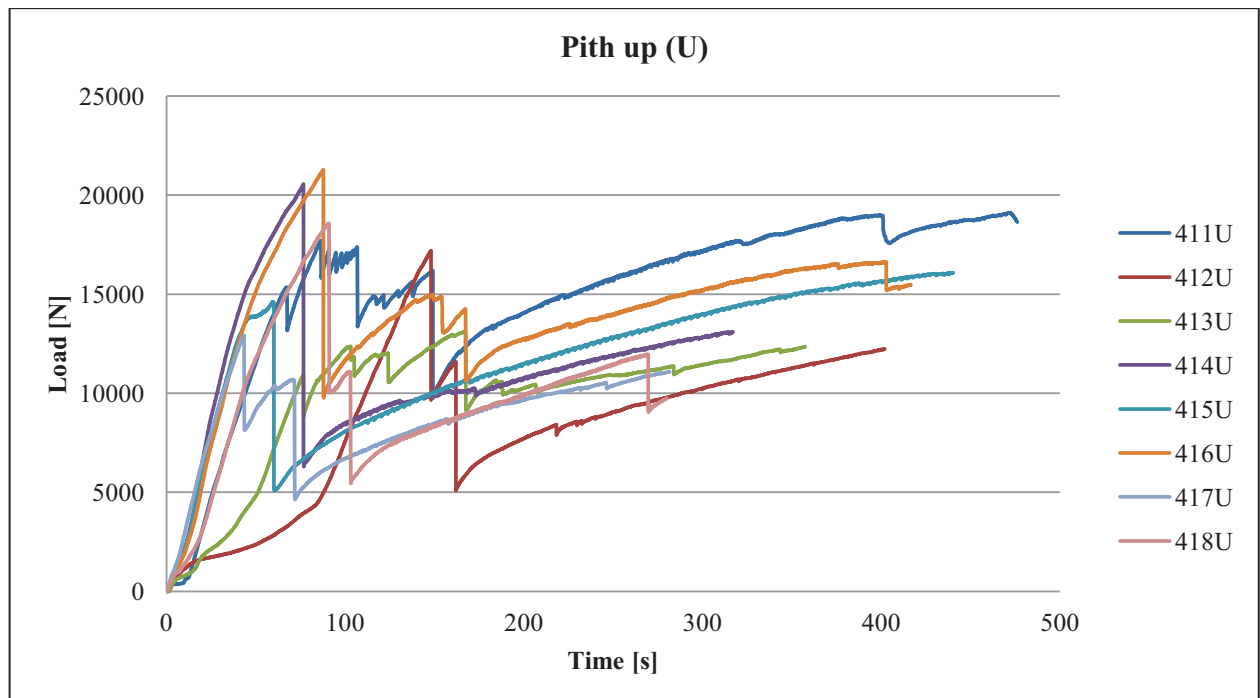
Figure 17: Load vs. time curves for bottom rail with pith up of Series 4 – Set 1.8 failure mode of type 1

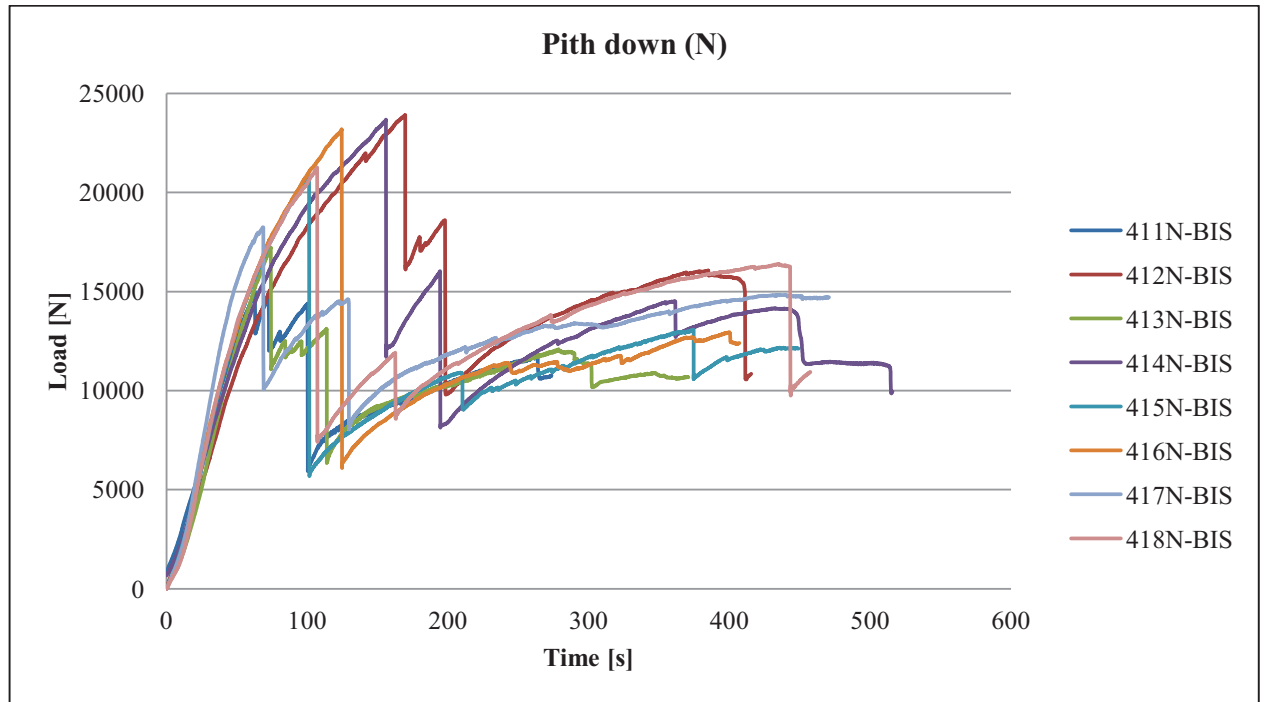
Figure 18: Load vs. time curves of bottom rail with pith down of Series 4 – Set 1-BIS. 8 failure mode of type 1

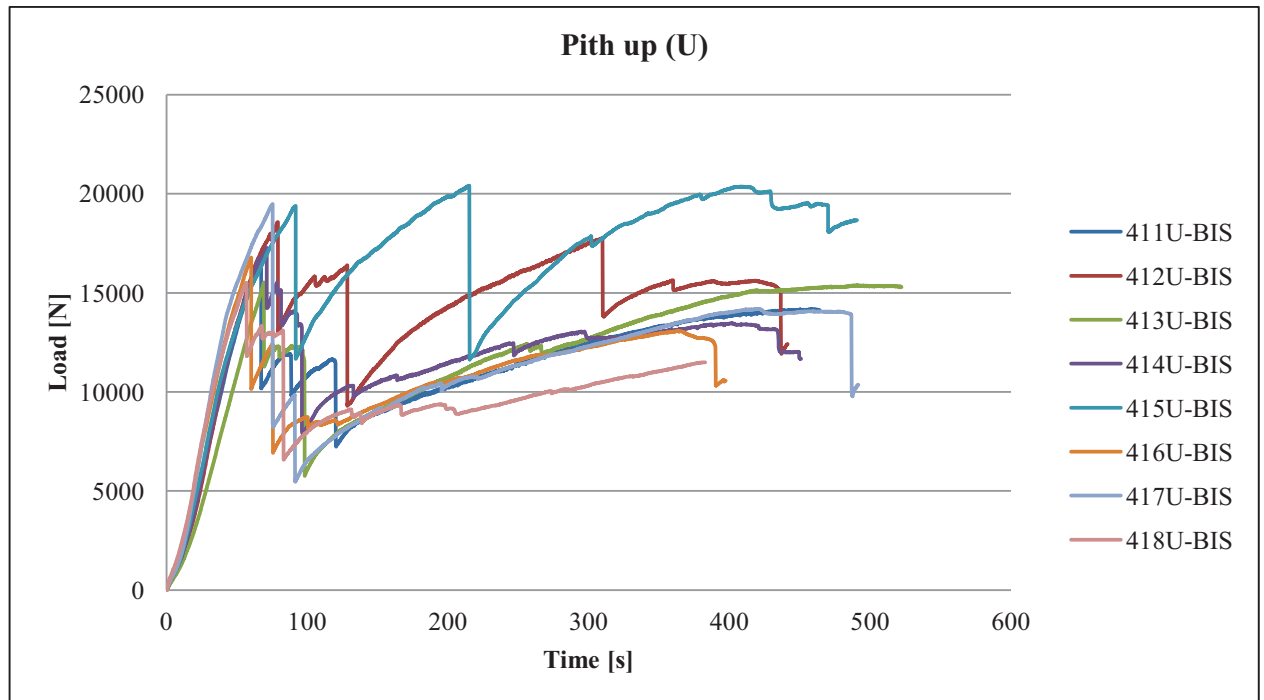
Figure 19: Load vs. time curves of bottom rail with pith up of Series 4 – Set 1-BIS. 8 Failure mode of type 1

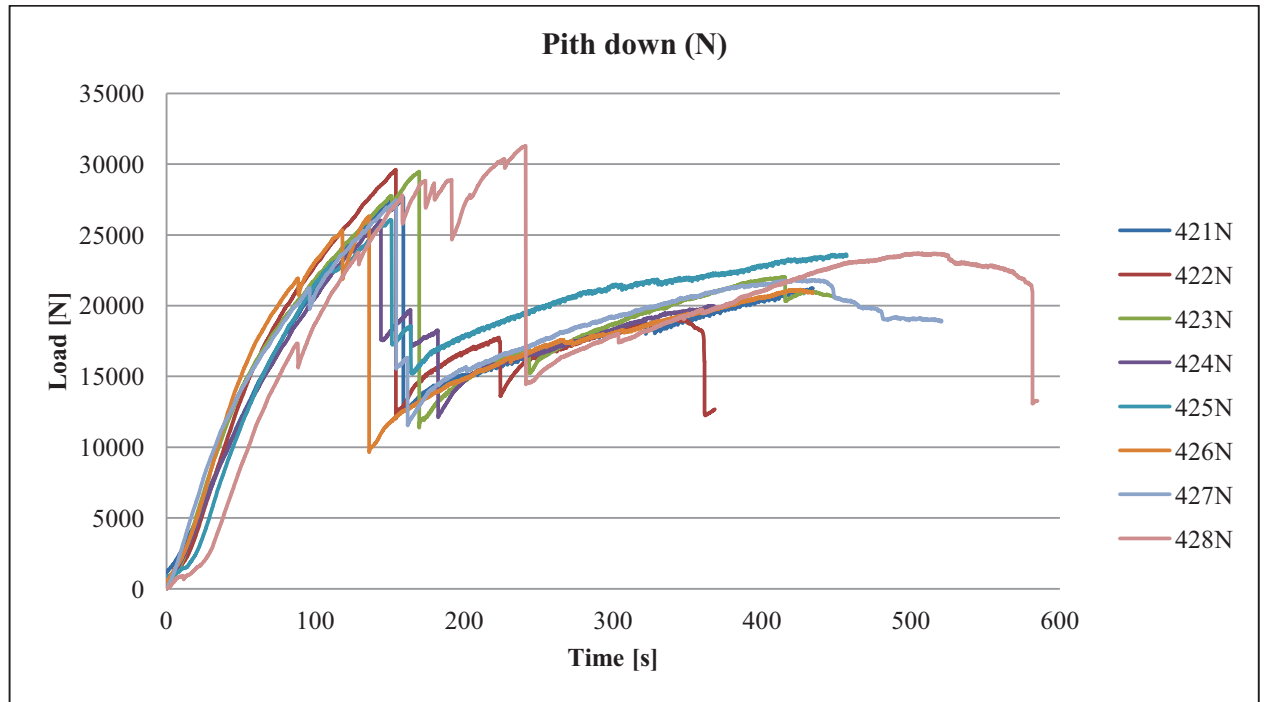
Figure 20: Load vs. time curves of bottom rail with pith down of Series 4 – Set 2. 8 failure mode of type 1

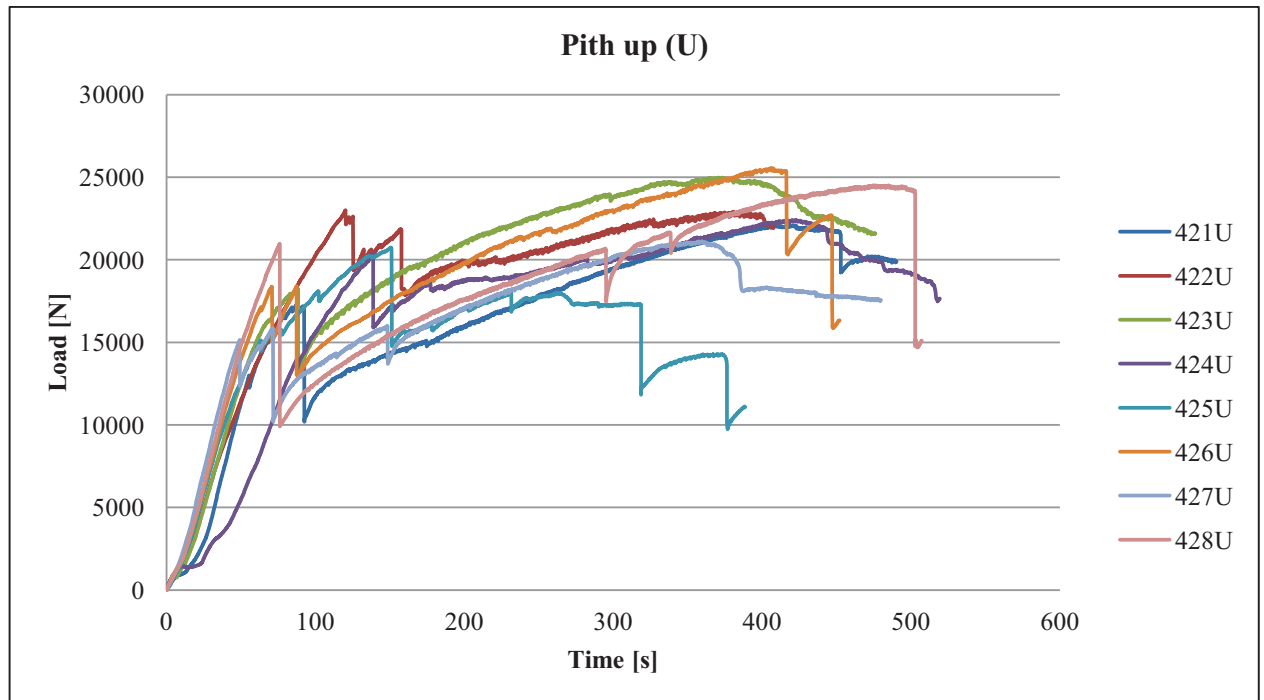
Figure 21: Load vs. time curves of bottom rail with pith up of Series 4 – Set 2. 8 failure mode of type 1

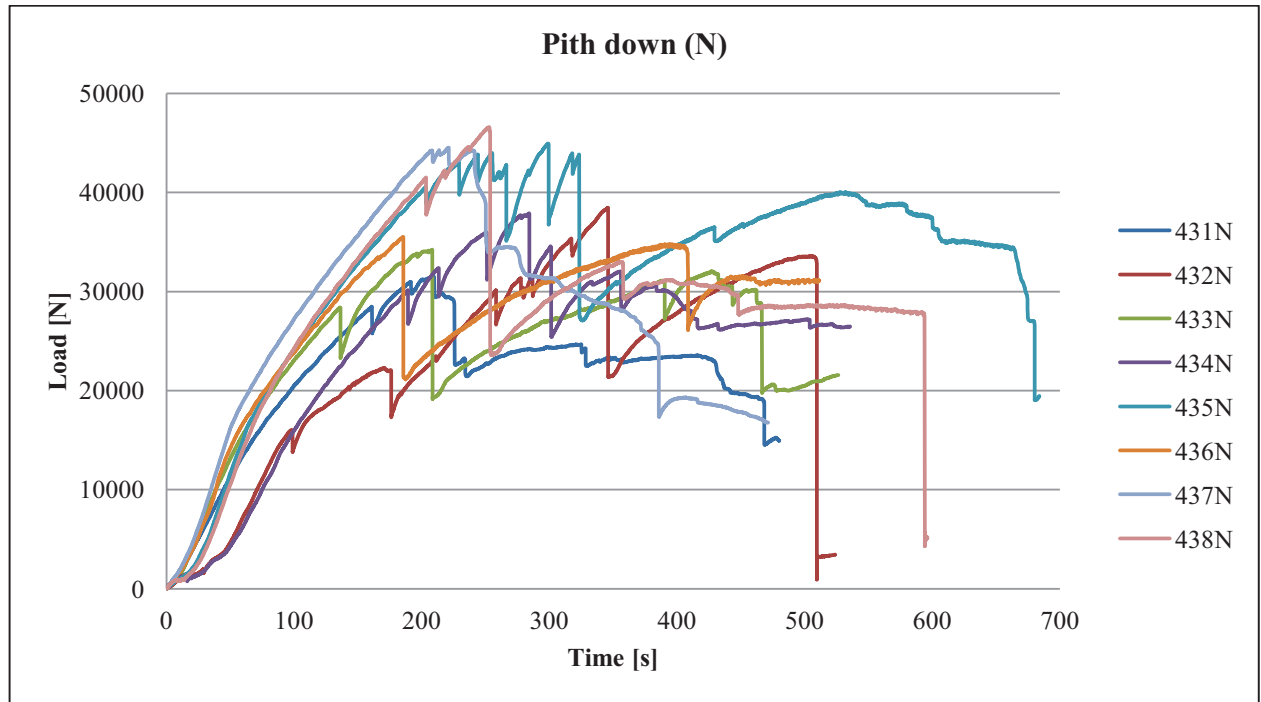
Figure 22: Load vs. time curves of bottom rail with pith down of Series 4 – Set 3. 6 failure mode of type 1 and 2 of type 2

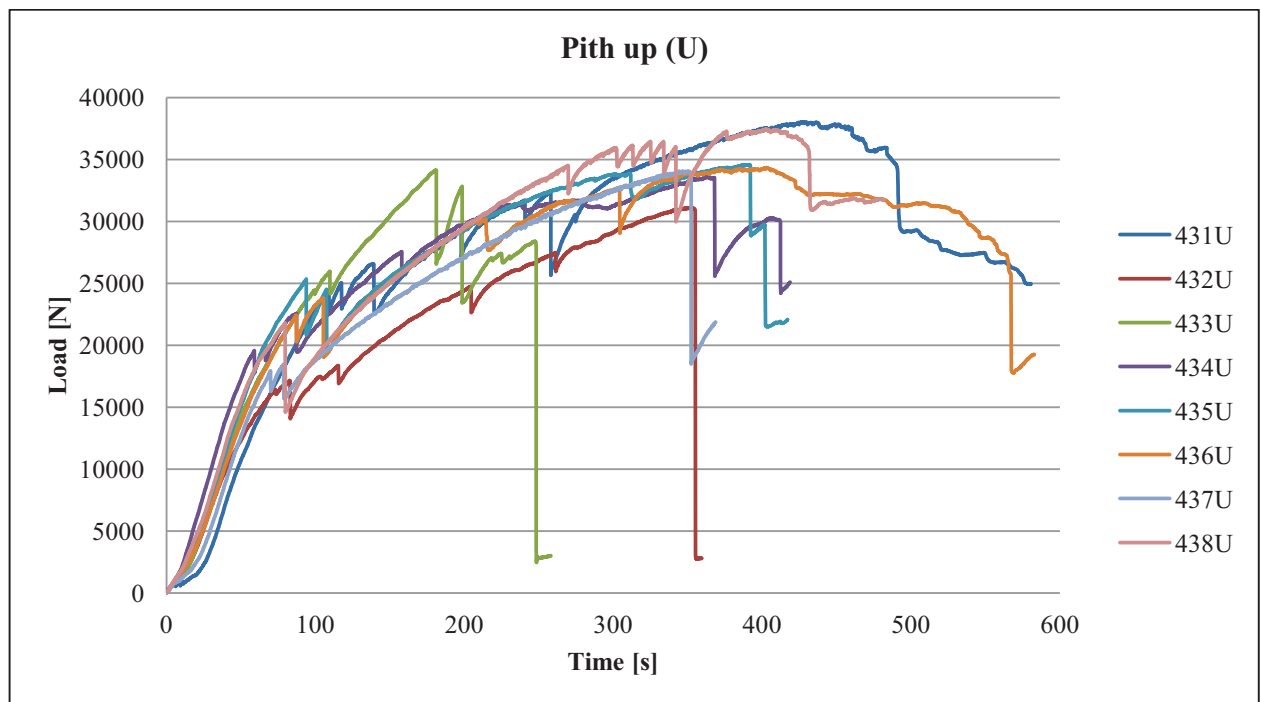
Figure 23: Load vs. time curves of bottom rail with pith up of Series 4 – Set 3. 8 failure mode of type 1

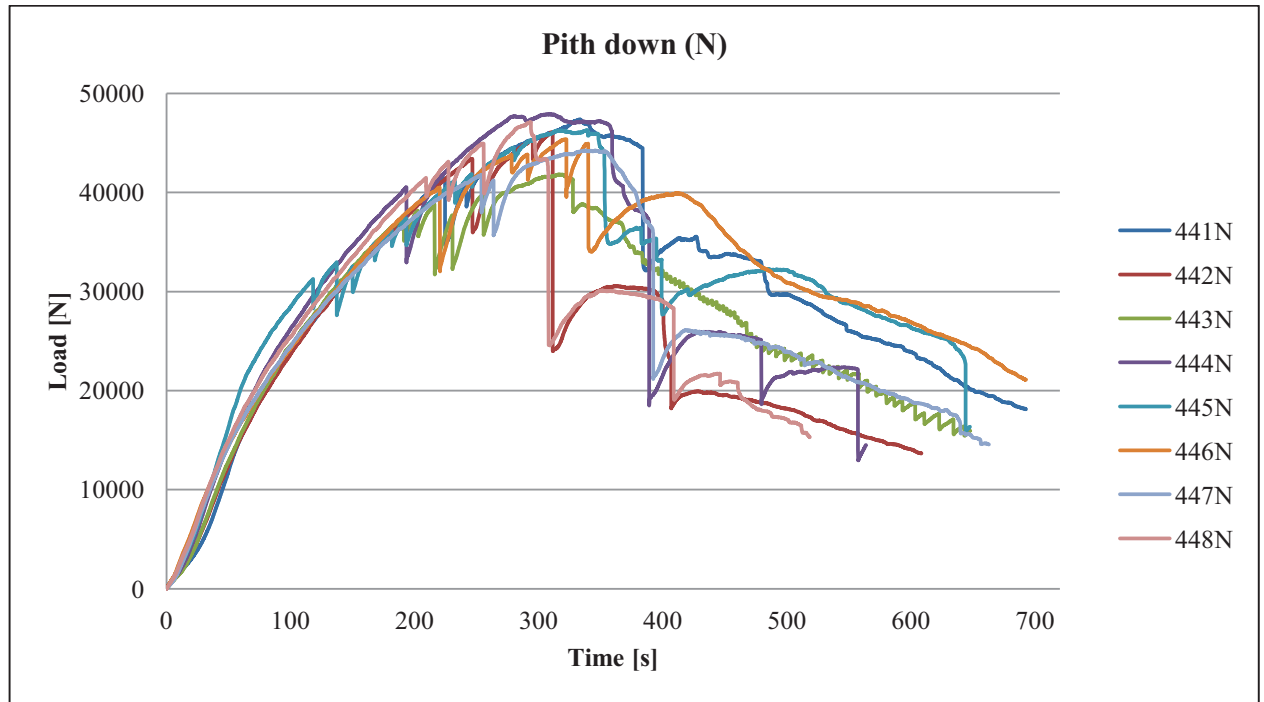
Figure 24: Load vs. time curves of bottom rail with pith down of Series 4 – Set 4. 1 failure mode of type 1, 4 failure mode of type 2 and 3 failure mode of type 3

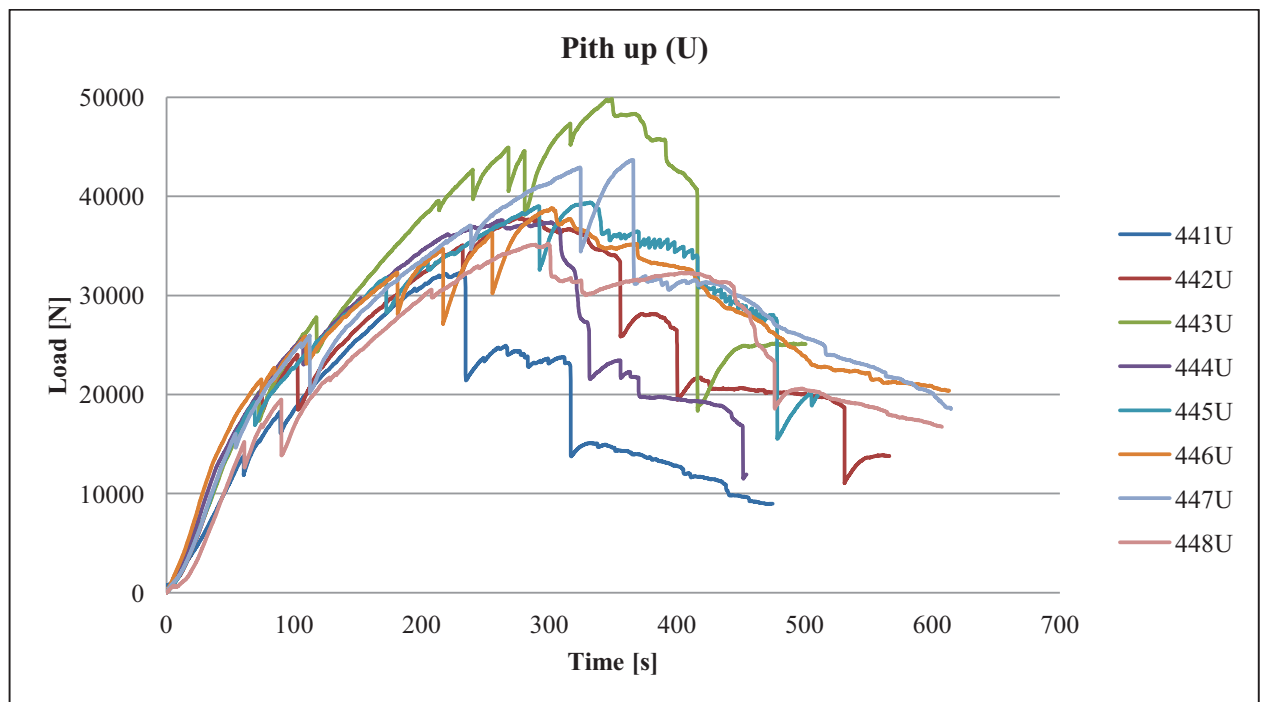
Figure 25: Load vs. time curves of bottom rail with pith up of Series 4 – Set 4. 8 failure mode of type 1 (see Appendix B notes ⁽¹⁾, ⁽²⁾ and ⁽³⁾ about the type of failure of this set)

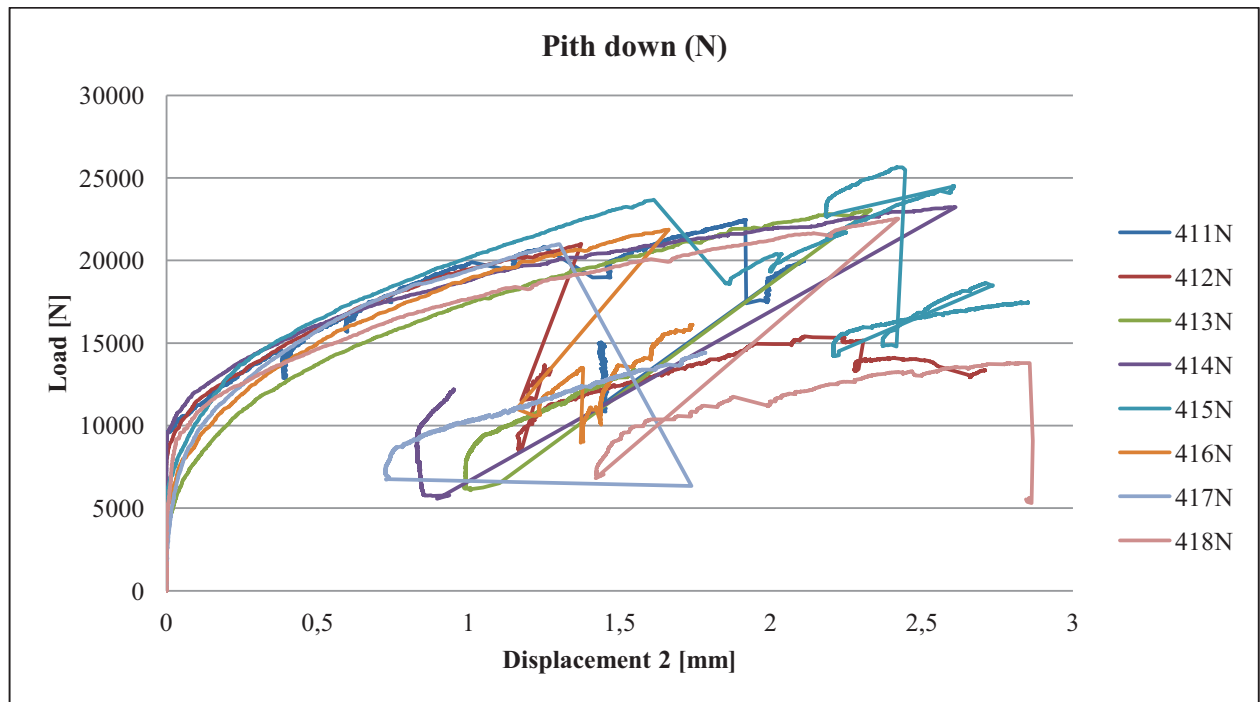
Figure 26: Load vs. displacement curves of bottom rail with pith down of Series 4 – Set 1. 8 failure mode of type 1

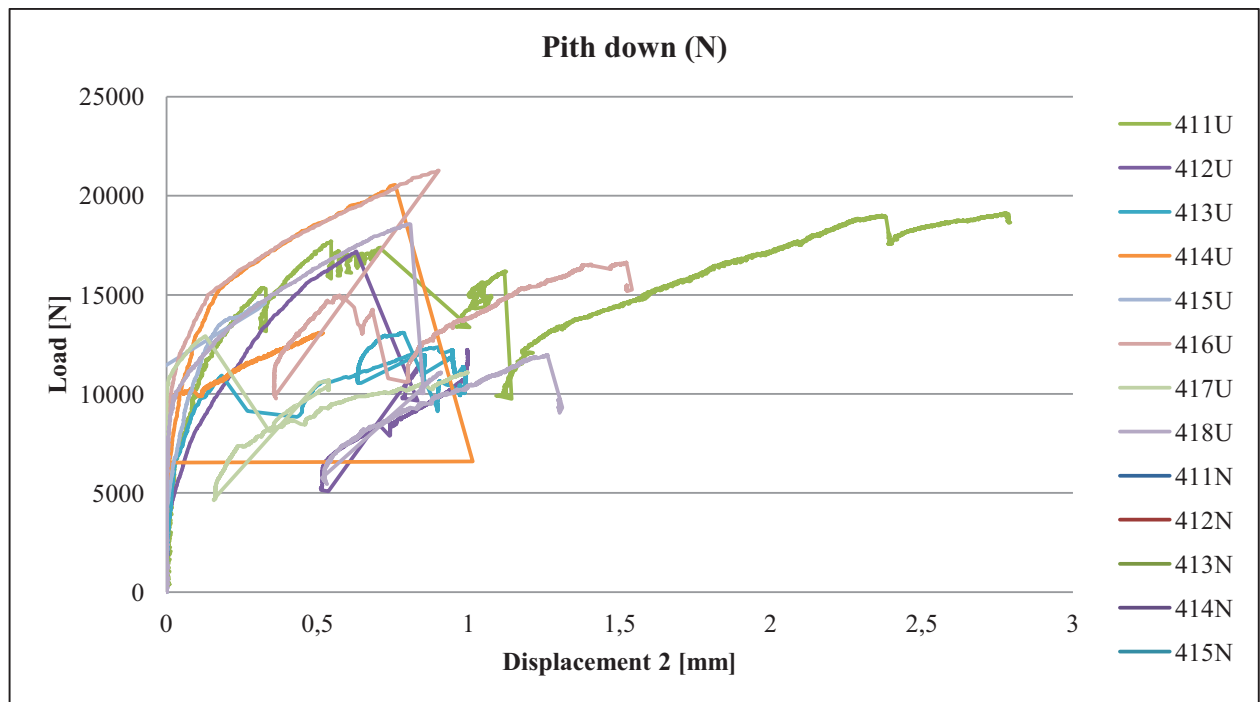
Figure 27: Load vs. displacement curves of bottom rail with pith up of Series 4 – Set 1. 8 failure mode of type 1

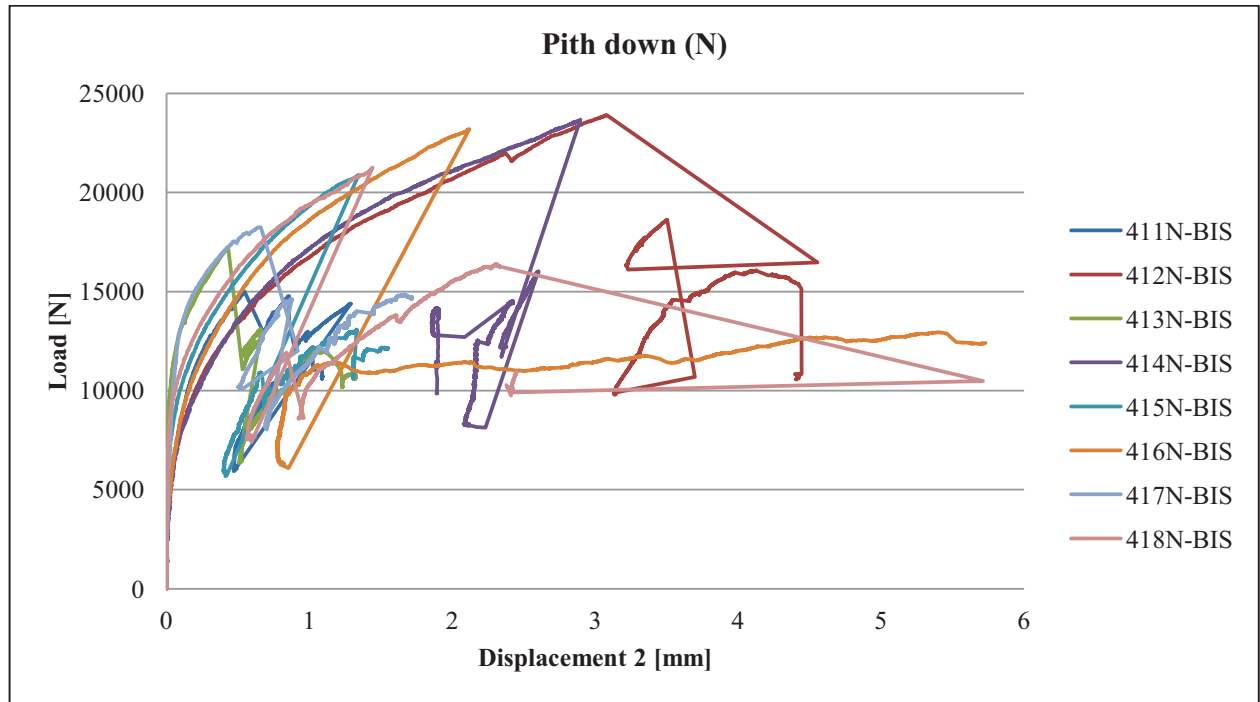
Figure 28: Load vs. displacement curves of bottom rail with pith down of Series 4 – Set 1-BIS. 8 failure mode of type 1

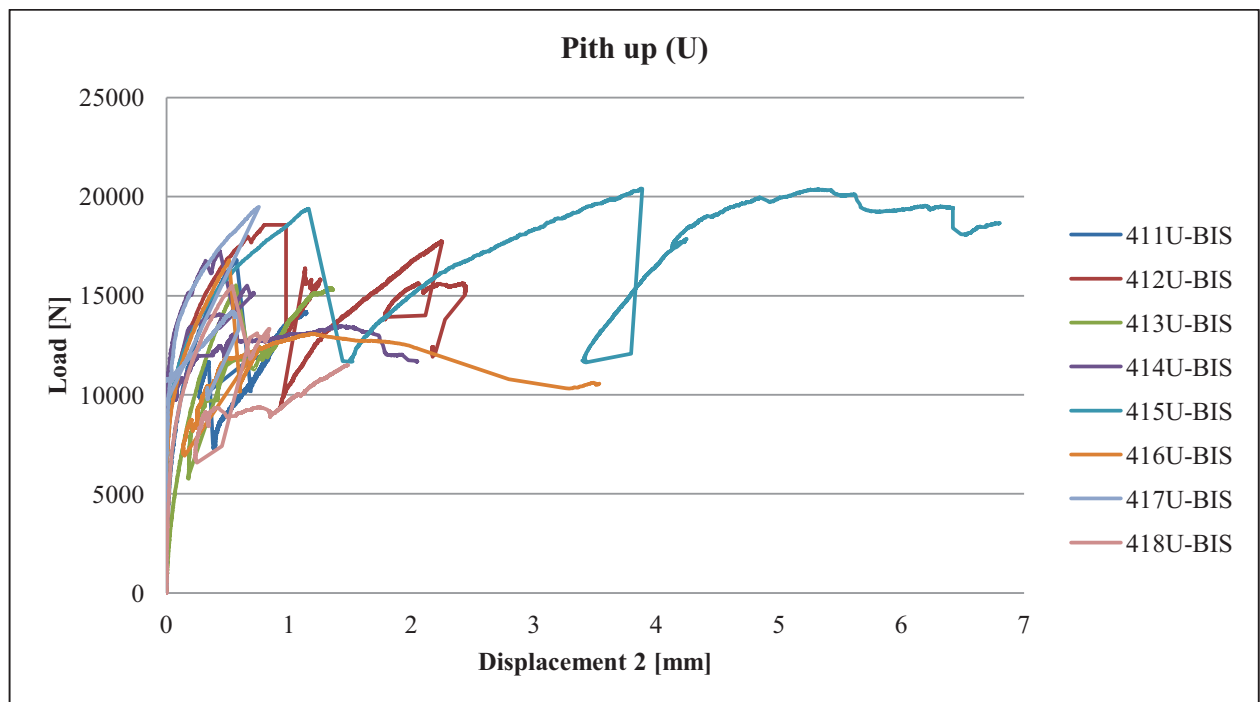
Figure 29: Load vs. displacement curves of bottom rail with pith up of Series 4 – Set 1-BIS. 8 failure mode of type 1

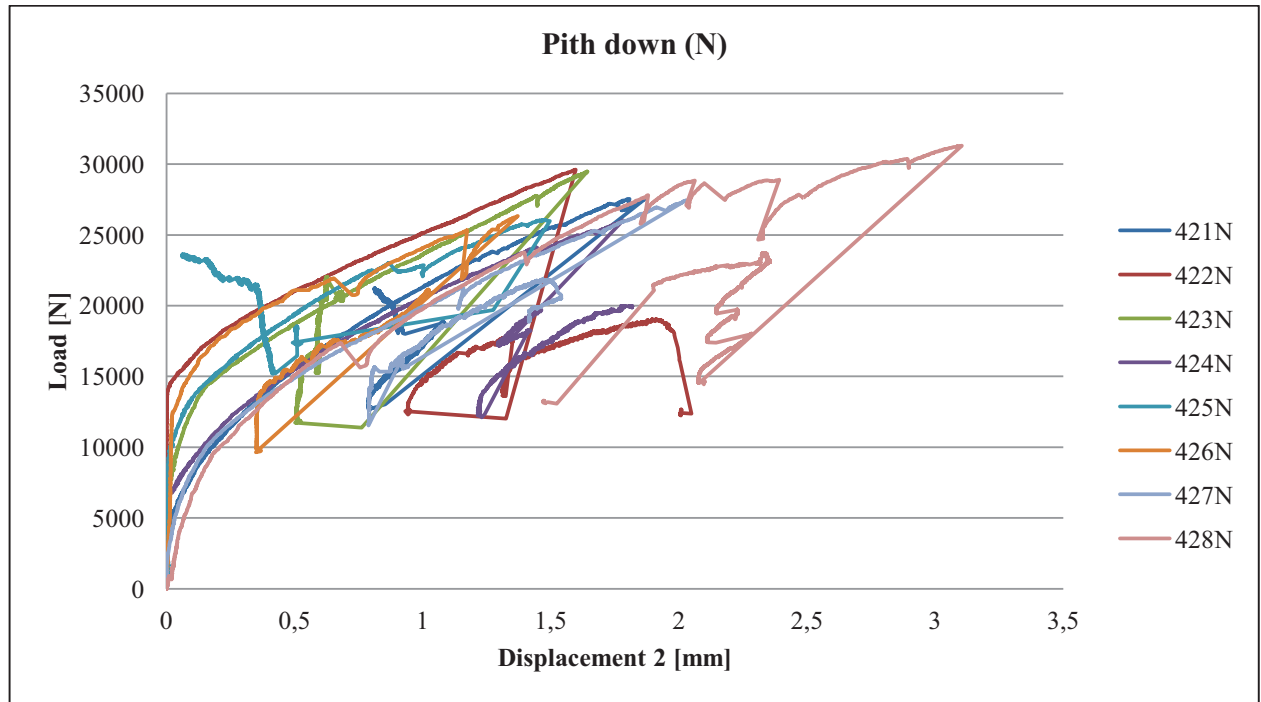
Figure 30: Load vs. displacement curves of bottom rail with pith down of Series 4 – Set 2. 8 failure mode of type 1

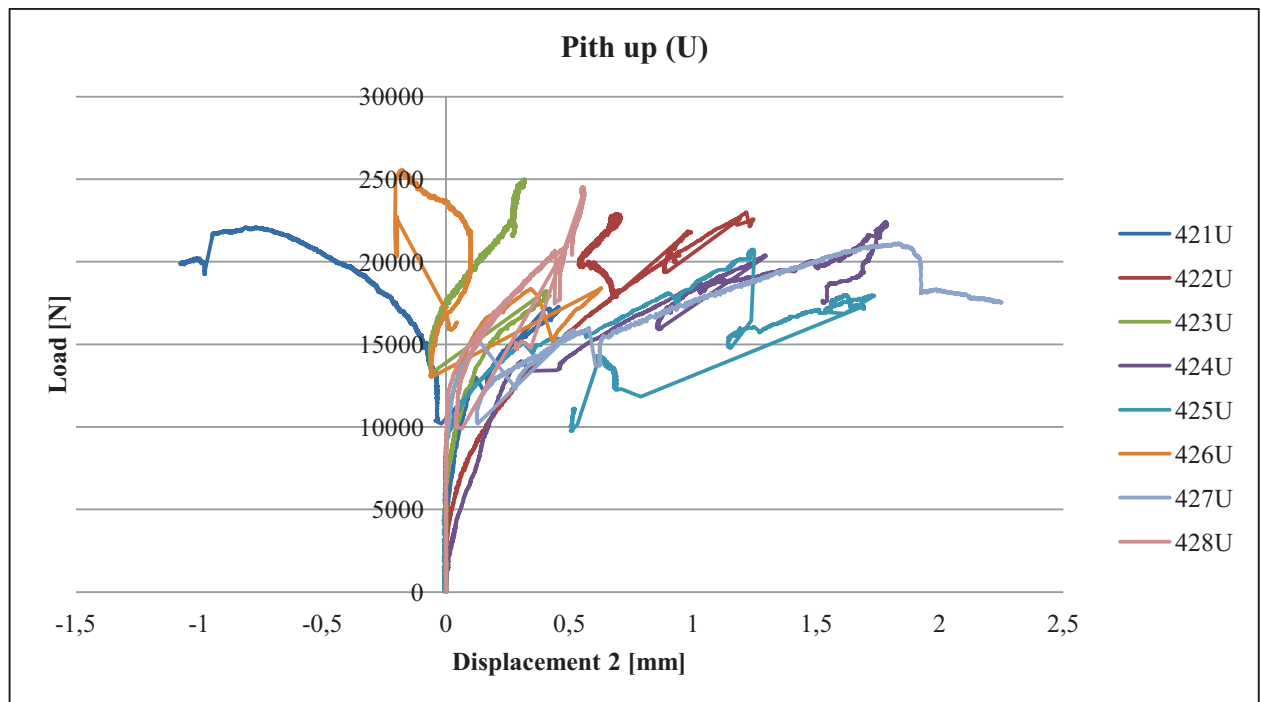
Figure 31: Load vs. displacement curves of bottom rail with pith up of Series 4 – Set 2. 8 failure mode of type 1

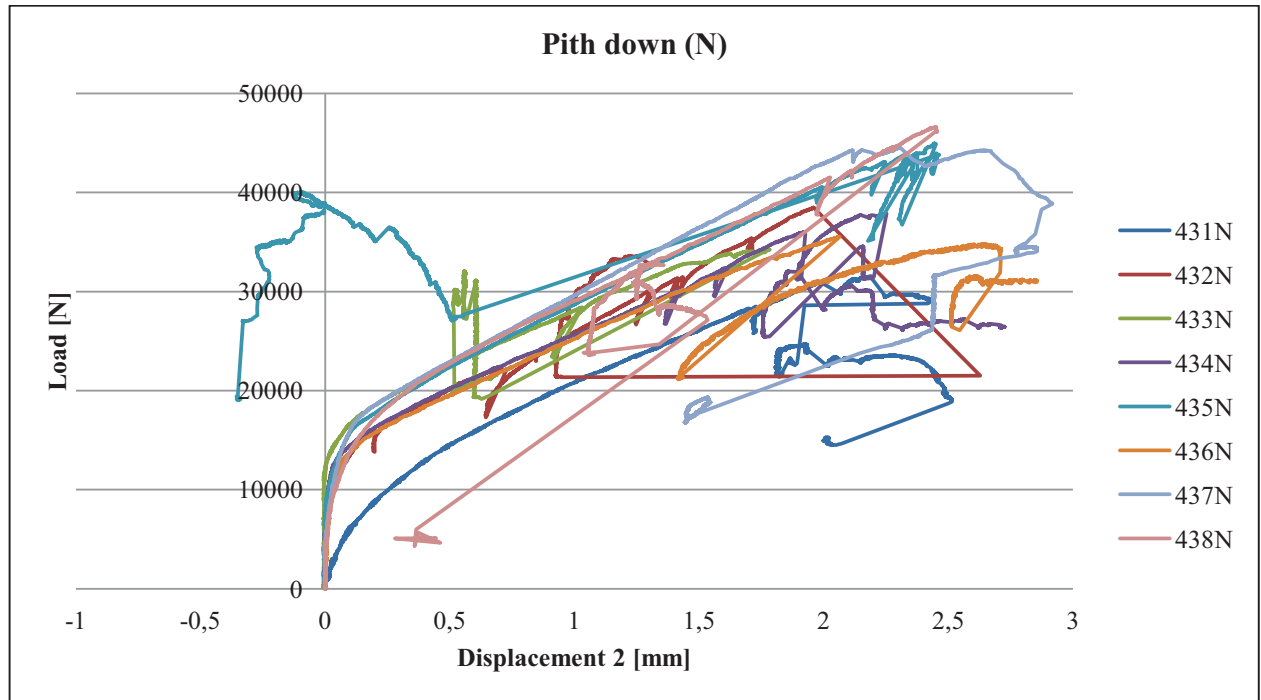
Figure 32: Load vs. displacement curves of bottom rail with pith down of Series 4 – Set 3. 6 failure mode of type 1 and 2 failure mode of type 2

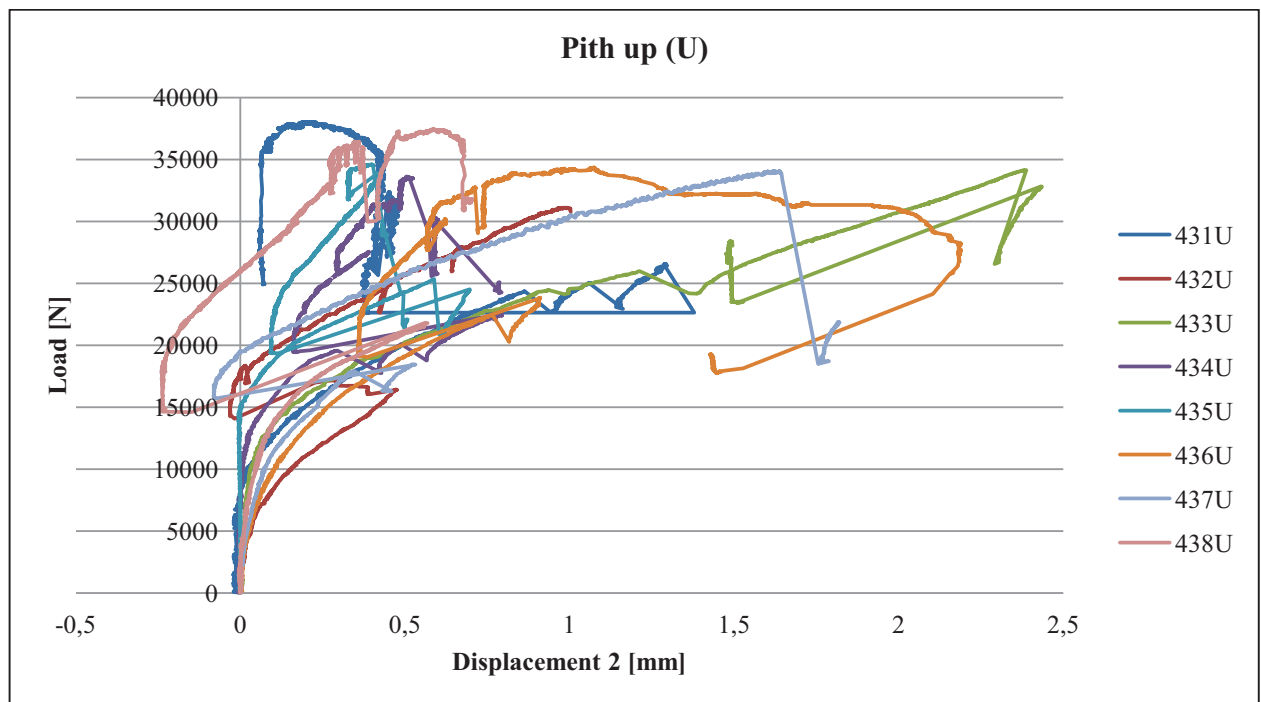
Figure 33: Load vs. displacement curves of bottom rail with pith up of Series 4 – Set 3. 8 failure mode of type 1

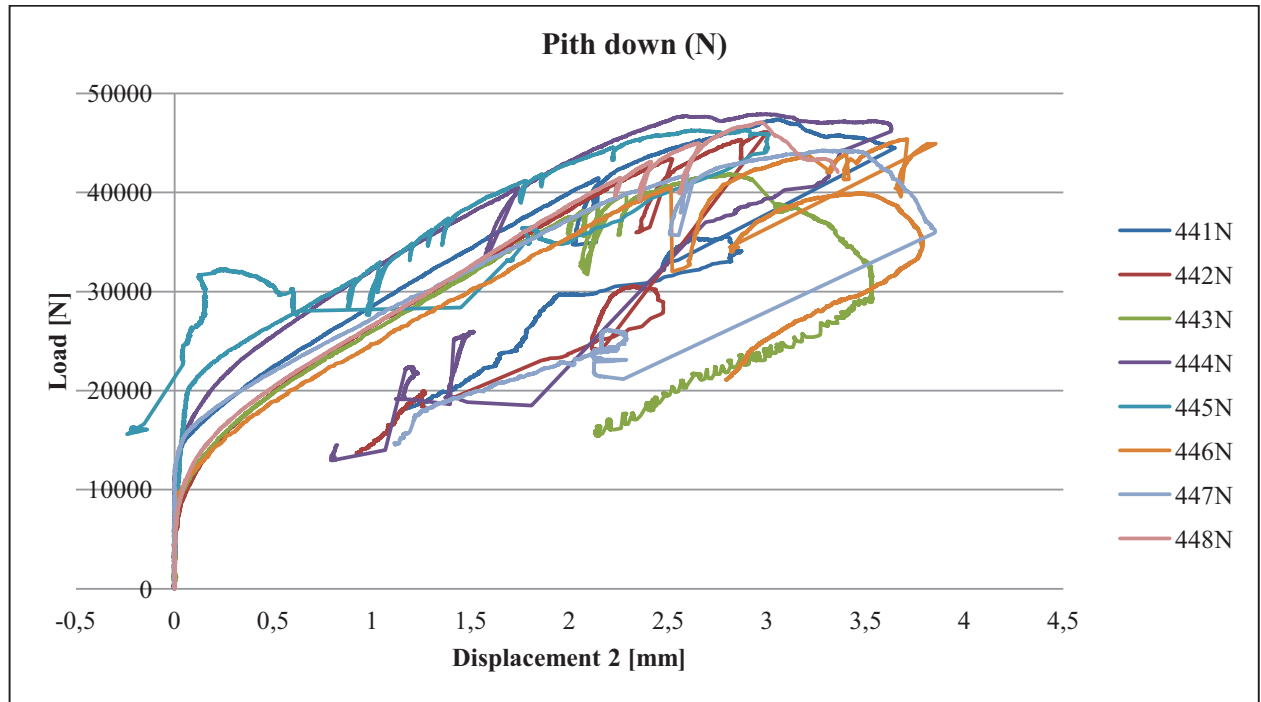
Figure 34: Load vs. displacement curves of bottom rail with pith down of Series 4 – Set 4. 1 failure mode of type 1, 4 failure mode of type 2 and 3 failure mode of type 3
