Experimental Testing of Anchoring Devices for Bottom Rail in Partially Anchored Timber Frame Shear Walls With Two-Sided Sheathing

Giuseppe Caprolu

Luleå University of Technology
Department of Civil, Environmental and Natural resources engineering
Division of Structural and Construction Engineering

Luleå 2012

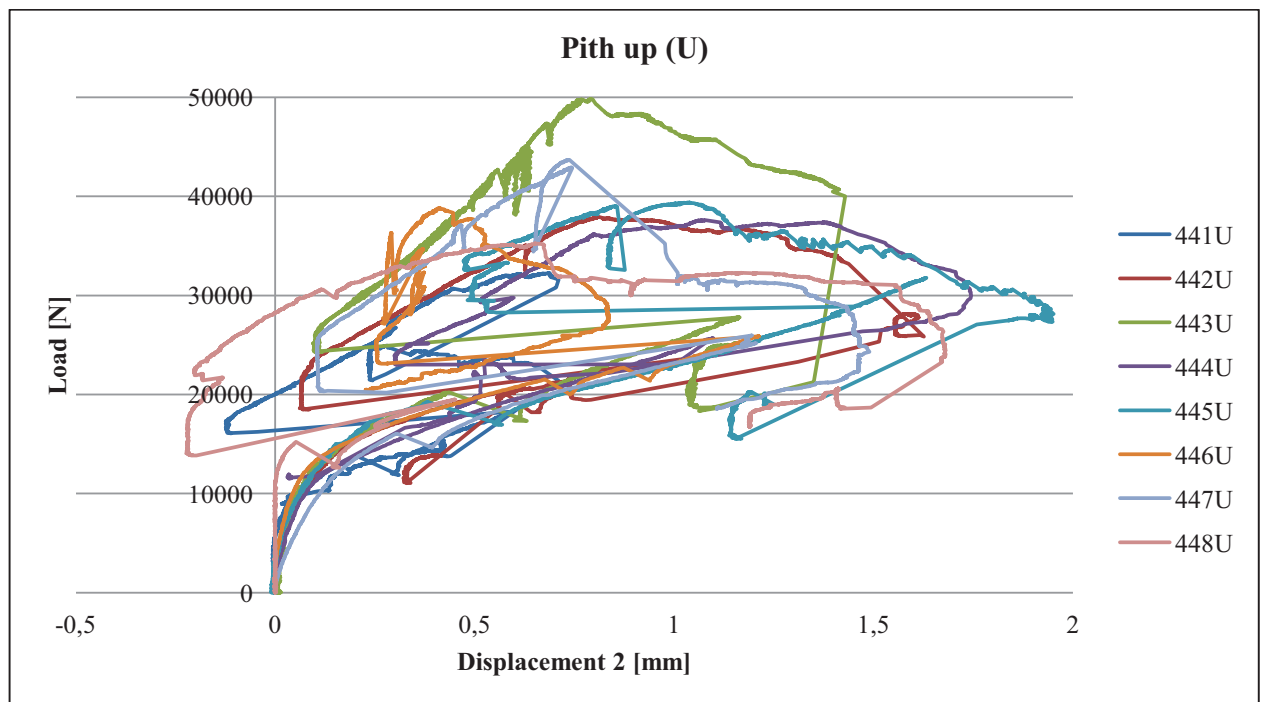
Figure 35: Load vs. displacement curves of bottom rail with pith up of Series 4 – Set 4. 8 failure mode of type 1 (see Appendix B notes ⁽¹⁾, ⁽²⁾ and ⁽³⁾ about the type of failure of this set)

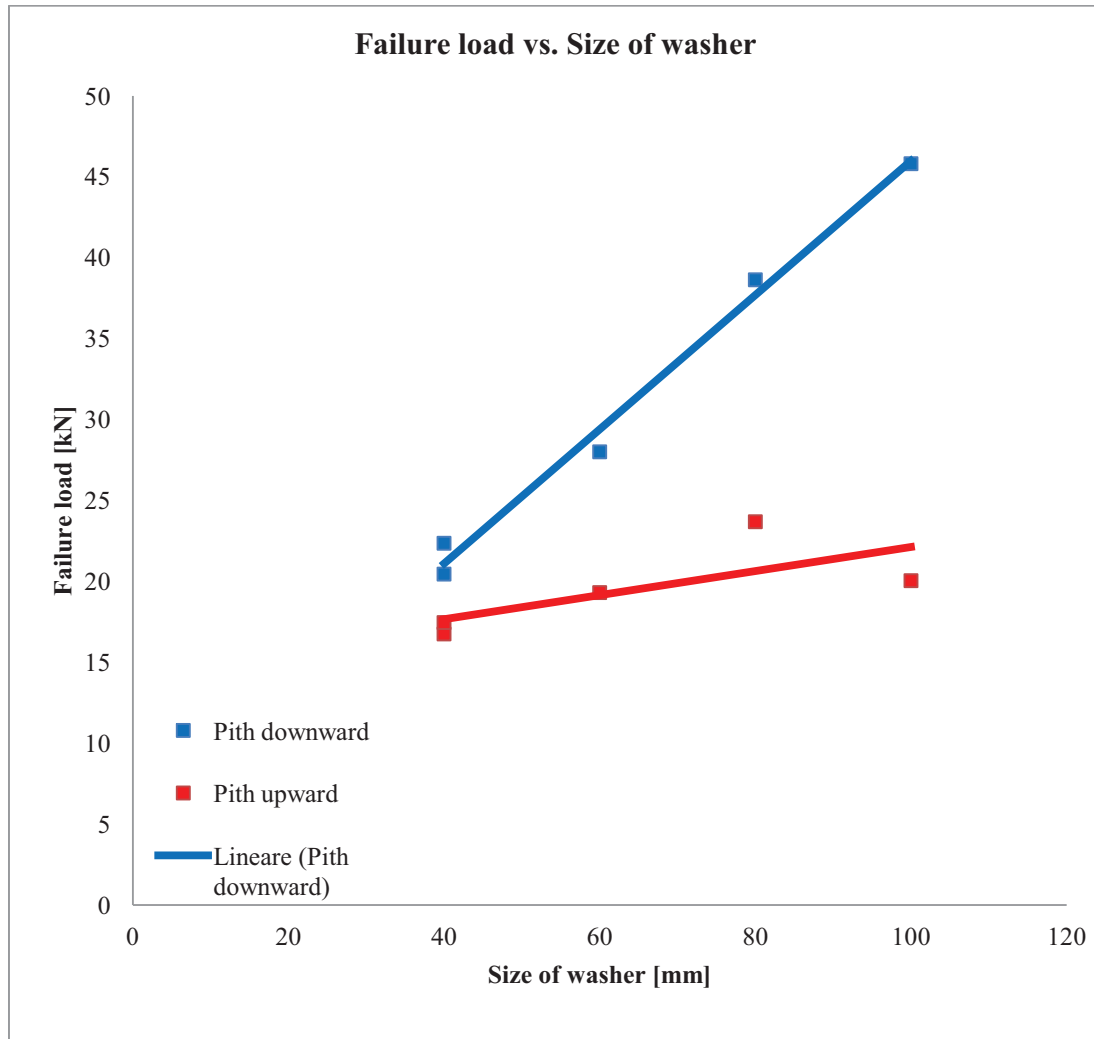
Figure 36: Failure load vs. size of washer of bottom rail with pith upward and pith downward

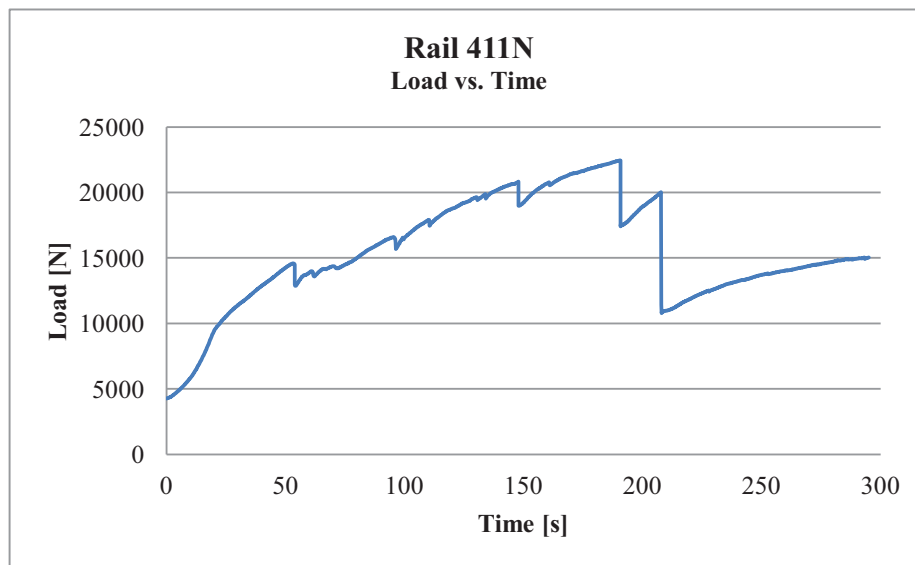
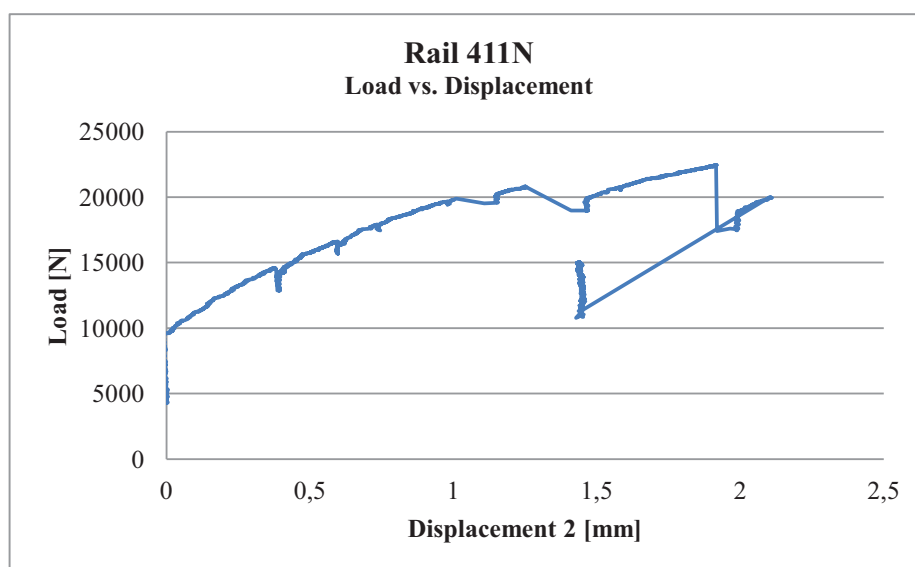
Type of failure	Failure 1 – 1 st crack at side 2
Failure load [N]	22451
Displacement 1 at failure [mm]	0,10
Displacement 2 at failure [mm]	1,91
Distance from crack to edge side 1 [mm]	50
Distance from crack to edge side 2 [mm]	72
Distance from crack to anchor bolt side 1 [mm]	45
Distance from crack to anchor bolt side 2 [mm]	83
Moisture [%]	11,8
Dry density [kg/m ³]	406

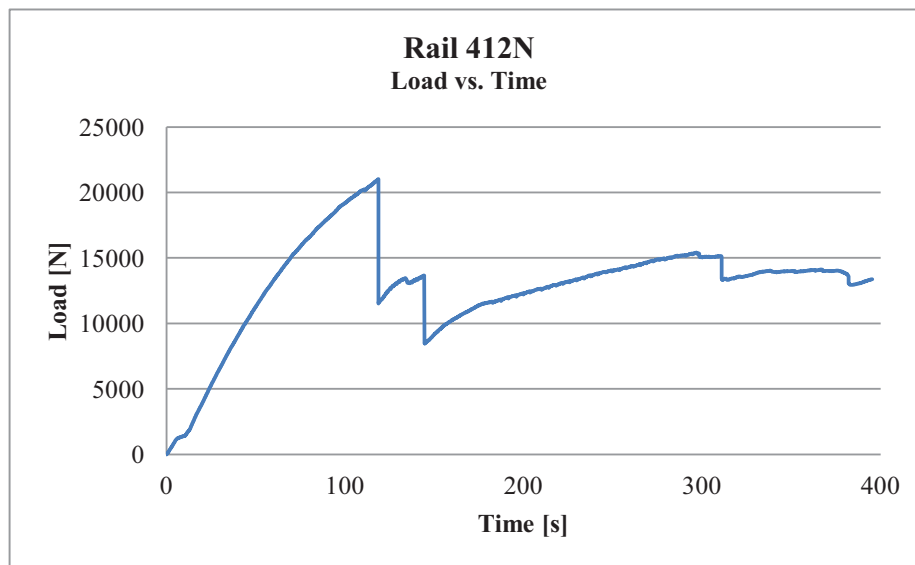
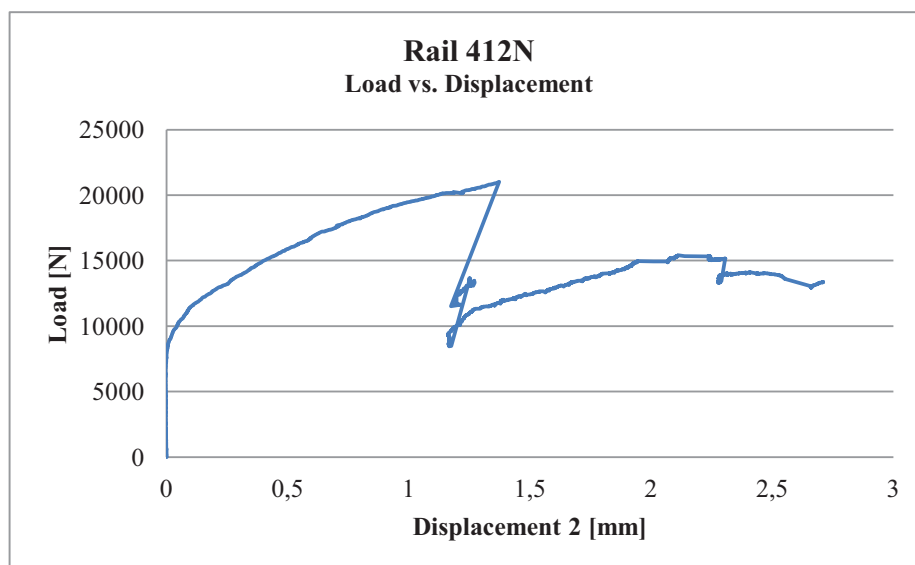
Type of failure	Failure 1 – 1 st crack at side 2
Failure load [N]	21010
Displacement 1 at failure [mm]	-0,02
Displacement 2 at failure [mm]	1,37
Distance from crack to edge side 1 [mm]	90
Distance from crack to edge side 2 [mm]	52
Distance from crack to anchor bolt side 1 [mm]	85
Distance from crack to anchor bolt side 2 [mm]	60
Moisture [%]	14,3
Dry density [kg/m ³]	462

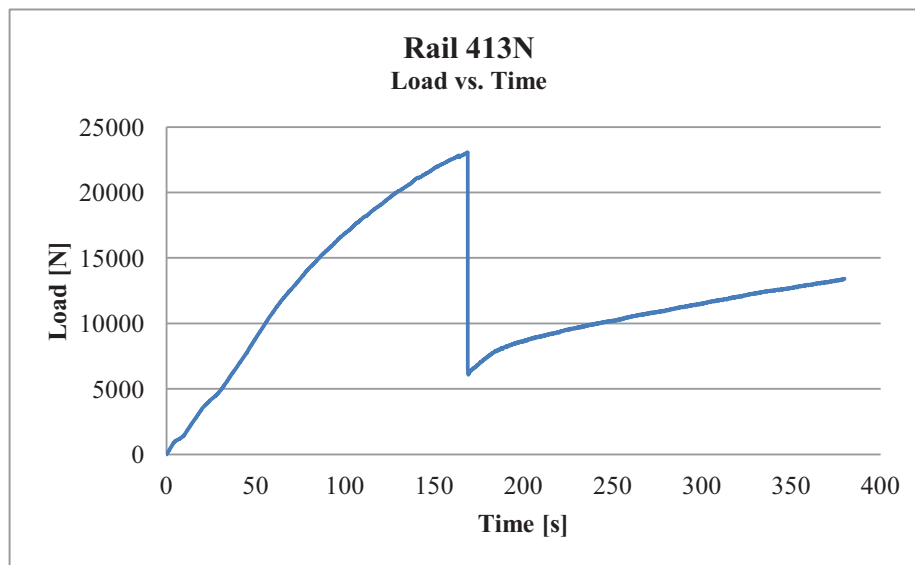
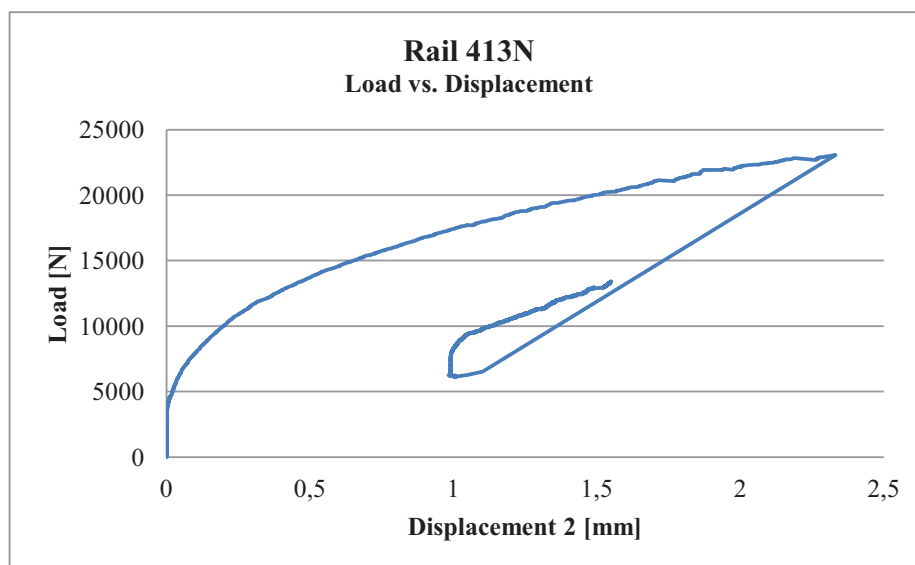
Type of failure	Failure 1 – Instantaneous crack on both sides
Failure load [N]	23057
Displacement 1 at failure [mm]	-0,09
Displacement 2 at failure [mm]	2,33
Distance from crack to edge side 1 [mm]	60
Distance from crack to edge side 2 [mm]	54
Distance from crack to anchor bolt side 1 [mm]	55
Distance from crack to anchor bolt side 2 [mm]	60
Moisture [%]	12,4
Dry density [kg/m ³]	389

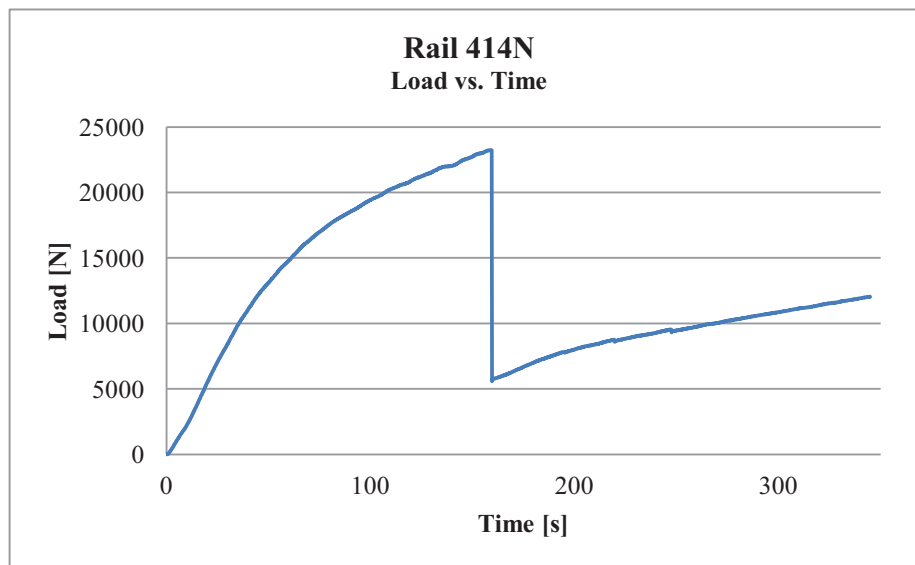
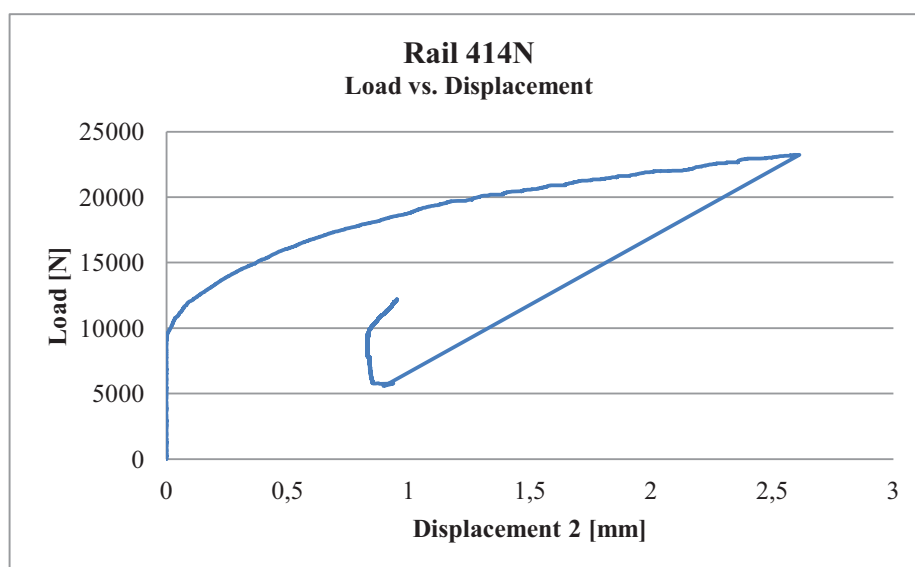
Type of failure	Failure 1 – Instantaneous crack on both sides
Failure load [N]	23240
Displacement 1 at failure [mm]	-0,01
Displacement 2 at failure [mm]	2,61
Distance from crack to edge side 1 [mm]	65
Distance from crack to edge side 2 [mm]	57
Distance from crack to anchor bolt side 1 [mm]	60
Distance from crack to anchor bolt side 2 [mm]	60
Moisture [%]	13,0
Dry density [kg/m ³]	338

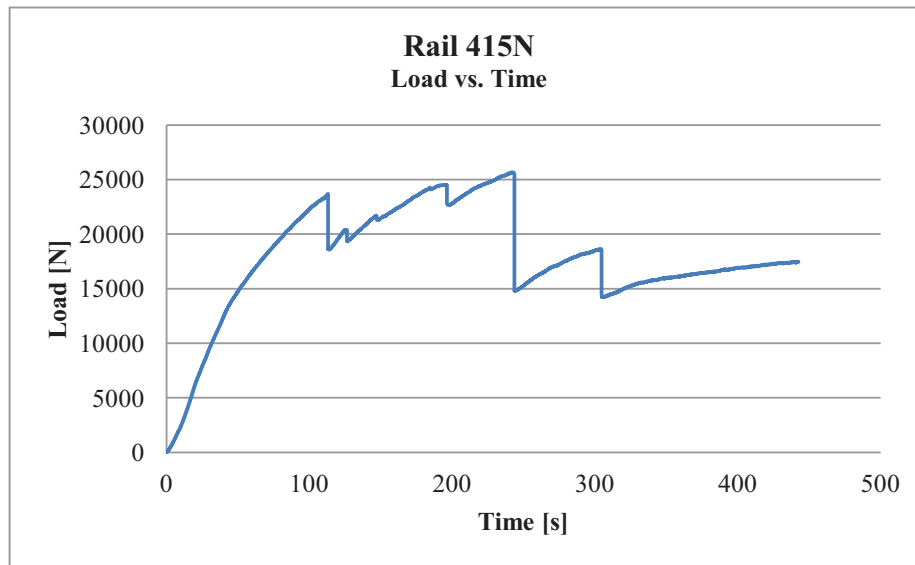
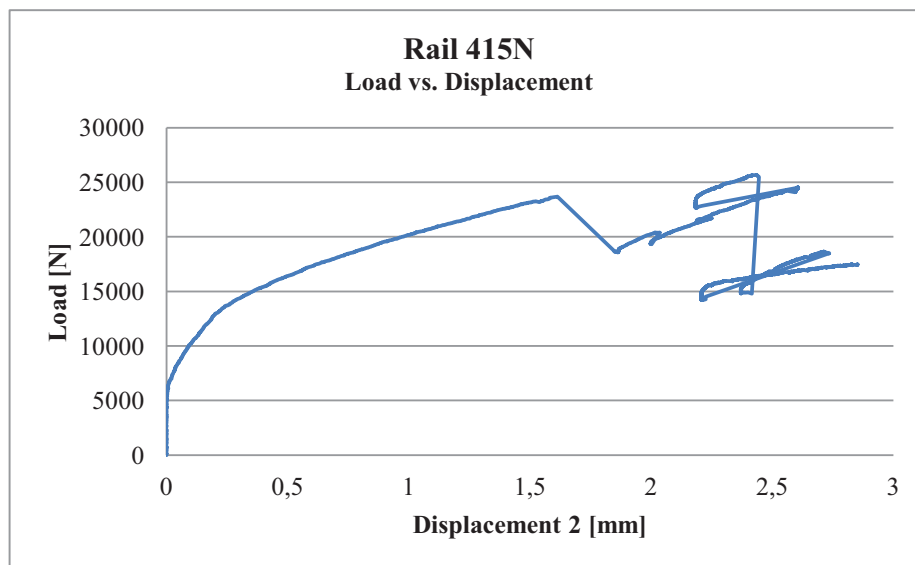
Type of failure	Failure 1 – 1 st crack at side 1
Failure load [N]	23676
Displacement 1 at failure [mm]	-0,04
Displacement 2 at failure [mm]	1,61
Distance from crack to edge side 1 [mm]	63
Distance from crack to edge side 2 [mm]	60
Distance from crack to anchor bolt side 1 [mm]	66
Distance from crack to anchor bolt side 2 [mm]	60
Moisture [%]	12,8
Dry density [kg/m ³]	449

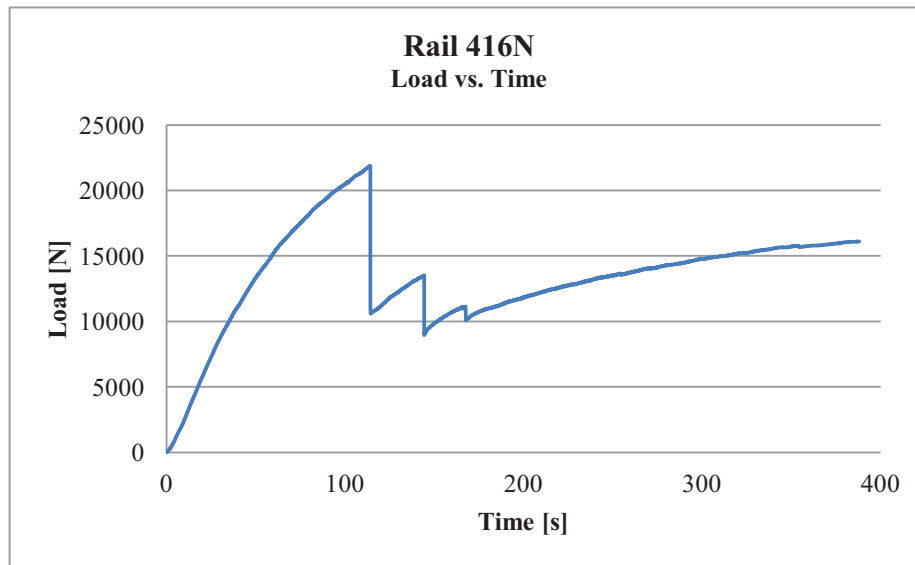
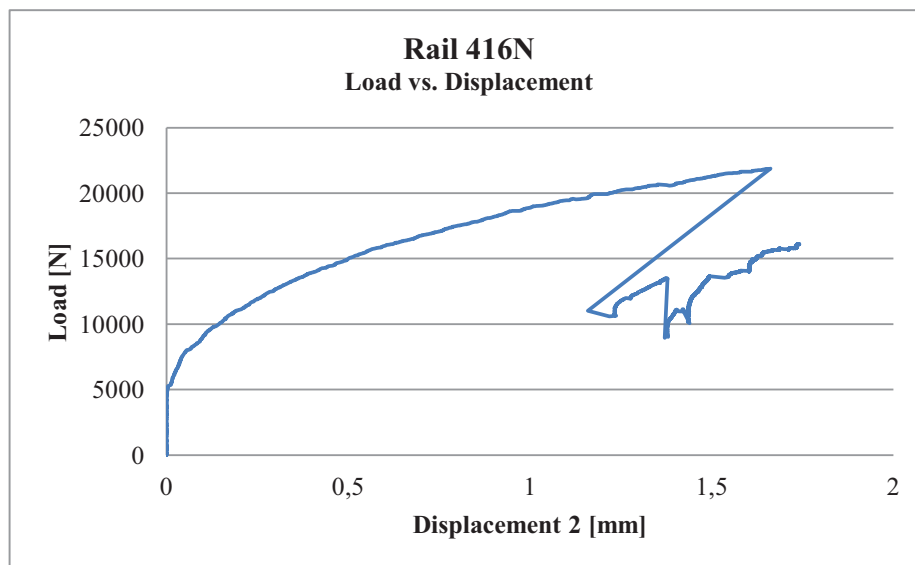
Type of failure	Failure 1 – 1 st crack at side 1
Failure load [N]	21866
Displacement 1 at failure [mm]	-0,02
Displacement 2 at failure [mm]	1,66
Distance from crack to edge side 1 [mm]	65
Distance from crack to edge side 2 [mm]	40
Distance from crack to anchor bolt side 1 [mm]	59
Distance from crack to anchor bolt side 2 [mm]	44
Moisture [%]	13,6
Dry density [kg/m ³]	443

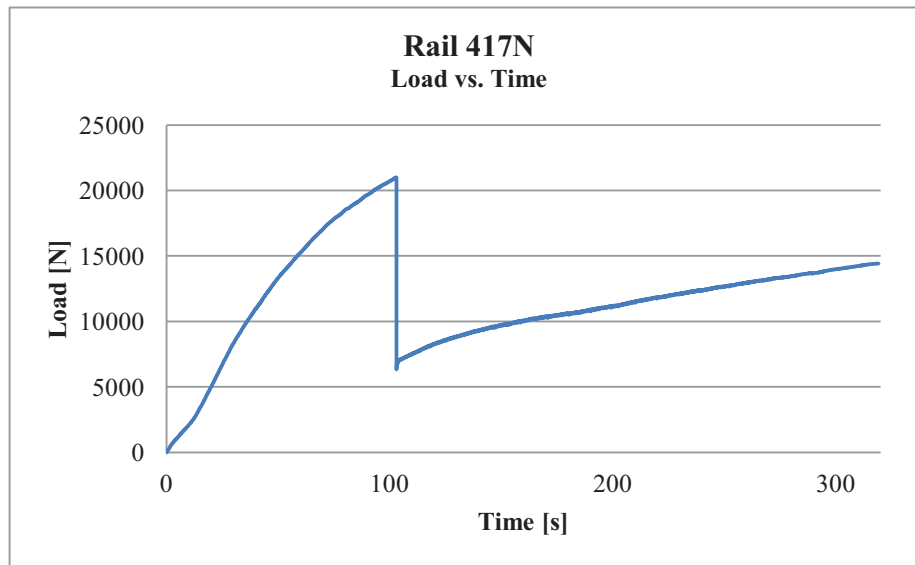
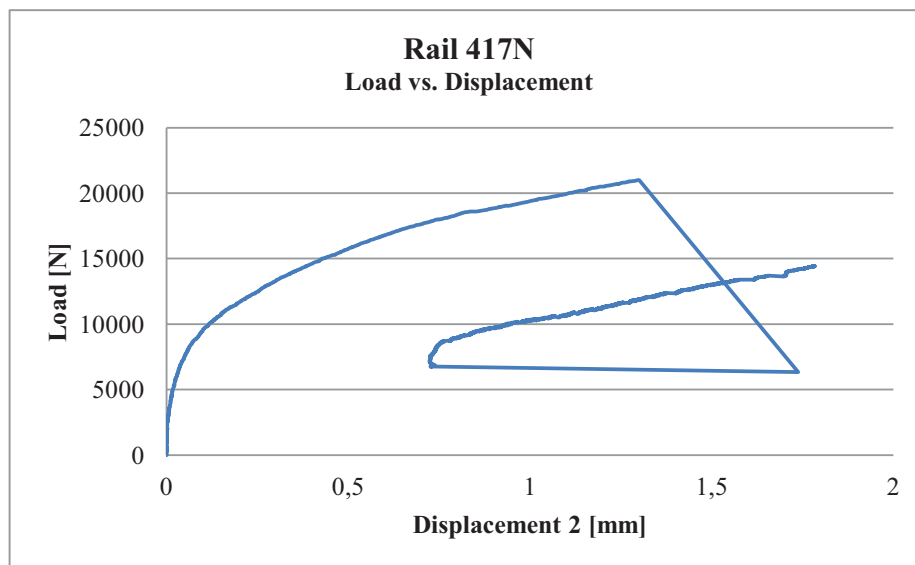
Type of failure	Failure 1 – Instantaneous crack on both sides
Failure load [N]	20995
Displacement 1 at failure [mm]	-0,01
Displacement 2 at failure [mm]	1,30
Distance from crack to edge side 1 [mm]	54
Distance from crack to edge side 2 [mm]	54
Distance from crack to anchor bolt side 1 [mm]	53
Distance from crack to anchor bolt side 2 [mm]	50
Moisture [%]	12,3
Dry density [kg/m ³]	442

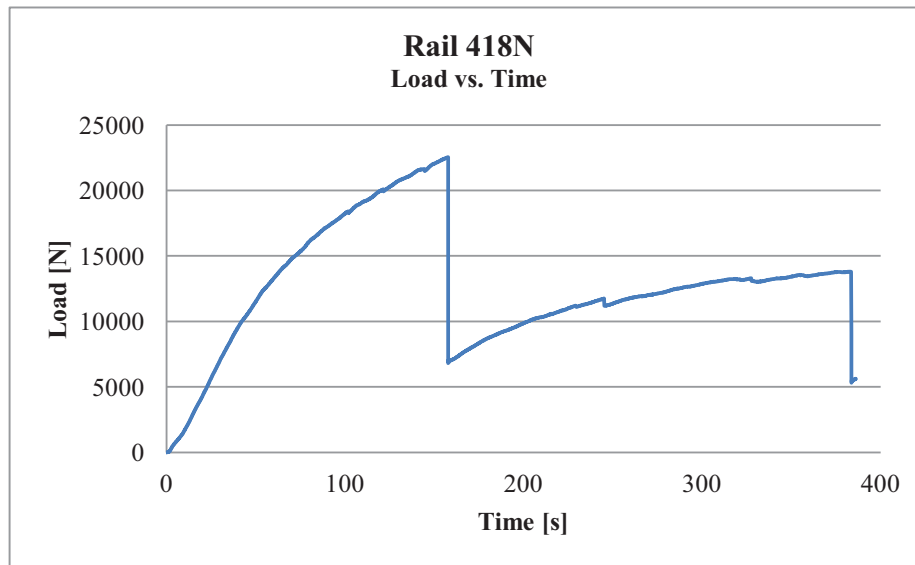
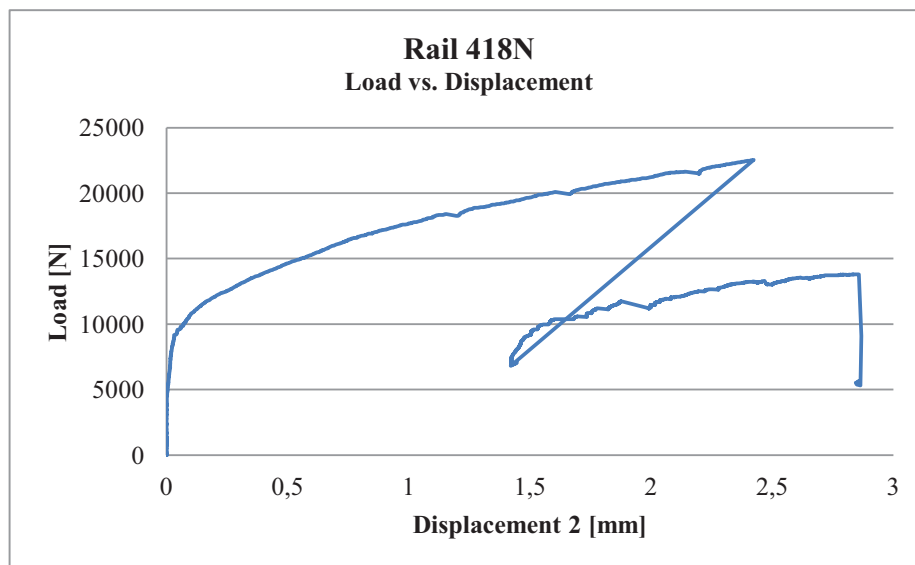
Type of failure	Failure 1 – Instantaneous crack on both sides
Failure load [N]	22532
Displacement 1 at failure [mm]	-0,20
Displacement 2 at failure [mm]	2,42
Distance from crack to edge side 1 [mm]	91
Distance from crack to edge side 2 [mm]	72
Distance from crack to anchor bolt side 1 [mm]	91
Distance from crack to anchor bolt side 2 [mm]	78
Moisture [%]	13,2
Dry density [kg/m ³]	386

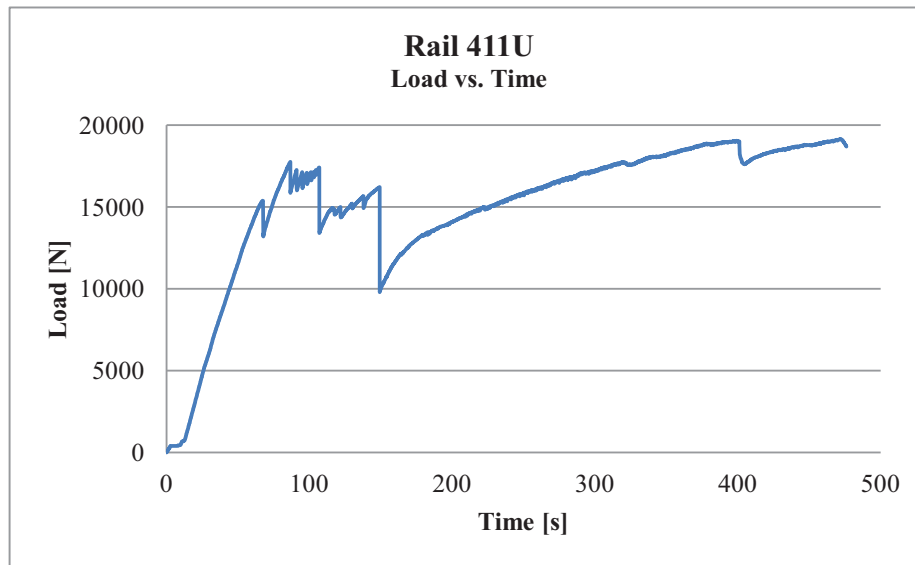
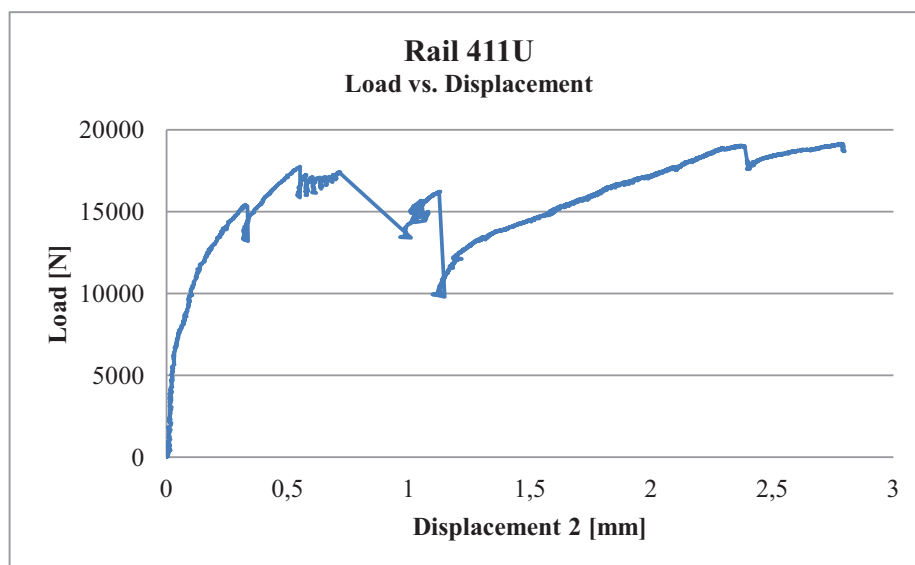
Type of failure	Failure 1 – 1 st crack at side 1
Failure load [N]	17745
Displacement 1 at failure [mm]	0,01
Displacement 2 at failure [mm]	0,55
Distance from crack to edge side 1 [mm]	52
Distance from crack to edge side 2 [mm]	65
Distance from crack to anchor bolt side 1 [mm]	60
Distance from crack to anchor bolt side 2 [mm]	60
Moisture [%]	12,4
Dry density [kg/m ³]	443

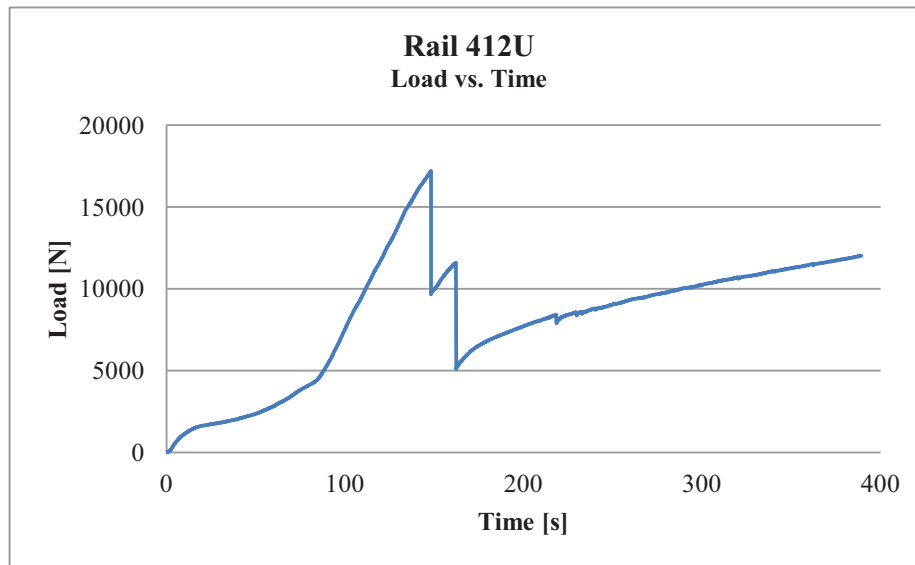
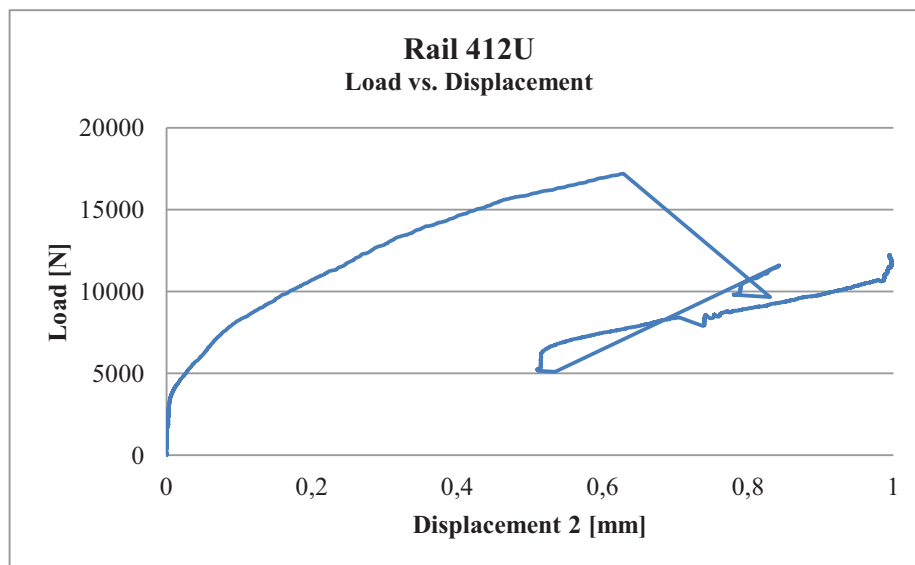
Type of failure	Failure 1 – 1 st crack at side 1
Failure load [N]	17193
Displacement 1 at failure [mm]	0,06
Displacement 2 at failure [mm]	0,63
Distance from crack to edge side 1 [mm]	59
Distance from crack to edge side 2 [mm]	63
Distance from crack to anchor bolt side 1 [mm]	59
Distance from crack to anchor bolt side 2 [mm]	64
Moisture [%]	13,8
Dry density [kg/m ³]	445

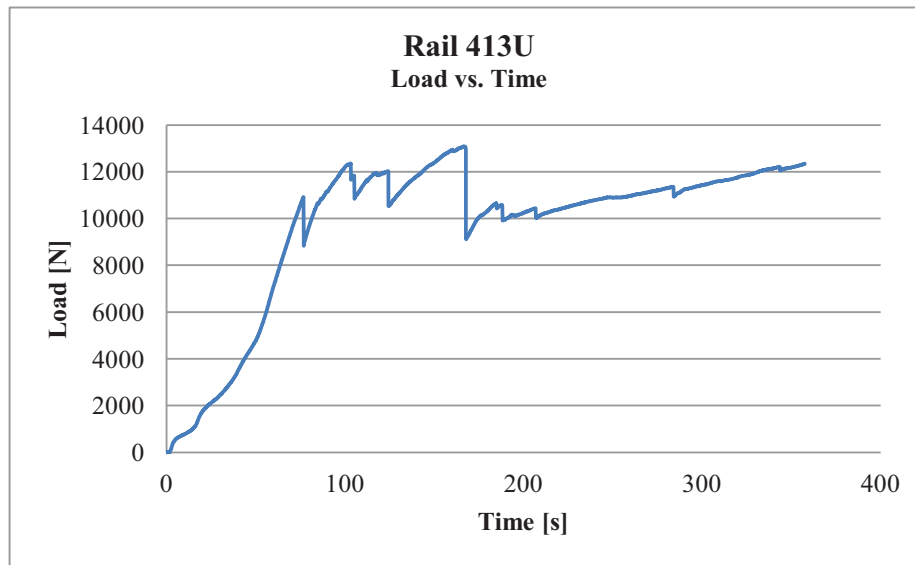
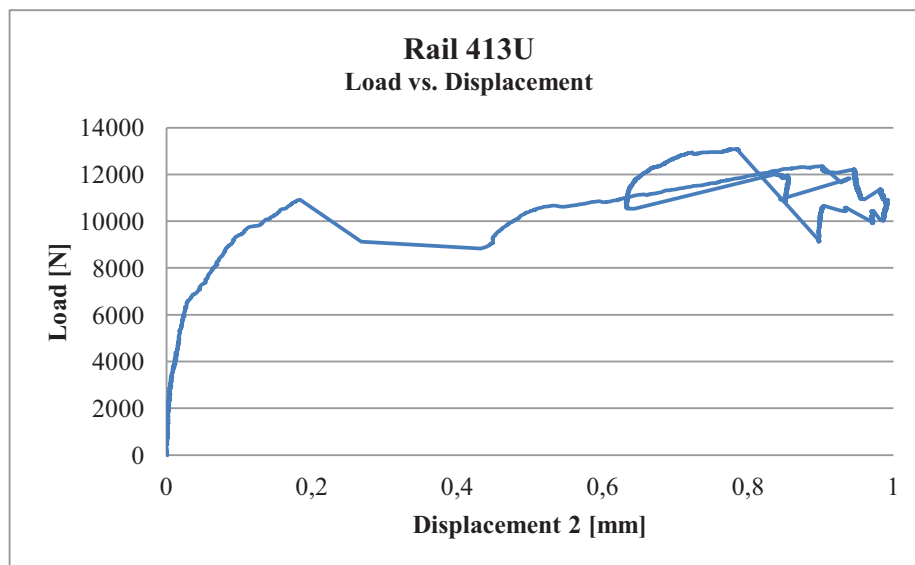
Type of failure	Failure 1 – 1 st crack at side 1
Failure load [N]	10922
Displacement 1 at failure [mm]	-0,03
Displacement 2 at failure [mm]	0,18
Distance from crack to edge side 1 [mm]	70
Distance from crack to edge side 2 [mm]	58
Distance from crack to anchor bolt side 1 [mm]	58
Distance from crack to anchor bolt side 2 [mm]	65
Moisture [%]	13,2
Dry density [kg/m ³]	422

Probable influence of the pre-crack in the side 1.

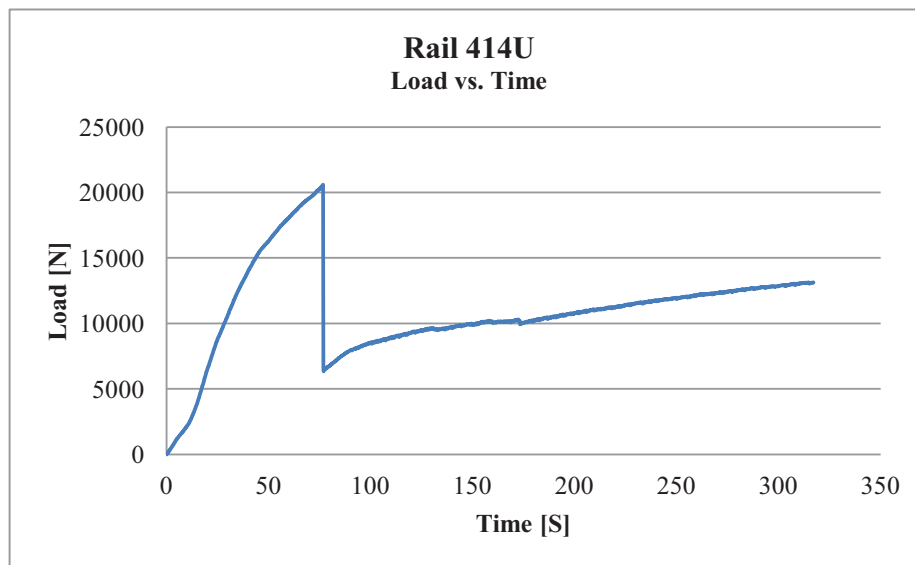
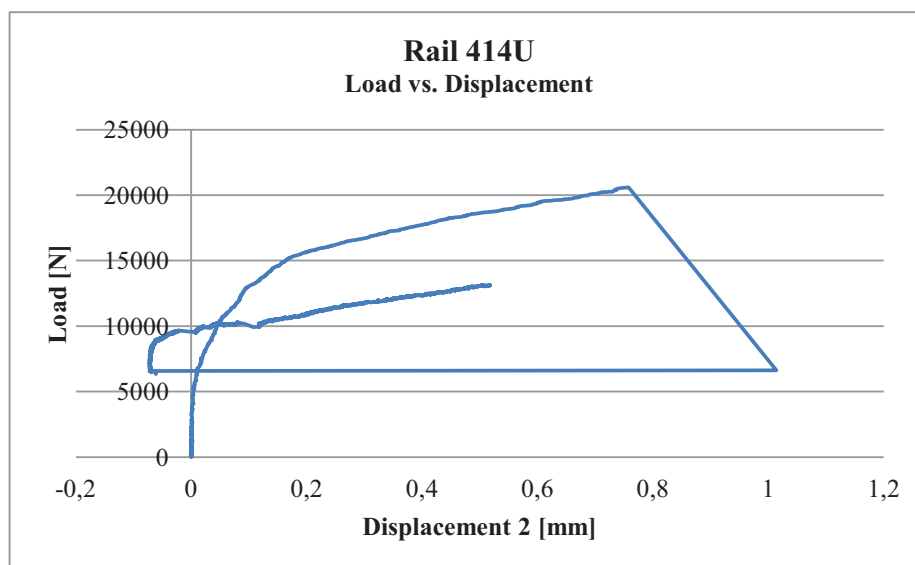
Type of failure	Failure 1 – Instantaneous crack on both sides
Failure load [N]	20589
Displacement 1 at failure [mm]	0,03
Displacement 2 at failure [mm]	0,76
Distance from crack to edge side 1 [mm]	53
Distance from crack to edge side 2 [mm]	85
Distance from crack to anchor bolt side 1 [mm]	60
Distance from crack to anchor bolt side 2 [mm]	83
Moisture [%]	14,7
Dry density [kg/m ³]	434

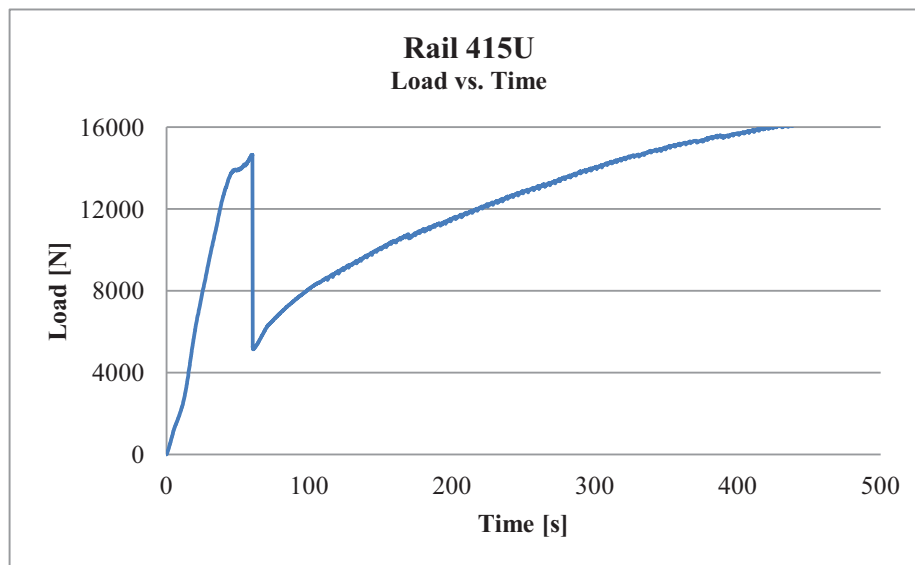
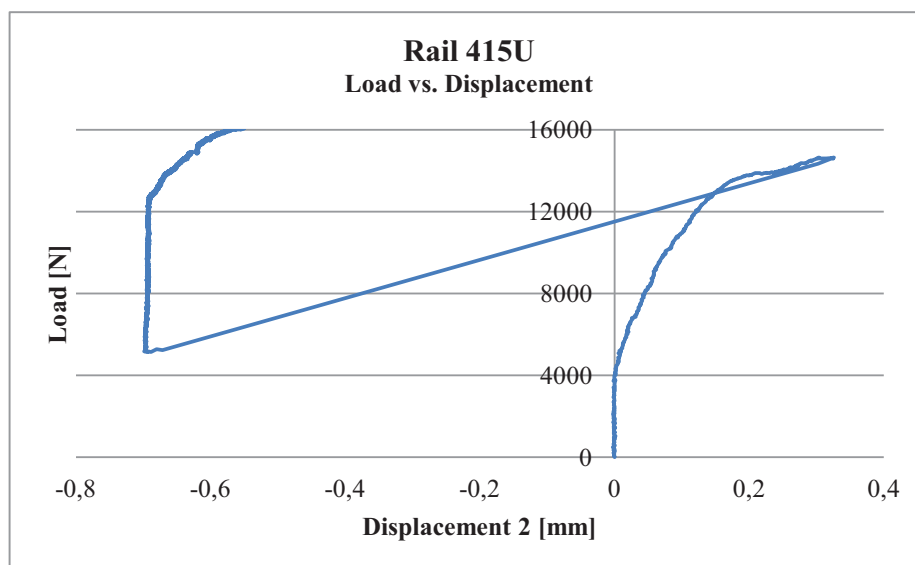
Type of failure	Failure 1 – 1 st crack at side 2
Failure load [N]	14643
Displacement 1 at failure [mm]	0,02
Displacement 2 at failure [mm]	0,33
Distance from crack to edge side 1 [mm]	52
Distance from crack to edge side 2 [mm]	63
Distance from crack to anchor bolt side 1 [mm]	51
Distance from crack to anchor bolt side 2 [mm]	60
Moisture [%]	13,7
Dry density [kg/m ³]	523

Probable influence of the pre-crack in the side 2.

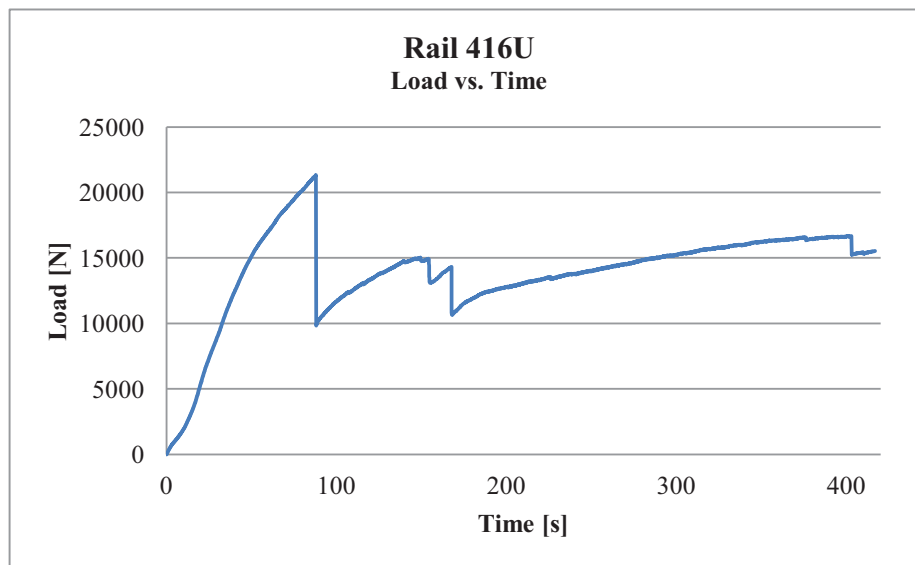
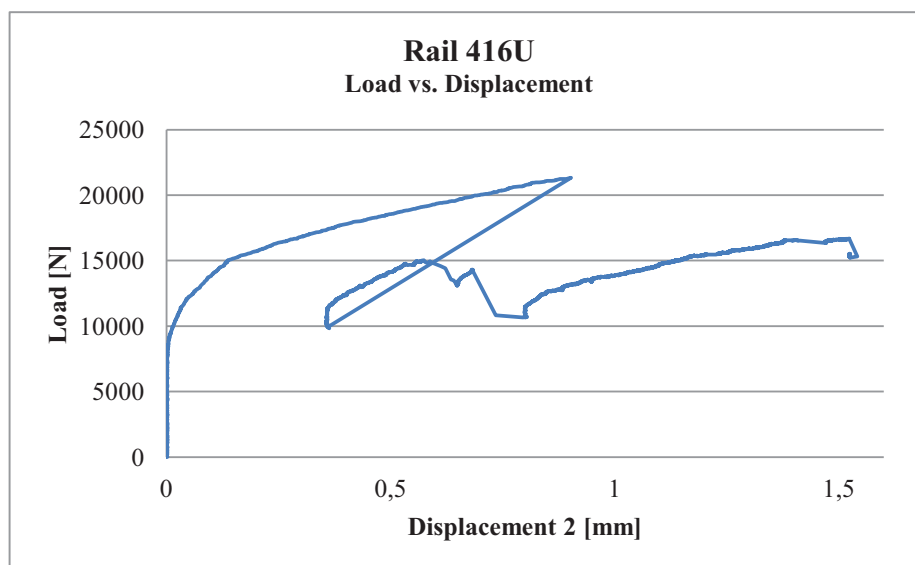
Type of failure	Failure 1 – 1 st crack at side 2
Failure load [N]	21328
Displacement 1 at failure [mm]	0,03
Displacement 2 at failure [mm]	0,90
Distance from crack to edge side 1 [mm]	57
Distance from crack to edge side 2 [mm]	63
Distance from crack to anchor bolt side 1 [mm]	64
Distance from crack to anchor bolt side 2 [mm]	56
Moisture [%]	12,8
Dry density [kg/m ³]	435

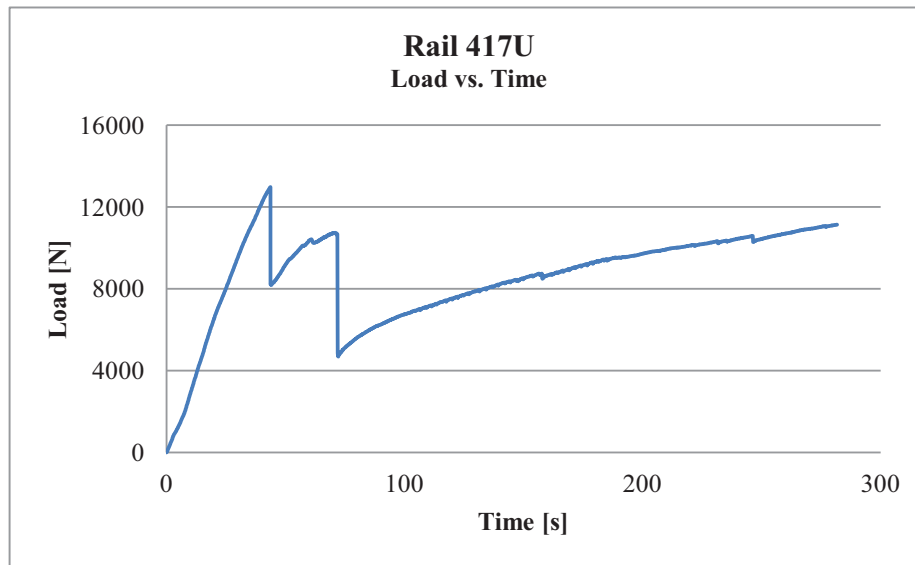
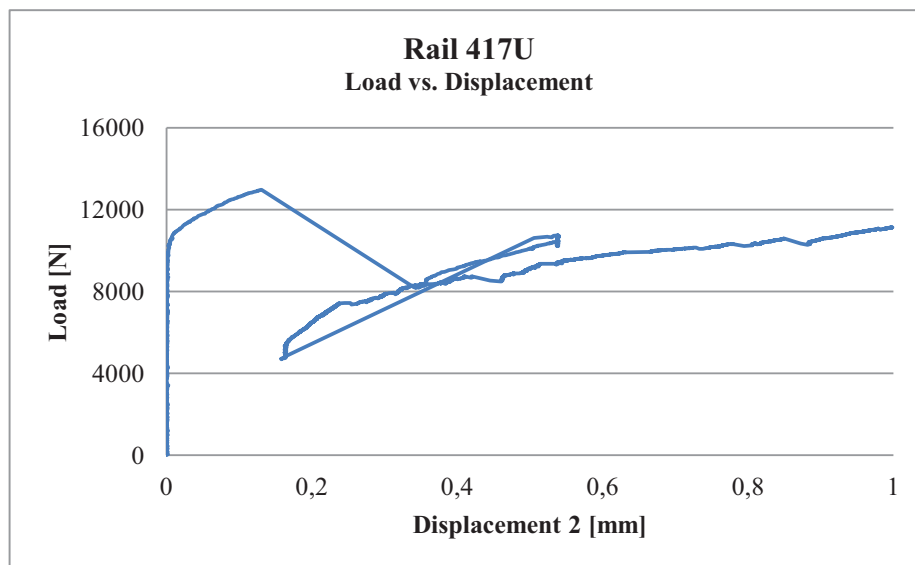
Type of failure	Failure 1 – 1 st crack at side 1
Failure load [N]	12972
Displacement 1 at failure [mm]	-0,01
Displacement 2 at failure [mm]	0,13
Distance from crack to edge side 1 [mm]	48
Distance from crack to edge side 2 [mm]	78
Distance from crack to anchor bolt side 1 [mm]	53
Distance from crack to anchor bolt side 2 [mm]	75
Moisture [%]	13,1
Dry density [kg/m ³]	374

Possible pre-crack on the side 1.

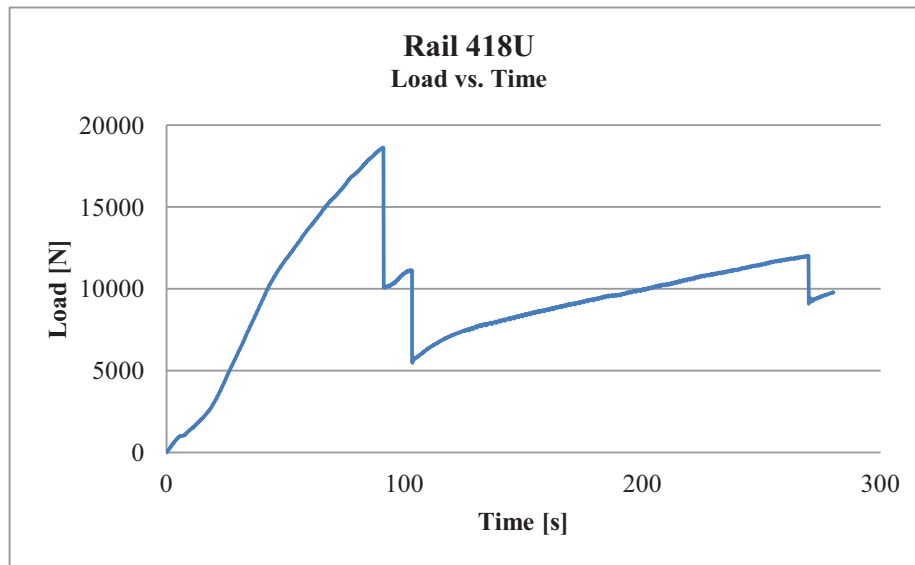
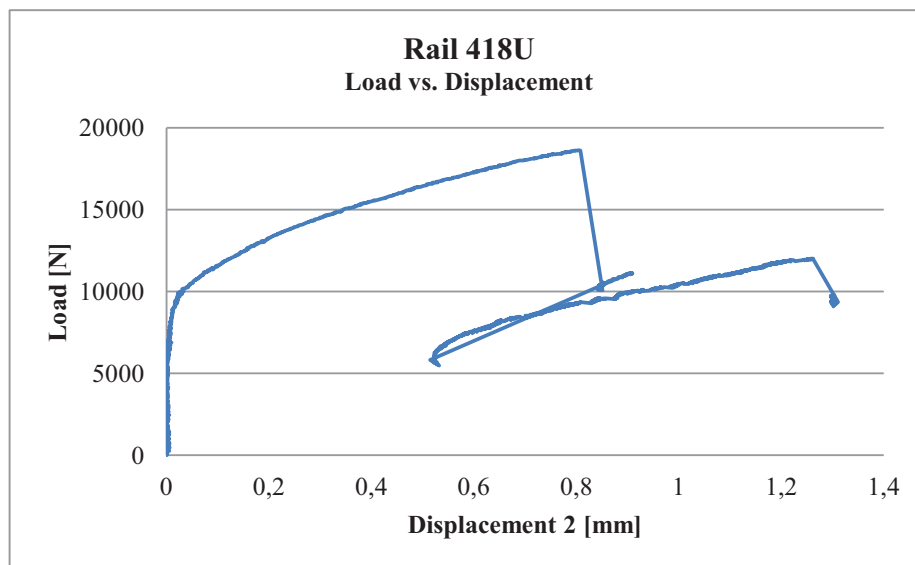
Type of failure	Failure 1 – 1 st crack at side 1
Failure load [N]	18612
Displacement 1 at failure [mm]	-0,02
Displacement 2 at failure [mm]	0,80
Distance from crack to edge side 1 [mm]	64
Distance from crack to edge side 2 [mm]	78
Distance from crack to anchor bolt side 1 [mm]	62
Distance from crack to anchor bolt side 2 [mm]	78
Moisture [%]	12,2
Dry density [kg/m ³]	411

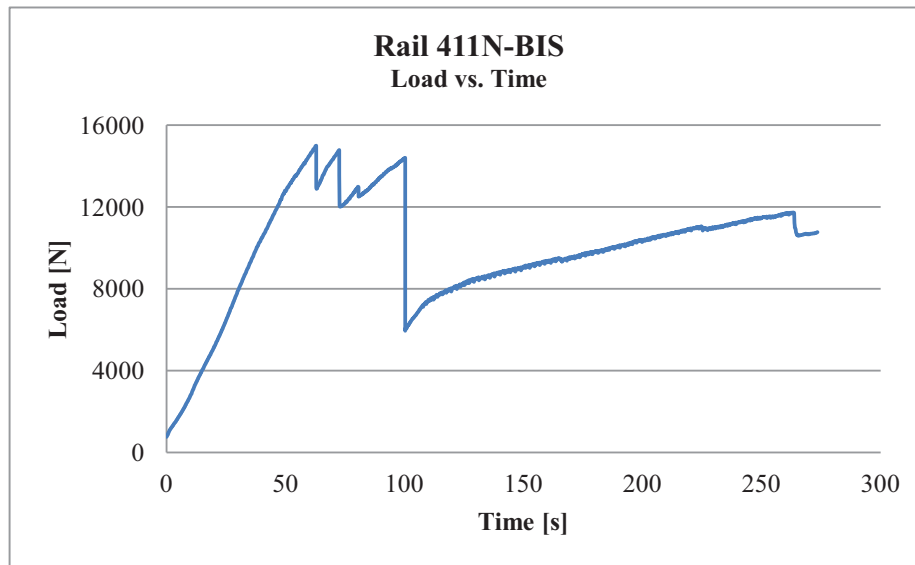
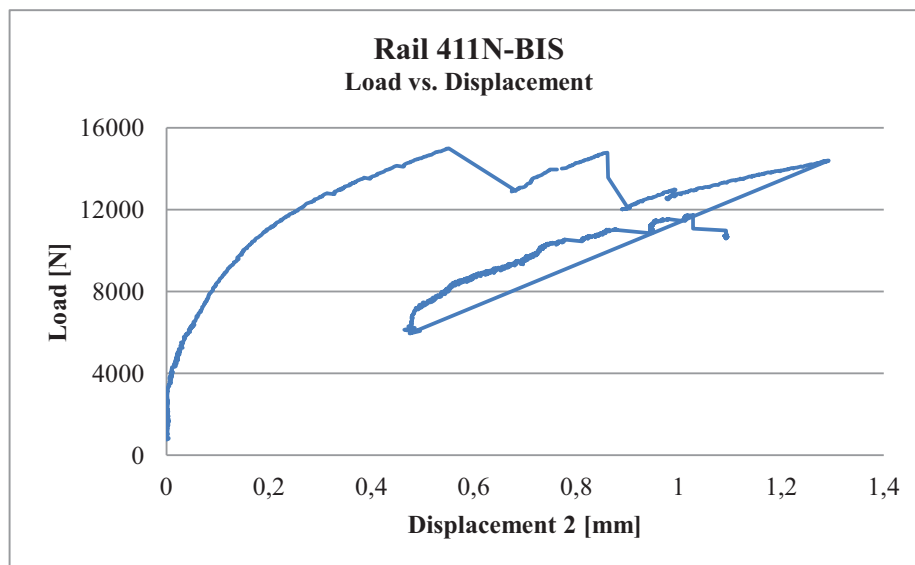
Type of failure	Failure 1 – 1 st crack at side 1
Failure load [N]	14987
Displacement 1 at failure [mm]	0,00
Displacement 2 at failure [mm]	0,55
Distance from crack to edge side 1 [mm]	53
Distance from crack to edge side 2 [mm]	40
Distance from crack to anchor bolt side 1 [mm]	54
Distance from crack to anchor bolt side 2 [mm]	39
Moisture [%]	13,8
Dry density [kg/m ³]	357

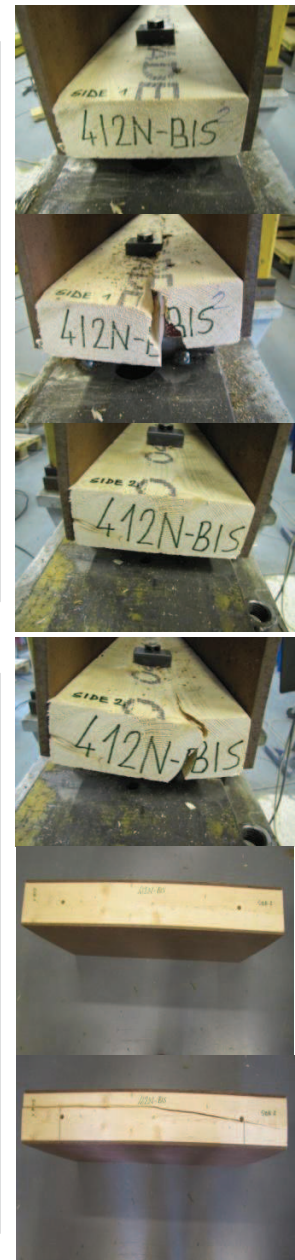
Type of failure	Failure 1 – 1 st crack at side 1
Failure load [N]	23952
Displacement 1 at failure [mm]	0,02
Displacement 2 at failure [mm]	3,08
Distance from crack to edge side 1 [mm]	84
Distance from crack to edge side 2 [mm]	40
Distance from crack to anchor bolt side 1 [mm]	85
Distance from crack to anchor bolt side 2 [mm]	55
Moisture [%]	13,8
Dry density [kg/m ³]	369

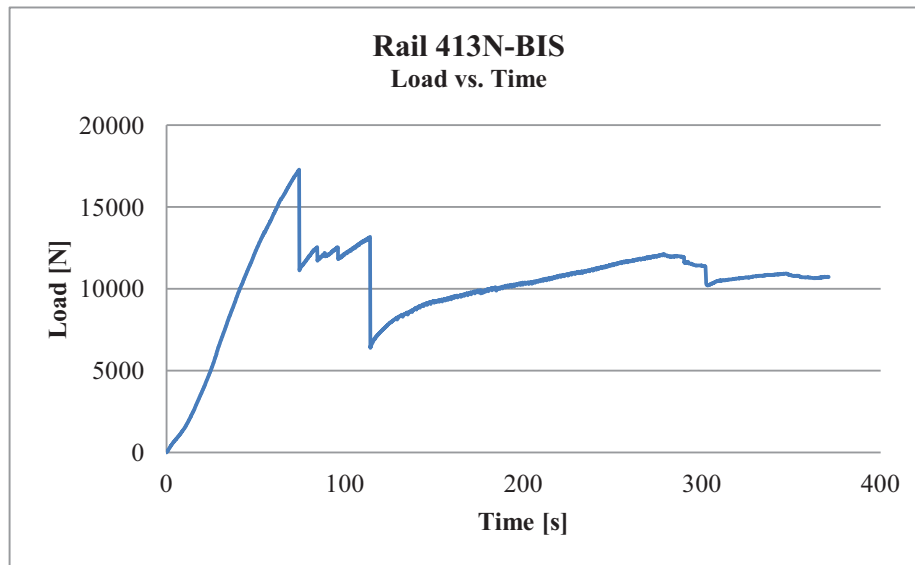
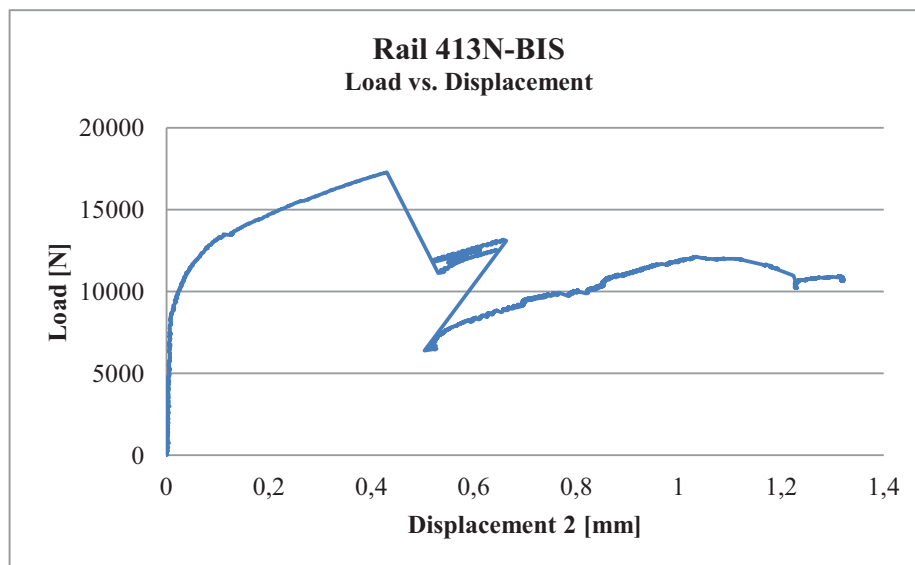
Type of failure	Failure 1 – 1 st crack at side 1
Failure load [N]	17263
Displacement 1 at failure [mm]	-0,03
Displacement 2 at failure [mm]	0,43
Distance from crack to edge side 1 [mm]	59
Distance from crack to edge side 2 [mm]	44
Distance from crack to anchor bolt side 1 [mm]	59
Distance from crack to anchor bolt side 2 [mm]	44
Moisture [%]	12,9
Dry density [kg/m ³]	410
