Experimental Testing of Anchoring Devices for Bottom Rail in Partially Anchored Timber Frame Shear Walls With Two-Sided Sheathing

Giuseppe Caprolu

Luleå University of Technology
Department of Civil, Environmental and Natural resources engineering
Division of Structural and Construction Engineering

Luleå 2012

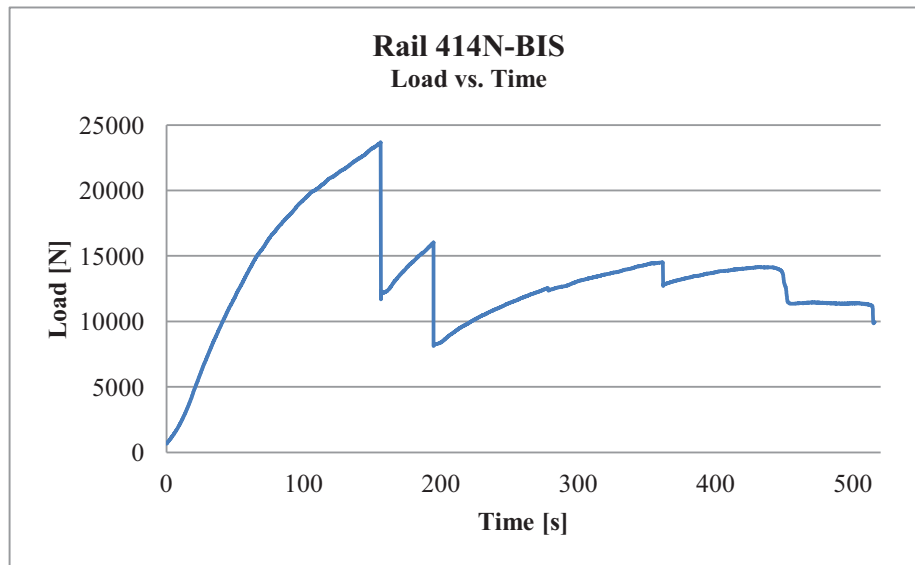
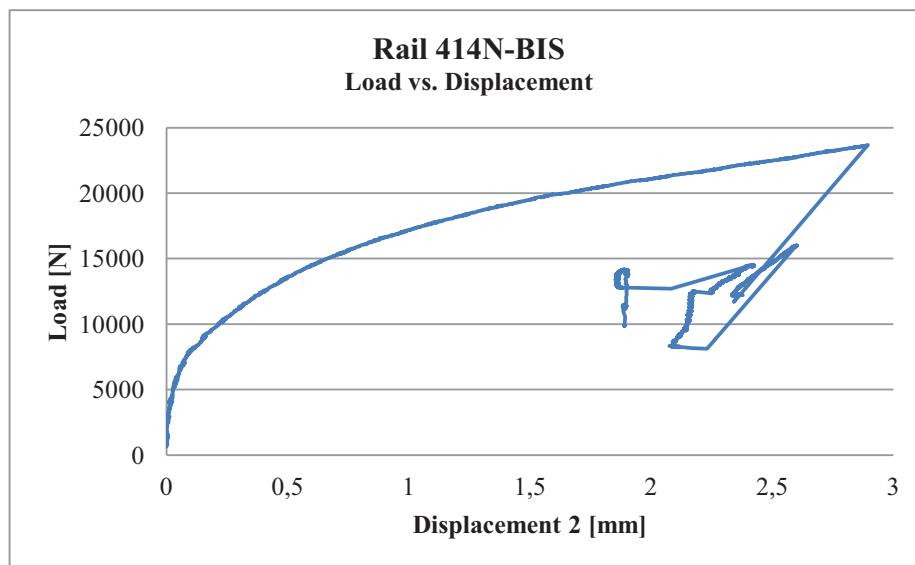
Type of failure	Failure 1 – 1 st crack at side 1
Failure load [N]	23682
Displacement 1 at failure [mm]	0,01
Displacement 2 at failure [mm]	2,89
Distance from crack to edge side 1 [mm]	65
Distance from crack to edge side 2 [mm]	48
Distance from crack to anchor bolt side 1 [mm]	59
Distance from crack to anchor bolt side 2 [mm]	52
Moisture [%]	13,5
Dry density [kg/m ³]	433

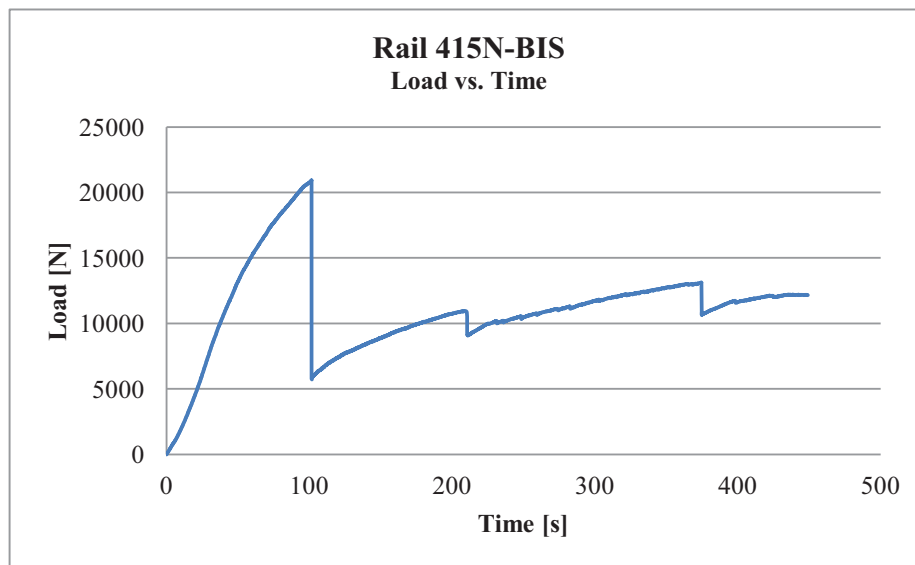
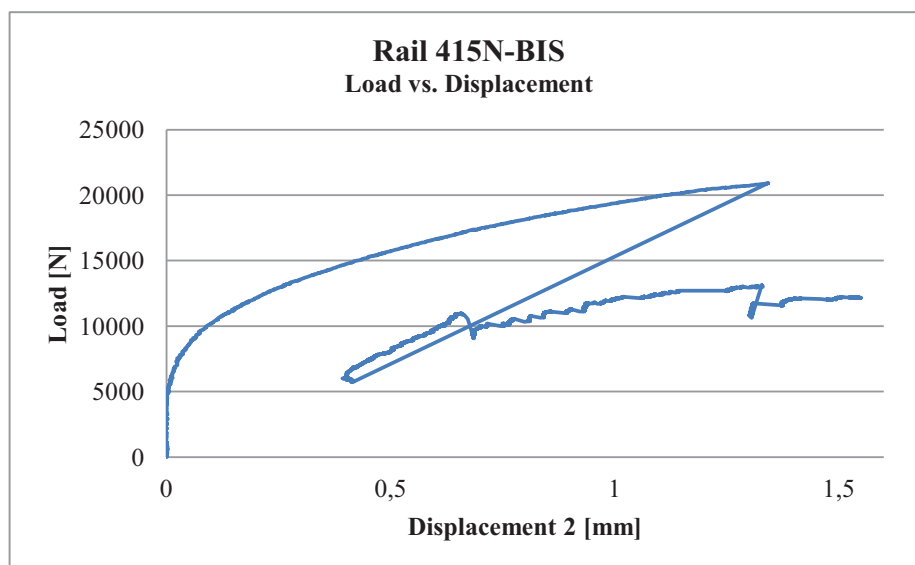
Type of failure	Failure 1 – 1 st crack at side 1
Failure load [N]	20917
Displacement 1 at failure [mm]	0,00
Displacement 2 at failure [mm]	1,34
Distance from crack to edge side 1 [mm]	65
Distance from crack to edge side 2 [mm]	36
Distance from crack to anchor bolt side 1 [mm]	60
Distance from crack to anchor bolt side 2 [mm]	36
Moisture [%]	13,6
Dry density [kg/m ³]	393

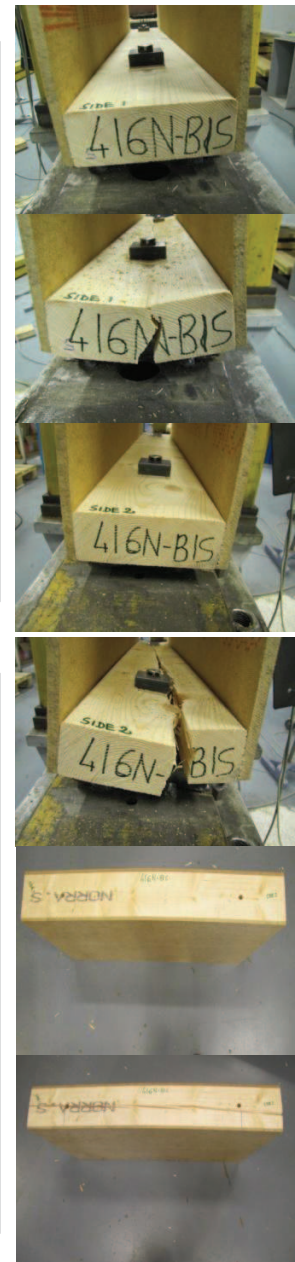
Type of failure	Failure 1 – Instantaneous crack on both sides
Failure load [N]	23217
Displacement 1 at failure [mm]	0,00
Displacement 2 at failure [mm]	2,12
Distance from crack to edge side 1 [mm]	62
Distance from crack to edge side 2 [mm]	40
Distance from crack to anchor bolt side 1 [mm]	60
Distance from crack to anchor bolt side 2 [mm]	46
Moisture [%]	13,6
Dry density [kg/m ³]	433

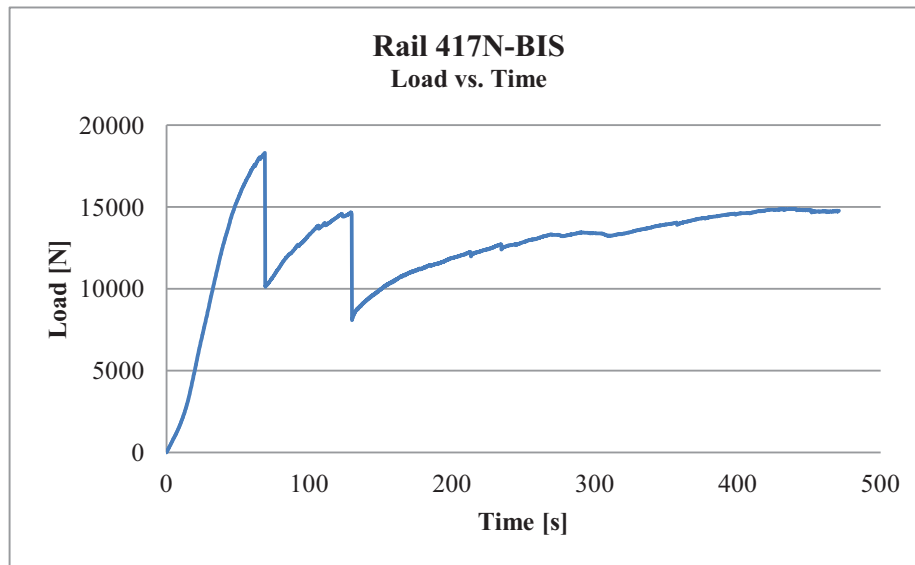
Type of failure	Failure 1 – 1 st crack at side 1
Failure load [N]	18293
Displacement 1 at failure [mm]	0,05
Displacement 2 at failure [mm]	0,65
Distance from crack to edge side 1 [mm]	66
Distance from crack to edge side 2 [mm]	45
Distance from crack to anchor bolt side 1 [mm]	60
Distance from crack to anchor bolt side 2 [mm]	45
Moisture [%]	13,2
Dry density [kg/m ³]	433

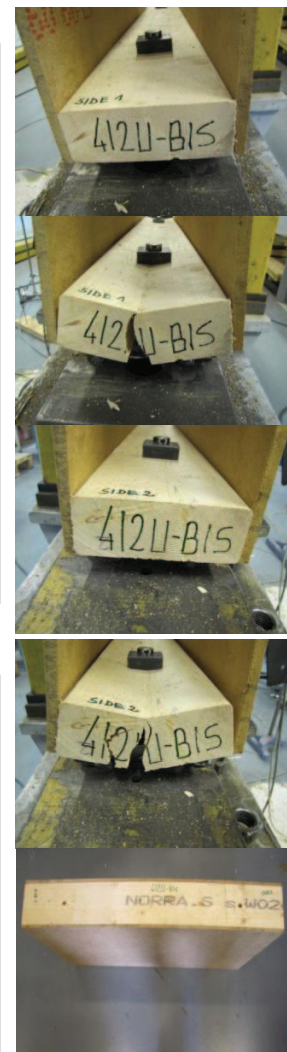
Type of failure	Failure 1 – 1 st crack at side 2
Failure load [N]	18601
Displacement 1 at failure [mm]	0,09
Displacement 2 at failure [mm]	0,97
Distance from crack to edge side 1 [mm]	57
Distance from crack to edge side 2 [mm]	70
Distance from crack to anchor bolt side 1 [mm]	60
Distance from crack to anchor bolt side 2 [mm]	60
Moisture [%]	13,8
Dry density [kg/m ³]	396

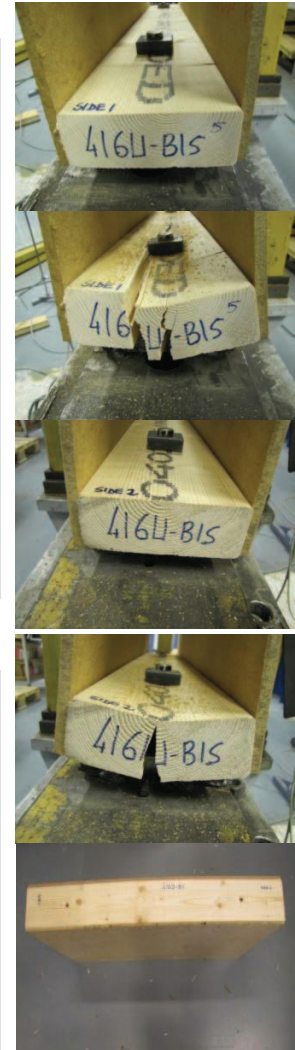
Type of failure	Failure 1 – 1 st crack at side 2
Failure load [N]	16809
Displacement 1 at failure [mm]	0,02
Displacement 2 at failure [mm]	0,51
Distance from crack to edge side 1 [mm]	47
Distance from crack to edge side 2 [mm]	63
Distance from crack to anchor bolt side 1 [mm]	51
Distance from crack to anchor bolt side 2 [mm]	60
Moisture [%]	13,3
Dry density [kg/m ³]	428

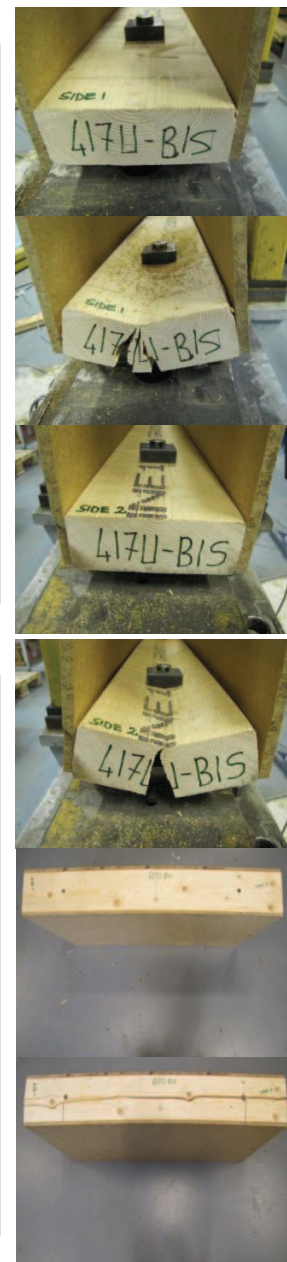
Type of failure	Failure 1 – 1 st crack at side 2
Failure load [N]	19519
Displacement 1 at failure [mm]	0,08
Displacement 2 at failure [mm]	0,75
Distance from crack to edge side 1 [mm]	44
Distance from crack to edge side 2 [mm]	62
Distance from crack to anchor bolt side 1 [mm]	48
Distance from crack to anchor bolt side 2 [mm]	60
Moisture [%]	13,2
Dry density [kg/m ³]	424

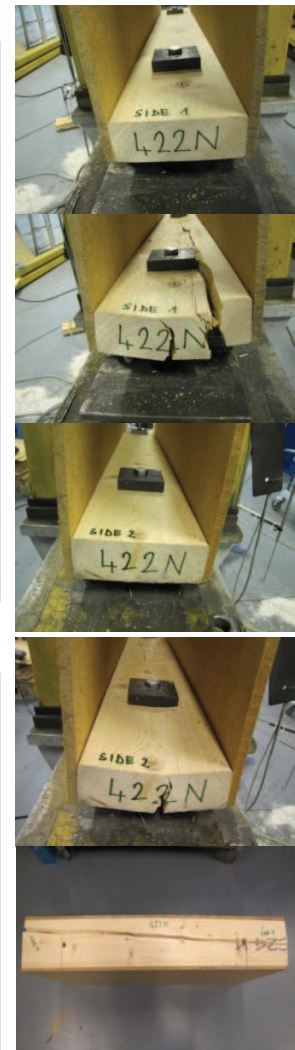
Type of failure	Failure 1 – Instantaneous crack on both sides
Failure load [N]	29616
Displacement 1 at failure [mm]	0,02
Displacement 2 at failure [mm]	1,60
Distance from crack to edge side 1 [mm]	98
Distance from crack to edge side 2 [mm]	54
Distance from crack to anchor bolt side 1 [mm]	88
Distance from crack to anchor bolt side 2 [mm]	61
Moisture [%]	13,4
Dry density [kg/m ³]	419

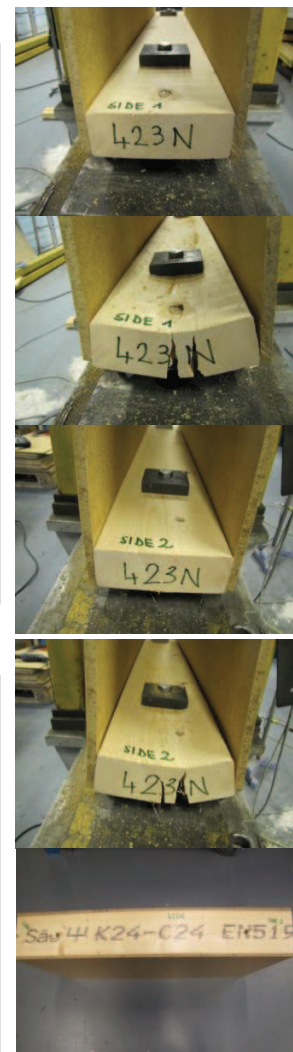
Type of failure	Failure 1 – Instantaneous crack on both sides
Failure load [N]	29506
Displacement 1 at failure [mm]	-0,12
Displacement 2 at failure [mm]	1,64
Distance from crack to edge side 1 [mm]	62
Distance from crack to edge side 2 [mm]	45
Distance from crack to anchor bolt side 1 [mm]	60
Distance from crack to anchor bolt side 2 [mm]	50
Moisture [%]	13,4
Dry density [kg/m ³]	367

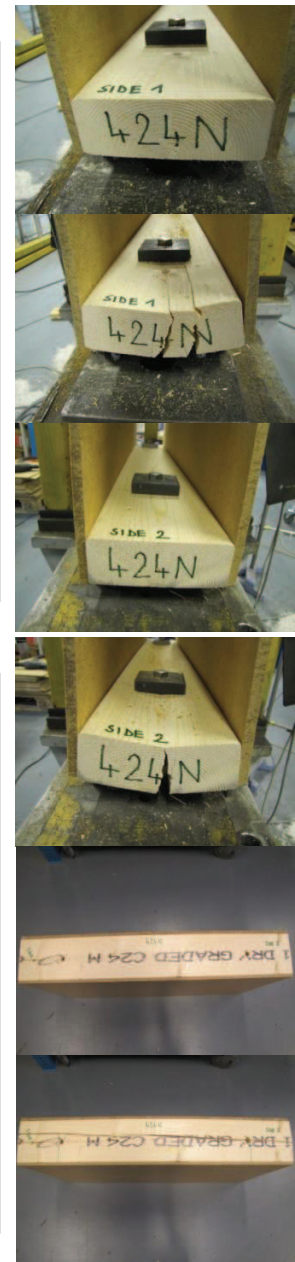
Type of failure	Failure 1 – 1 st crack at side 1
Failure load [N]	26065
Displacement 1 at failure [mm]	0,03
Displacement 2 at failure [mm]	1,78
Distance from crack to edge side 1 [mm]	82
Distance from crack to edge side 2 [mm]	55
Distance from crack to anchor bolt side 1 [mm]	80
Distance from crack to anchor bolt side 2 [mm]	60
Moisture [%]	12,3
Dry density [kg/m ³]	367

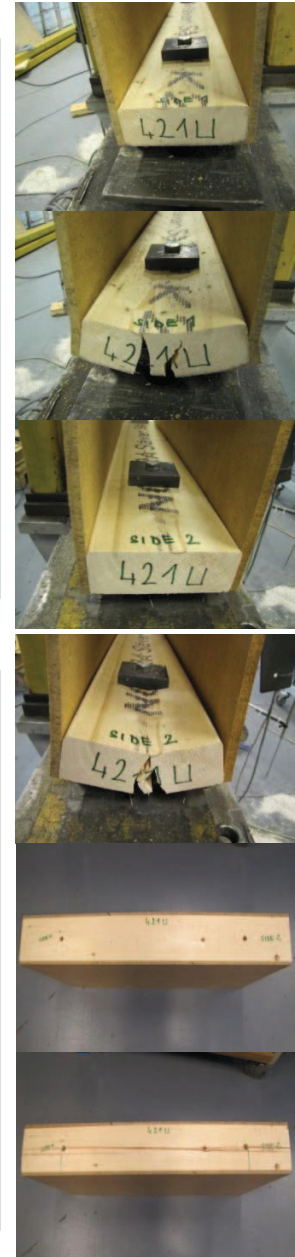
Type of failure	Failure 1 – 1 st crack at side 1
Failure load [N]	17315
Displacement 1 at failure [mm]	-0,02
Displacement 2 at failure [mm]	0,46
Distance from crack to edge side 1 [mm]	62
Distance from crack to edge side 2 [mm]	57
Distance from crack to anchor bolt side 1 [mm]	62
Distance from crack to anchor bolt side 2 [mm]	60
Moisture [%]	13,9
Dry density [kg/m ³]	390

Probable problem not visible in the rail, because the failure load is under the average.

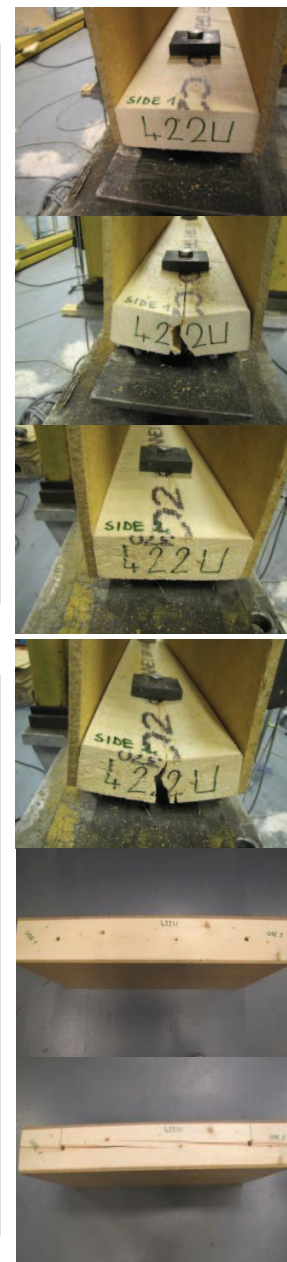
Type of failure	Failure 1 – 1 st crack at side 1
Failure load [N]	23037
Displacement 1 at failure [mm]	0,07
Displacement 2 at failure [mm]	1,21
Distance from crack to edge side 1 [mm]	64
Distance from crack to edge side 2 [mm]	55
Distance from crack to anchor bolt side 1 [mm]	60
Distance from crack to anchor bolt side 2 [mm]	60
Moisture [%]	11,0
Dry density [kg/m ³]	390

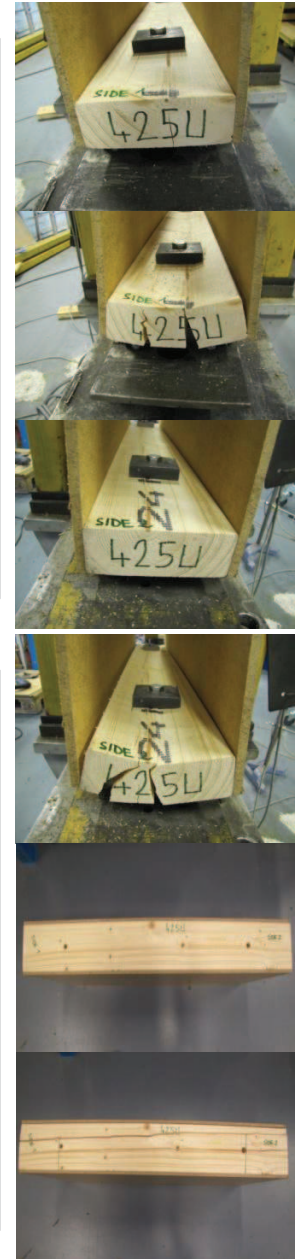
Type of failure	Failure 1 – 1 st crack at side 1
Failure load [N]	20768
Displacement 1 at failure [mm]	-0,11
Displacement 2 at failure [mm]	1,25
Distance from crack to edge side 1 [mm]	75
Distance from crack to edge side 2 [mm]	104
Distance from crack to anchor bolt side 1 [mm]	81
Distance from crack to anchor bolt side 2 [mm]	102
Moisture [%]	12,9
Dry density [kg/m ³]	404

Pre-crack on the side 1. The crack started immediately from the side 1 until the side 2.

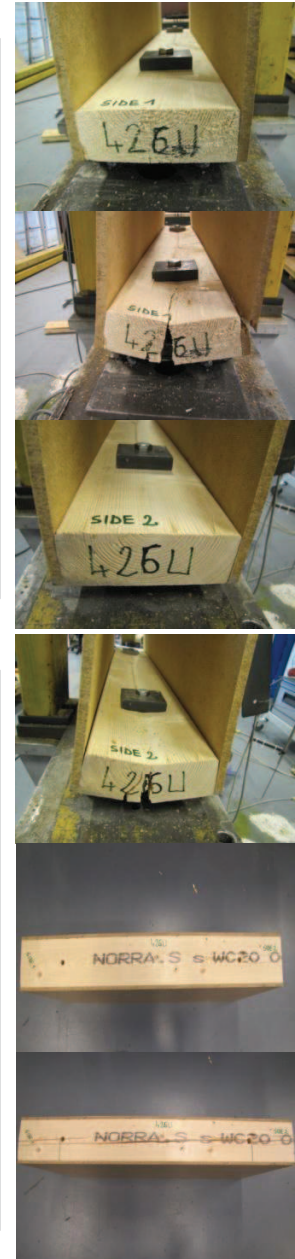
Type of failure	Failure 1 – 1 st crack at side 1
Failure load [N]	18409
Displacement 1 at failure [mm]	-0,01
Displacement 2 at failure [mm]	0,34
Distance from crack to edge side 1 [mm]	44 (<i>pre-crack</i>) – 56 (<i>failure crack</i>)
Distance from crack to edge side 2 [mm]	62
Distance from crack to anchor bolt side 1 [mm]	48 (<i>pre-crack</i>) – 61 (<i>failure crack</i>)
Distance from crack to anchor bolt side 2 [mm]	58
Moisture [%]	13,5
Dry density [kg/m ³]	437

First crack started from the pre-crack on the side 1 but after another crack line happened.

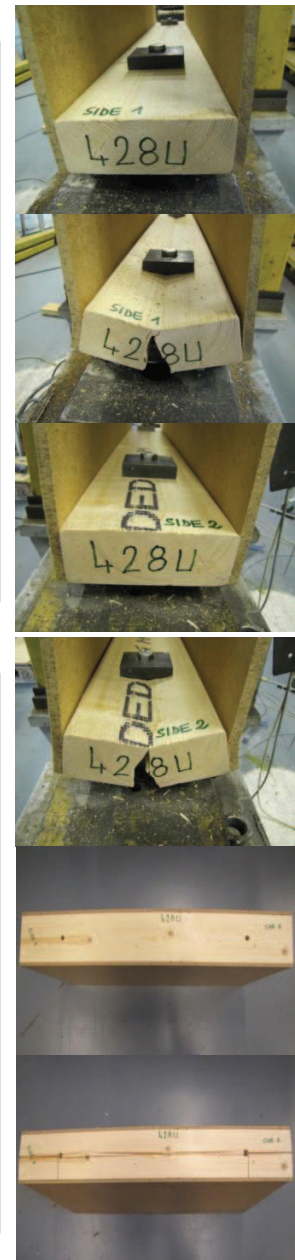
Type of failure	Failure 1 – Instantaneous crack on both sides
Failure load [N]	21019
Displacement 1 at failure [mm]	0,02
Displacement 2 at failure [mm]	0,49
Distance from crack to edge side 1 [mm]	58
Distance from crack to edge side 2 [mm]	60
Distance from crack to anchor bolt side 1 [mm]	60
Distance from crack to anchor bolt side 2 [mm]	59
Moisture [%]	12,7
Dry density [kg/m ³]	471

Possible pre-crack on both sides but they seem do not have any influence on the test.

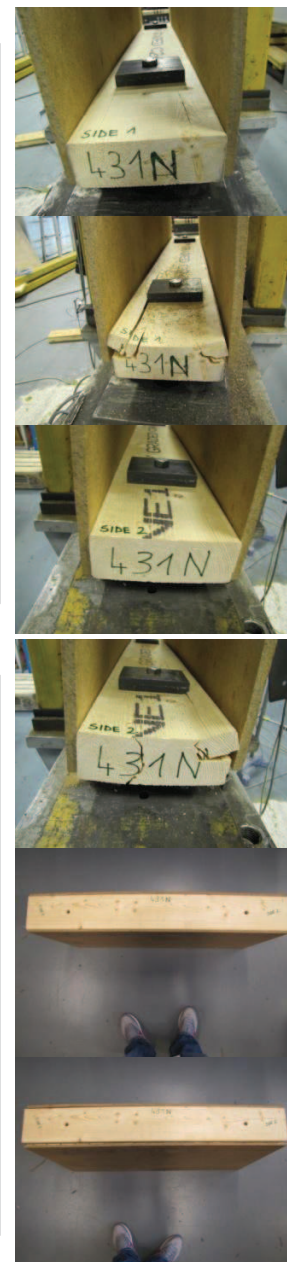
Type of failure	Failure 2 – 1 st crack at side 1
Failure load [N]	31530
Displacement 1 at failure [mm]	0,14
Displacement 2 at failure [mm]	2,19
Moisture [%]	14,5
Dry density [kg/m ³]	455

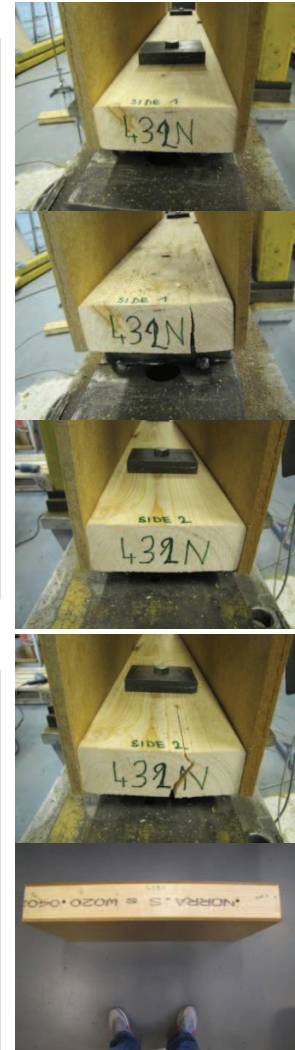
Type of failure	Failure 1 – Instantaneous crack on both sides
Failure load [N]	38469
Displacement 1 at failure [mm]	-0,01
Displacement 2 at failure [mm]	1,96
Distance from crack to edge side 1 [mm]	89
Distance from crack to edge side 2 [mm]	50
Distance from crack to anchor bolt side 1 [mm]	85
Distance from crack to anchor bolt side 2 [mm]	62
Moisture [%]	14,4
Dry density [kg/m ³]	450

The cracks before the failure at 38 kN are movement of the rail. Anchor bolt failure at 33 kN.

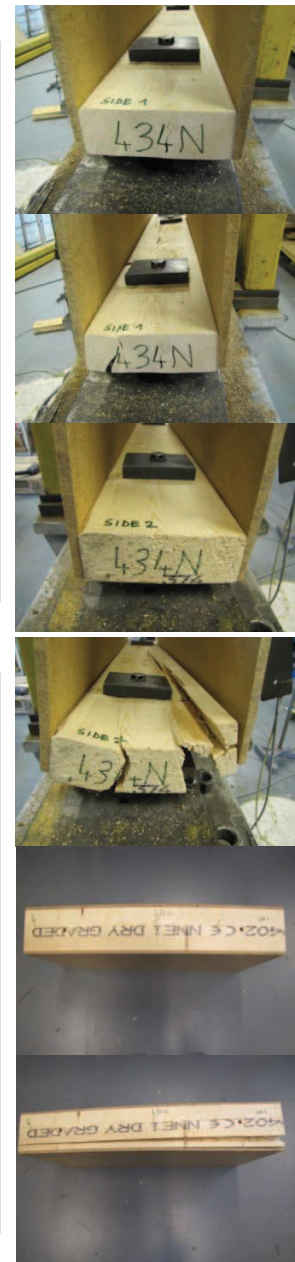
Type of failure	Failure 1 – 1 st crack at side 1
Failure load [N]	37884
Displacement 1 at failure [mm]	0,02
Displacement 2 at failure [mm]	2,25
Distance from crack to edge side 1 [mm]	19
Distance from crack to edge side 2 [mm]	14
Distance from crack to anchor bolt side 1 [mm]	18
Distance from crack to anchor bolt side 2 [mm]	16
Moisture [%]	12,9
Dry density [kg/m ³]	421

The cracks before the failure at 37 kN are movement of the rail.

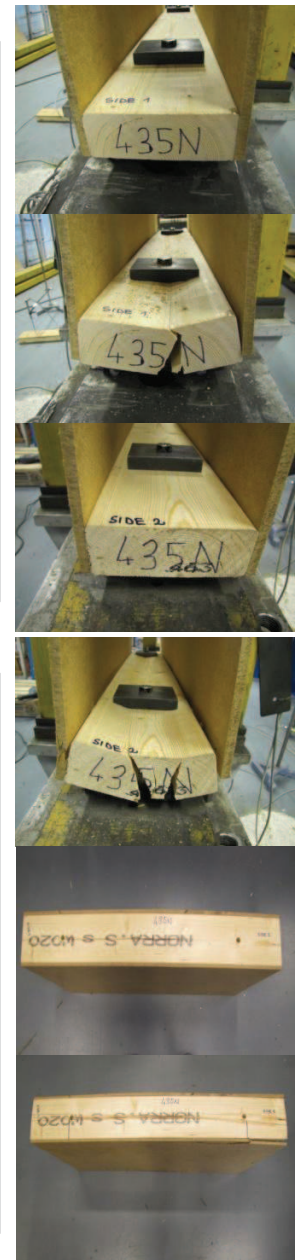
Type of failure	Failure 1 – Instantaneous crack on both sides
Failure load [N]	43987
Displacement 1 at failure [mm]	0,06
Displacement 2 at failure [mm]	2,37
Distance from crack to edge side 1 [mm]	65
Distance from crack to edge side 2 [mm]	39
Distance from crack to anchor bolt side 1 [mm]	60
Distance from crack to anchor bolt side 2 [mm]	50
Moisture [%]	11,7
Dry density [kg/m ³]	449

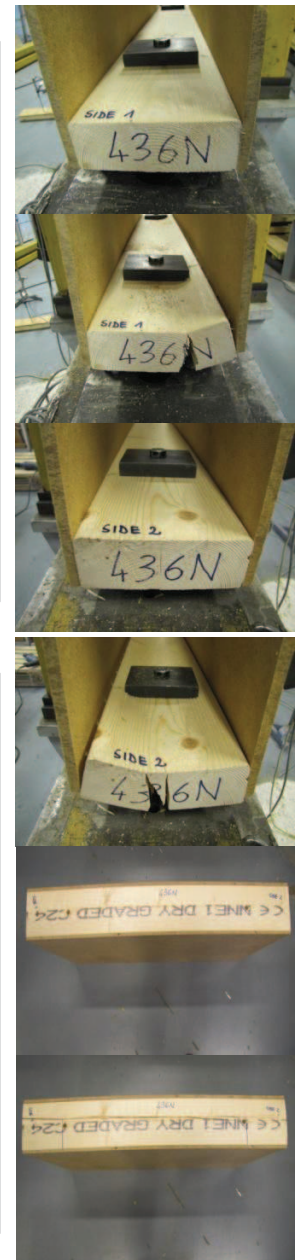
Type of failure	Failure 1 – Instantaneous crack on both sides
Failure load [N]	35521
Displacement 1 at failure [mm]	0,03
Displacement 2 at failure [mm]	2,06
Distance from crack to edge side 1 [mm]	80
Distance from crack to edge side 2 [mm]	64
Distance from crack to anchor bolt side 1 [mm]	74
Distance from crack to anchor bolt side 2 [mm]	72
Moisture [%]	13,6
Dry density [kg/m ³]	378

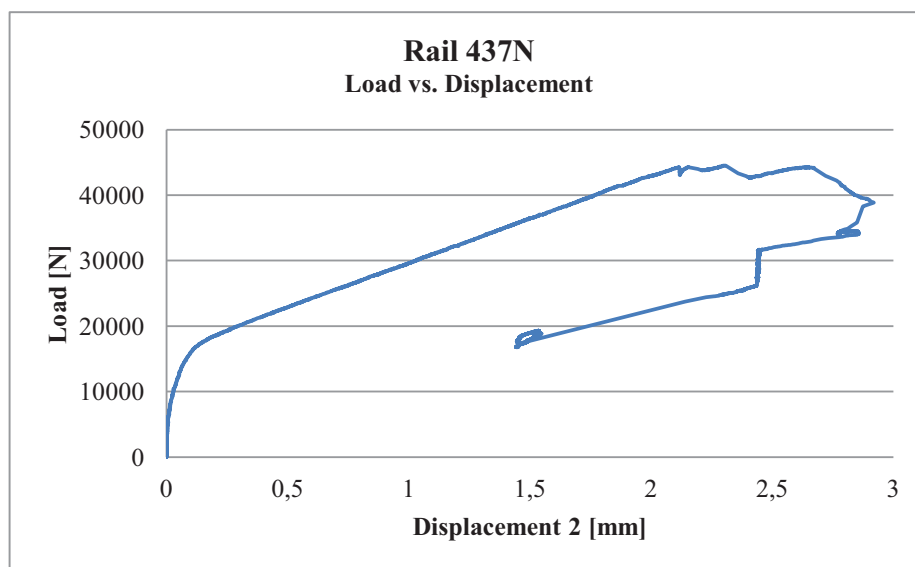
Type of failure	Failure 2 – 1 st crack at side 1
Failure load [N]	44512
Displacement 1 at failure [mm]	0,20
Displacement 2 at failure [mm]	2,31
Moisture [%]	14,3
Dry density [kg/m ³]	526

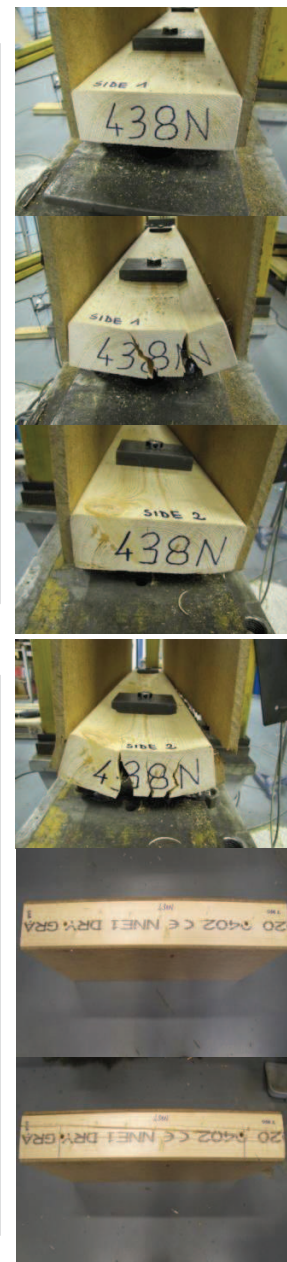
Type of failure	Failure 1 – Instantaneous crack on both sides
Failure load [N]	46611
Displacement 1 at failure [mm]	0,09
Displacement 2 at failure [mm]	2,45
Distance from crack to edge side 1 [mm]	91
Distance from crack to edge side 2 [mm]	69
Distance from crack to anchor bolt side 1 [mm]	88
Distance from crack to anchor bolt side 2 [mm]	77
Moisture [%]	11,4
Dry density [kg/m ³]	454

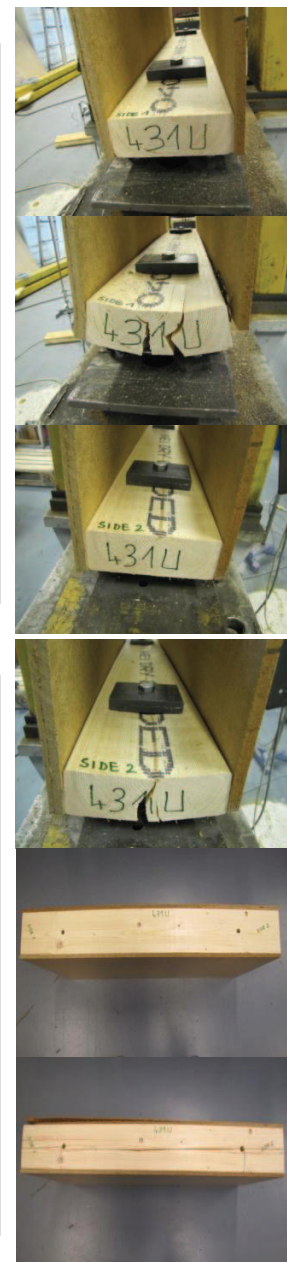
Type of failure	Failure 1 – 1 st crack at side 1
Failure load [N]	26576
Displacement 1 at failure [mm]	0,04
Displacement 2 at failure [mm]	1,29
Distance from crack to edge side 1 [mm]	56
Distance from crack to edge side 2 [mm]	63
Distance from crack to anchor bolt side 1 [mm]	60
Distance from crack to anchor bolt side 2 [mm]	60
Moisture [%]	14,6
Dry density [kg/m ³]	464

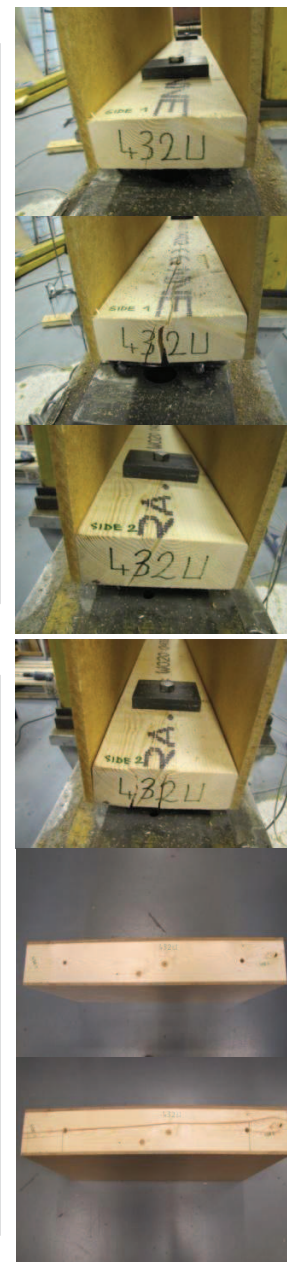
Type of failure	Failure 1 – 1 st crack at side 1
Failure load [N]	17161
Displacement 1 at failure [mm]	-0,04
Displacement 2 at failure [mm]	0,28
Distance from crack to edge side 1 [mm]	55
Distance from crack to edge side 2 [mm]	86
Distance from crack to anchor bolt side 1 [mm]	60
Distance from crack to anchor bolt side 2 [mm]	81
Moisture [%]	11,8
Dry density [kg/m ³]	394

Pre-crack on the side 1 by tightening the bolt. This had considerable influence in the test.

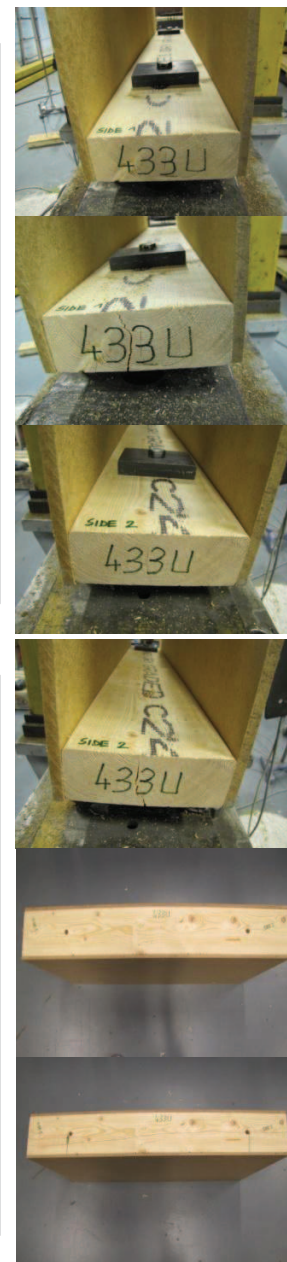
Type of failure	Failure 1 – 1 st crack at side 1
Failure load [N]	34145
Displacement 1 at failure [mm]	0,06
Displacement 2 at failure [mm]	2,38
Distance from crack to edge side 1 [mm]	29
Distance from crack to edge side 2 [mm]	59
Distance from crack to anchor bolt side 1 [mm]	30
Distance from crack to anchor bolt side 2 [mm]	60
Moisture [%]	14,0
Dry density [kg/m ³]	489

The last crack is caused by the anchor bolt failure on the side 2.

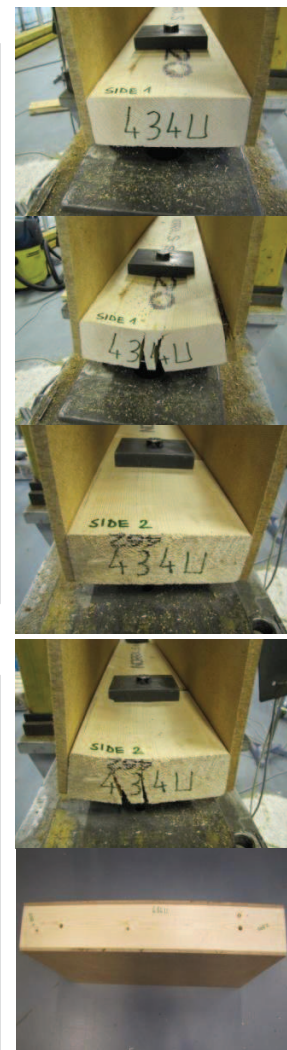
Type of failure	Failure 1 – 1 st crack at side 2
Failure load [N]	22564
Displacement 1 at failure [mm]	0,01
Displacement 2 at failure [mm]	0,80
Distance from crack to edge side 1 [mm]	54
Distance from crack to edge side 2 [mm]	75
Distance from crack to anchor bolt side 1 [mm]	59
Distance from crack to anchor bolt side 2 [mm]	71
Moisture [%]	13,1
Dry density [kg/m ³]	425

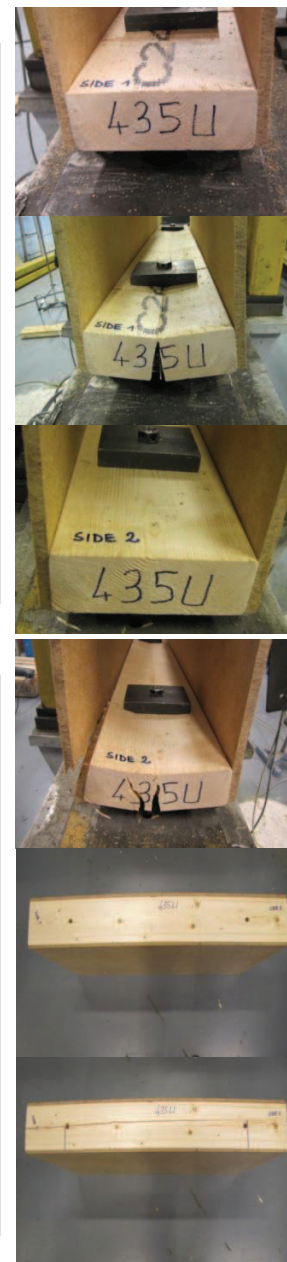
Type of failure	Failure 1 – 1 st crack at side 1
Failure load [N]	24986
Displacement 1 at failure [mm]	0,03
Displacement 2 at failure [mm]	0,56
Distance from crack to edge side 1 [mm]	57
Distance from crack to edge side 2 [mm]	75
Distance from crack to anchor bolt side 1 [mm]	60
Distance from crack to anchor bolt side 2 [mm]	72
Moisture [%]	13,2
Dry density [kg/m ³]	411

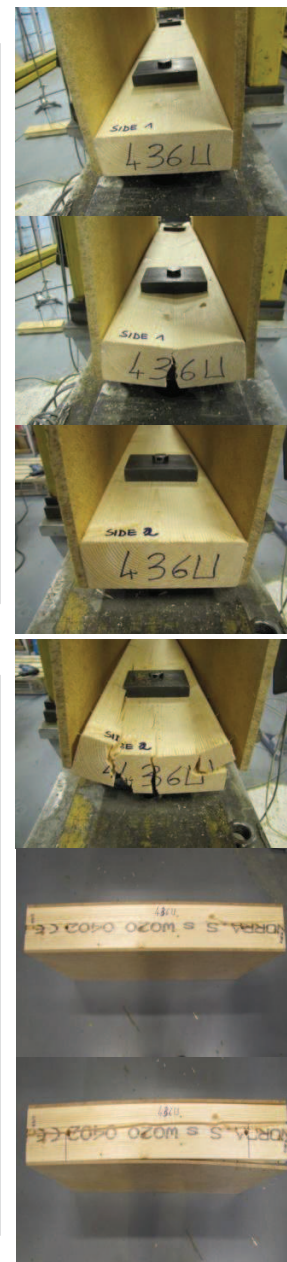
Type of failure	Failure 1 – 1 st crack at side 2
Failure load [N]	23822
Displacement 1 at failure [mm]	0,05
Displacement 2 at failure [mm]	0,91
Distance from crack to edge side 1 [mm]	58
Distance from crack to edge side 2 [mm]	80
Distance from crack to anchor bolt side 1 [mm]	59
Distance from crack to anchor bolt side 2 [mm]	76
Moisture [%]	-
Dry density [kg/m ³]	-

Due problems with the rail, moisture and density were not measured.

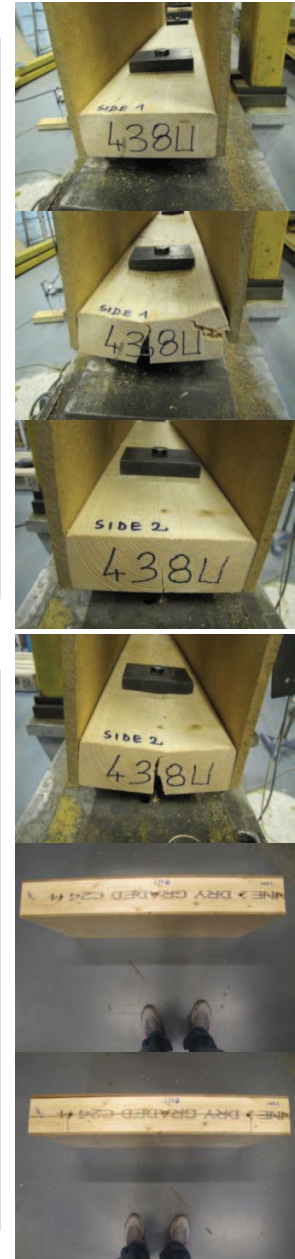
Type of failure	Failure 1 – 1 st crack at side 2
Failure load [N]	21747
Displacement 1 at failure [mm]	0,03
Displacement 2 at failure [mm]	0,56
Distance from crack to edge side 1 [mm]	54
Distance from crack to edge side 2 [mm]	52
Distance from crack to anchor bolt side 1 [mm]	62
Distance from crack to anchor bolt side 2 [mm]	57
Moisture [%]	11,5
Dry density [kg/m ³]	433

Pre-crack on the side 2 by tightening the bolt. This had considerable influence in the test.

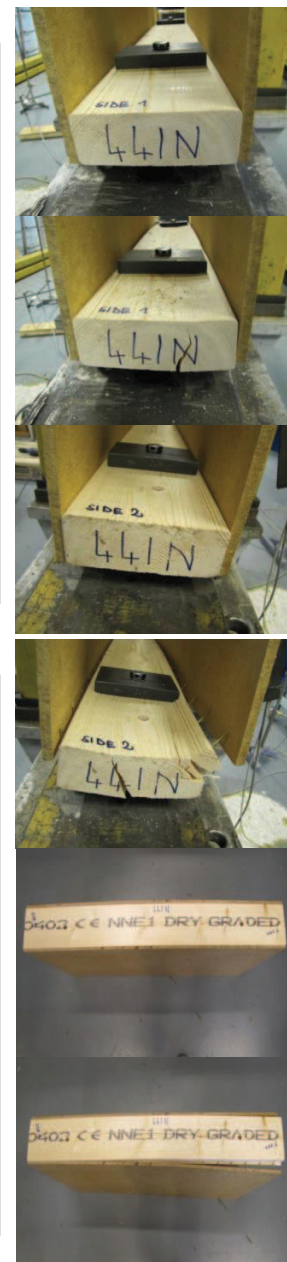
Type of failure	Failure 2 – 1 st crack at side 2
Failure load [N]	47372
Displacement 1 at failure [mm]	0,16
Displacement 2 at failure [mm]	3,06
Moisture [%]	12,9
Dry density [kg/m ³]	395

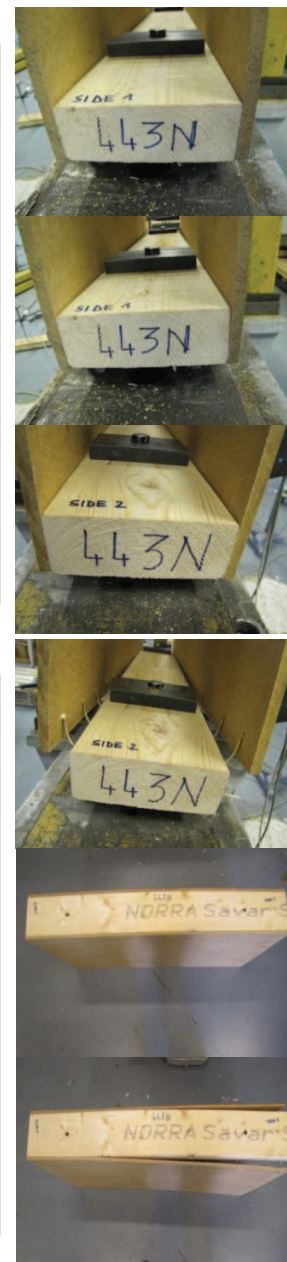
Type of failure	Failure 3
Failure load [N]	41868
Displacement 1 at failure [mm]	0,07
Displacement 2 at failure [mm]	2,80
Moisture [%]	11,6
Dry density [kg/m ³]	385

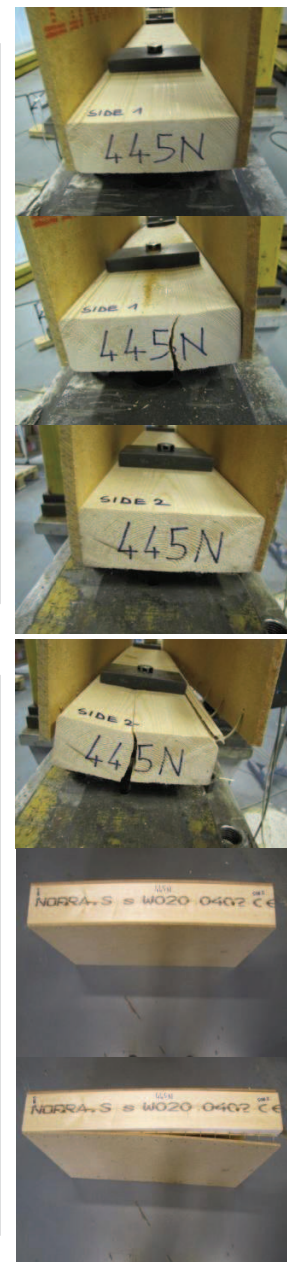
Type of failure	Failure 3
Failure load [N]	46306
Displacement 1 at failure [mm]	0,15
Displacement 2 at failure [mm]	2,90
Moisture [%]	12,8
Dry density [kg/m ³]	400

The bottom rail failure happens after the nails pull-out.

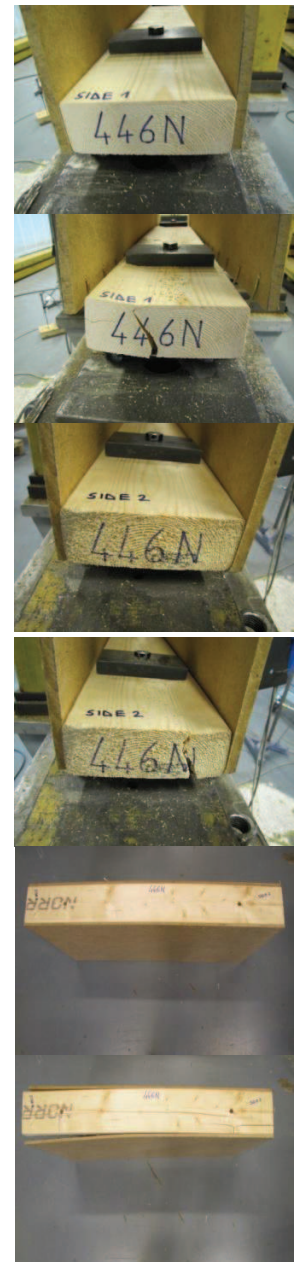
Type of failure	Failure 1 – 1 st crack at side 2
Failure load [N]	45414
Displacement 1 at failure [mm]	0,26
Displacement 2 at failure [mm]	3,71
Distance from crack to edge side 1 [mm]	50
Distance from crack to edge side 2 [mm]	24
Distance from crack to anchor bolt side 1 [mm]	54
Distance from crack to anchor bolt side 2 [mm]	17
Moisture [%]	12,7
Dry density [kg/m ³]	396

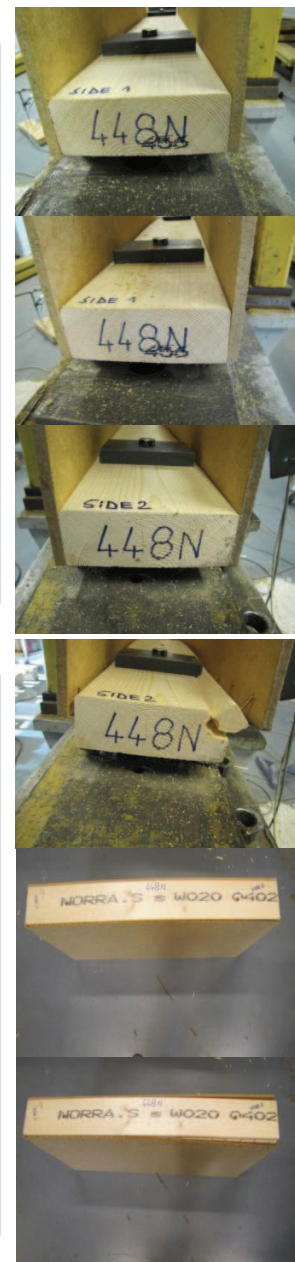
Type of failure	Failure 2 – 1 st crack at side 2
Failure load [N]	47164
Displacement 1 at failure [mm]	0,16
Displacement 2 at failure [mm]	2,97
Moisture [%]	12,3
Dry density [kg/m ³]	380

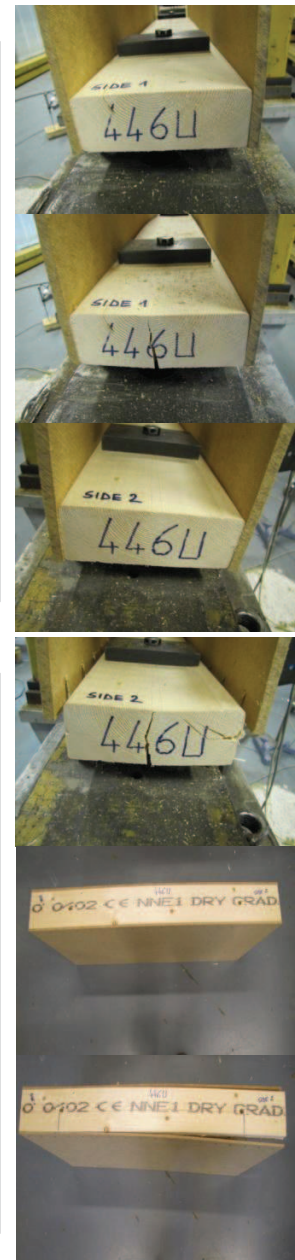
Type of failure	Failure 1 – 1 st crack at side 2
Failure load [N]	25930
Displacement 1 at failure [mm]	0,04
Displacement 2 at failure [mm]	1,21
Distance from crack to edge side 1 [mm]	57
Distance from crack to edge side 2 [mm]	60
Distance from crack to anchor bolt side 1 [mm]	59
Distance from crack to anchor bolt side 2 [mm]	59
Moisture [%]	13,1
Dry density [kg/m ³]	490

After the crack at 26 kN the load increase a lot until 39 kN causing the failure type 2 and 3.

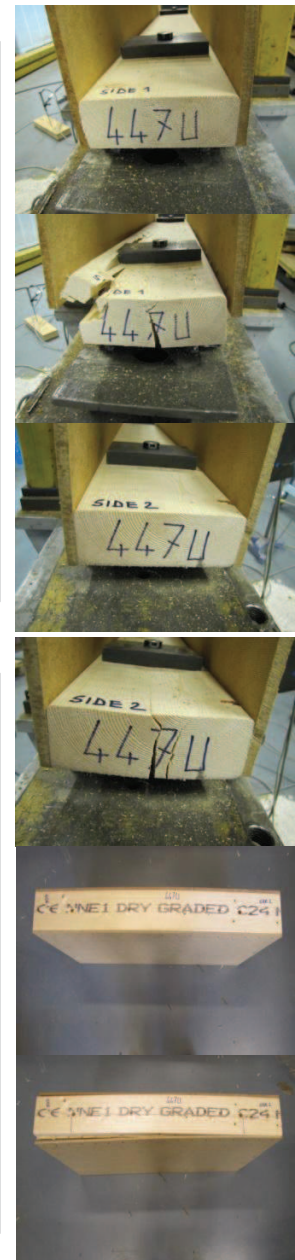
Type of failure	Failure 1 – 1 st crack at side 1
Failure load [N]	16068
Displacement 1 at failure [mm]	0,04
Displacement 2 at failure [mm]	0,30
Distance from crack to edge side 1 [mm]	63
Distance from crack to edge side 2 [mm]	55
Distance from crack to anchor bolt side 1 [mm]	60
Distance from crack to anchor bolt side 2 [mm]	59
Moisture [%]	11,2
Dry density [kg/m ³]	385

After the crack at 16 kN the load increase a lot until 44 kN causing the failure type 2.

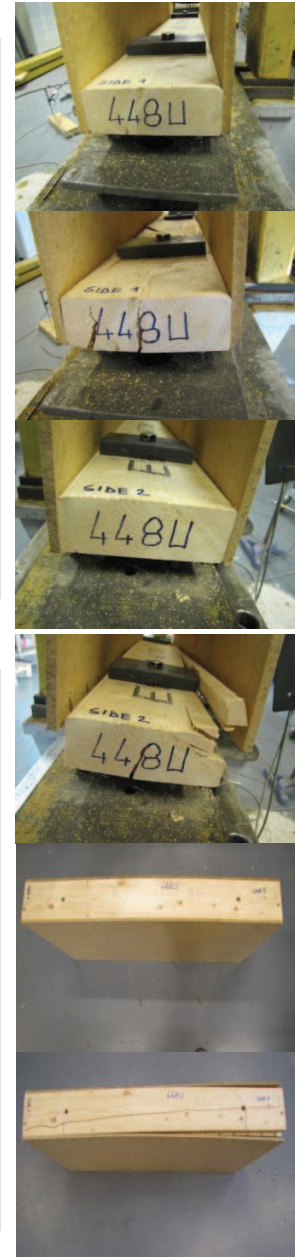
Type of failure	Failure 1 – 1 st crack at side 1
Failure load [N]	15266
Displacement 1 at failure [mm]	-0,03
Displacement 2 at failure [mm]	0,05
Distance from crack to edge side 1 [mm]	18
Distance from crack to edge side 2 [mm]	66
Distance from crack to anchor bolt side 1 [mm]	30
Distance from crack to anchor bolt side 2 [mm]	61
Moisture [%]	9,97
Dry density [kg/m ³]	398

After the crack at 15 kN the load increase a lot until 35 kN causing the failure type 2.
