Repairing of a timber truss through two different techniques using timber elements and screwed metal plates

Keywords: Timber trusses, Repair, Timber elements, Screwed metal plates

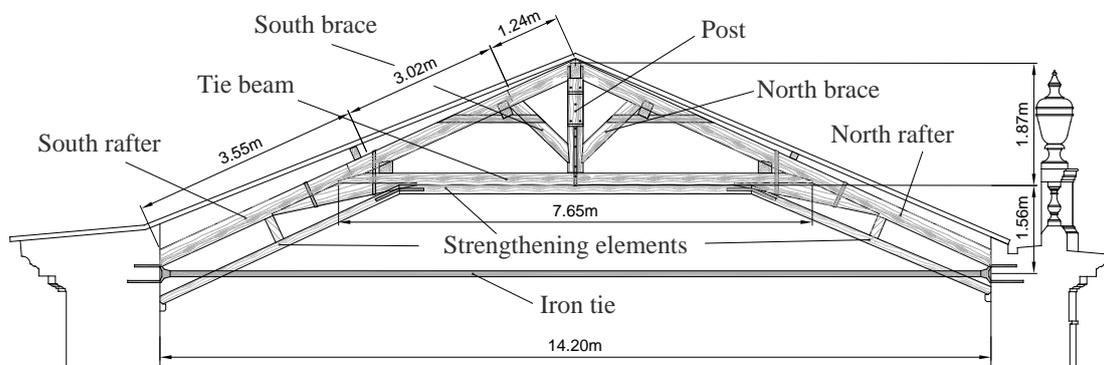
Fig. 1 - Roof structure of the Chimico Laboratory in Coimbra [5].

Failure of the truss was found in both rafters near the loading position and on the connection between one rafter and the post (Fig. 2). The failure of the rafters coincided with sections where significant knots were found on the tensioned side of the element. Slight crushing of the supports (bottom of the rafters) was also found (due to decayed segments).
