Mystery of Mosul Dam the most Dangerous Dam in the World: Foundation Treatment during Construction

Abstract

2 Grouting Works Details

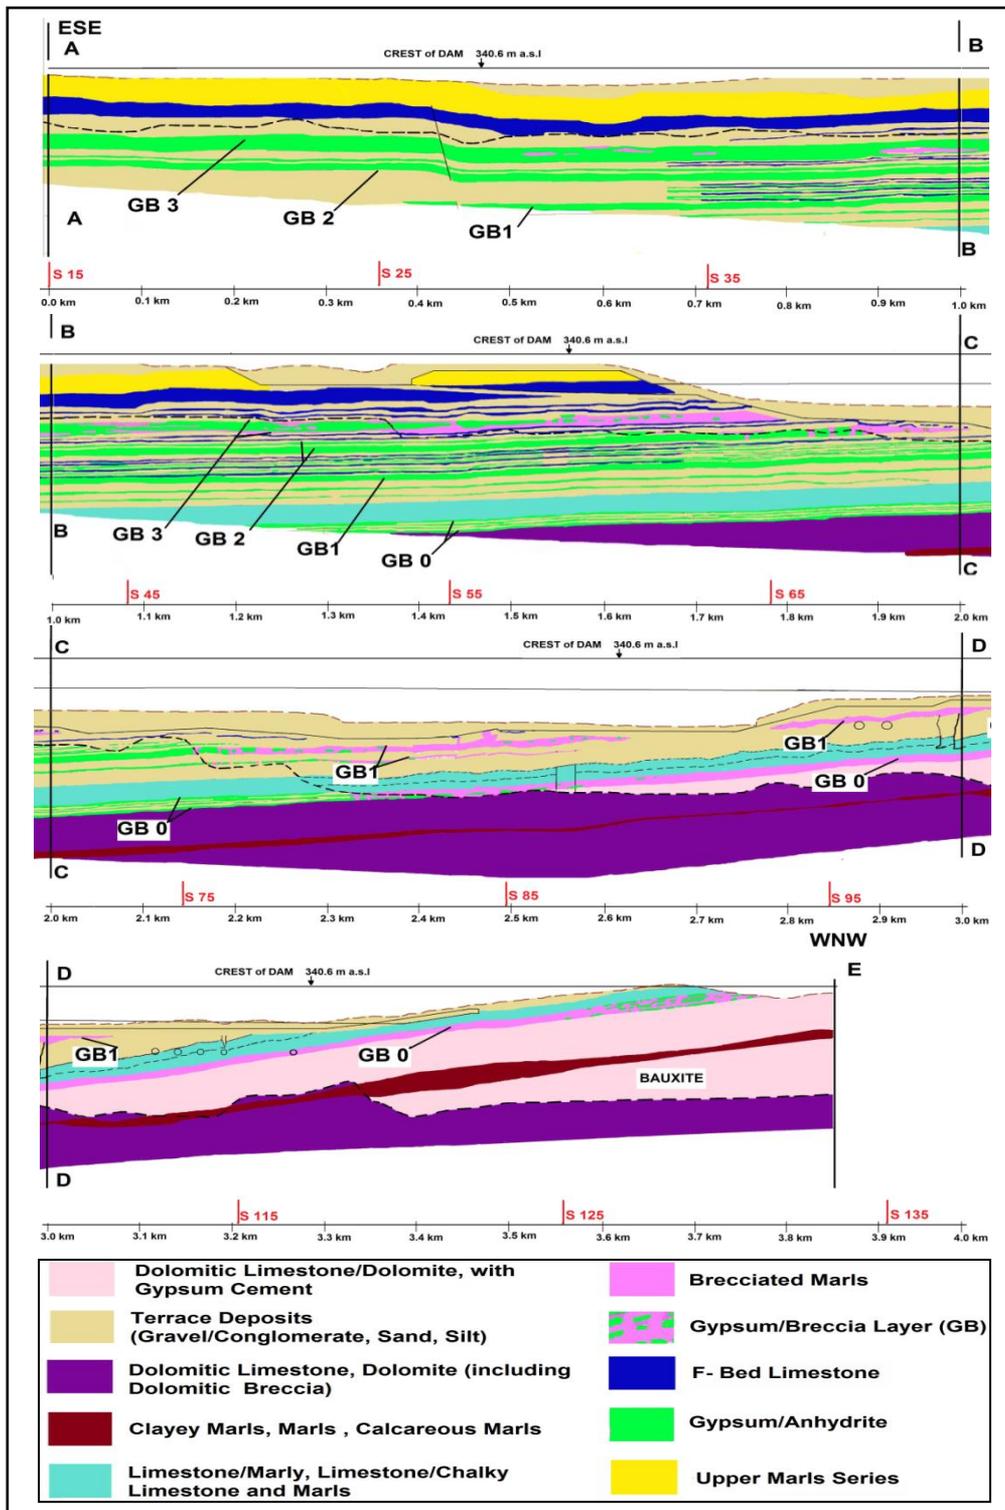
Figure 1: Geologic cross section along the axis of the dam.

exploratory holes before starting grouting operation to find out later the efficiency of completed work. High permeability zones were found with average values of 28.7 Lu on the right bank from Sec. 87 to Sec. 113 and on left bank an average value of 54.5 Lu from Sec. 64 to Sec.86 (Fig. 1).
