Experimental Testing of Hold Down Devices for Timber Frame Shear Walls

Giuseppe Caprolu

ISSN: 1402-1536
ISBN 978-91-7439-386-6

Luleå 2012

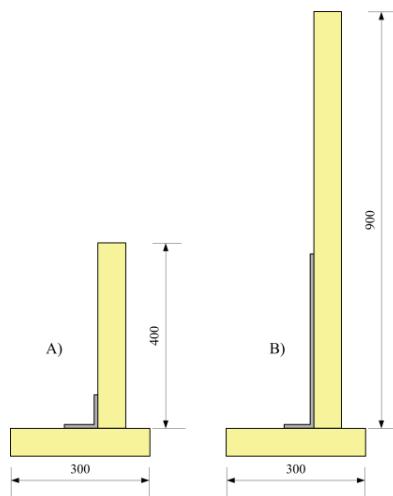
Figure 1: A) dimensions of the specimen of series 1, 2 and 3; B) dimensions of the specimen of series 4.

The specimens tested were built with two timber pieces of different lengths joined by four different connectors. The horizontal part of the specimen is the bottom rail of a shear wall whilst the vertical part is the stud. The length of the bottom rail was 300 mm for each series whilst the length of the stud was 400 mm for series 1, 2 and 3 and 900 mm for series 4 (*see figure 1*).

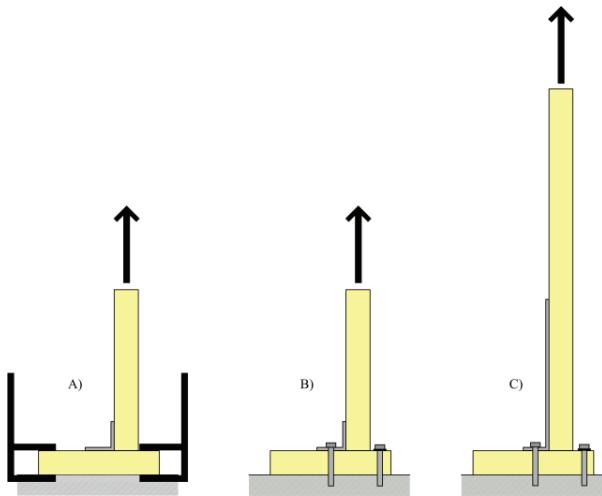
Figure 2: A) test setup for series 1 and 2; B) test setup for series 3; C) test setup for series 4.

Two different anchorage systems were used during the test. Series 1 and 2 had an anchorage system composed by two clamps in order to fix the specimen to the I steel beams simulating the foundation which in turn was welded to a steel structure (*see figures 2, 3 and 4*). In series 3 and 4 two different types of connectors were used: M12 bolt for series 3 and M16 bolt for series 4 which were tightened to a steel plate simulating the foundation which in turn was welded to a steel structure (*see figures 2, 5, 6, 7, 8, 9 and 10*).

A tensile load with a rate of 2 mm/min was applied by a hydraulic piston (static load capacity 100 kN). The connection between the hydraulic piston and the stud was made by steel bars and bolt M16.

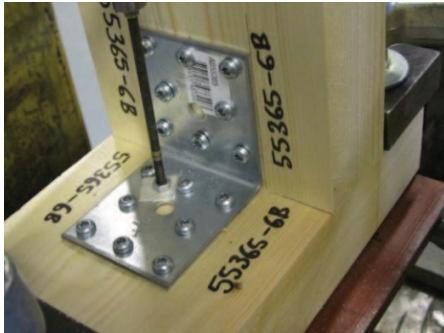
Figure 11: position of LVDT before to start the test.

During the testing the displacement was recorded using a Linear Voltage Displacement Transducer (LVDT). For series 1 – set 2 from specimen 55365-1B to 55365-9B only one LVDT was used and it was positioned on the upper surface of the angle connector in the part of the rail. However this displacement was not good because during the deformation of the connector the LVDT moved and did not measure the displacement at the same point (*see figures 11 and 12*). The stud was not guided and it was free to move in horizontal direction due to the eccentricity.

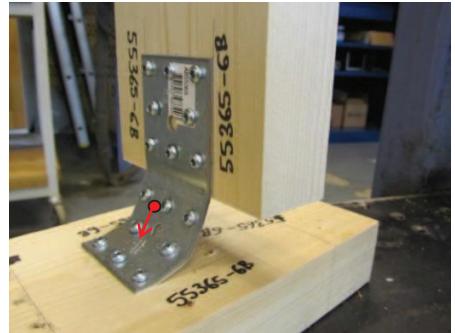
Figure 12: movement of LVDT during the test.

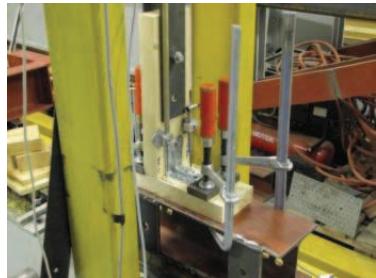
Figure 13: position of the two LVDT.

Therefore, in order to resolve this problem, another displacement was measured. The displacement measured was the distance between the end of the stud and the upper surface of the rail. Two LVDT were fixed on both edge of the rail, at the same distance from the edge, in order to see the possible influence of eccentricity (see figures 13, 14 and 15).

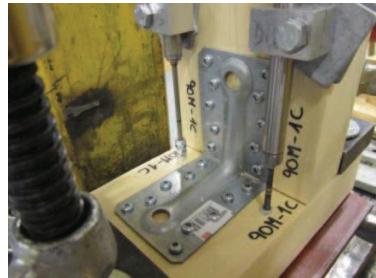
Figure 14: position of the two LVDT.

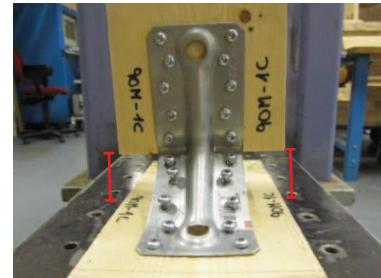
Figure 15: displacements measured.

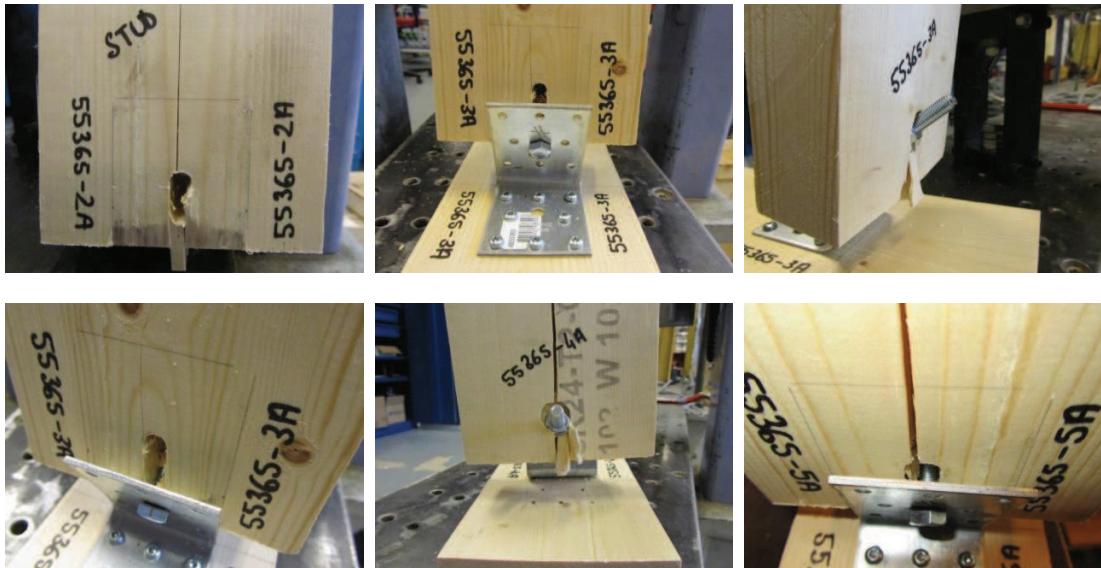
- **Failure mode 1:** failure of the stud when a bolt is used as the connector between connector and stud (*see figure 16*);

Figure 16: failure mode 1, failure of the stud

- failure mode 1: failure of the stud when a bolt is used as the connector between connector and stud;
- failure mode 2: failure due to pull-out of the screws or nails from the rail;
- failure mode 3a: failure due to failure or pull-out of screws or nails from stud;
- failure 3b: failure of the stud caused by some defect of the timber.

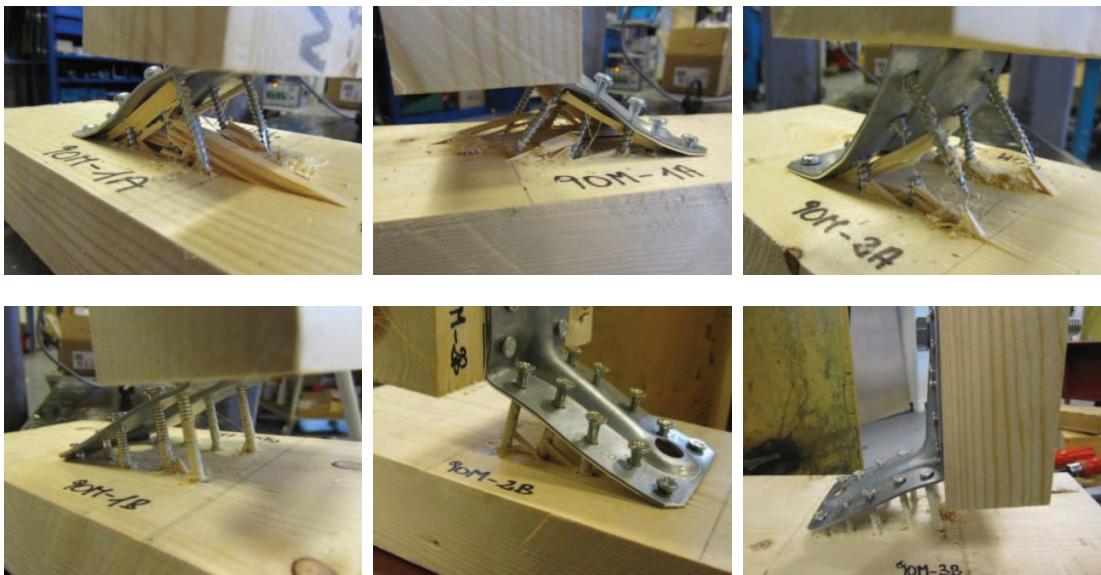
- **Failure mode 2:** failure due to pull-out of the screws or nails from the rail (*see figure 17*);

Figure 17: failure mode 2, pull-out of the screws or nails from the rail

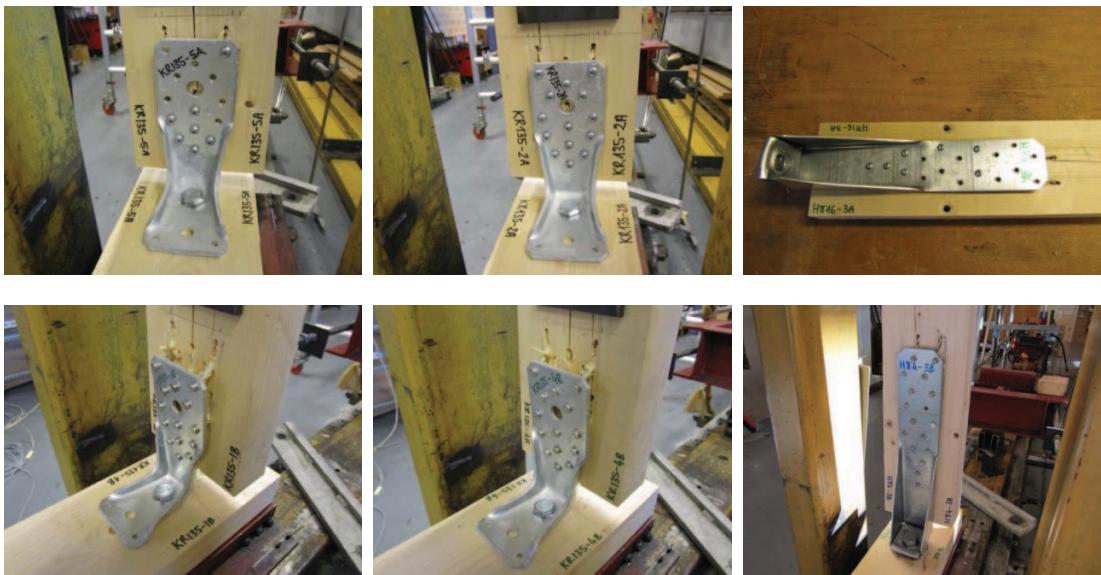
- **Failure mode 3a:** failure due to failure or pull-out of screws or nails from stud (see figure 18);

Figure 18: failure mode 3a, failure or pull-out of screws or nails

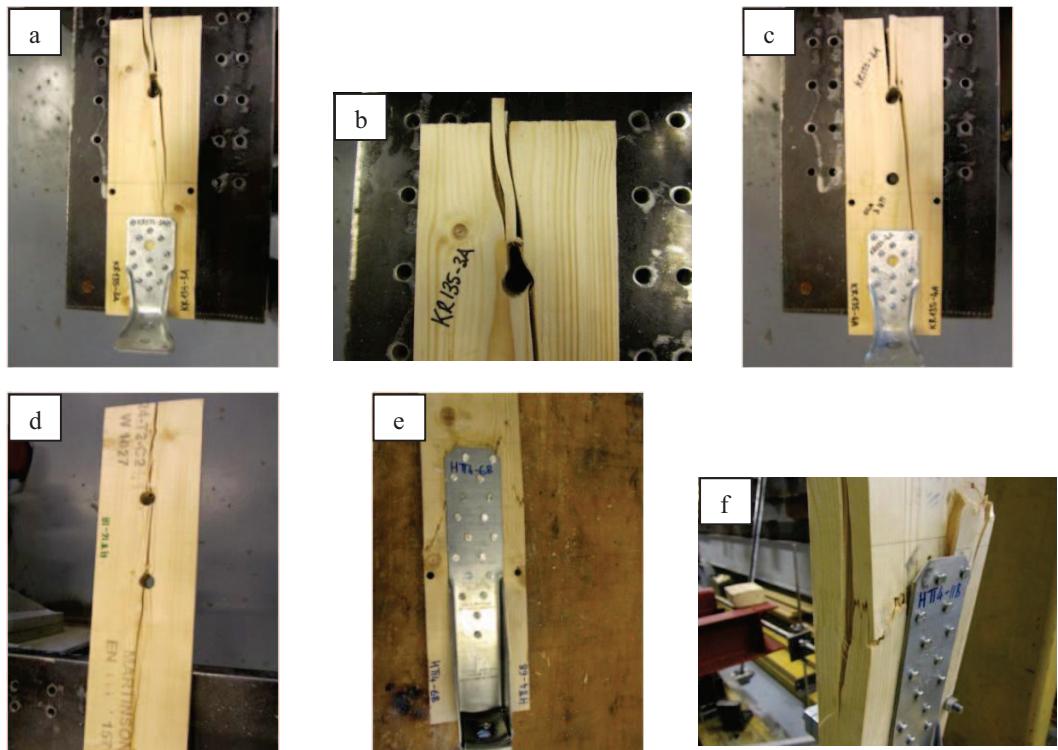
- **Failure mode 3b:** failure of the stud caused by some defect of the timber (see figure 19);

Figure 19: failure mode 3b, failure of the stud due to different defect. a), b), c) and d) four different failure of the stud due defects of the timber in the connection between stud and steel bars of the hydraulic piston. e) and f) failure of the stud due defects of the timber, in this case in the position of the finger joint

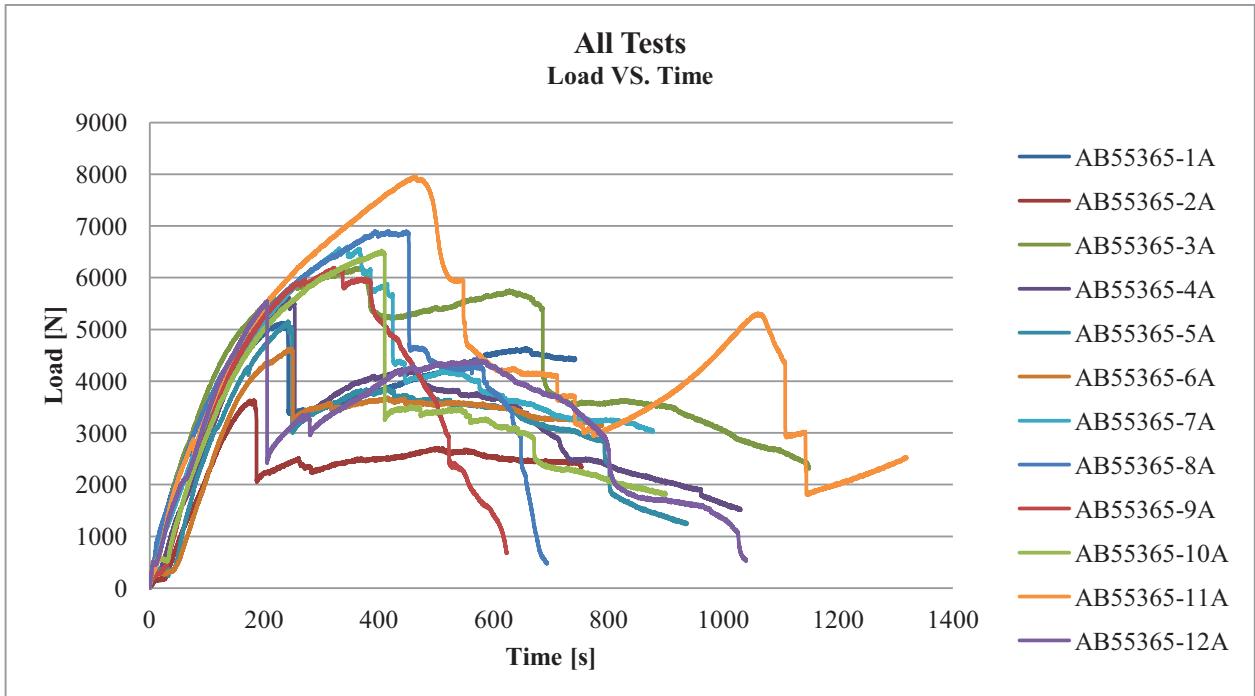
Figure 20: Load vs. time curves for angle connector AB 55365 of Series 1 – Set 1.

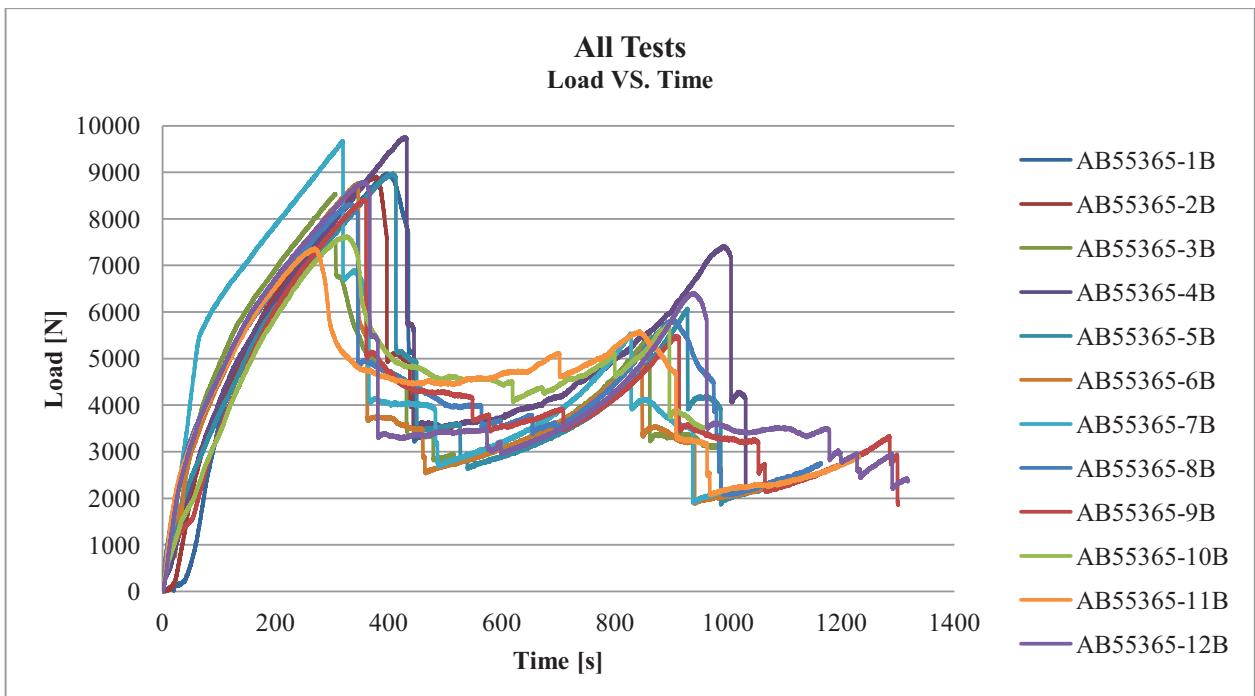
Figure 21: Load vs. time curves for angle connector AB 55365 of Series 1 – Set 2.

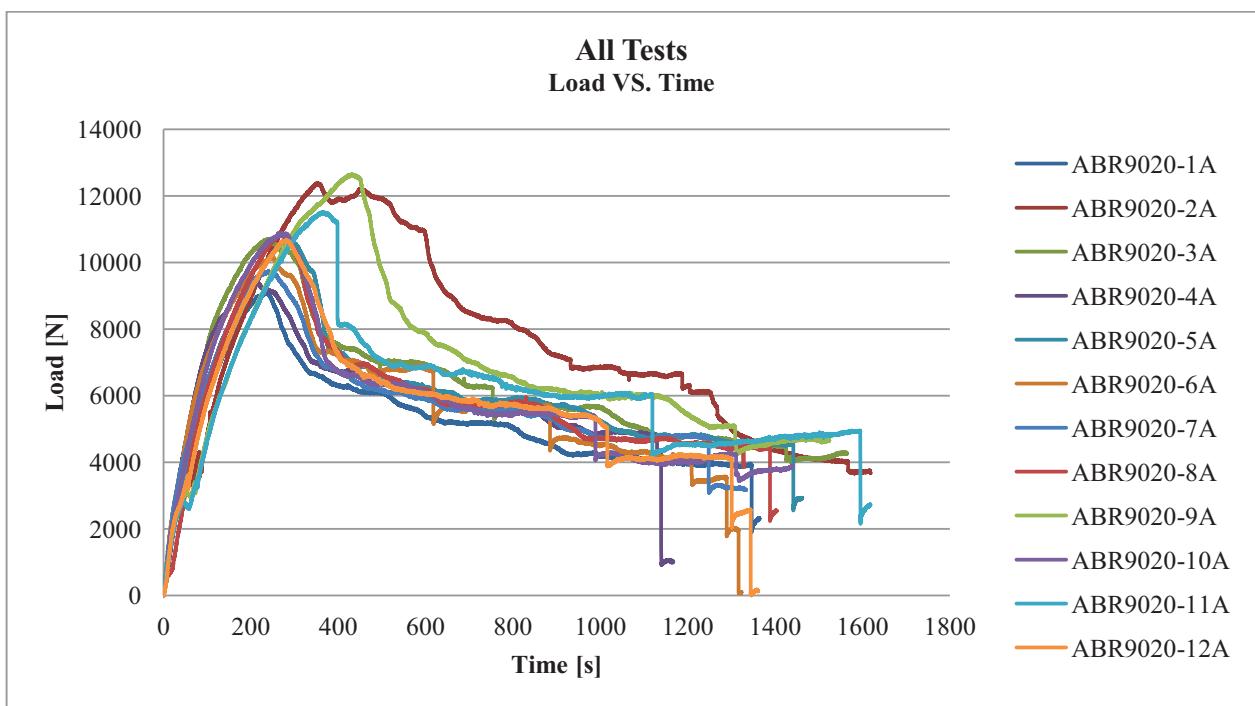
Figure 22: Load vs. time curves for angle connector ABR 9020 of Series 2 – Set 1.

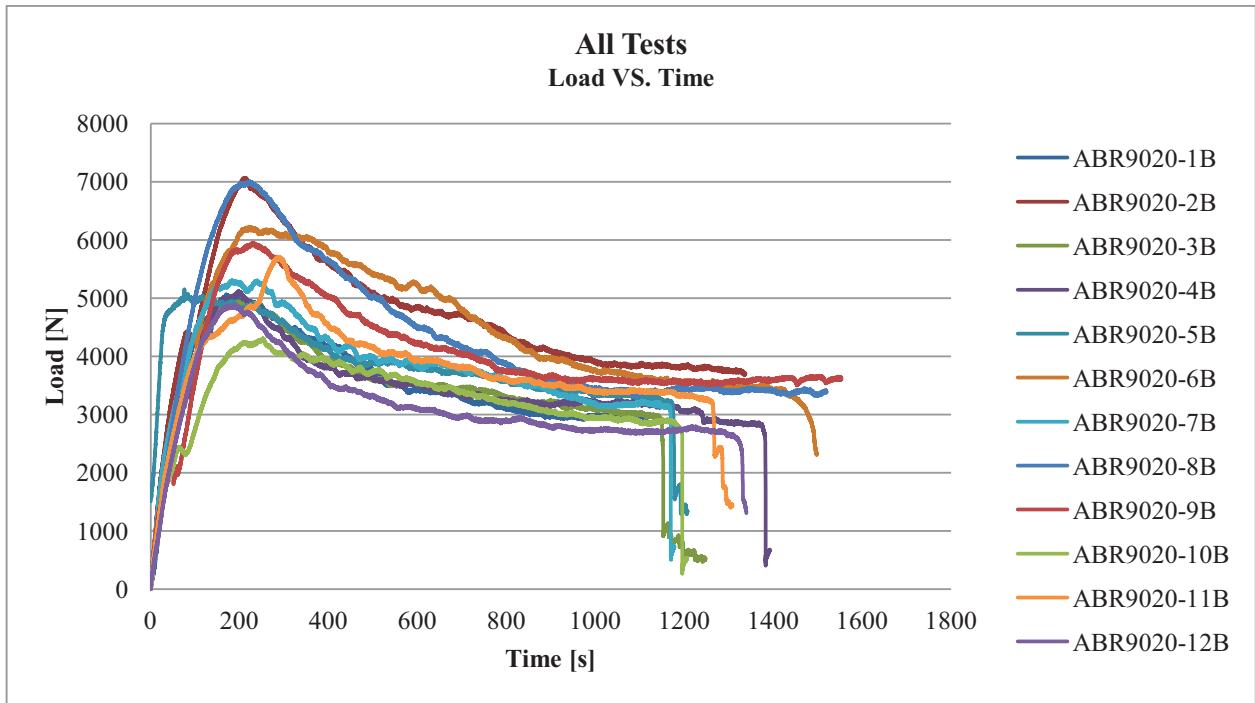
Figure 23: Load vs. time for angle connector ABR 9020 of Series 2 – Set 2.

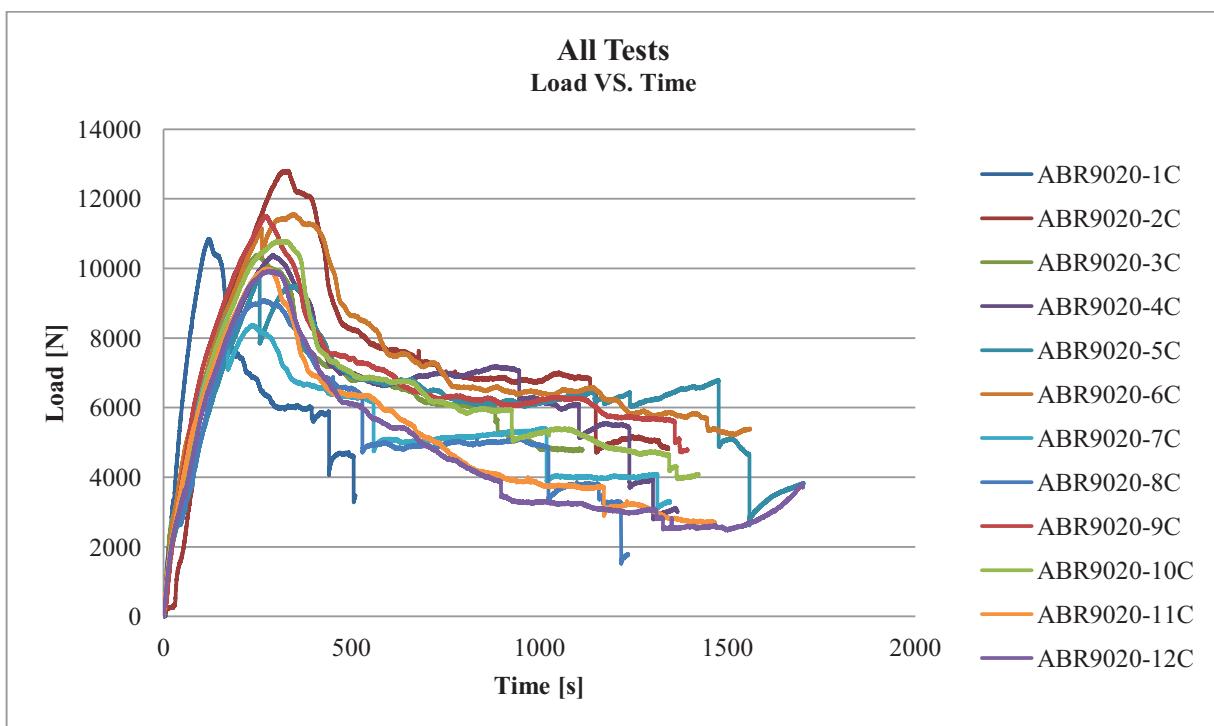
Figure 24: Load vs. time curves for angle connector ABR 9020 of Series 2 – Set 3.

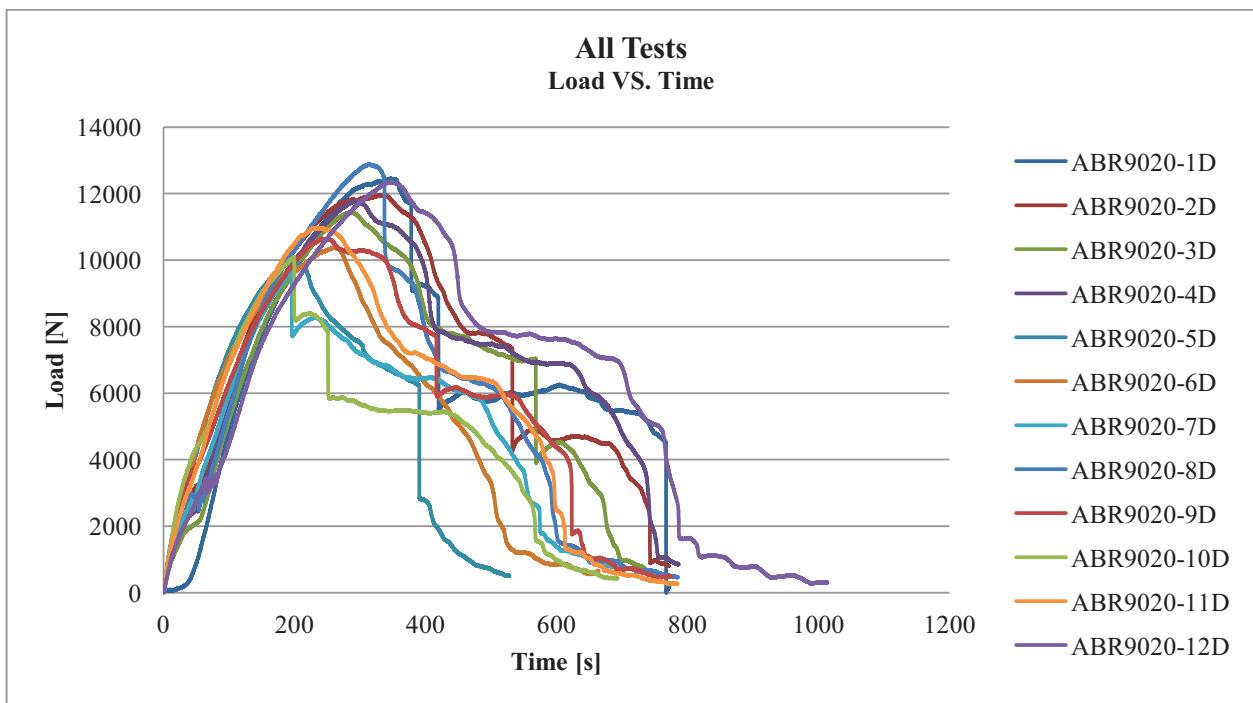
Figure 25: Load vs. time curves for angle connector ABR 9020 of Series 2 – Set 4.

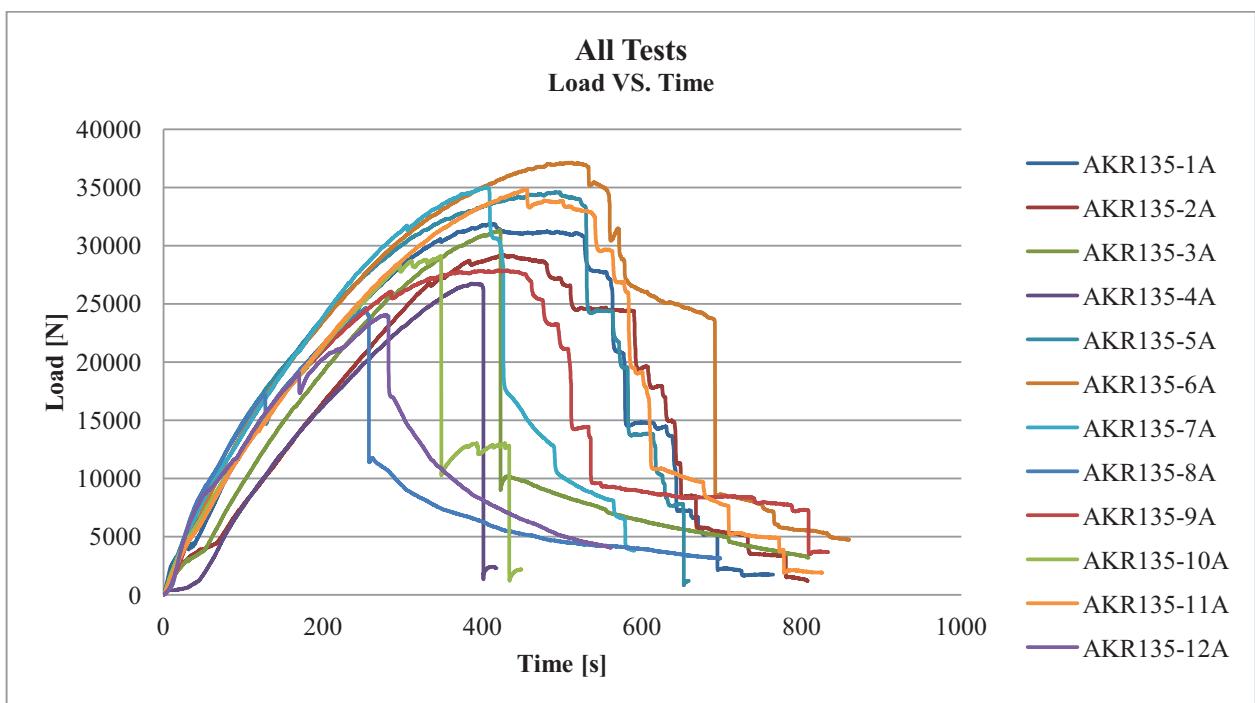
Figure 26: Load vs. time curves of connector AKR 135 of Series 3 – Set 1.

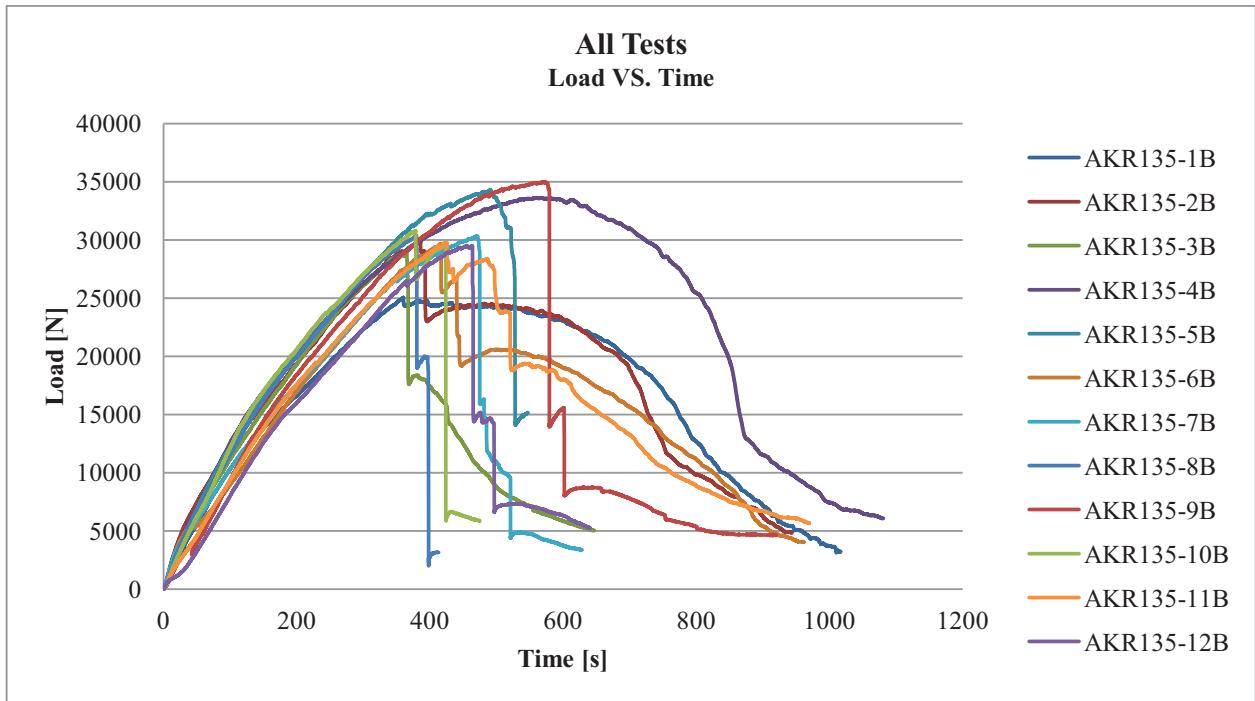
Figure 27: Load vs. time curves for angle connector AKR 135 of Series 3 – Set 2.

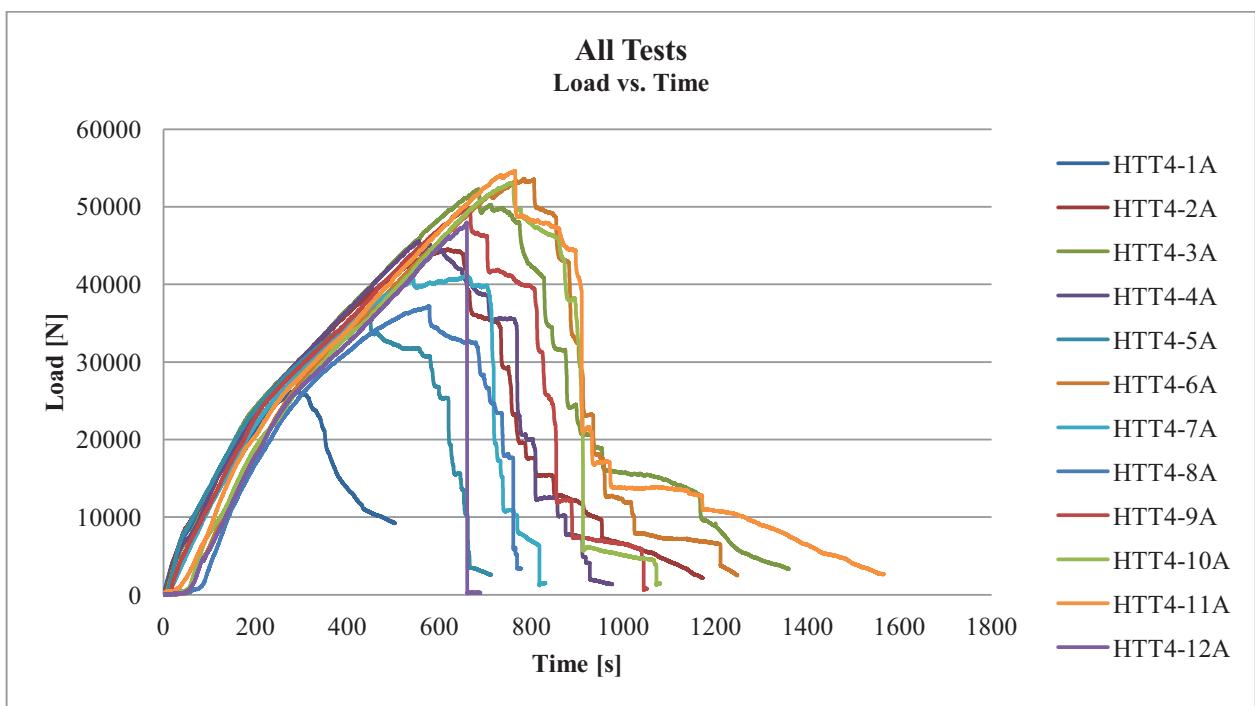
Figure 28: Load vs. time curves for tension tie HTT4 of Series 4 – Set 1.

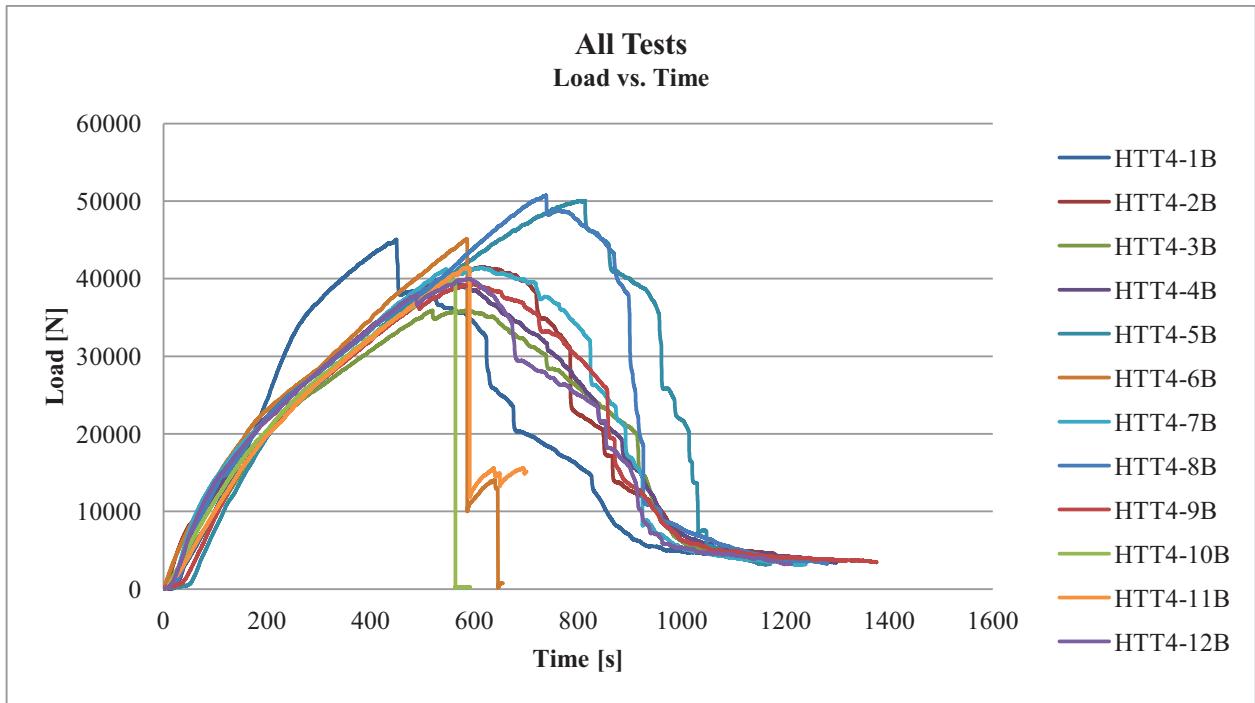
Figure 29: Load vs. time curves for tension tie HTT4 of Series 4 – Set 2.

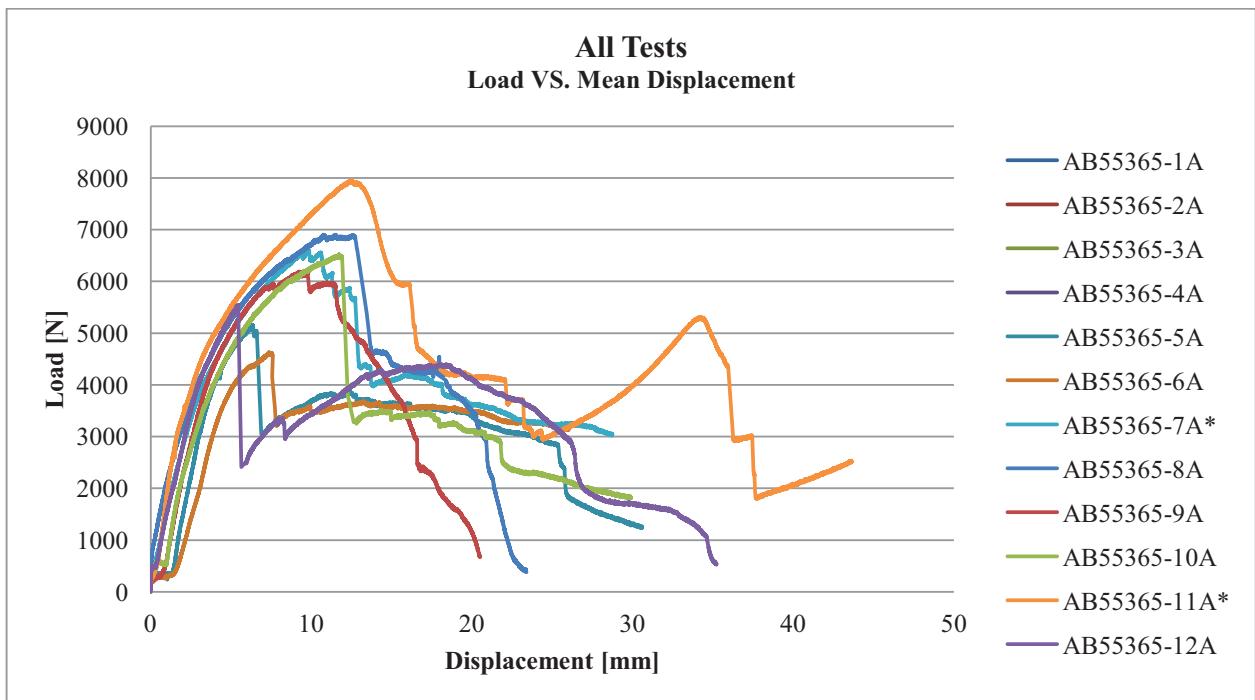
Figure 30: *mean displacement not available, only one displacement is used. Load vs. mean displacement curves for angle connector AB 55365 of Series 1 – Set 1.

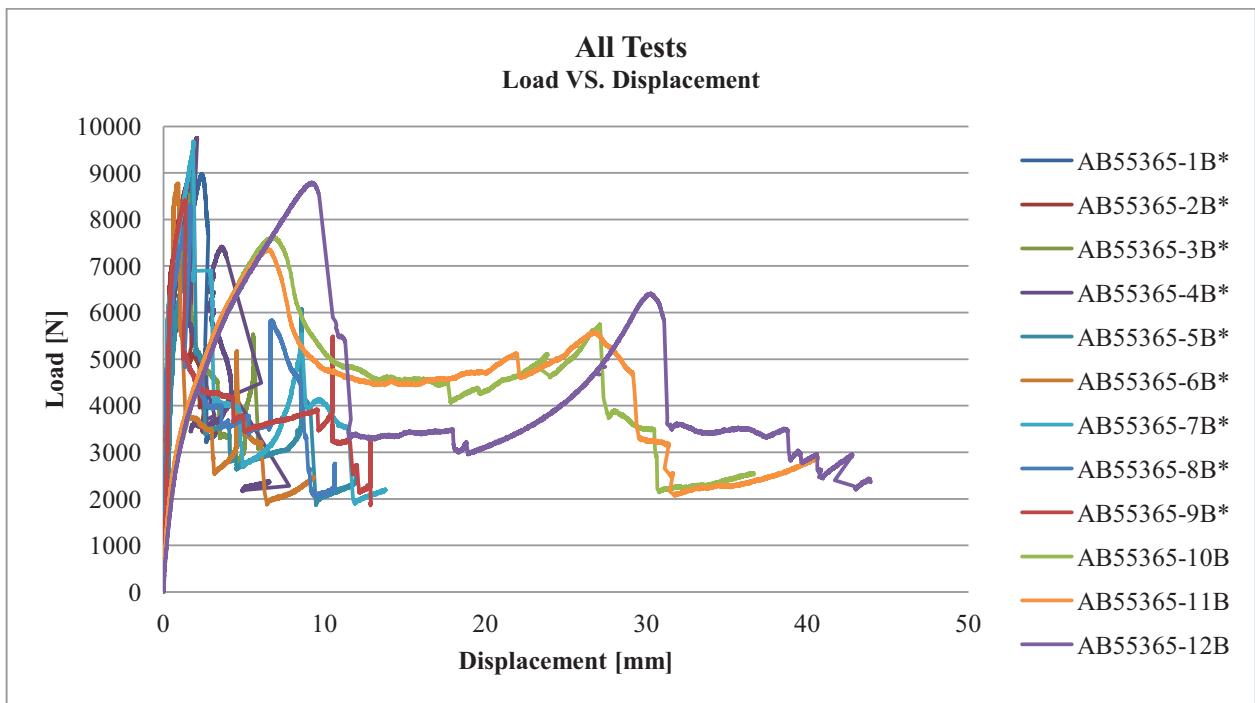
Figure 31: *mean displacement not available, only one displacement is used. Load vs. mean displacement curves for angle connector AB 55365 of Series 1 – Set 2.

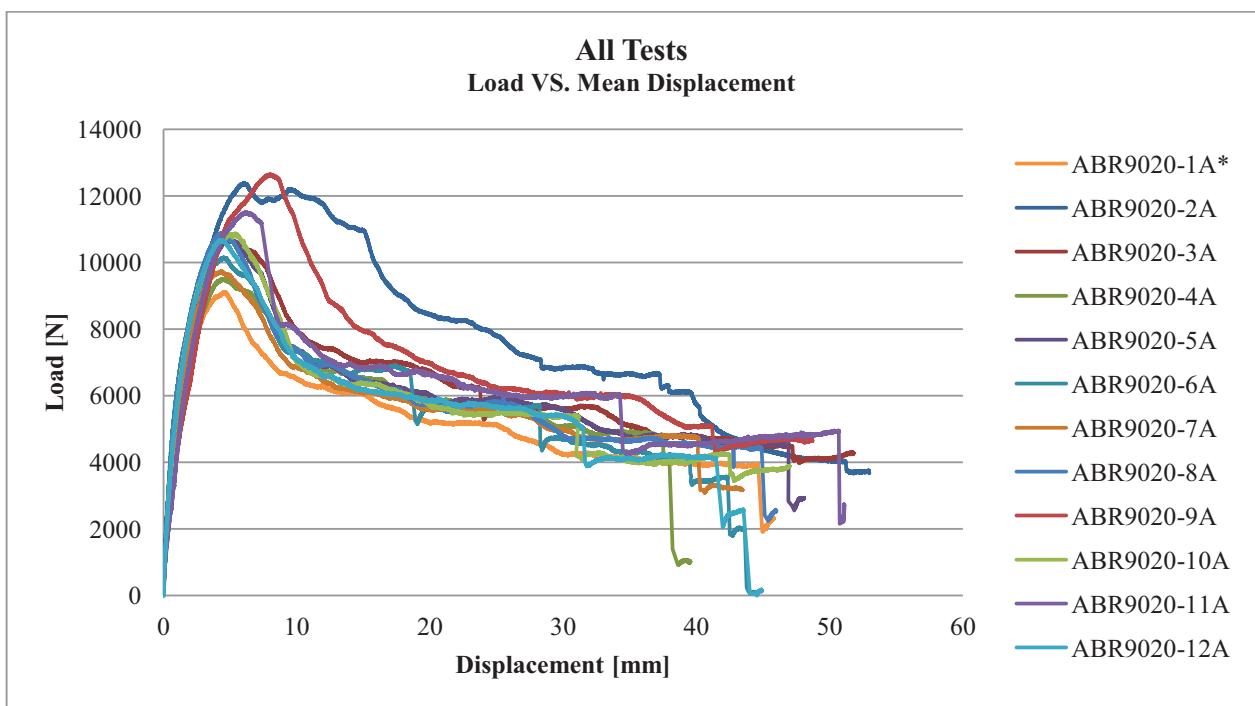
Figure 32: *mean displacement not available, only one displacement is used. Load vs. mean displacement curves for angle connector ABR 9020 of Series 2 – Set 1.

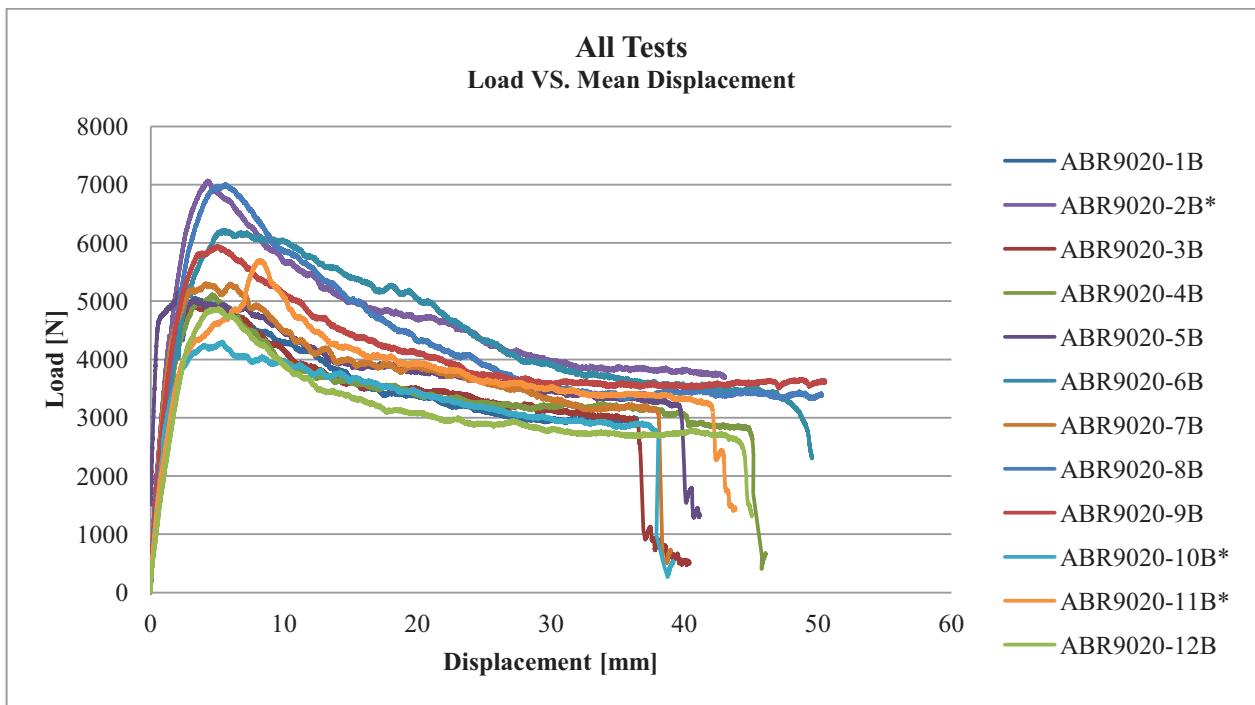
Figure 33: *mean displacement not available, only one displacement is used. Load vs. mean displacement curves for angle connector ABR 9020 of Series 2 – Set 2.

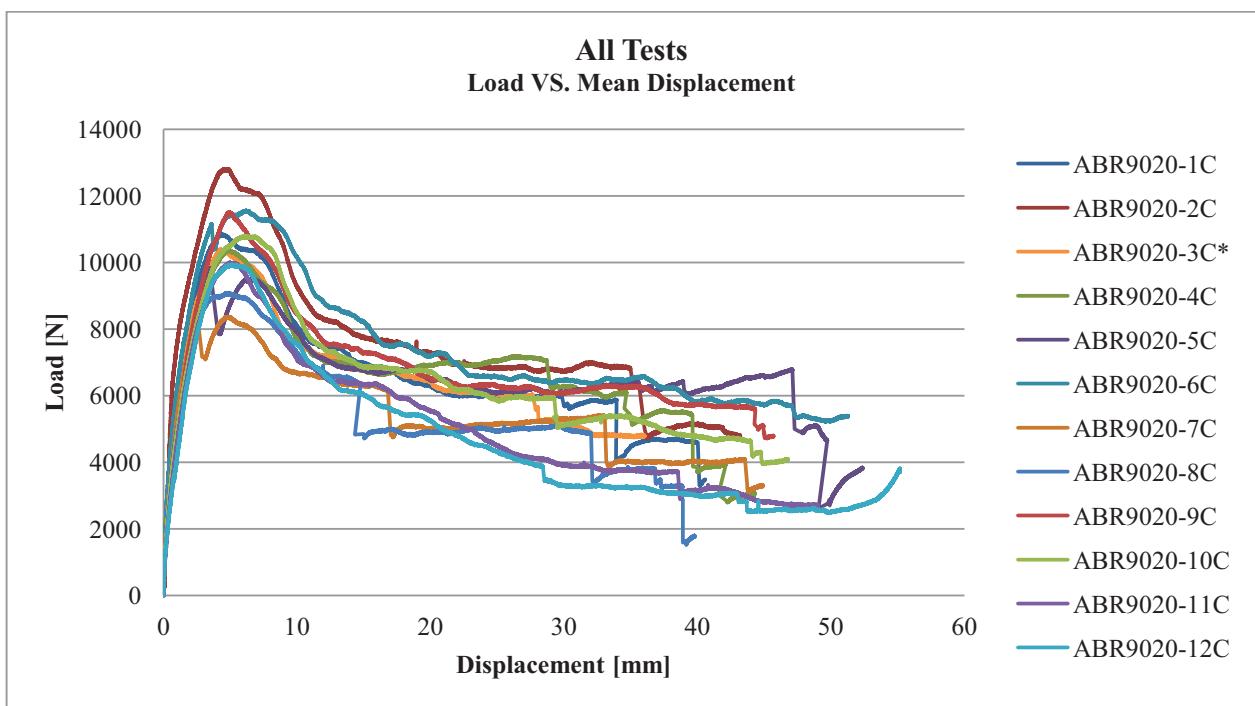
Figure 34: *mean displacement not available, only one displacement is used. Load vs. mean displacement curves for angle connector ABR 9020 of Series 2 – Set 3.

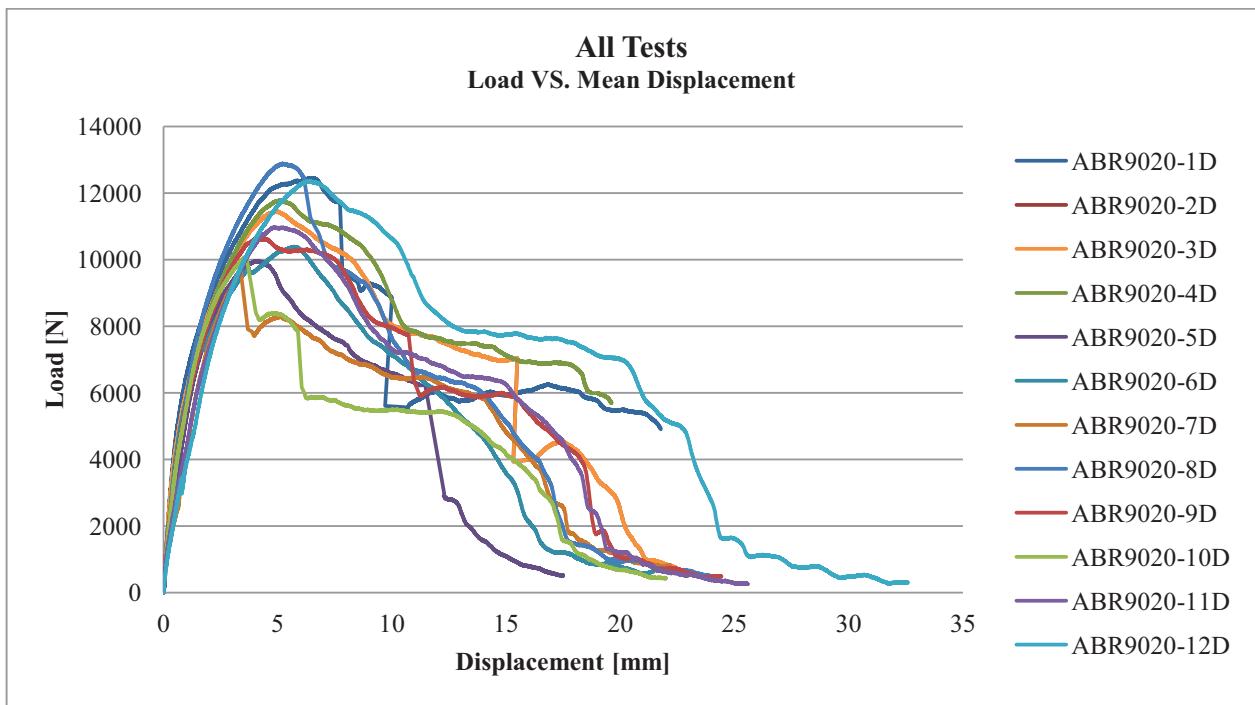
Figure 35: Load vs. mean displacement curves for angle connector ABR 9020 of Series 2 – Set 4.

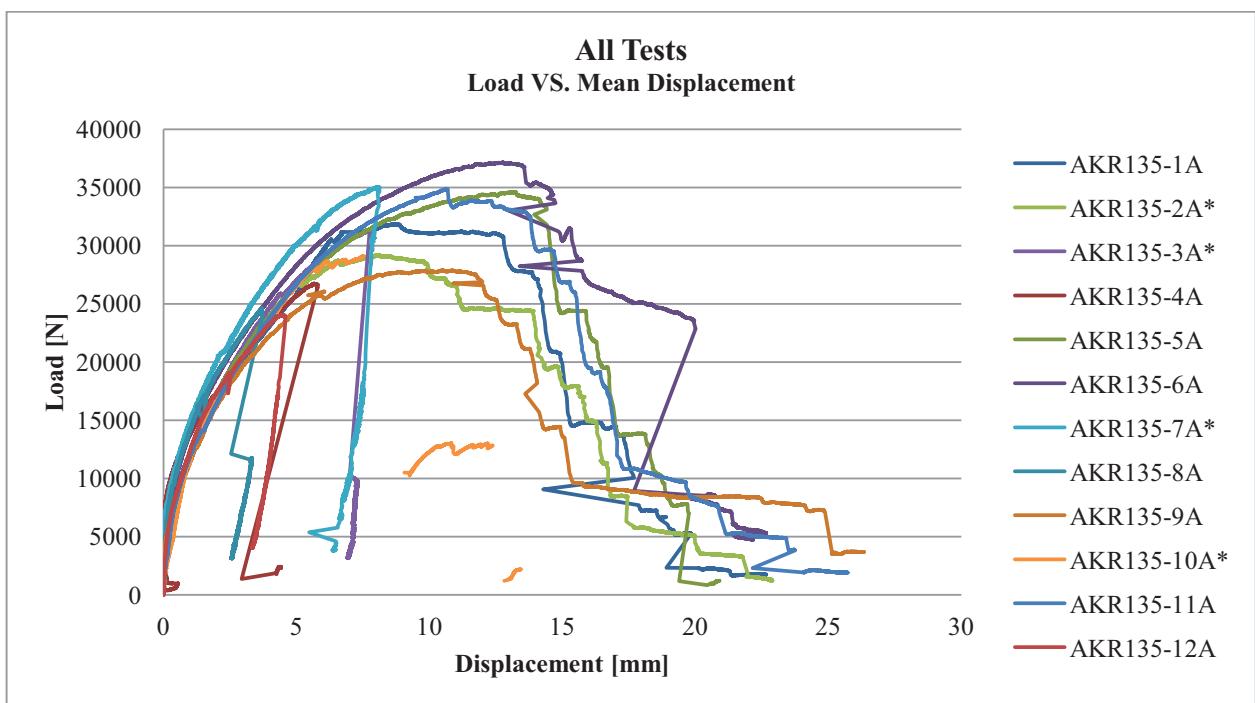
Figure 36: *mean displacement not available, only one displacement is used. Load vs. mean displacement for angle connector AKR 135 of Series 3 – Set 1.

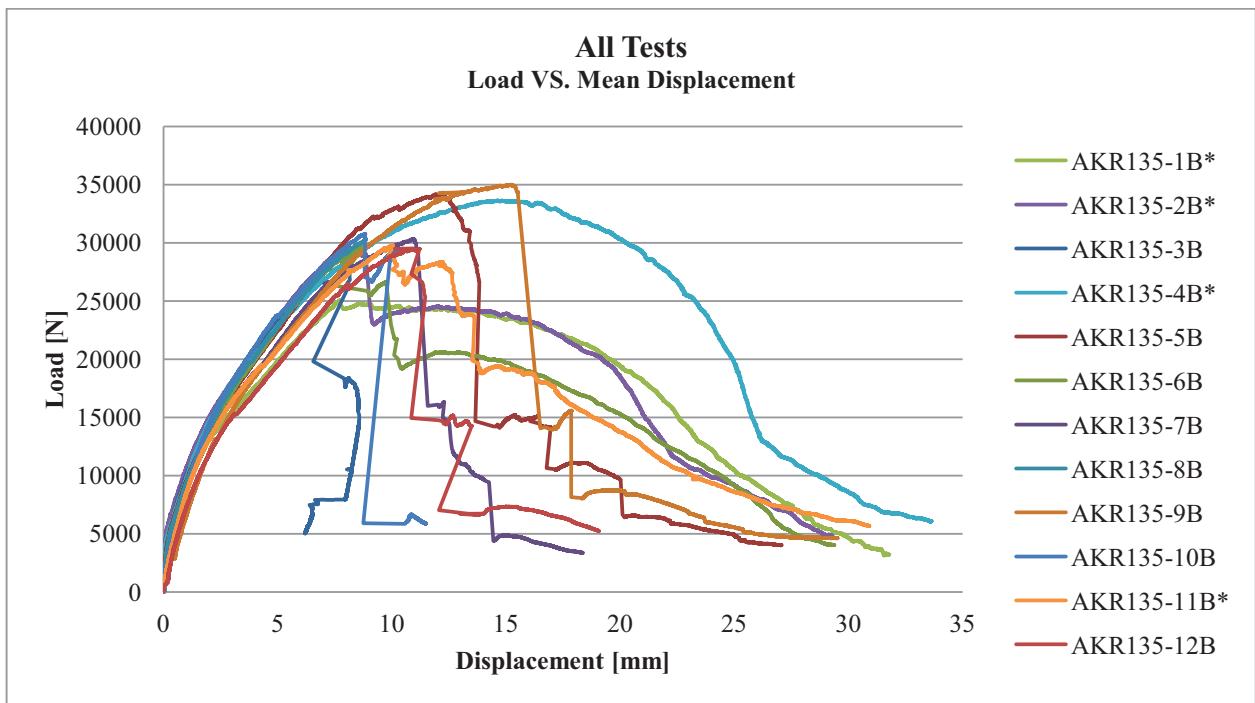
Figure 37: *mean displacement not available, only one displacement is used. Load vs. mean displacement curves of angle connector AKR 135 of Series 3 – Set 2.

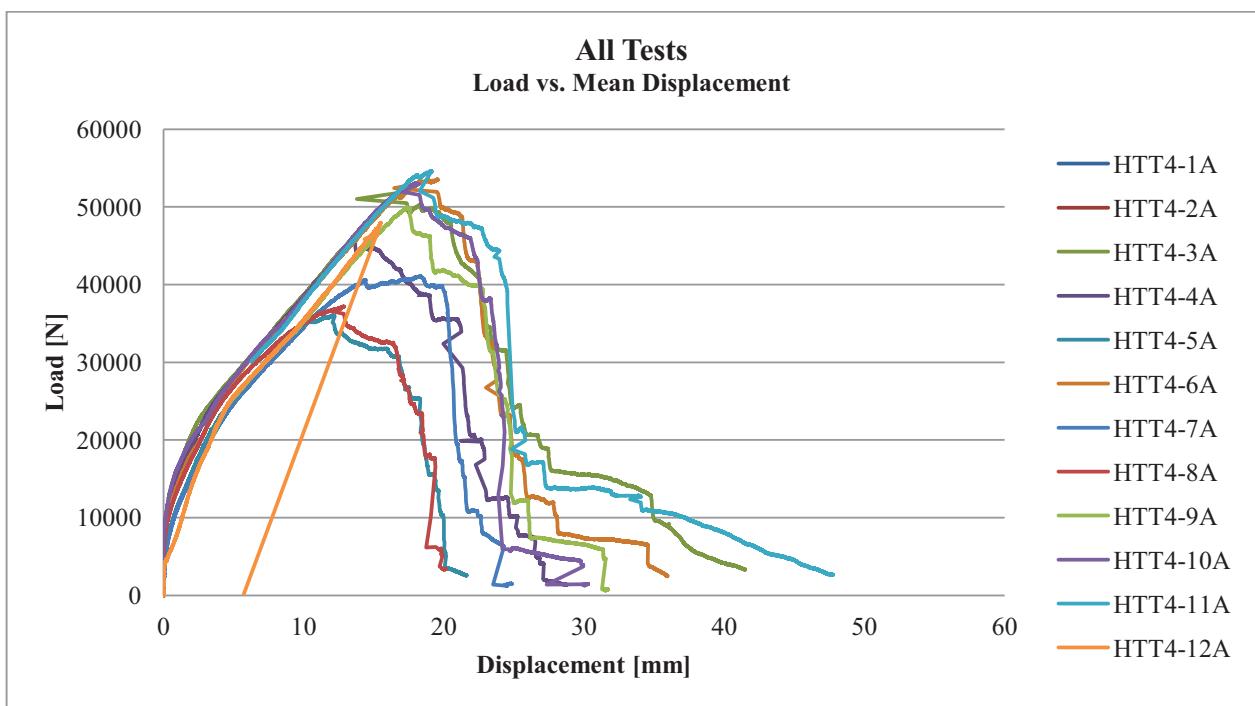
Figure 38: Load vs. mean displacement curves for tension tie HTT4 of Series 4 – Set 1.

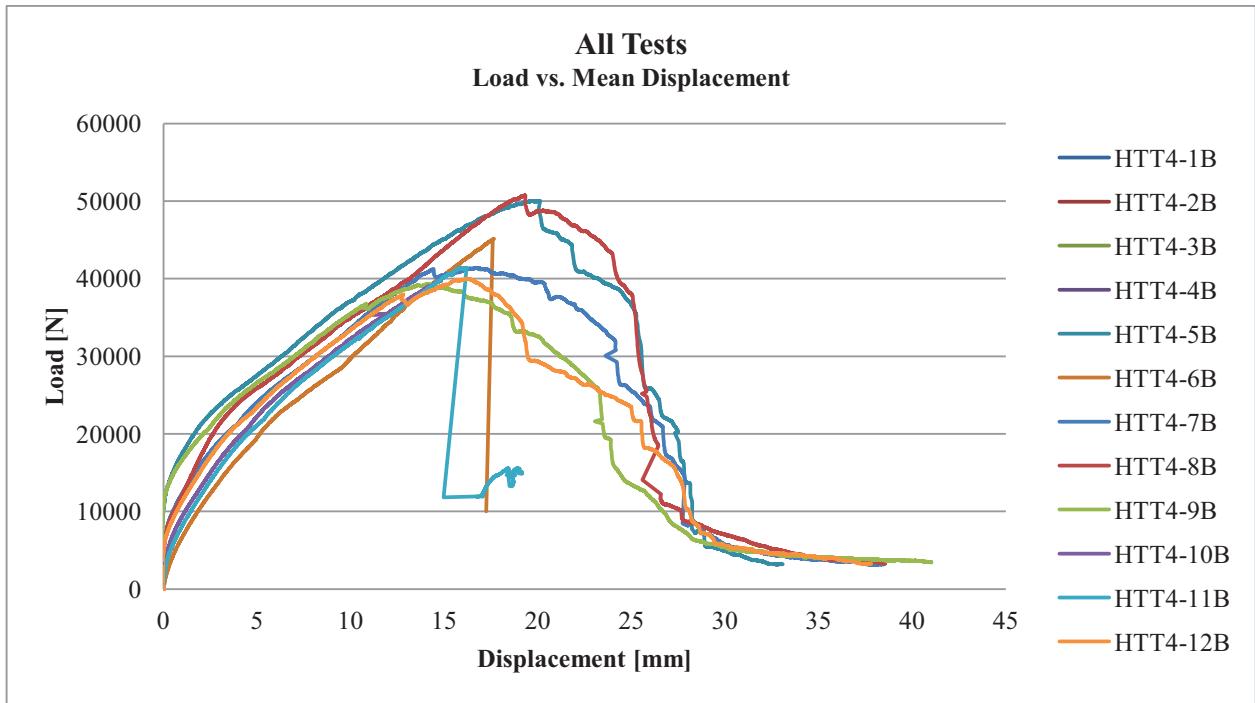
Figure 39: Load vs. mean displacement curves for tension tie HTT4 of Series 4 – Set 2.
