Experimental Testing of Hold Down Devices for Timber Frame Shear Walls

Giuseppe Caprolu

ISSN: 1402-1536
ISBN 978-91-7439-386-6

Luleå 2012

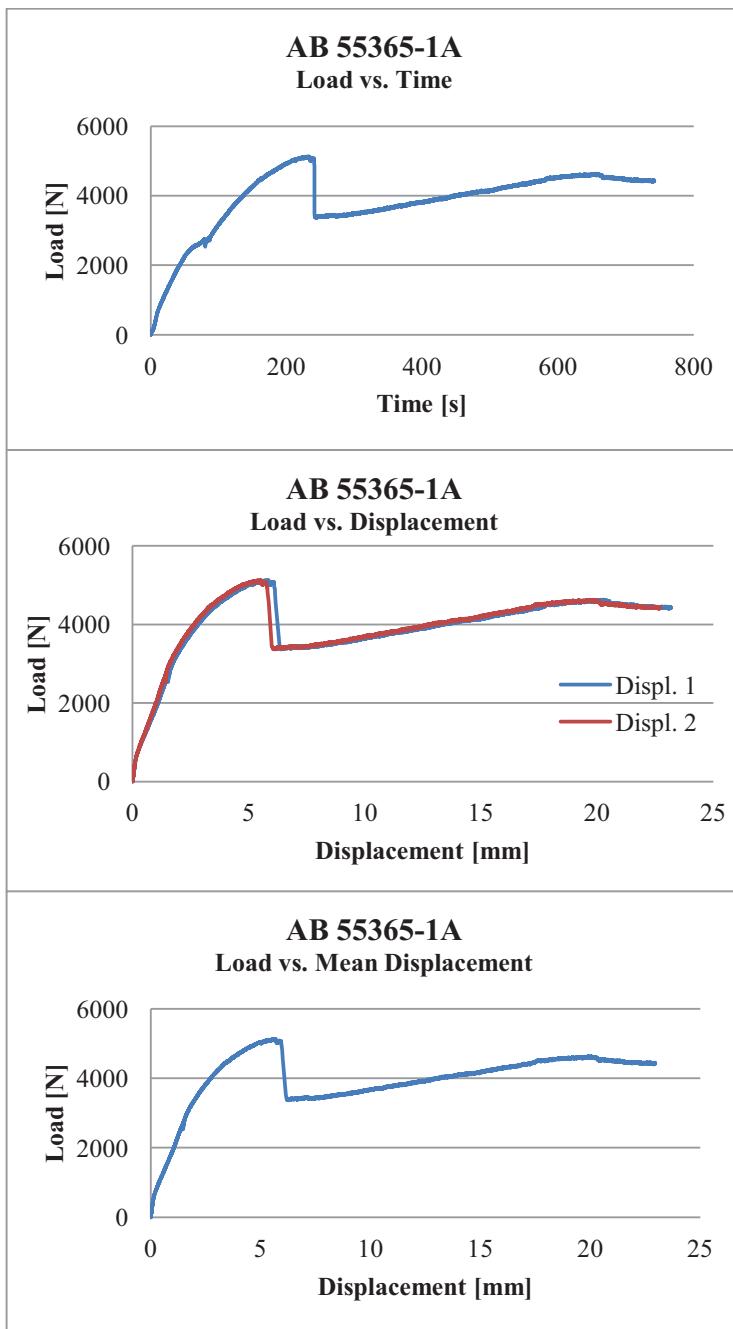
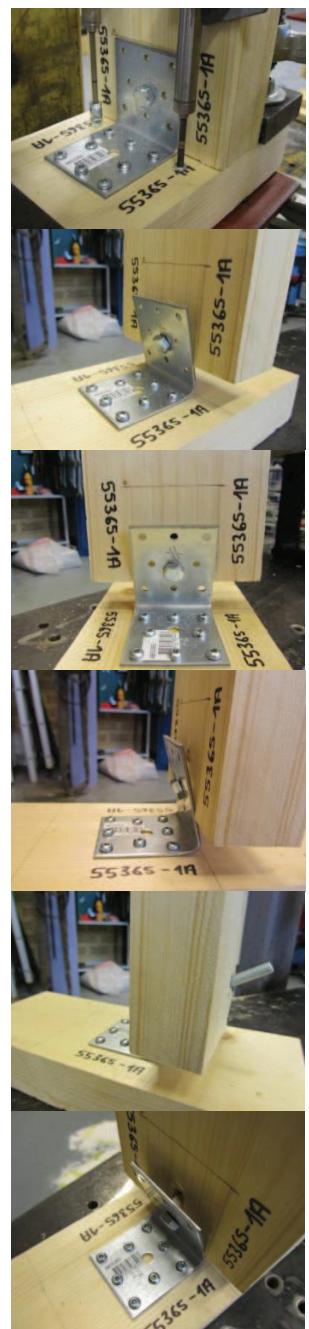
Failure	1
Failure load [N]	5127
Displacement 1 [mm]	5.72
Displacement 2 [mm]	5.40
Mean Displacement [mm]	5.56
Moisture [%]	8.95
Density [kg/m ³]	327

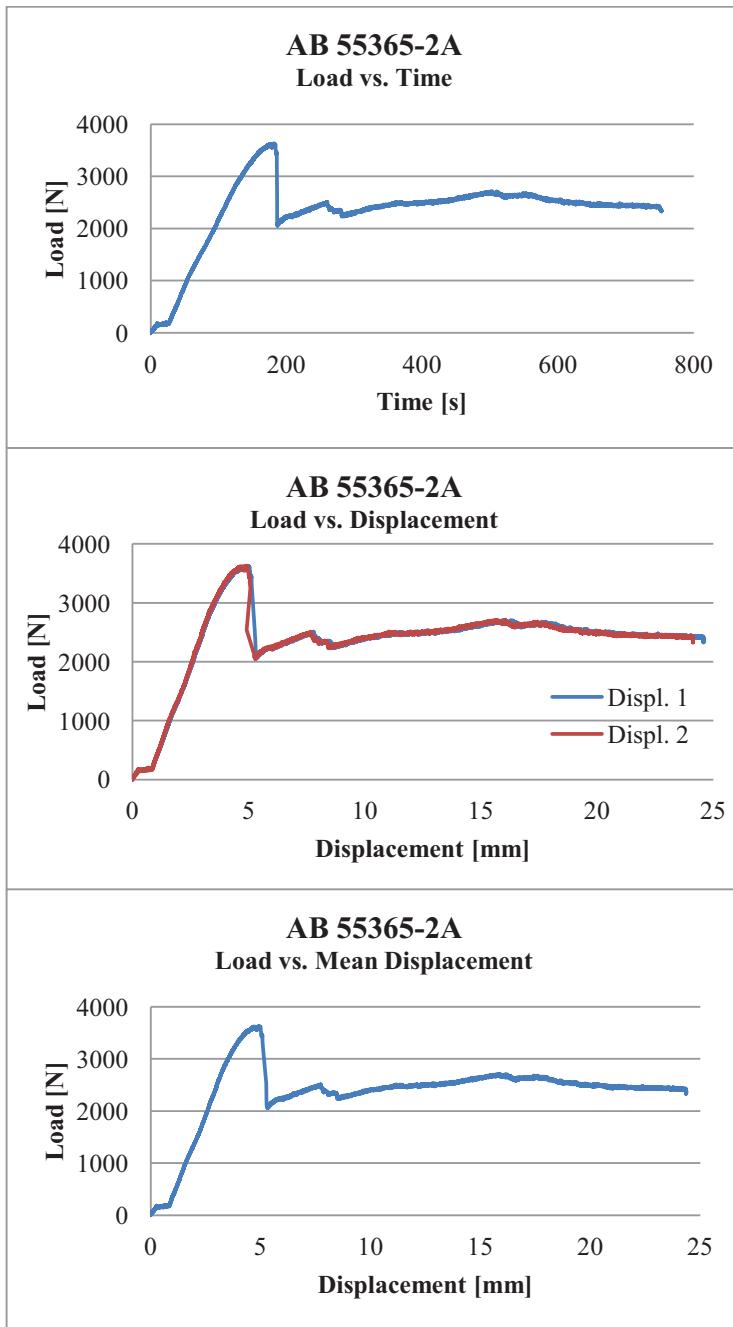
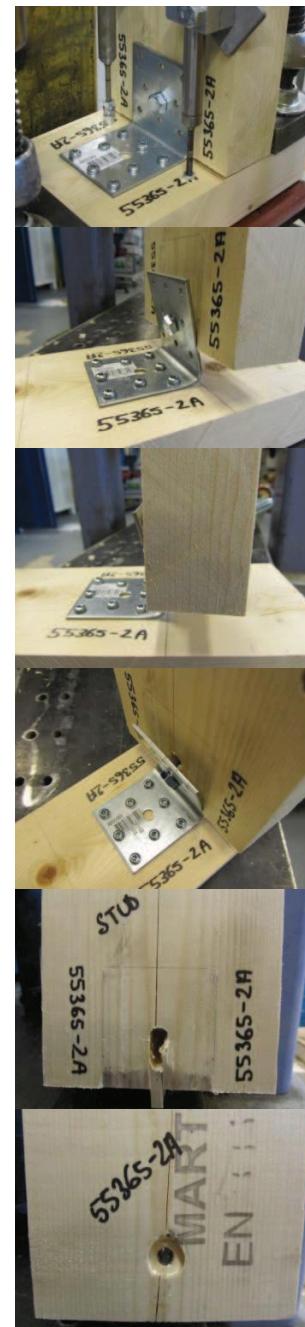
Failure	1
Failure load [N]	3630
Displacement 1 [mm]	4.96
Displacement 2 [mm]	4.87
Mean Displacement [mm]	4.91
Moisture [%]	8.85
Density [kg/m ³]	298

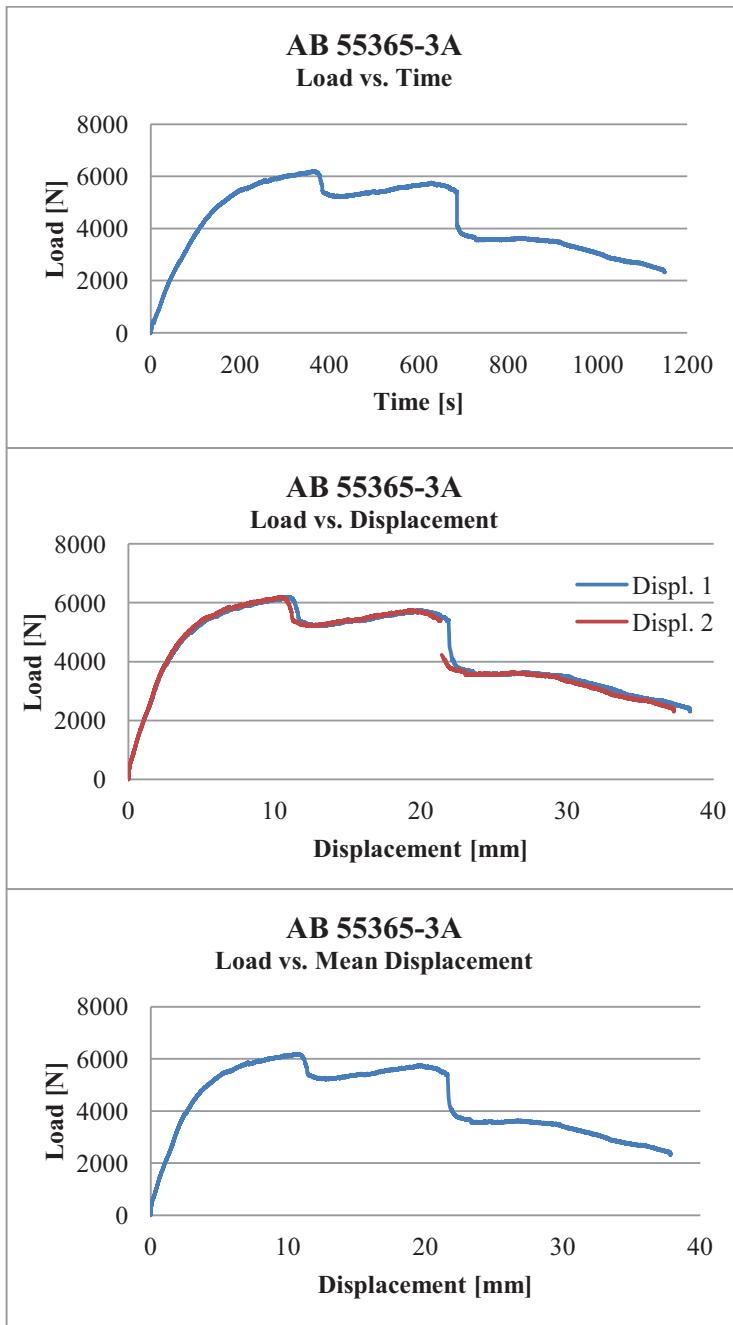
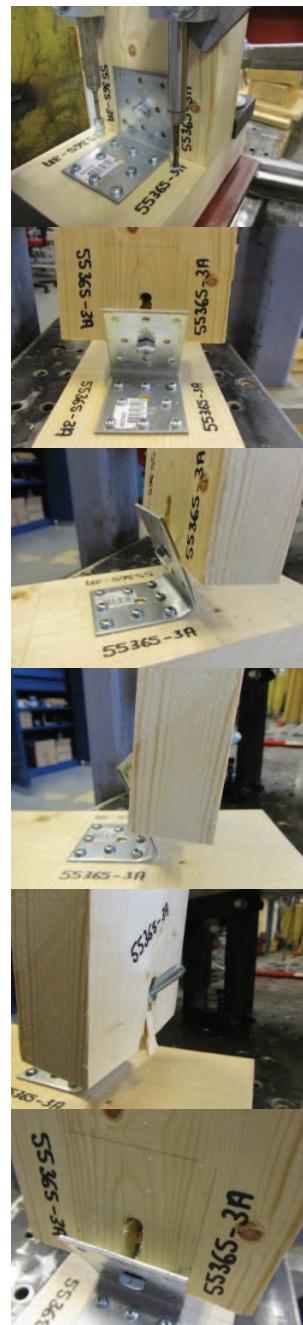
Failure	1
Failure load [N]	6191
Displacement 1 [mm]	11.1
Displacement 2 [mm]	10.6
Mean Displacement [mm]	10.9
Moisture [%]	8.38
Density [kg/m ³]	337

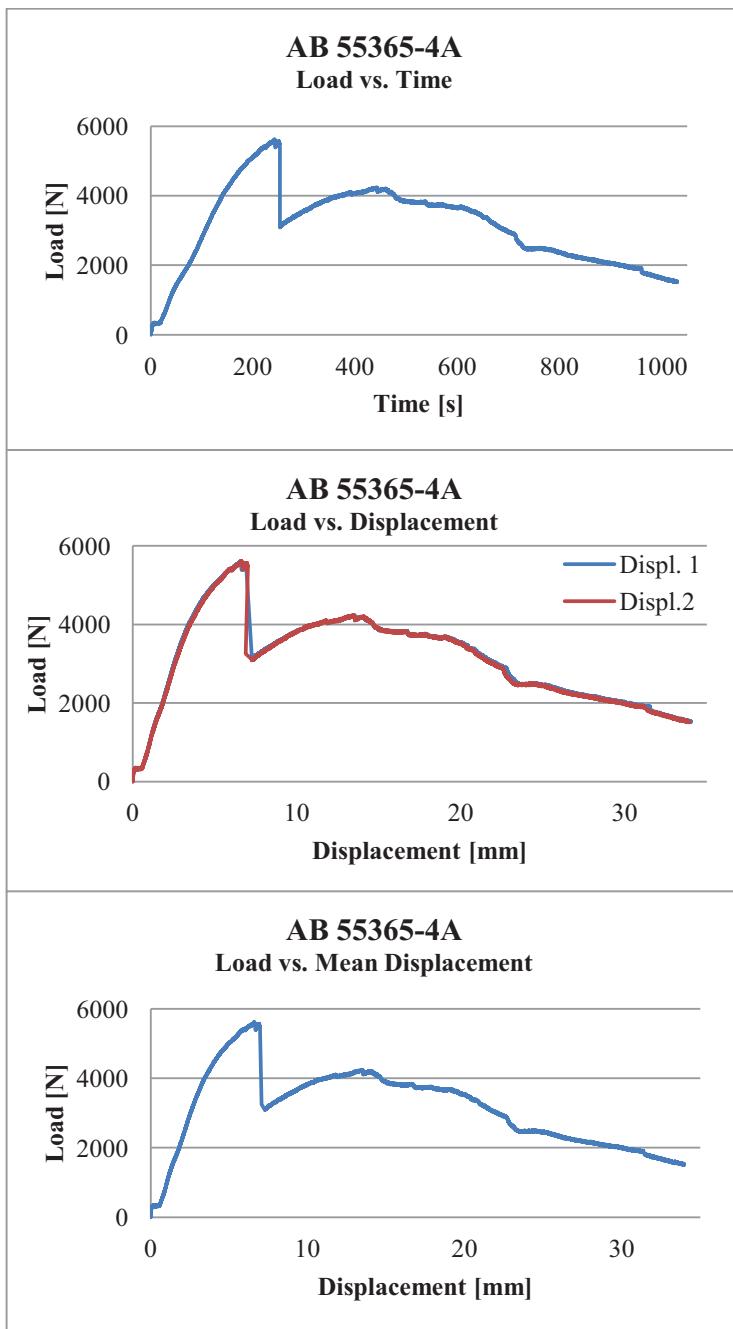
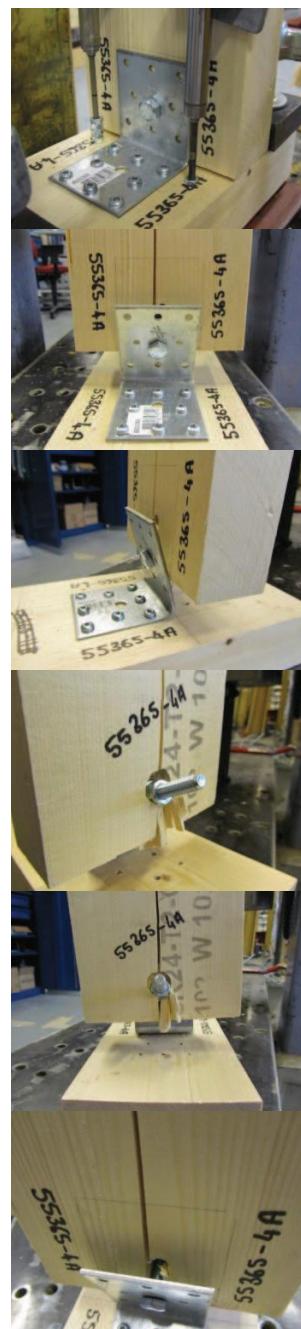
Failure	1
Failure load [N]	5618
Displacement 1 [mm]	6.58
Displacement 2 [mm]	6.62
Mean Displacement [mm]	6.60
Moisture [%]	7.31
Density [kg/m ³]	376

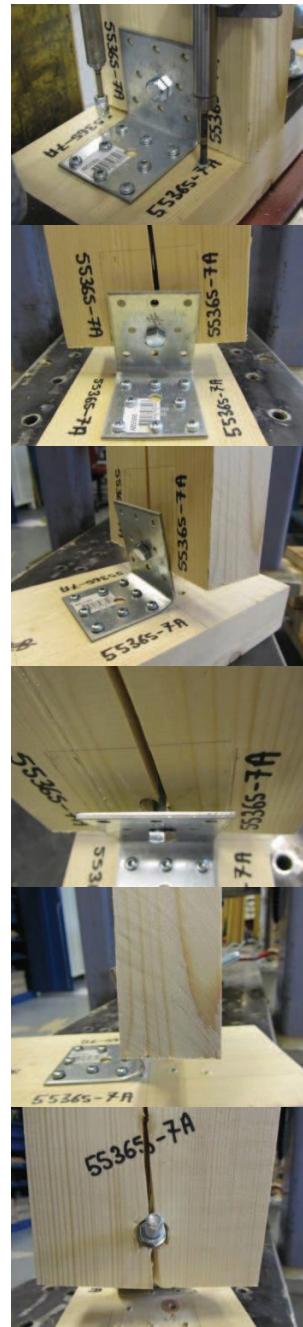
Failure	1
Failure load [N]	4268
Displacement 1 [mm]	7.41
Displacement 2 [mm]	7.34
Mean Displacement [mm]	7.38
Moisture [%]	8.23
Density [kg/m ³]	373

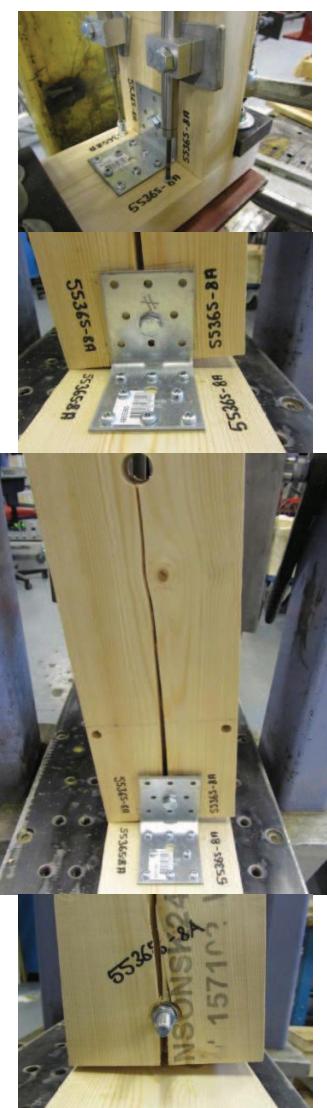
Failure	1
Failure load [N]	6603
Displacement 1 [mm]	9.87
Displacement 2 [mm]	-
Mean Displacement [mm]	-
Moisture [%]	8.32
Density [kg/m ³]	372

The LVDT number 2 did not work.

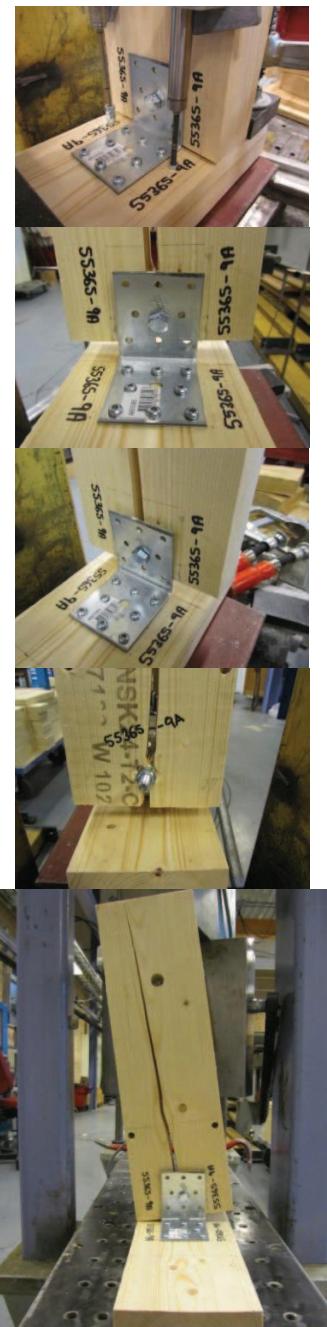
Failure	1
Failure load [N]	6904
Displacement 1 [mm]	11.1
Displacement 2 [mm]	10.4
Mean Displacement [mm]	10.8
Moisture [%]	8.34
Density [kg/m ³]	385

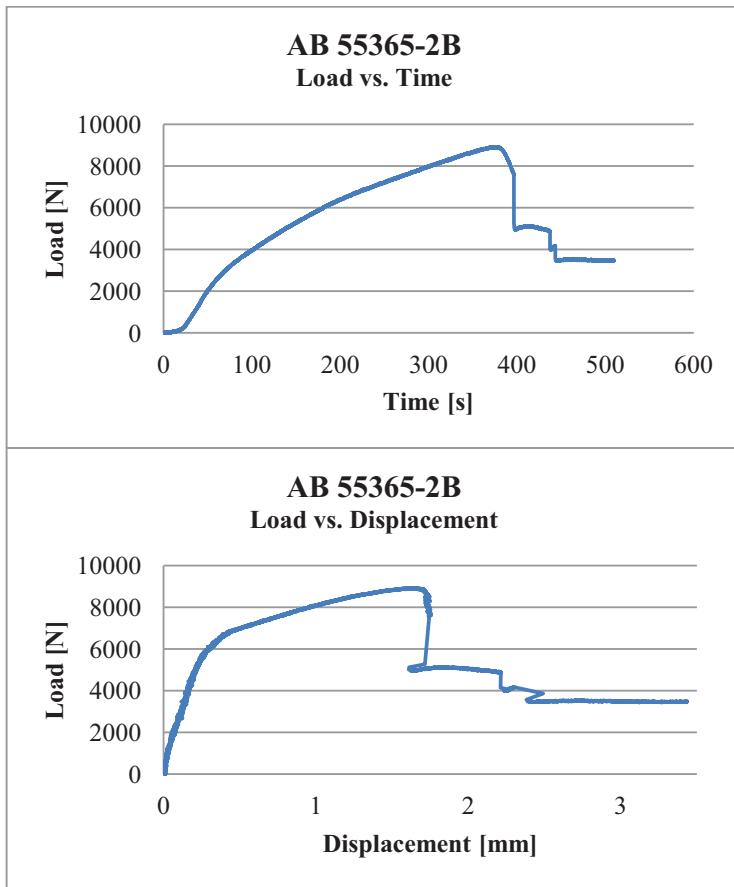
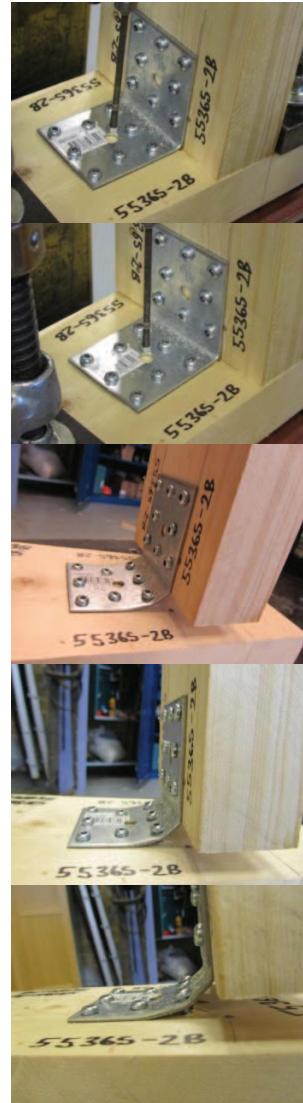
Failure	2
Failure load [N]	8975
Displacement 1 [mm]	2.35
Displacement 2 [mm]	-
Mean Displacement [mm]	-
Moisture [%]	7.99
Density [kg/m ³]	470

In this test only one displacement was recorded.

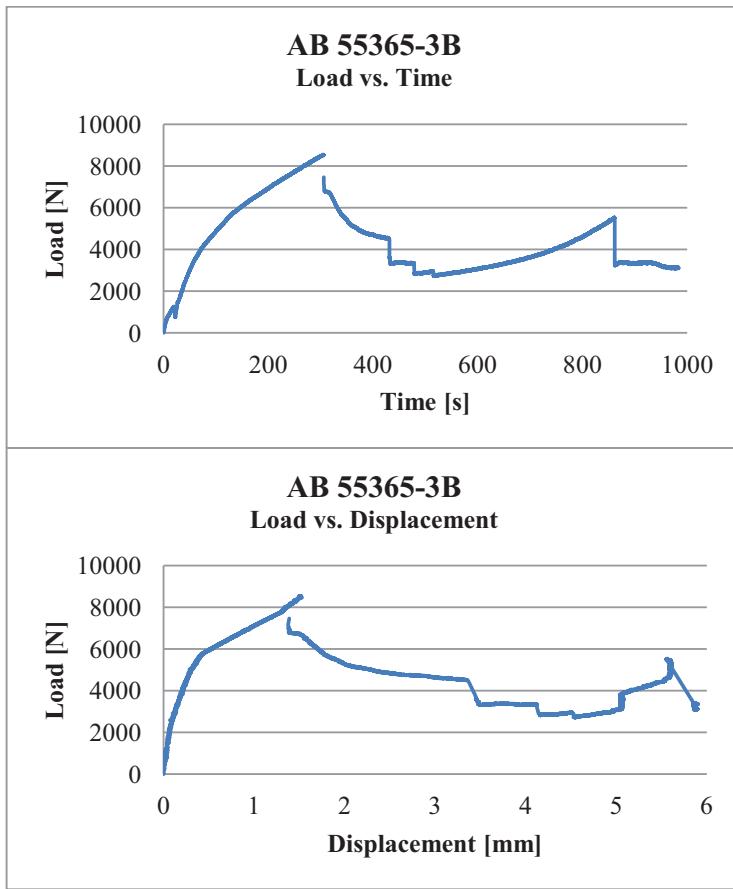
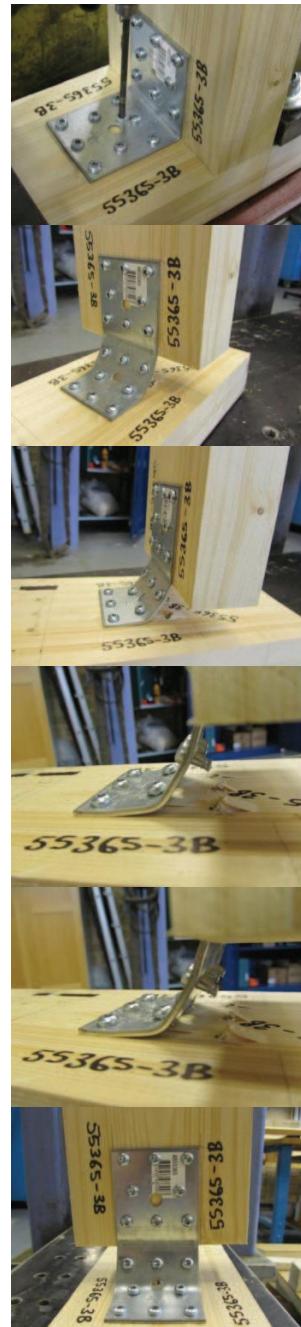
Failure	2
Failure load [N]	8910
Displacement 1 [mm]	1.64
Displacement 2 [mm]	-
Mean Displacement [mm]	-
Moisture [%]	7.89
Density [kg/m ³]	419

In this test only one displacement was recorded.

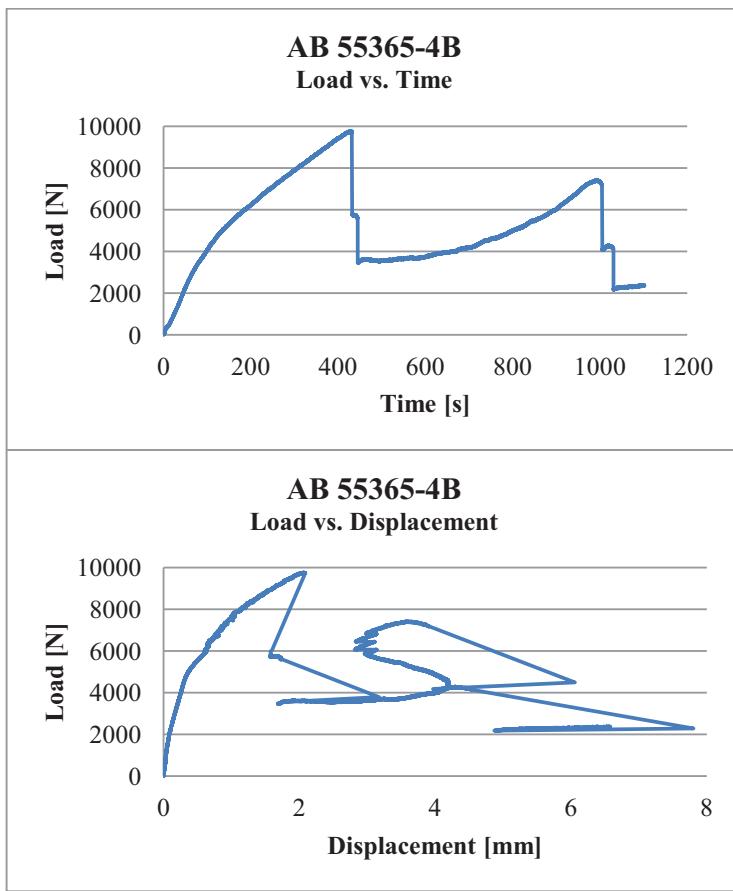
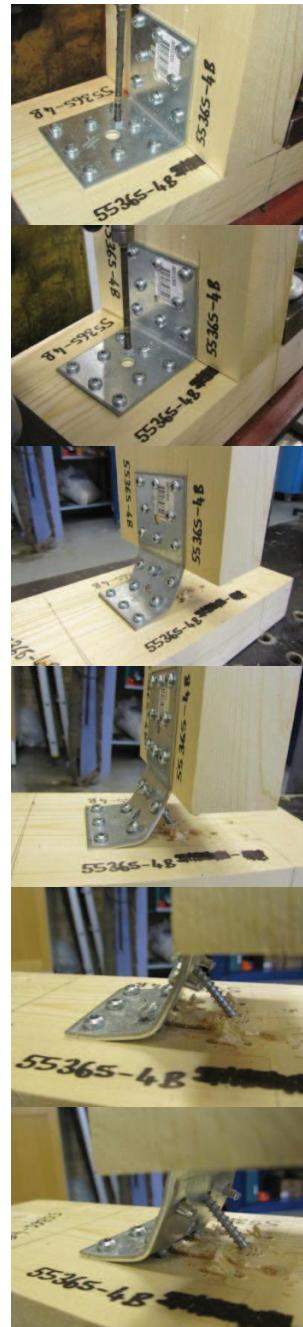
Failure	2
Failure load [N]	8541
Displacement 1 [mm]	1.51
Displacement 2 [mm]	-
Mean Displacement [mm]	-
Moisture [%]	6.43
Density [kg/m ³]	420

In this test only one displacement was recorded.

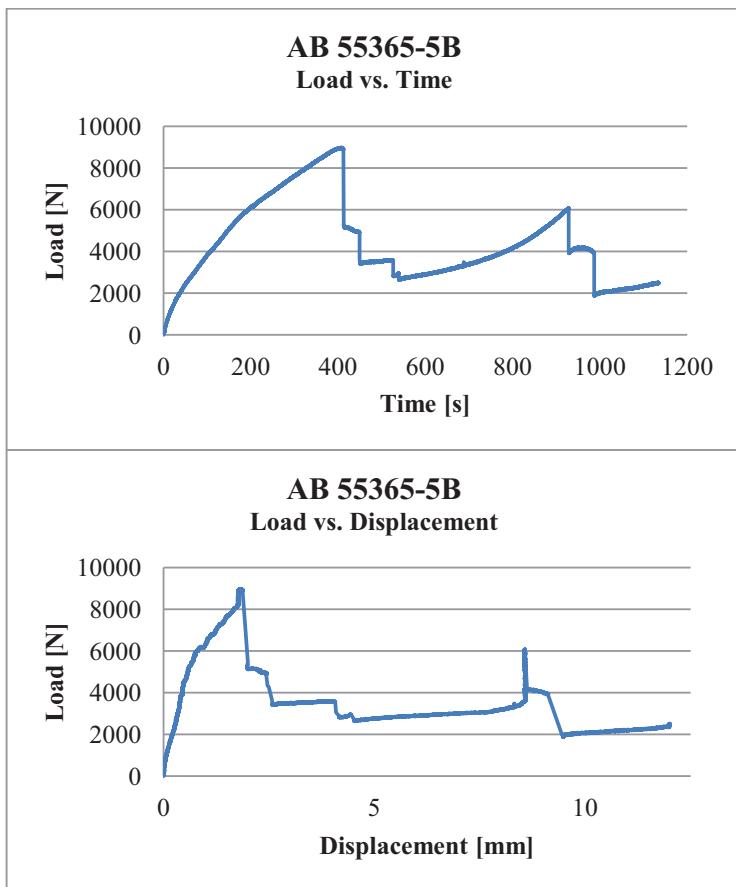
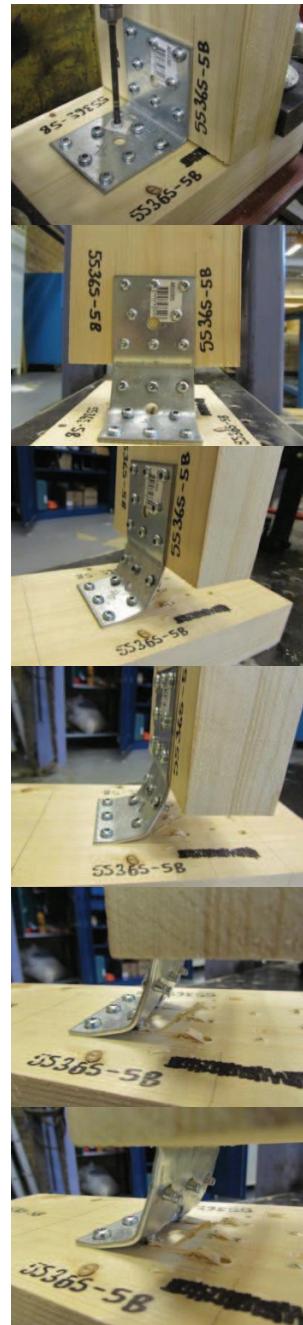
Failure	2
Failure load [N]	9755
Displacement 1 [mm]	2.06
Displacement 2 [mm]	-
Mean Displacement [mm]	-
Moisture [%]	7.17
Density [kg/m ³]	437

In this test only one displacement was recorded.

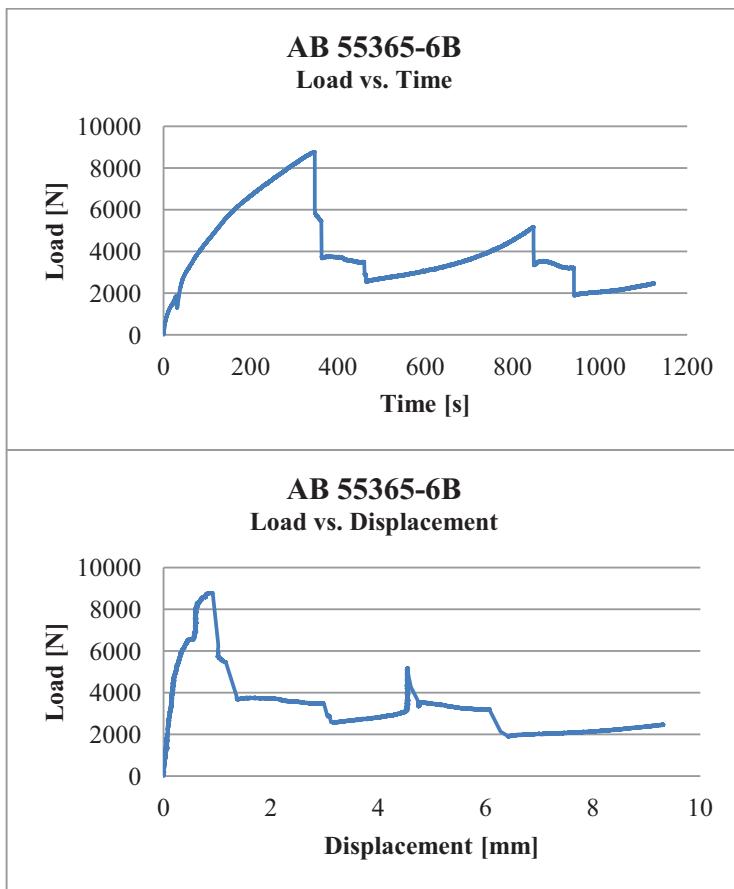
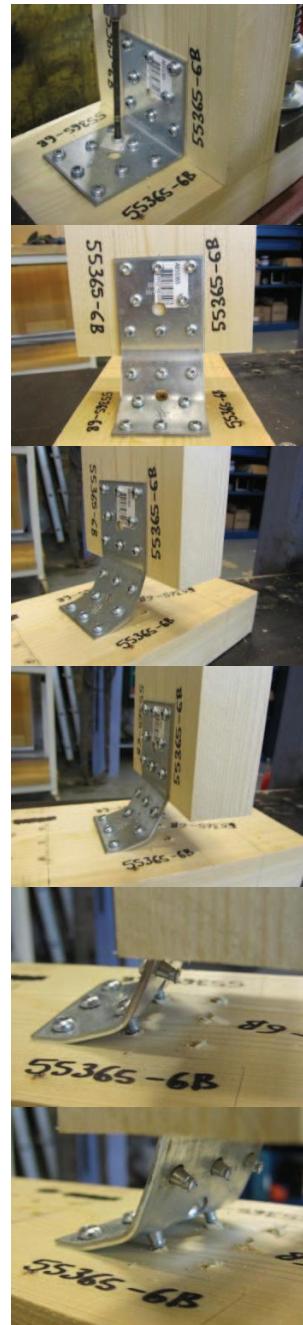
Failure	2
Failure load [N]	8981
Displacement 1 [mm]	1.83
Displacement 2 [mm]	-
Mean Displacement [mm]	-
Moisture [%]	7.20
Density [kg/m ³]	506

In this test only one displacement was recorded.

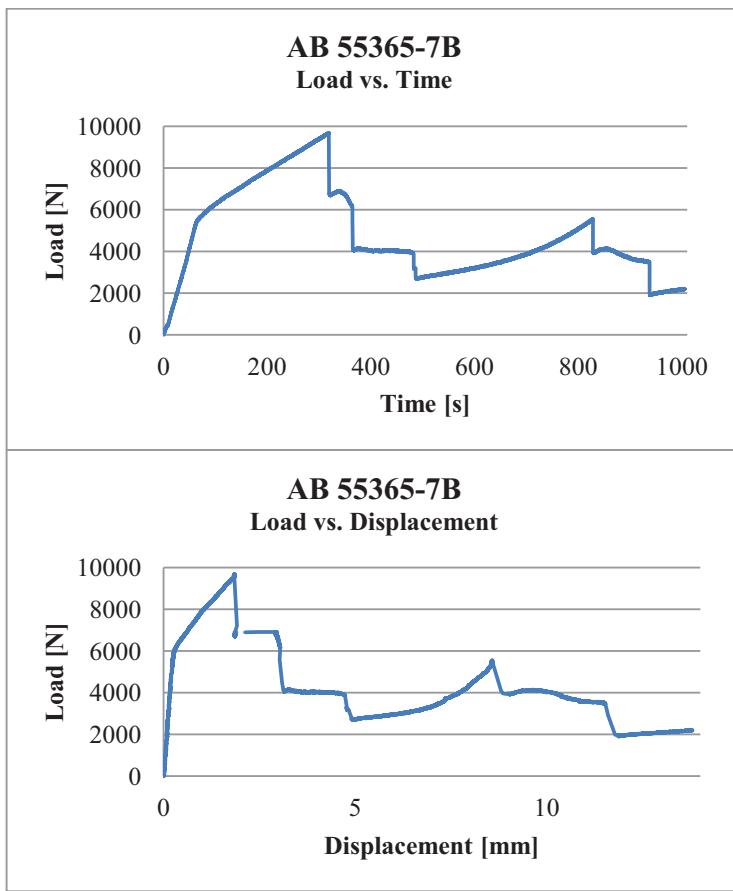
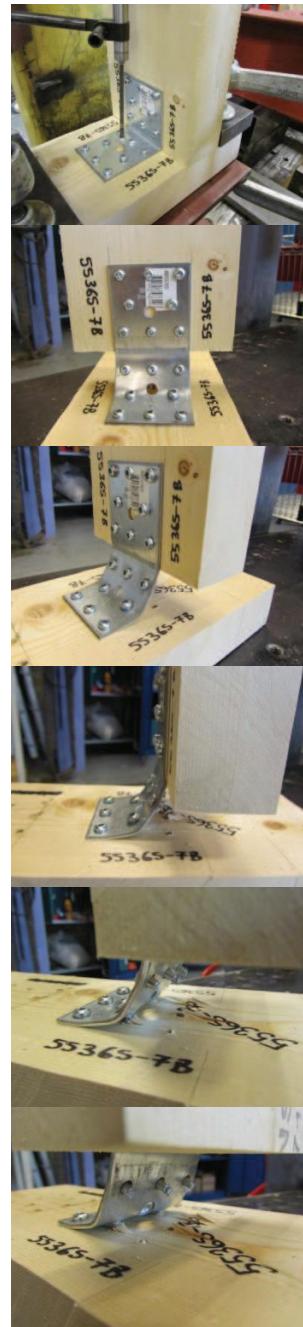
Failure	2
Failure load [N]	8774
Displacement 1 [mm]	0.87
Displacement 2 [mm]	-
Mean Displacement [mm]	-
Moisture [%]	9.33
Density [kg/m ³]	421

In this test only one displacement was recorded.

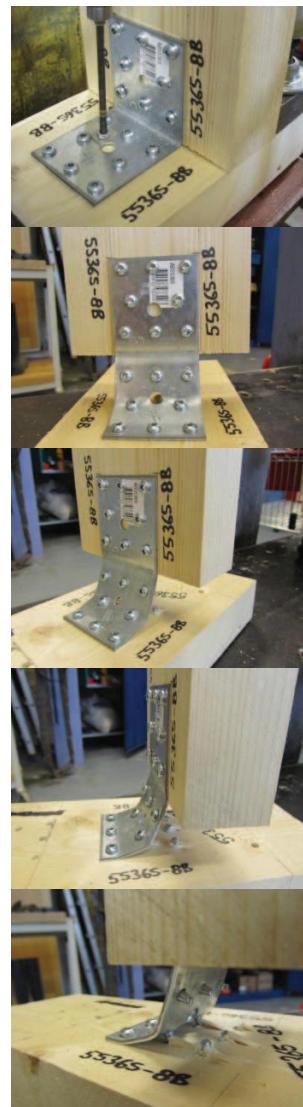
Failure	2
Failure load [N]	9676
Displacement 1 [mm]	1.85
Displacement 2 [mm]	-
Mean Displacement [mm]	-
Moisture [%]	8.49
Density [kg/m ³]	459

In this test only one displacement was recorded. Under 5 kN the LVDT did not work.

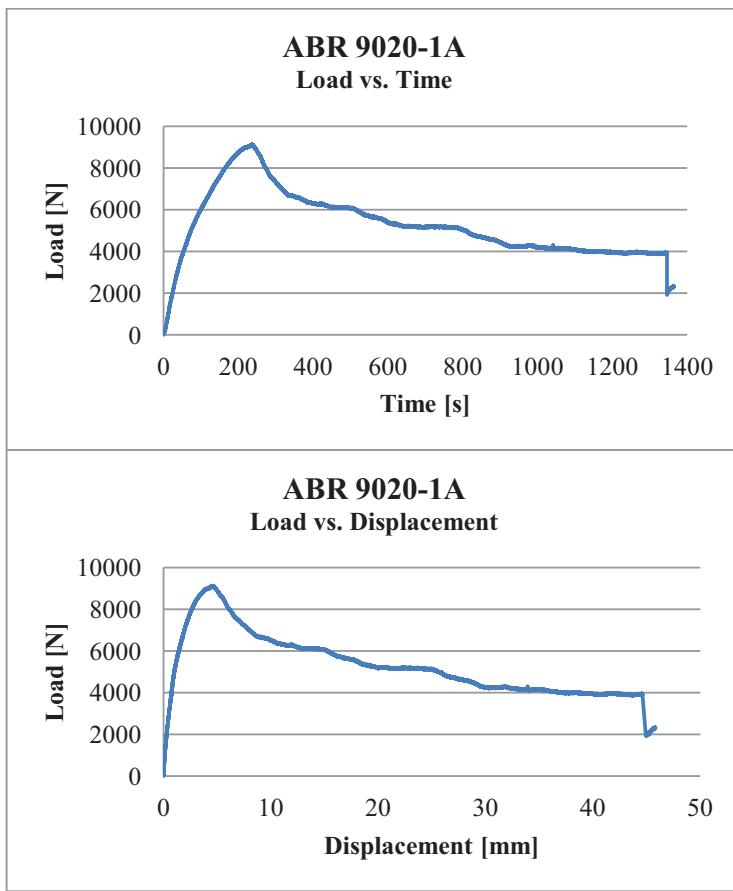
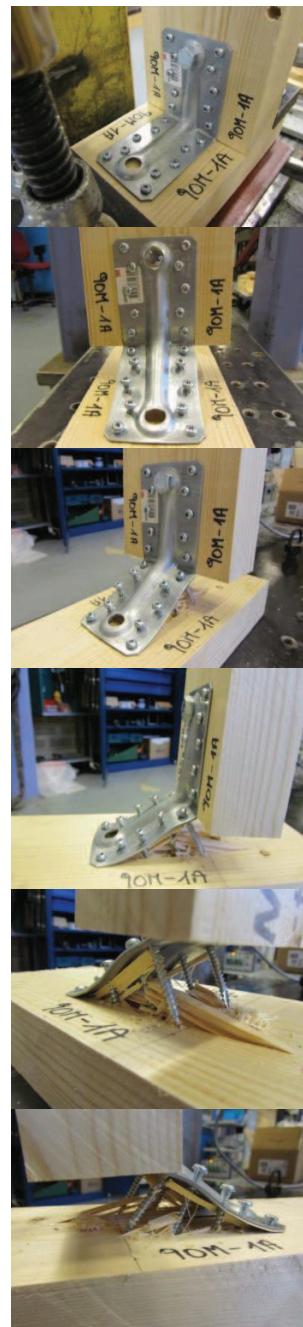
Set 1 – 10 wooden screws 5x40 on the stud and 10 wooden screws 5x40 on the rail

Failure	2
Failure load [N]	9120
Displacement 1 [mm]	-
Displacement 2 [mm]	4.55
Mean Displacement [mm]	-
Moisture [%]	9.75
Density [kg/m ³]	392

The LVDT number 1 did not work.

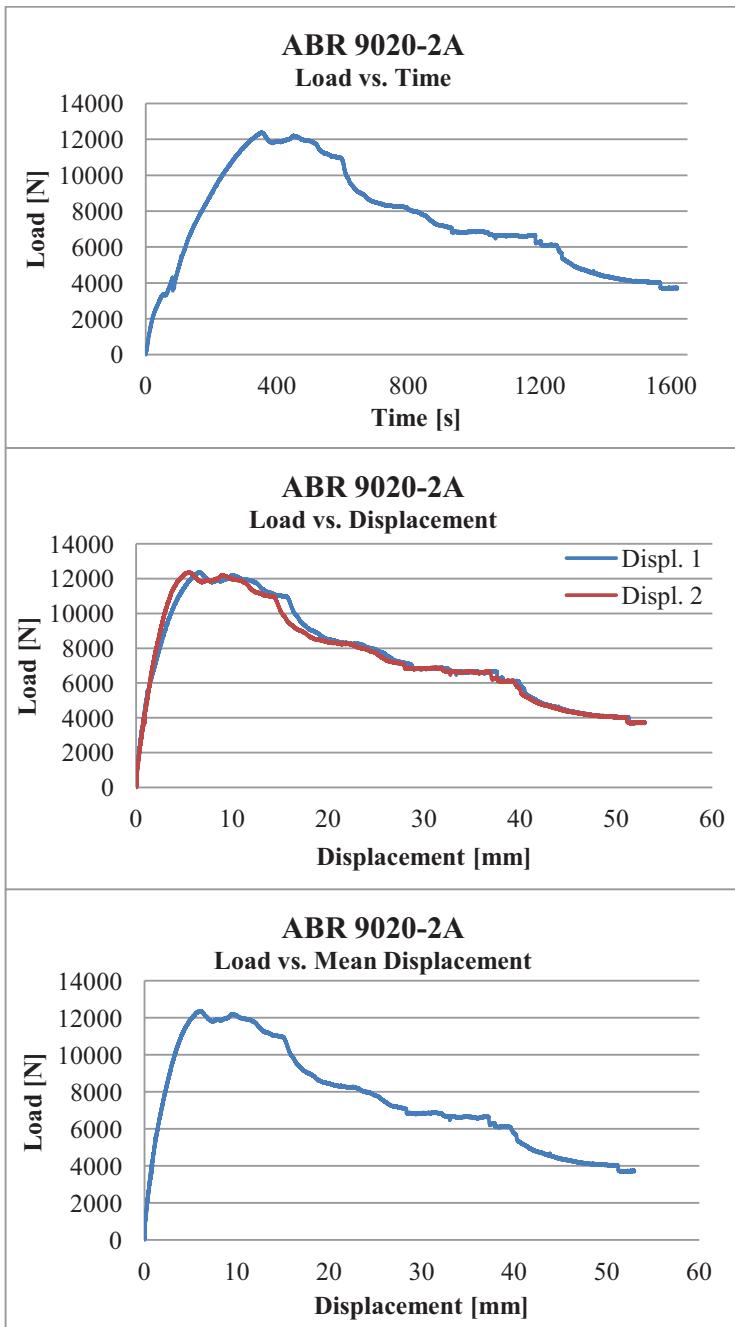
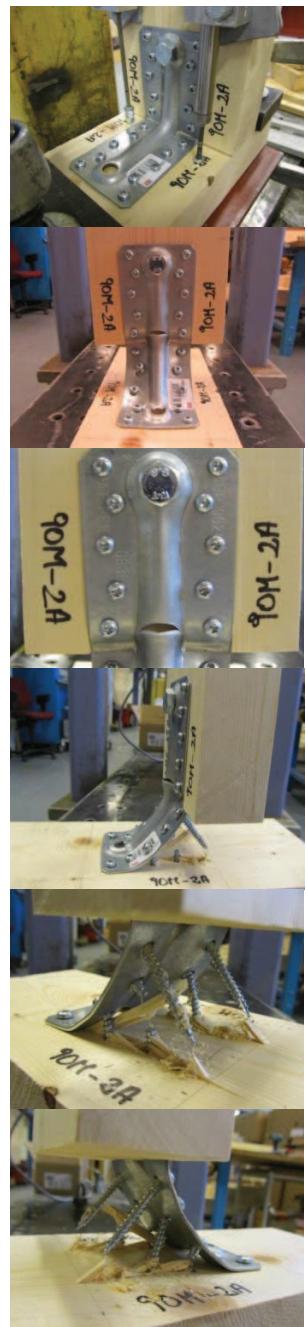
Failure	2
Failure load [N]	12378
Displacement 1 [mm]	6.59
Displacement 2 [mm]	5.53
Mean Displacement [mm]	6.06
Moisture [%]	9.97
Density [kg/m ³]	459

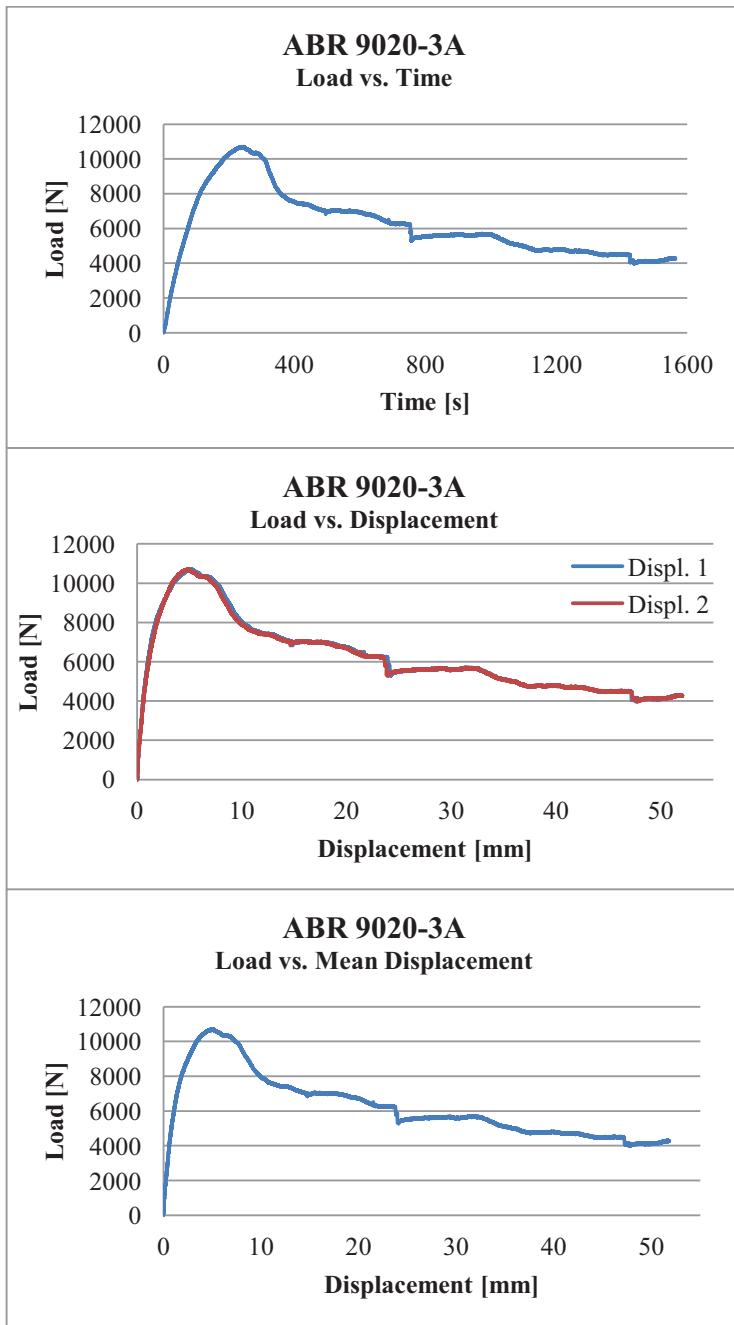
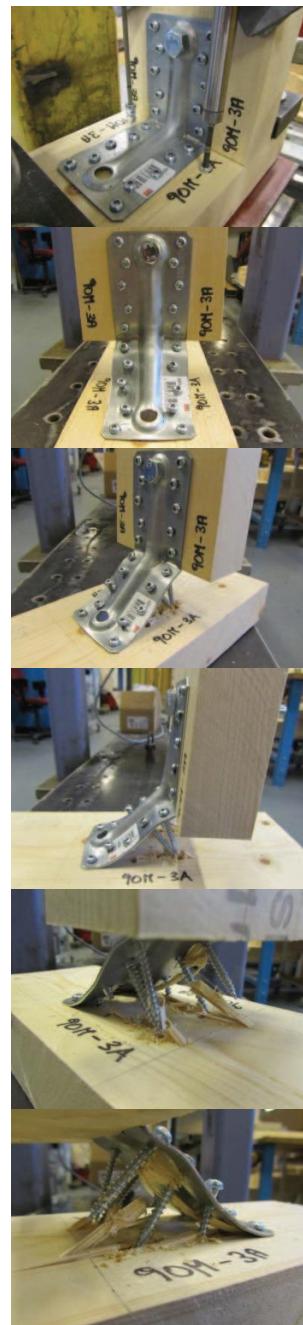
Failure	2
Failure load [N]	10709
Displacement 1 [mm]	5.11
Displacement 2 [mm]	4.78
Mean Displacement [mm]	4.94
Moisture [%]	10.4
Density [kg/m ³]	402

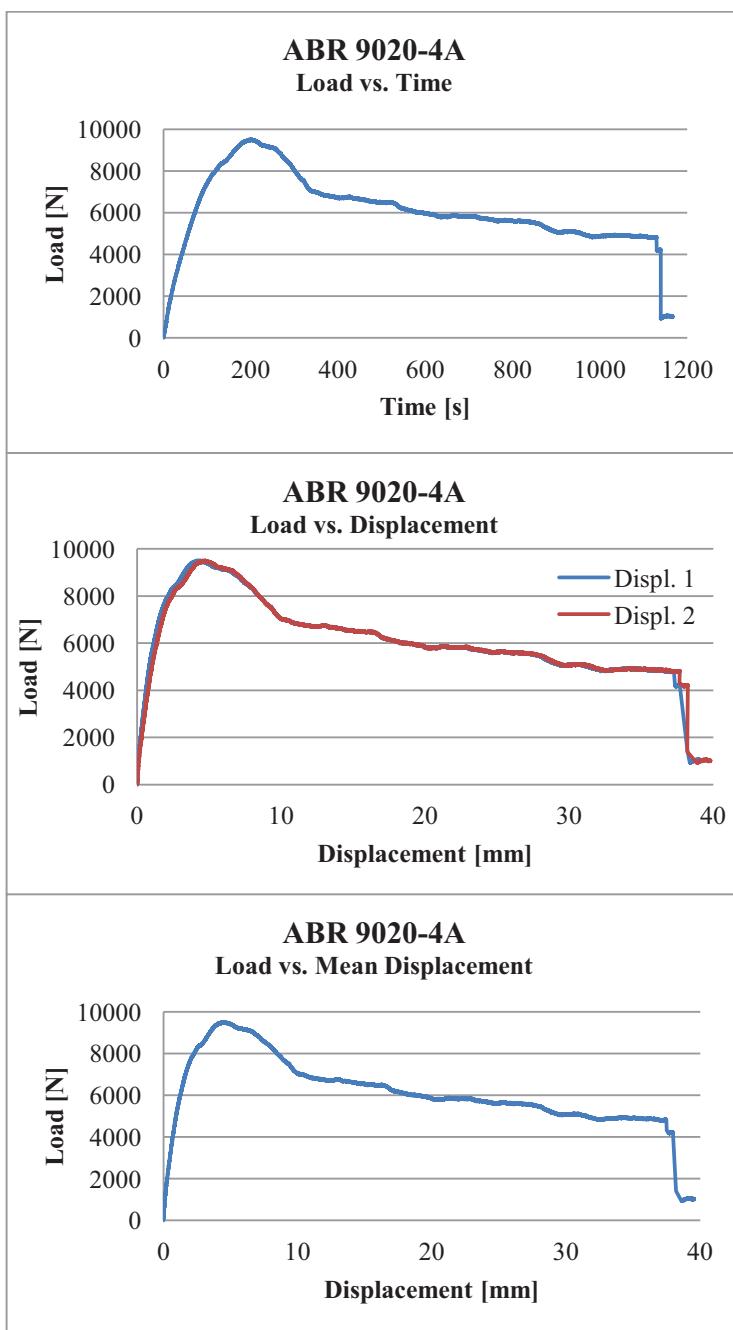
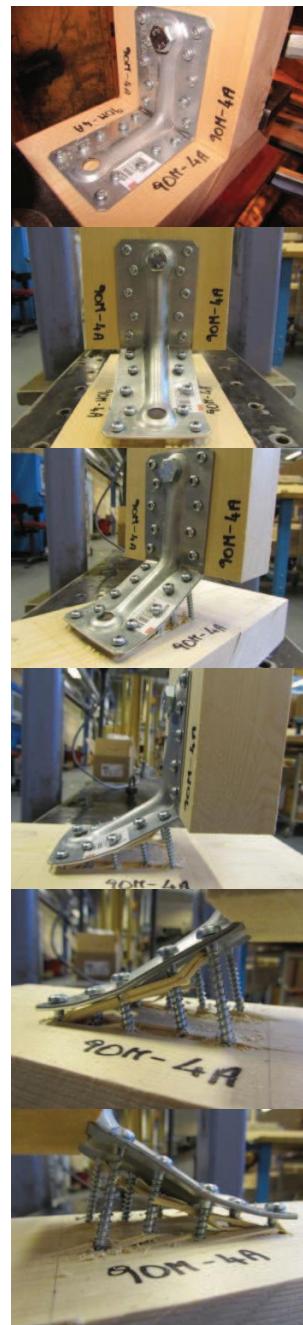
Failure	2
Failure load [N]	9503
Displacement 1 [mm]	4.29
Displacement 2 [mm]	4.66
Mean Displacement [mm]	4.48
Moisture [%]	10.3
Density [kg/m ³]	387

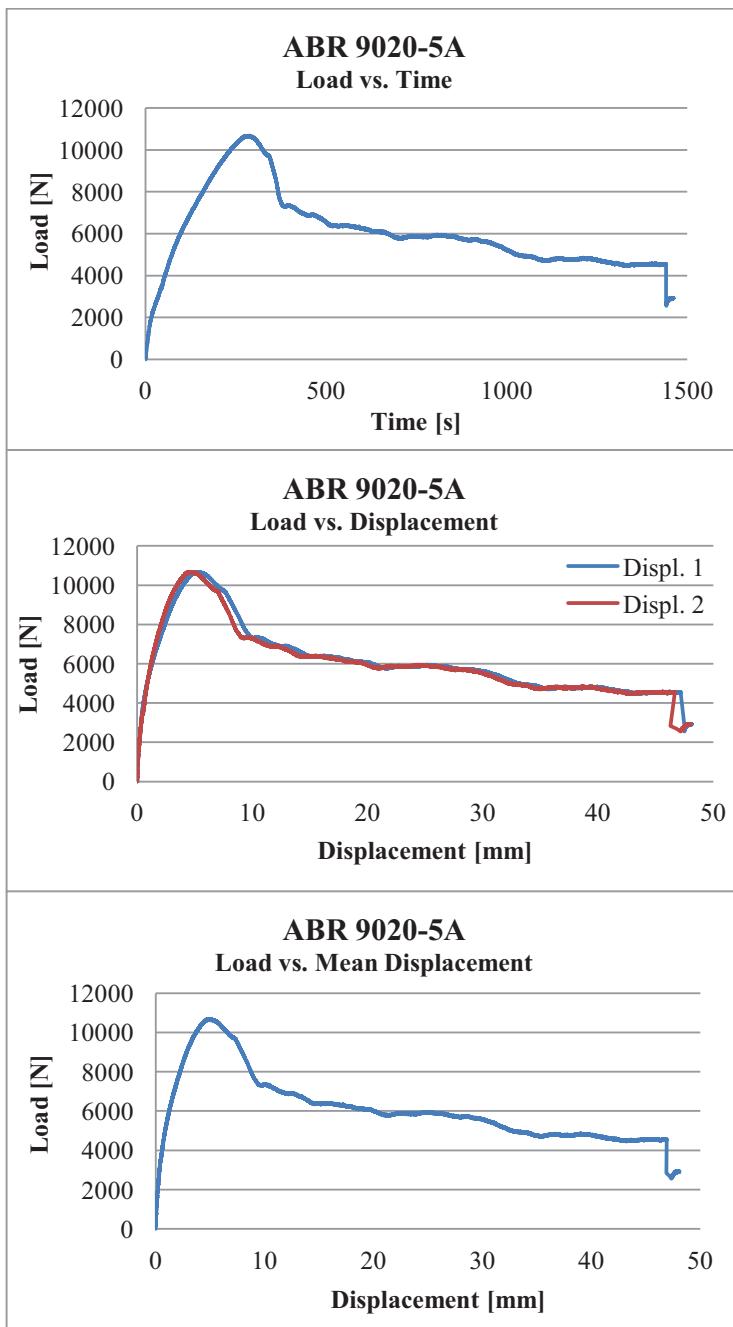
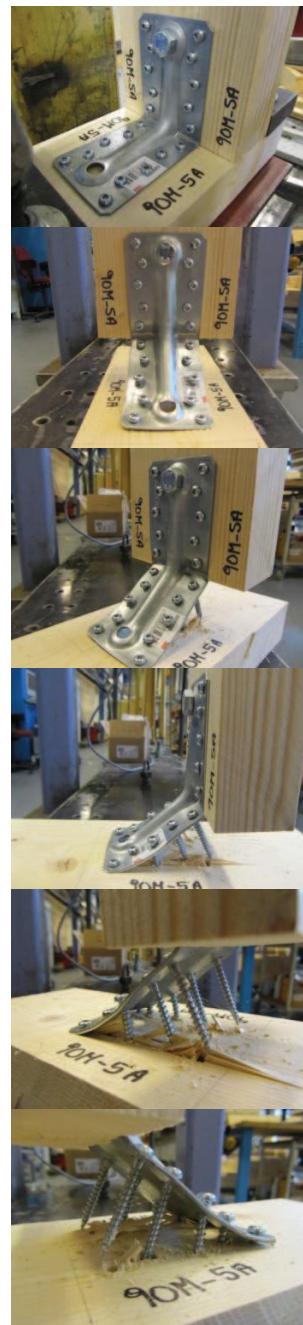
Failure	2
Failure load [N]	10676
Displacement 1 [mm]	5.39
Displacement 2 [mm]	4.80
Mean Displacement [mm]	5.09
Moisture [%]	9.39
Density [kg/m ³]	418

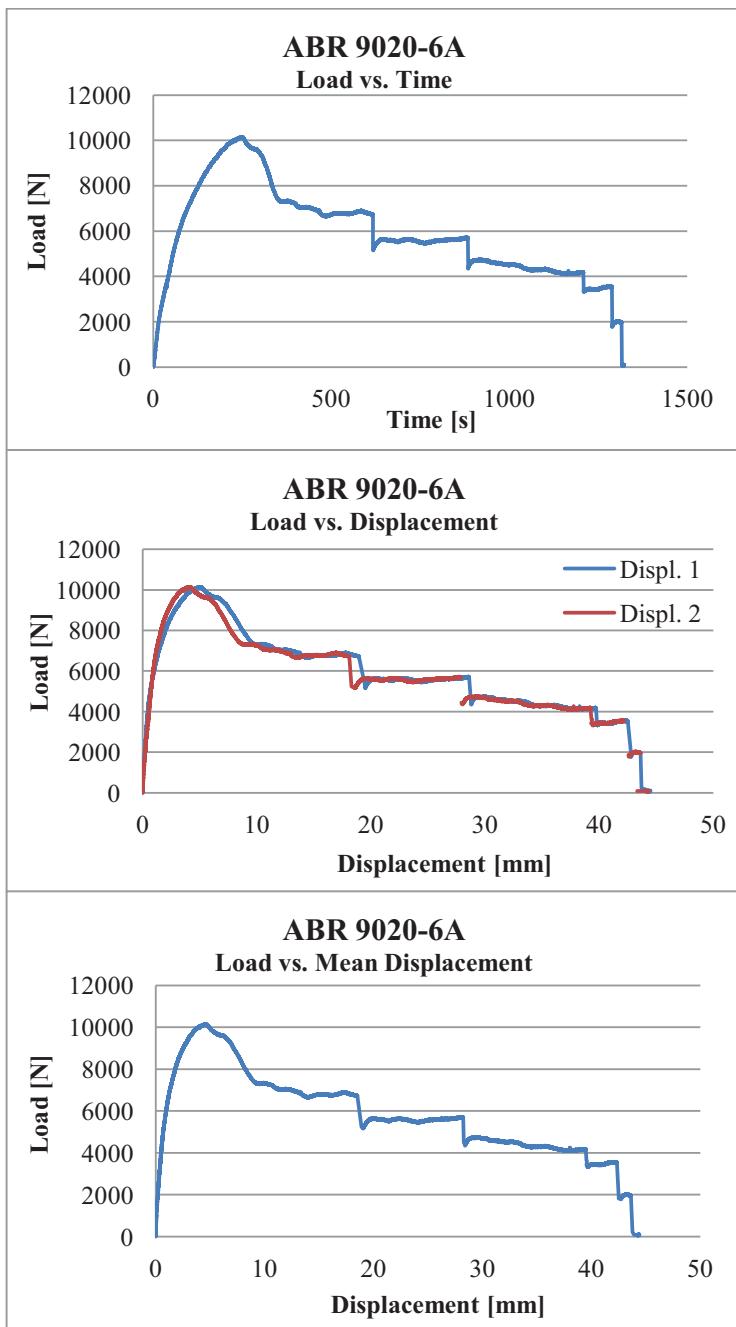
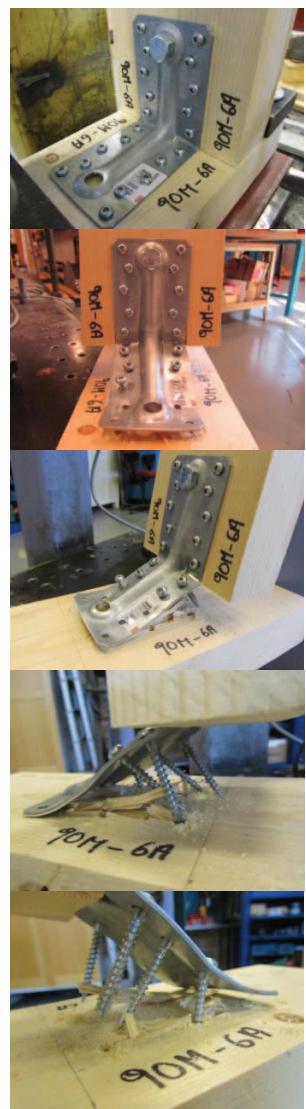
Failure	2
Failure load [N]	10145
Displacement 1 [mm]	4.92
Displacement 2 [mm]	4.00
Mean Displacement [mm]	4.46
Moisture [%]	11.0
Density [kg/m ³]	373
