Experimental Testing of Hold Down Devices for Timber Frame Shear Walls

Giuseppe Caprolu

ISSN: 1402-1536
ISBN 978-91-7439-386-6

Luleå 2012

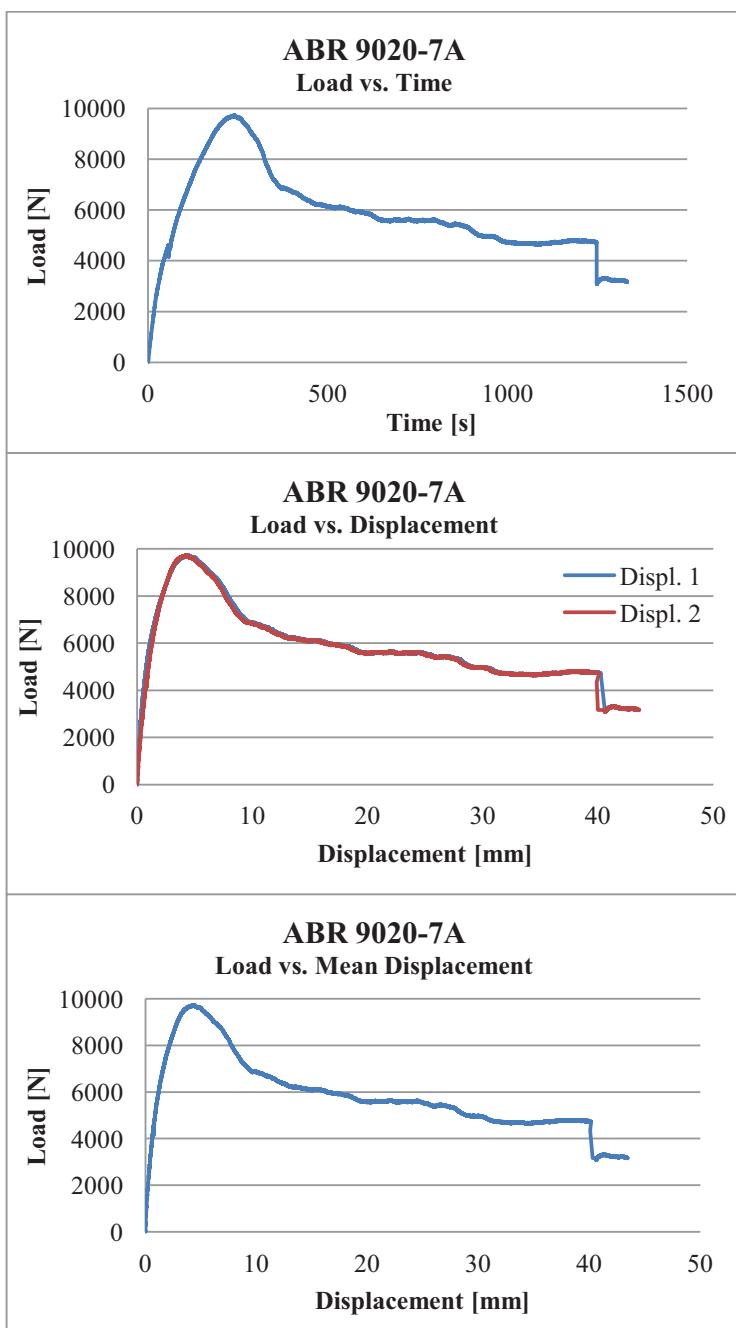
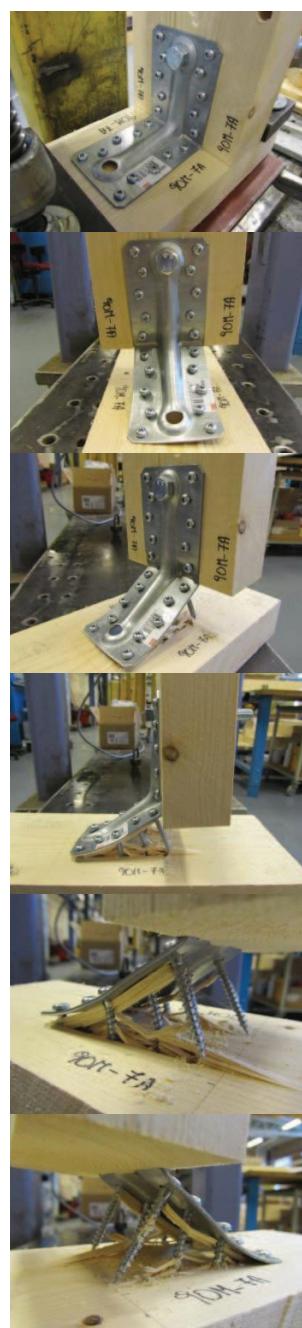
Failure	2
Failure load [N]	9732
Displacement 1 [mm]	4.45
Displacement 2 [mm]	4.25
Mean Displacement [mm]	4.35
Moisture [%]	8.98
Density [kg/m ³]	397

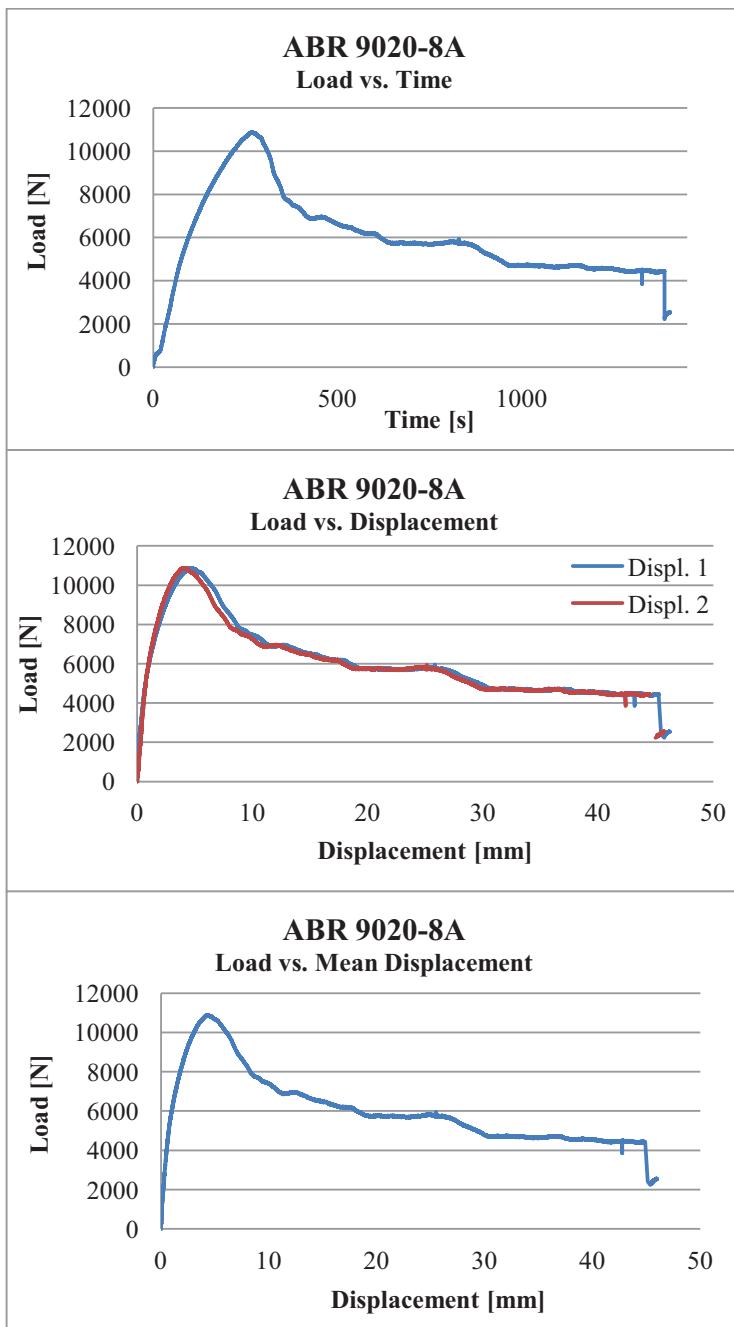
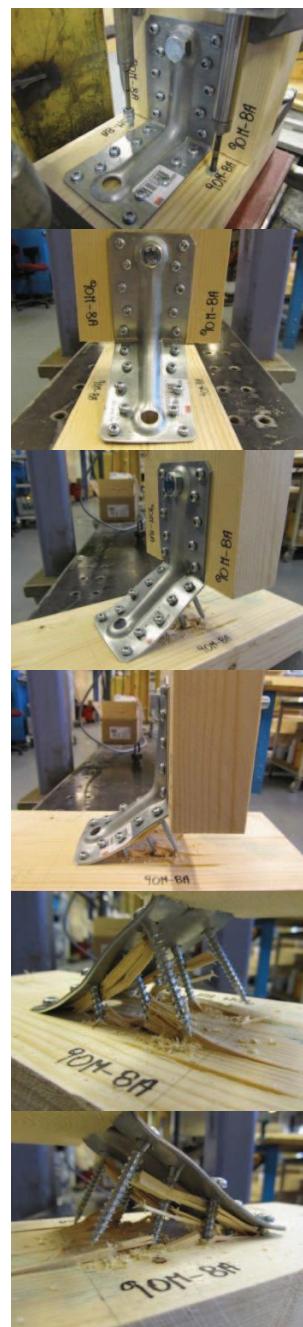
Failure	2
Failure load [N]	10872
Displacement 1 [mm]	4.55
Displacement 2 [mm]	3.95
Mean Displacement [mm]	4.25
Moisture [%]	8.53
Density [kg/m ³]	416

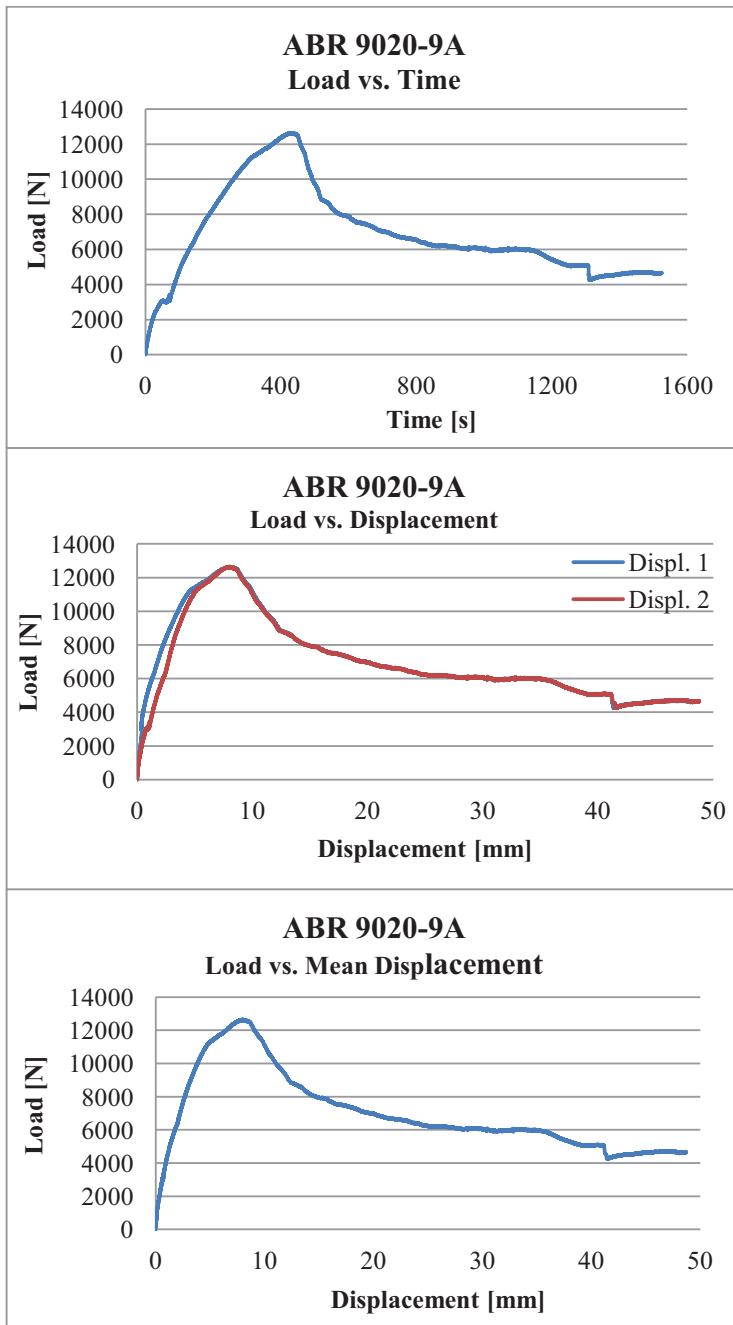
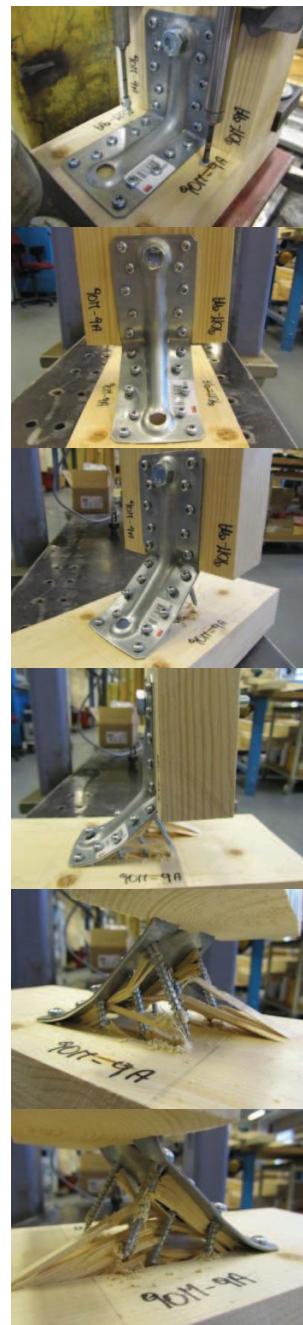
Failure	2
Failure load [N]	12649
Displacement 1 [mm]	8.04
Displacement 2 [mm]	8.00
Mean Displacement [mm]	8.02
Moisture [%]	8.52
Density [kg/m ³]	422

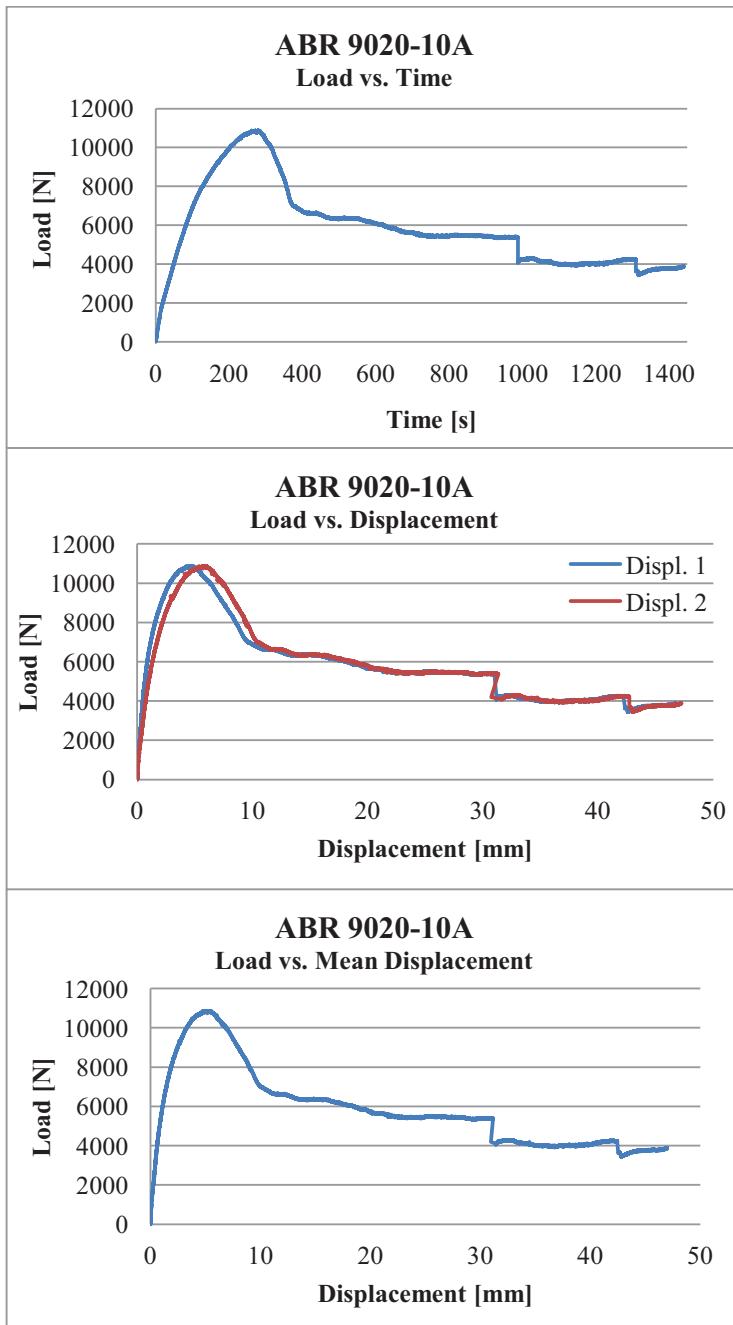
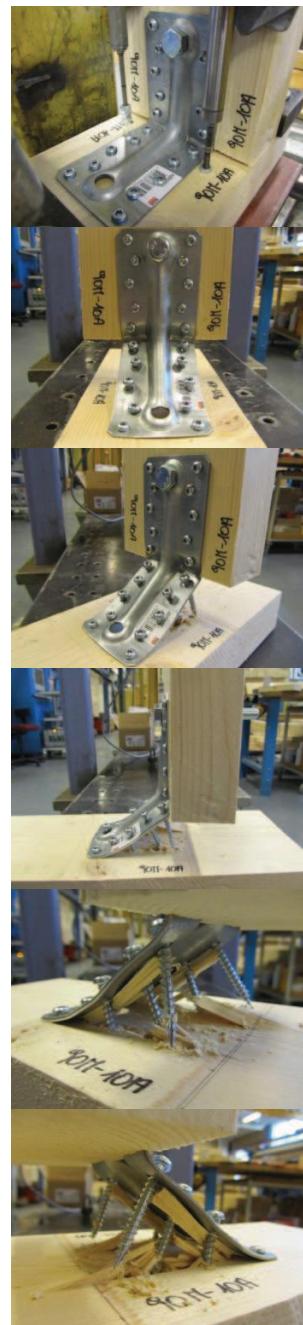
Failure	2
Failure load [N]	10870
Displacement 1 [mm]	4.28
Displacement 2 [mm]	5.37
Mean Displacement [mm]	4.83
Moisture [%]	7.36
Density [kg/m ³]	391

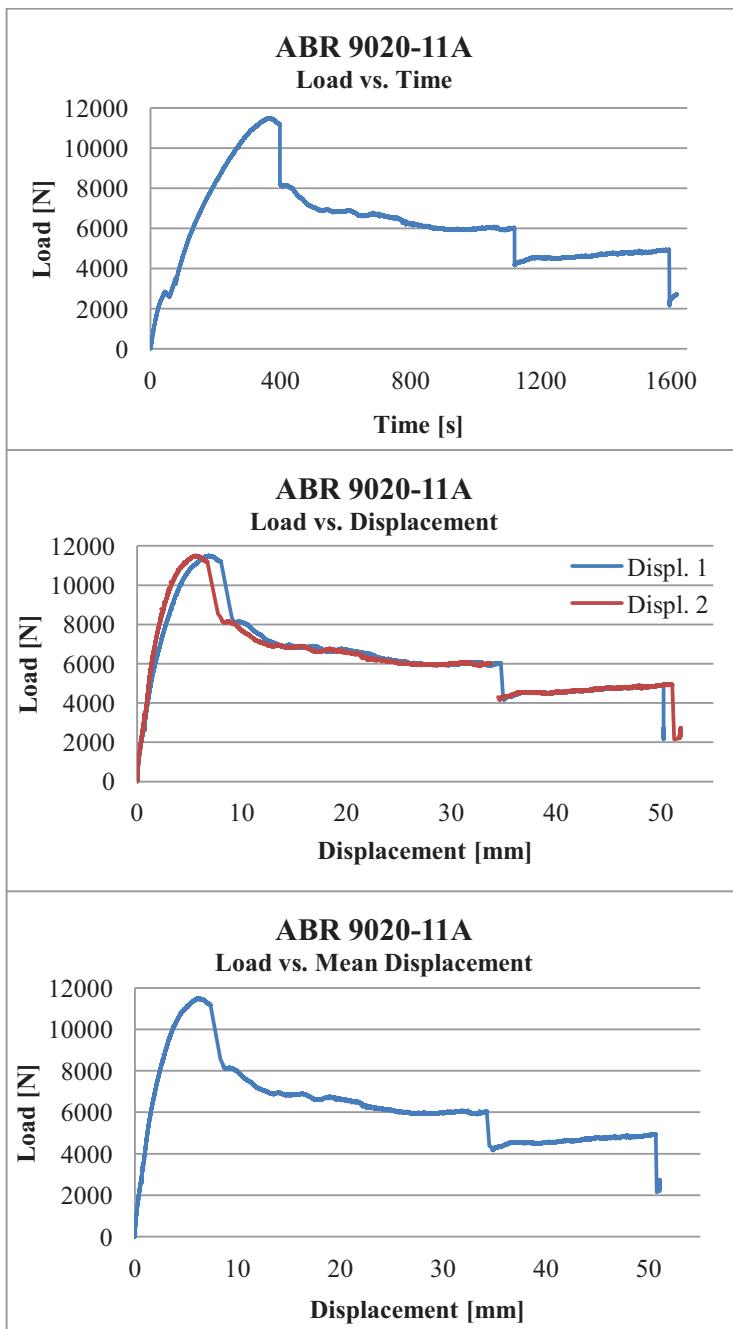
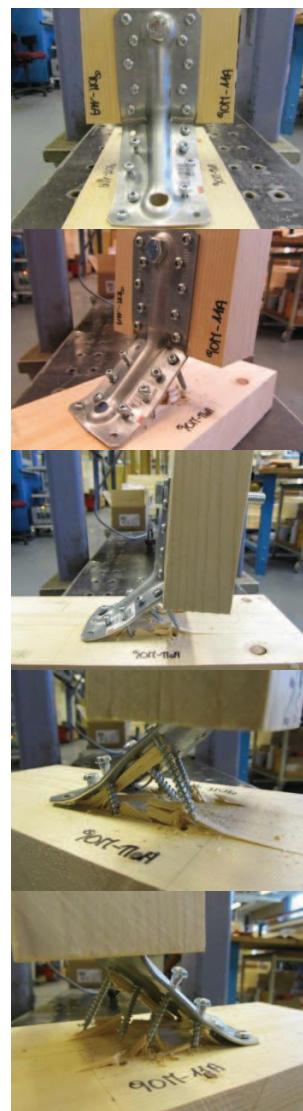
Failure	2
Failure load [N]	11506
Displacement 1 [mm]	6.84
Displacement 2 [mm]	5.59
Mean Displacement [mm]	6.21
Moisture [%]	9.24
Density [kg/m ³]	445

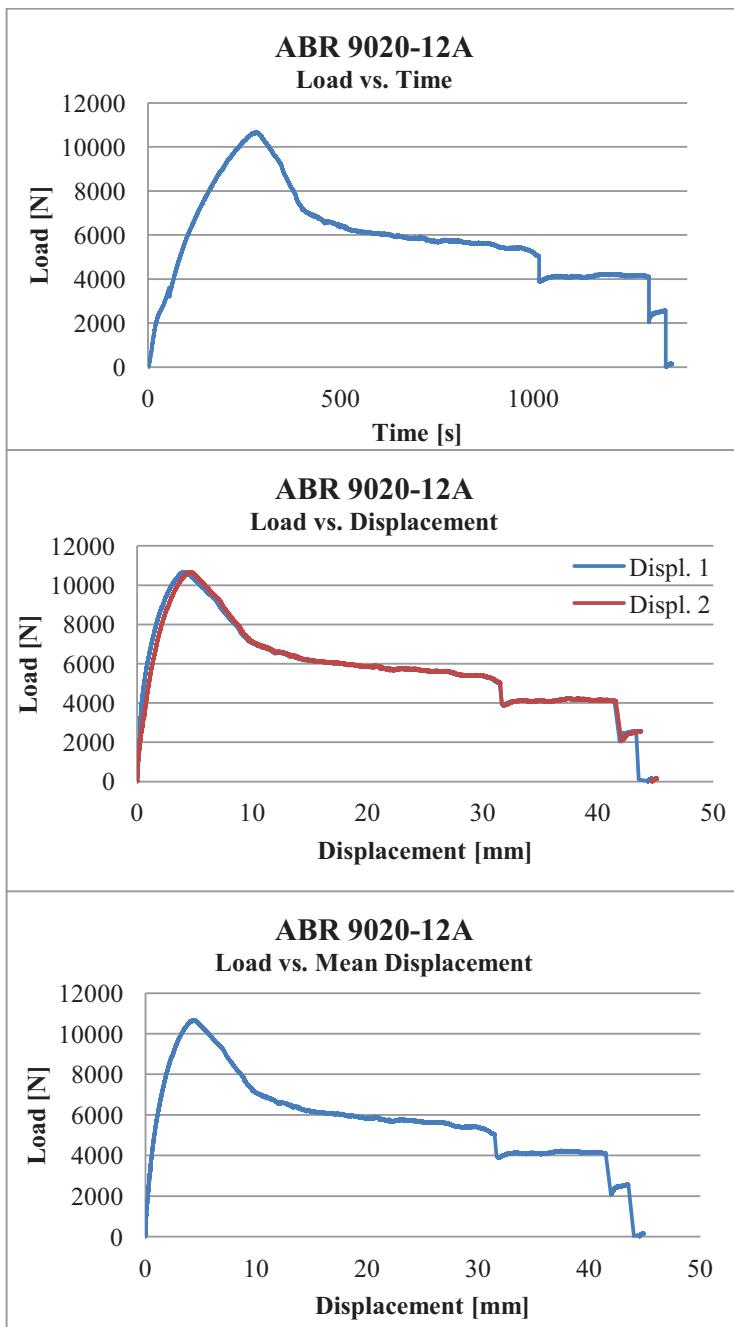
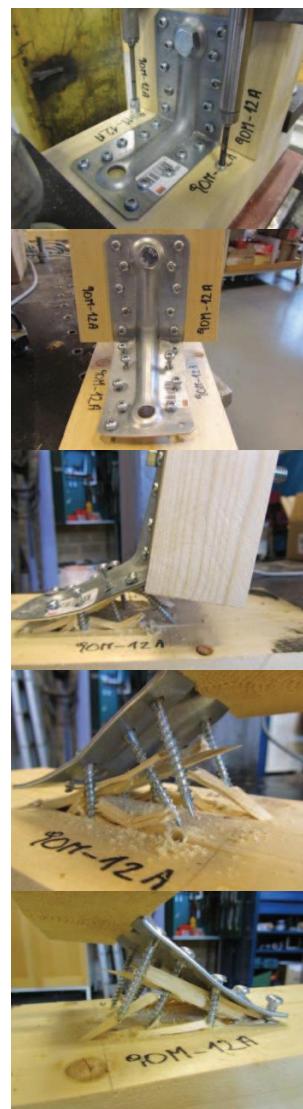
Failure	2
Failure load [N]	10670
Displacement 1 [mm]	4.16
Displacement 2 [mm]	4.68
Mean Displacement [mm]	4.42
Moisture [%]	9.86
Density [kg/m ³]	387

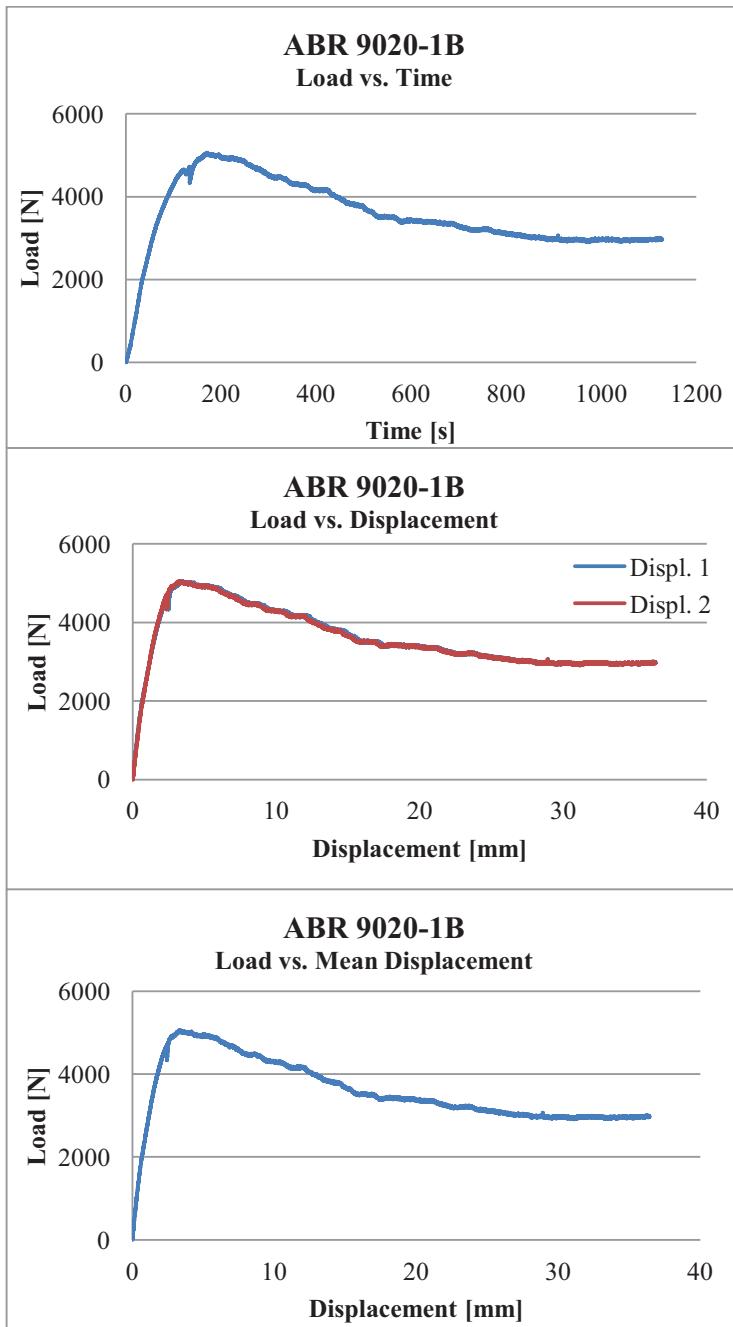
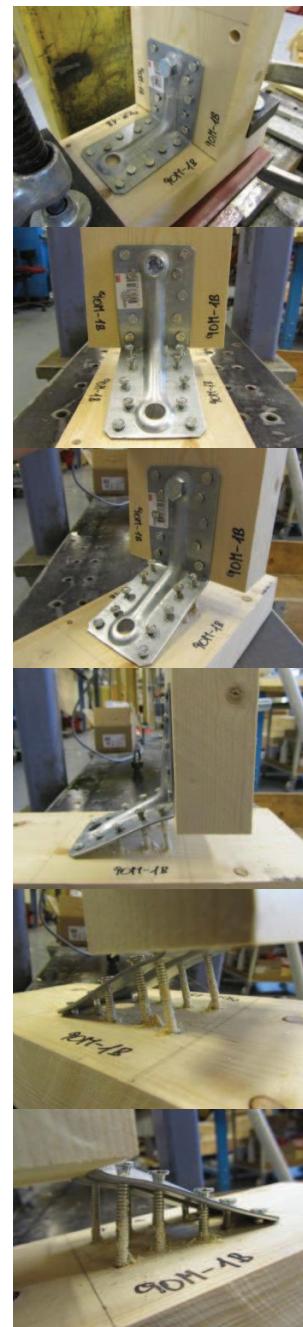
Set 2 – 1 bolt M 10 and 10 annular ringed shank nails 4x40 on the stud and 10 annular ringed shank nail 4x40 on the rail

Failure	2
Failure load [N]	5061
Displacement 1 [mm]	3.41
Displacement 2 [mm]	3.25
Mean Displacement [mm]	3.33
Moisture [%]	9.71
Density [kg/m ³]	402

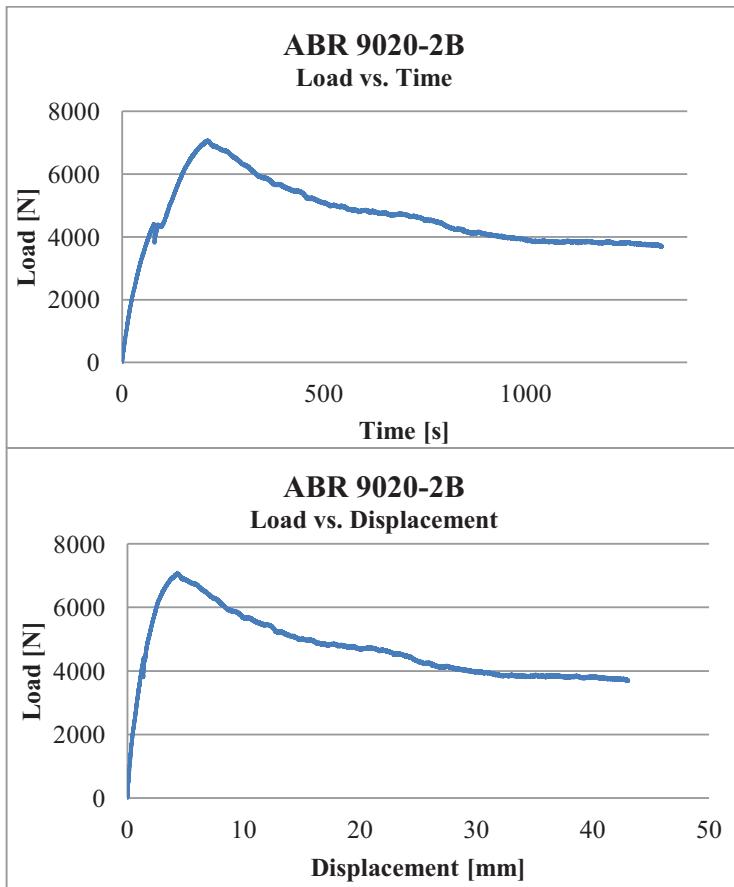
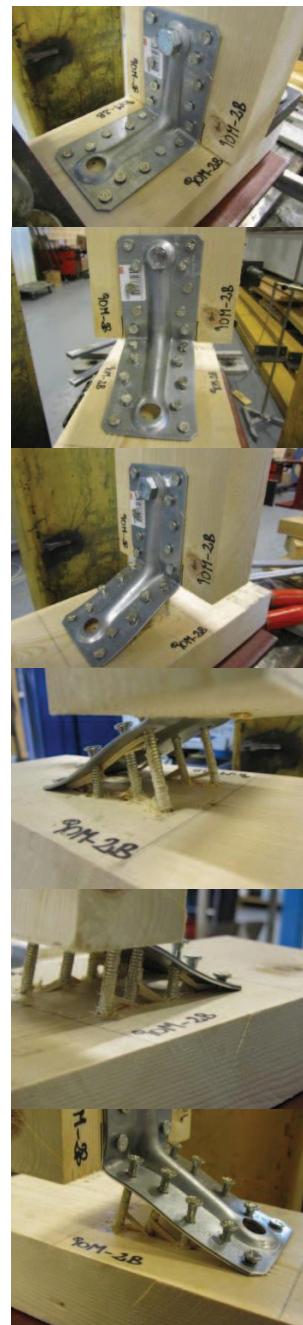
Failure	2
Failure load [N]	7069
Displacement 1 [mm]	4.25
Displacement 2 [mm]	-
Mean Displacement [mm]	-
Moisture [%]	8.29
Density [kg/m ³]	484

The LVDT number 2 did not work.

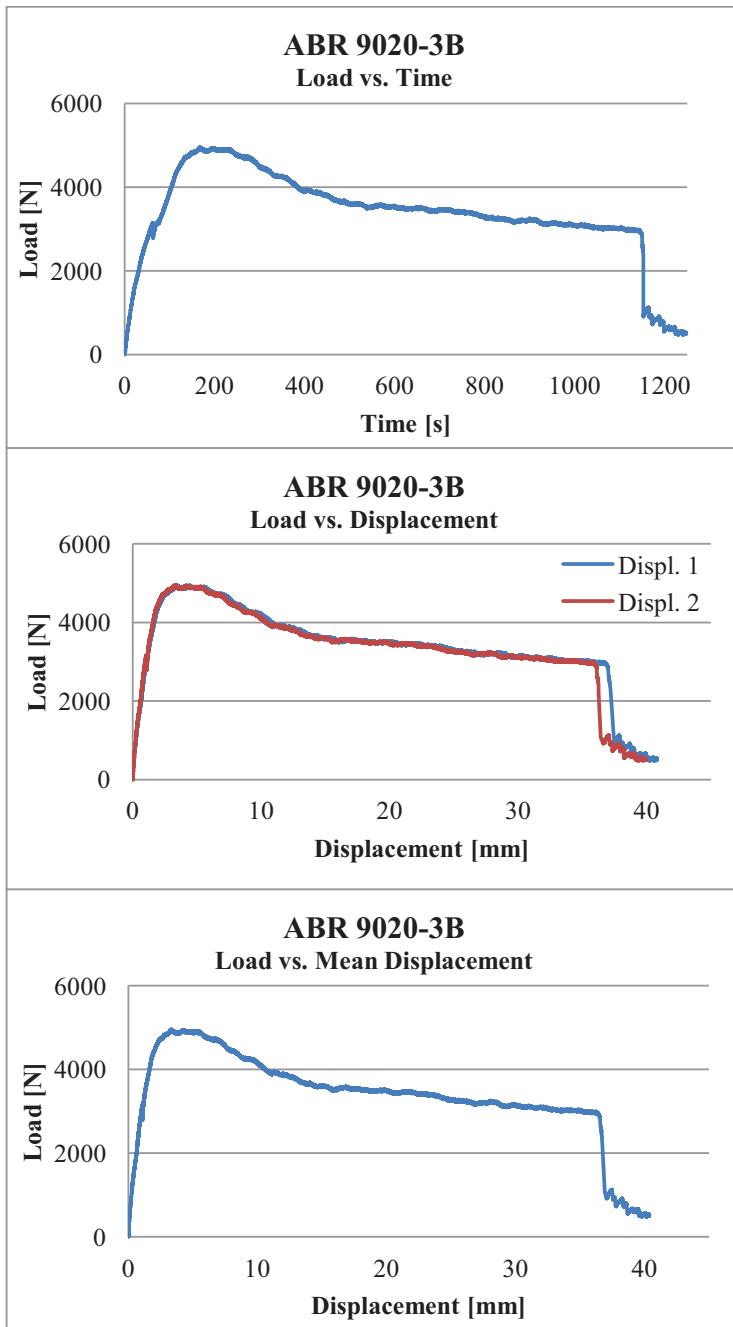
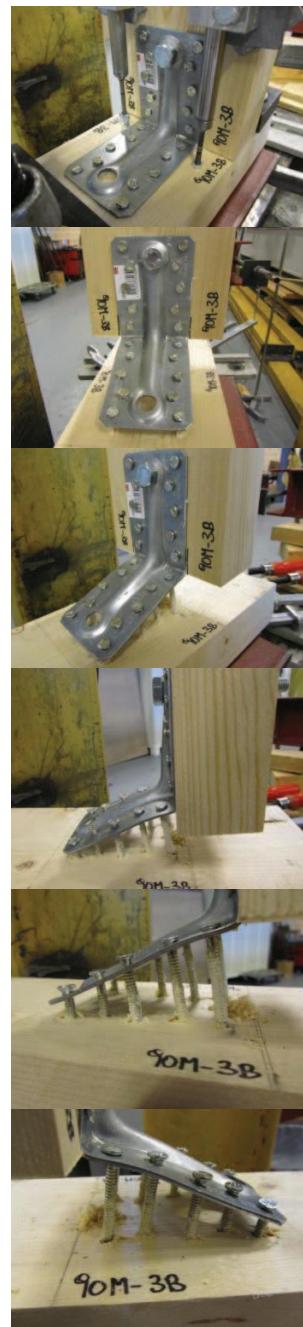
Failure	2
Failure load [N]	4956
Displacement 1 [mm]	3.41
Displacement 2 [mm]	3.23
Mean Displacement [mm]	3.32
Moisture [%]	9.15
Density [kg/m ³]	421

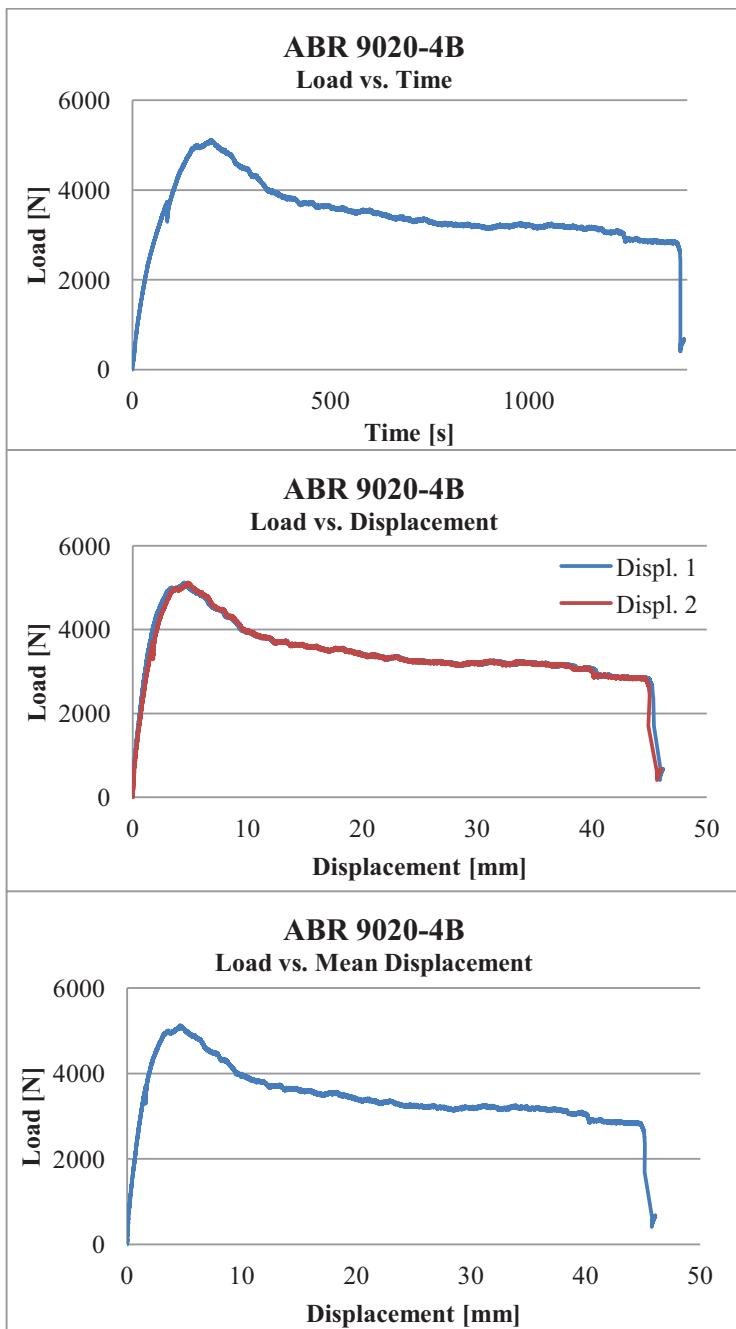
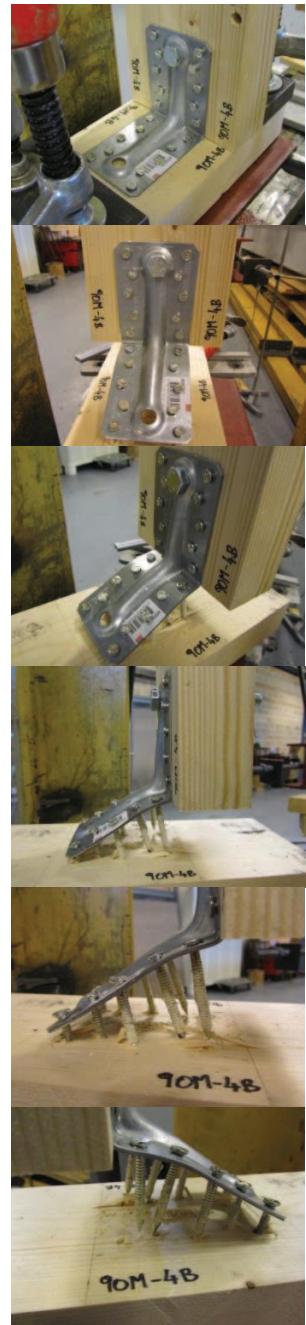
Failure	2
Failure load [N]	5122
Displacement 1 [mm]	4.47
Displacement 2 [mm]	4.80
Mean Displacement [mm]	4.63
Moisture [%]	11.2
Density [kg/m ³]	395

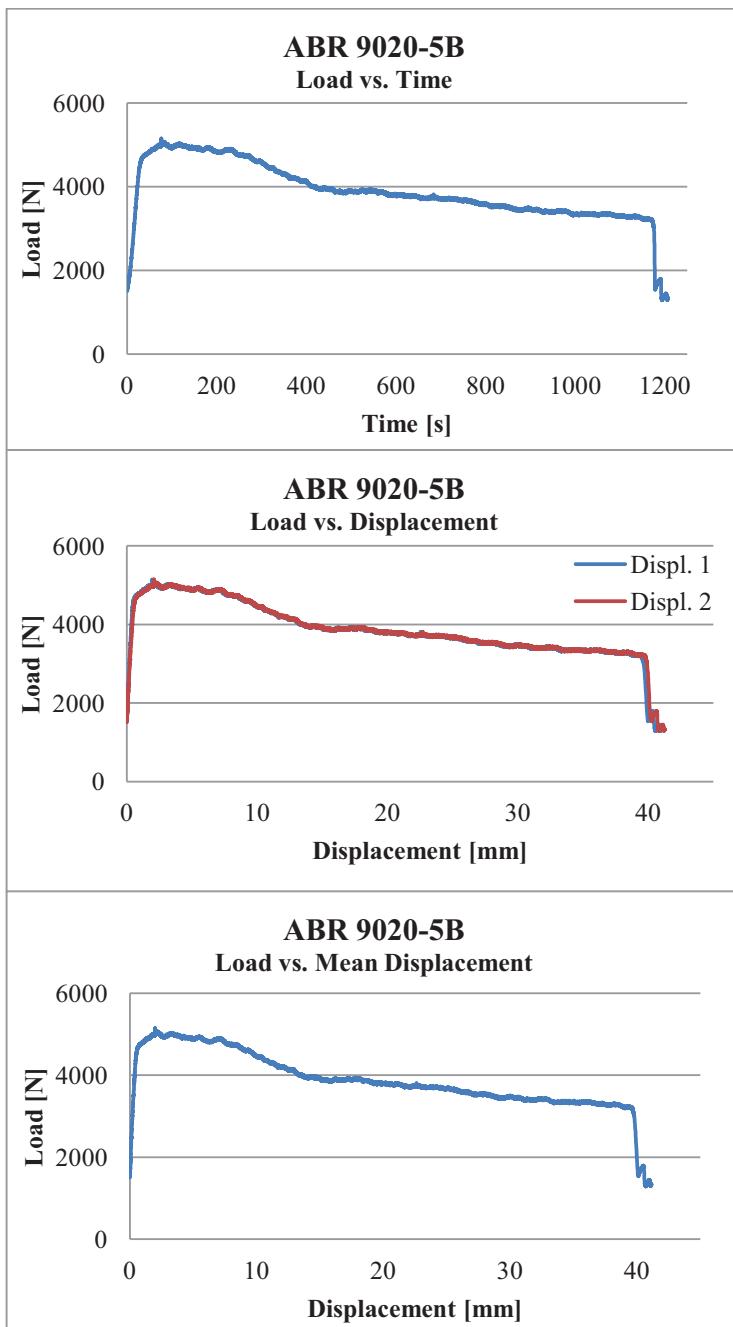
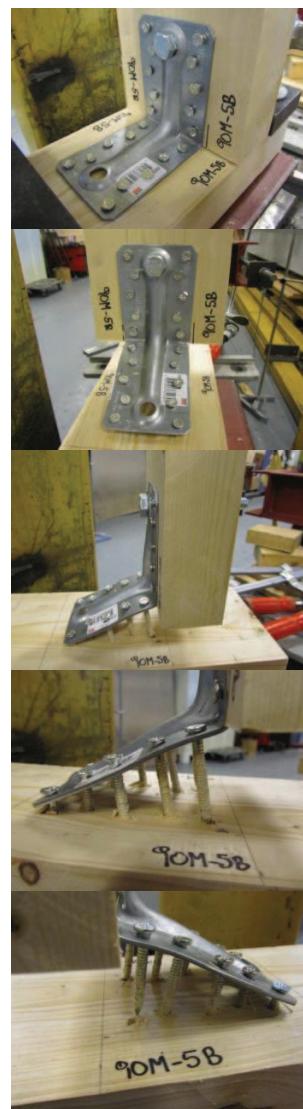
Failure	2
Failure load [N]	5148
Displacement 1 [mm]	1.92
Displacement 2 [mm]	2.07
Mean Displacement [mm]	2.00
Moisture [%]	8.81
Density [kg/m ³]	476

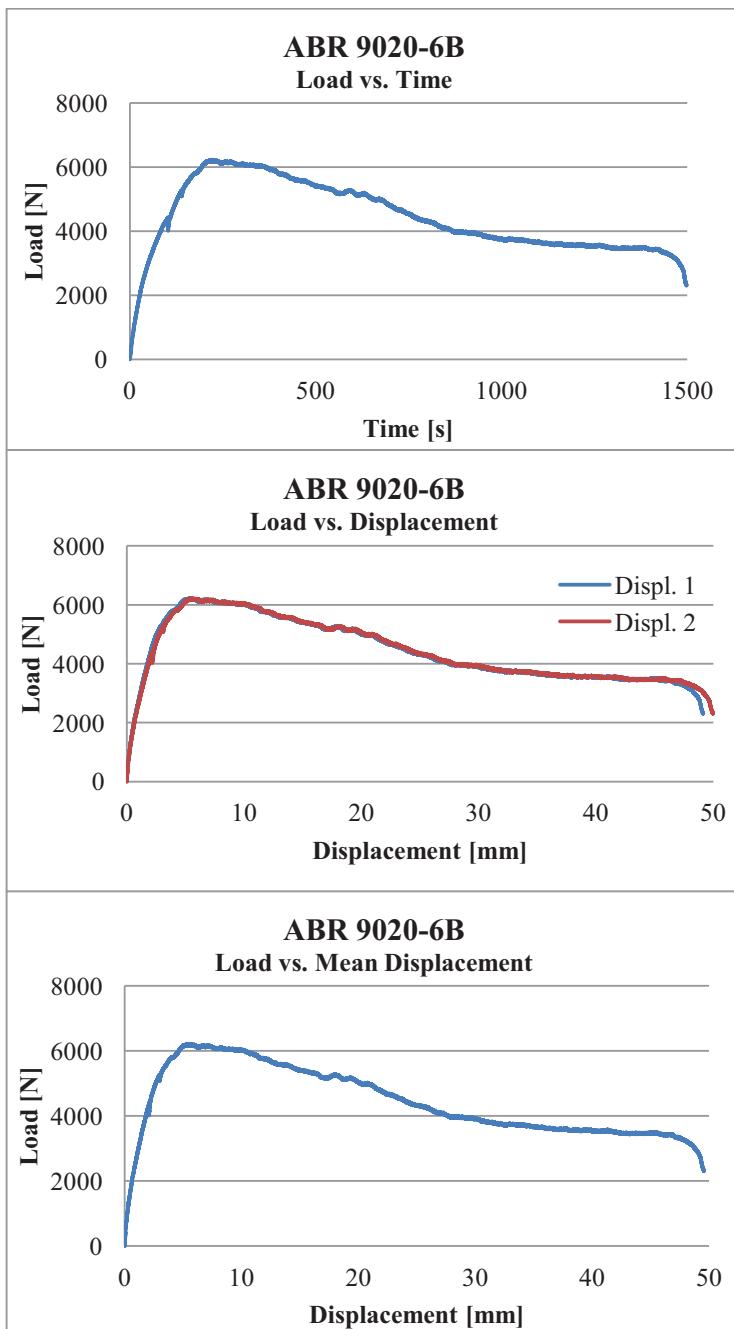
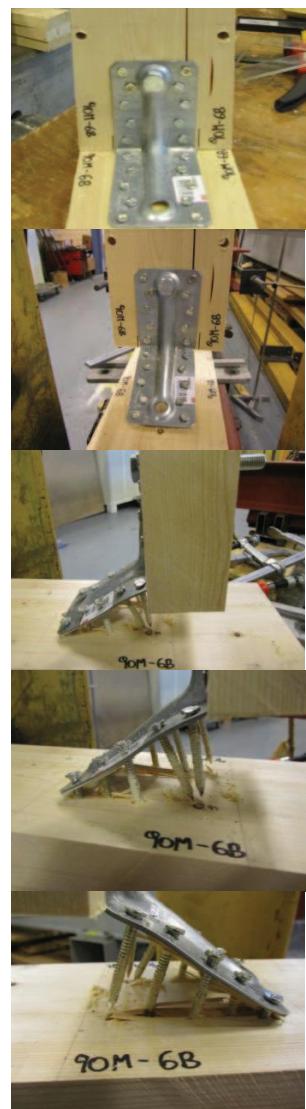
Failure	2
Failure load [N]	6226
Displacement 1 [mm]	5.30
Displacement 2 [mm]	5.55
Mean Displacement [mm]	5.43
Moisture [%]	10.2
Density [kg/m ³]	457

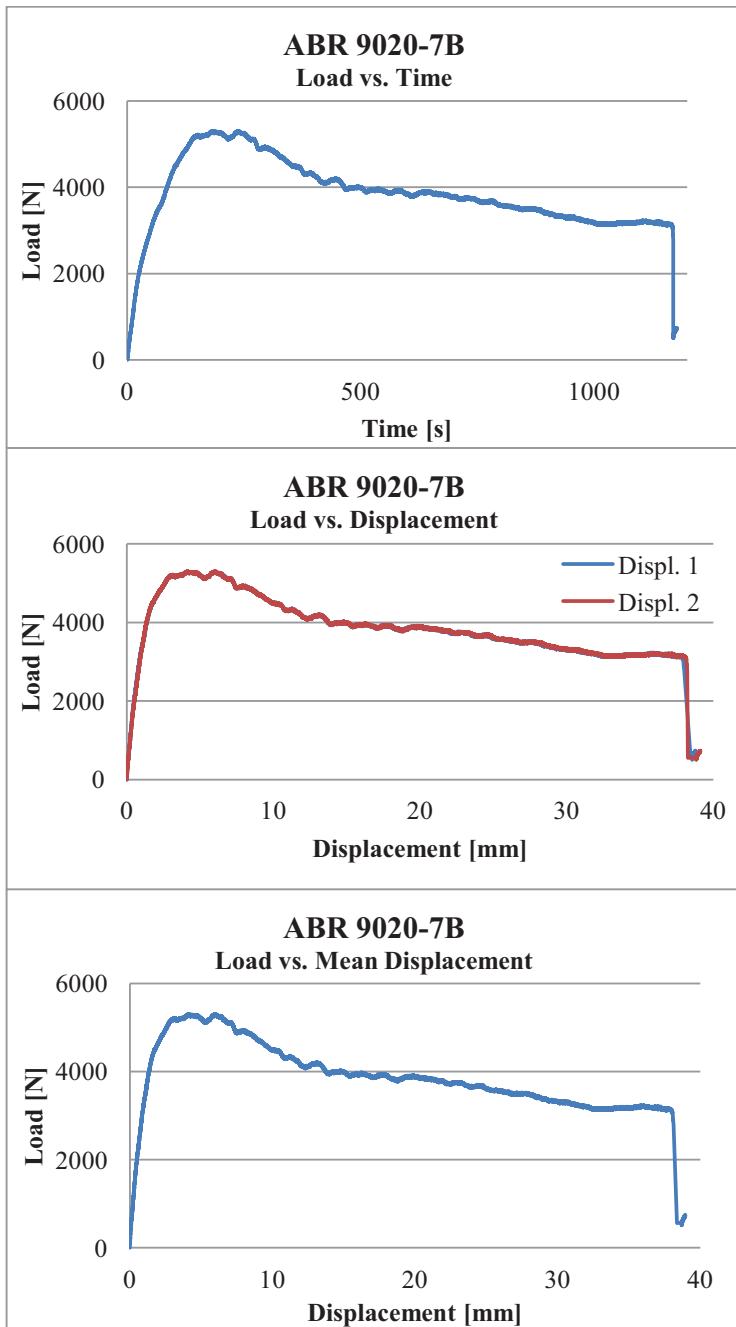
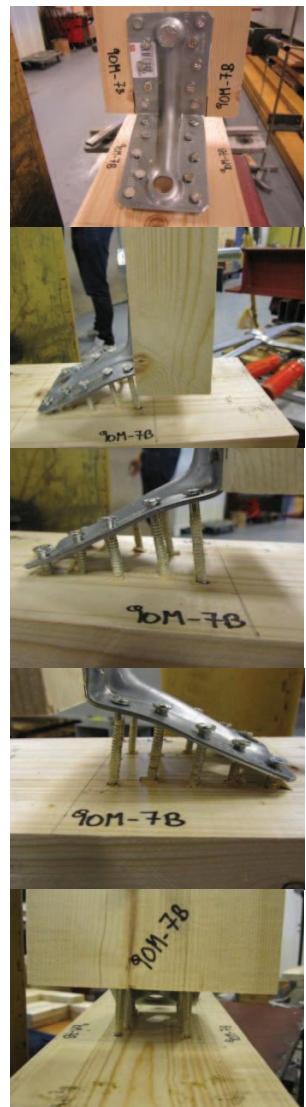
Failure	2
Failure load [N]	5306
Displacement 1 [mm]	4.14
Displacement 2 [mm]	4.13
Mean Displacement [mm]	4.14
Moisture [%]	9.32
Density [kg/m ³]	391

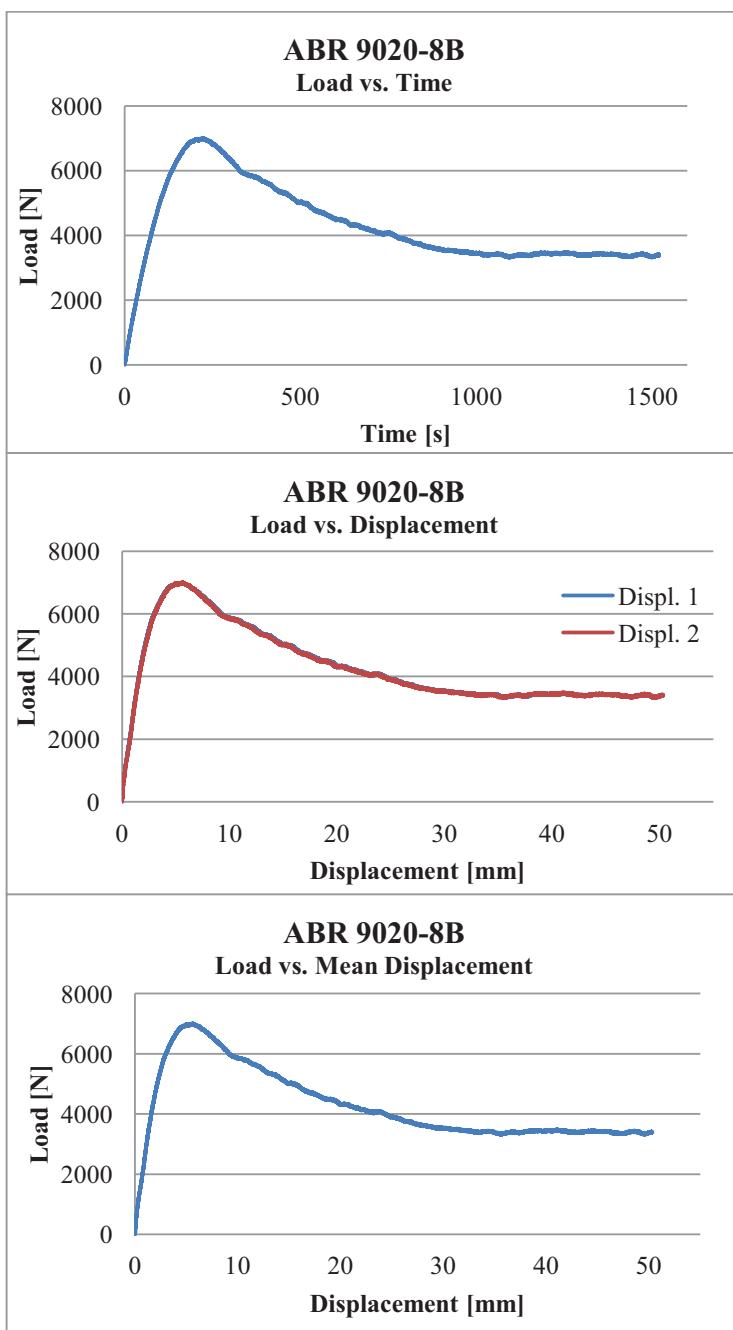
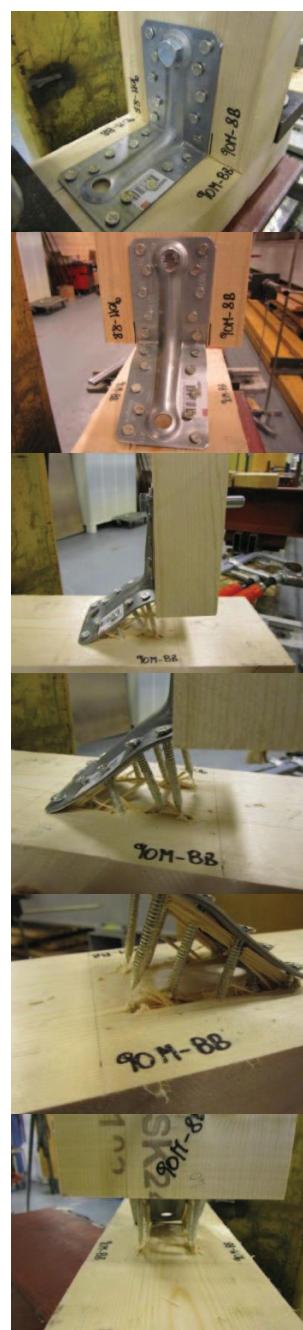
Failure	2
Failure load [N]	7010
Displacement 1 [mm]	5.61
Displacement 2 [mm]	5.63
Mean Displacement [mm]	5.62
Moisture [%]	9.67
Density [kg/m ³]	442

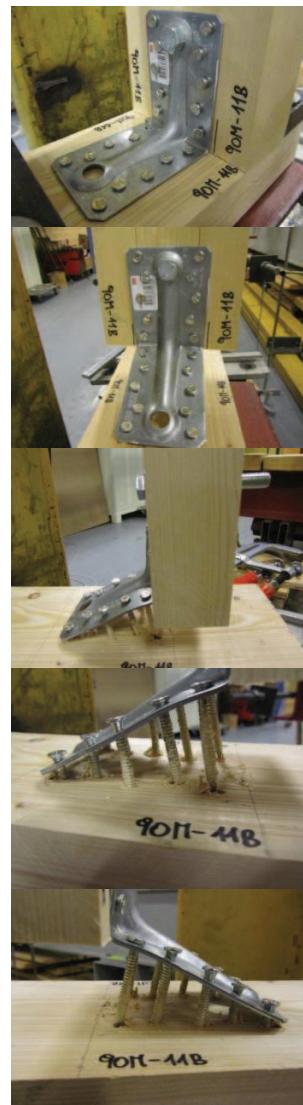
Failure	2
Failure load [N]	4308
Displacement 1 [mm]	-
Displacement 2 [mm]	5.34
Mean Displacement [mm]	-
Moisture [%]	10.8
Density [kg/m ³]	436

The LVDT number 1 did not work.

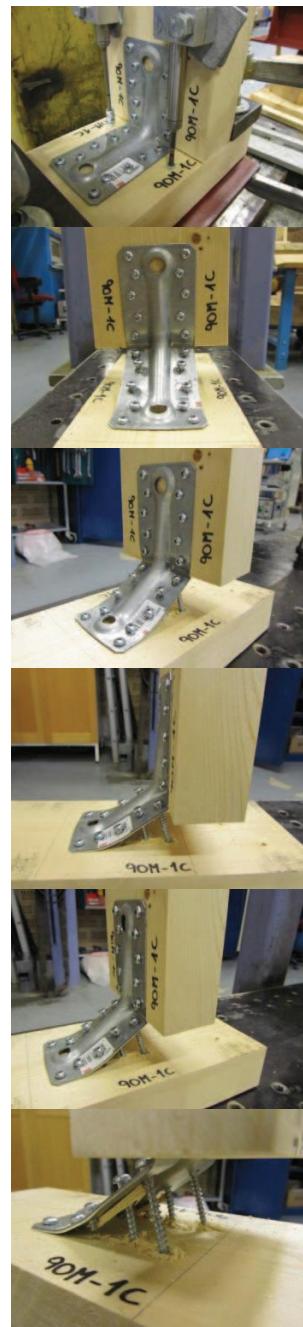
Failure	2
Failure load [N]	4881
Displacement 1 [mm]	5.09
Displacement 2 [mm]	5.16
Mean Displacement [mm]	5.12
Moisture [%]	8.85
Density [kg/m ³]	386

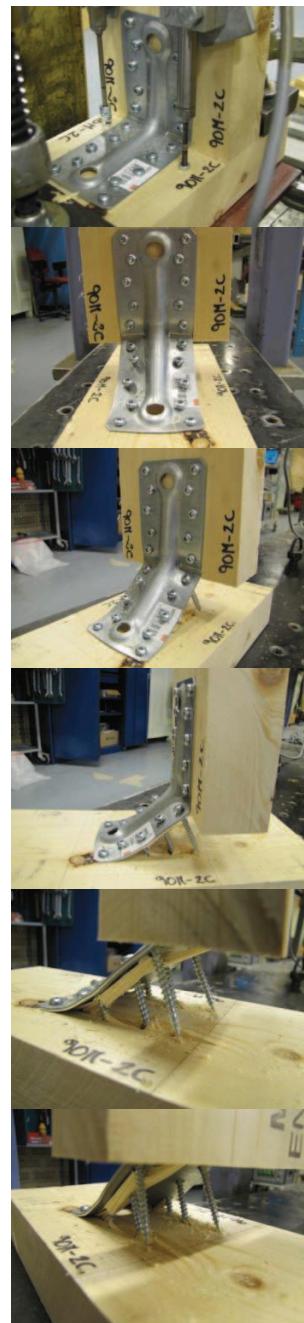
Failure	2
Failure load [N]	10845
Displacement 1 [mm]	4.44
Displacement 2 [mm]	4.33
Mean Displacement [mm]	4.39
Moisture [%]	9.24
Density [kg/m ³]	400

By mistake the rate of this test was 5 mm/min instead 2 mm/min.

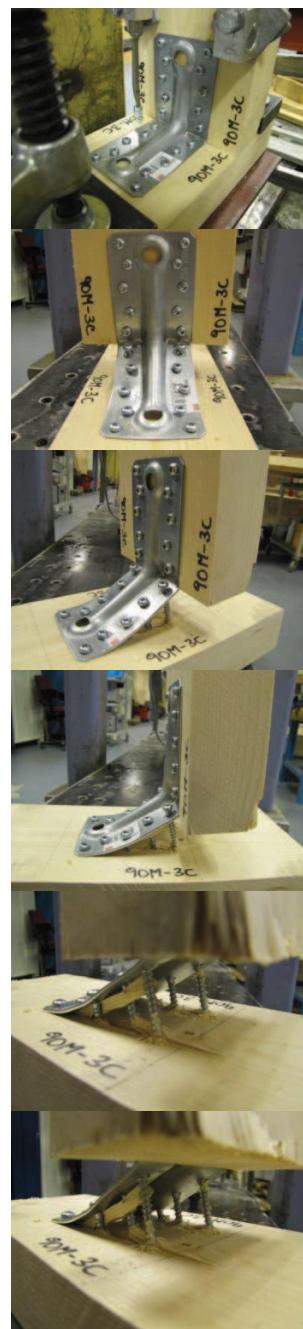
Failure	2
Failure load [N]	12804
Displacement 1 [mm]	4.17
Displacement 2 [mm]	5.37
Mean Displacement [mm]	4.77
Moisture [%]	8.23
Density [kg/m ³]	441

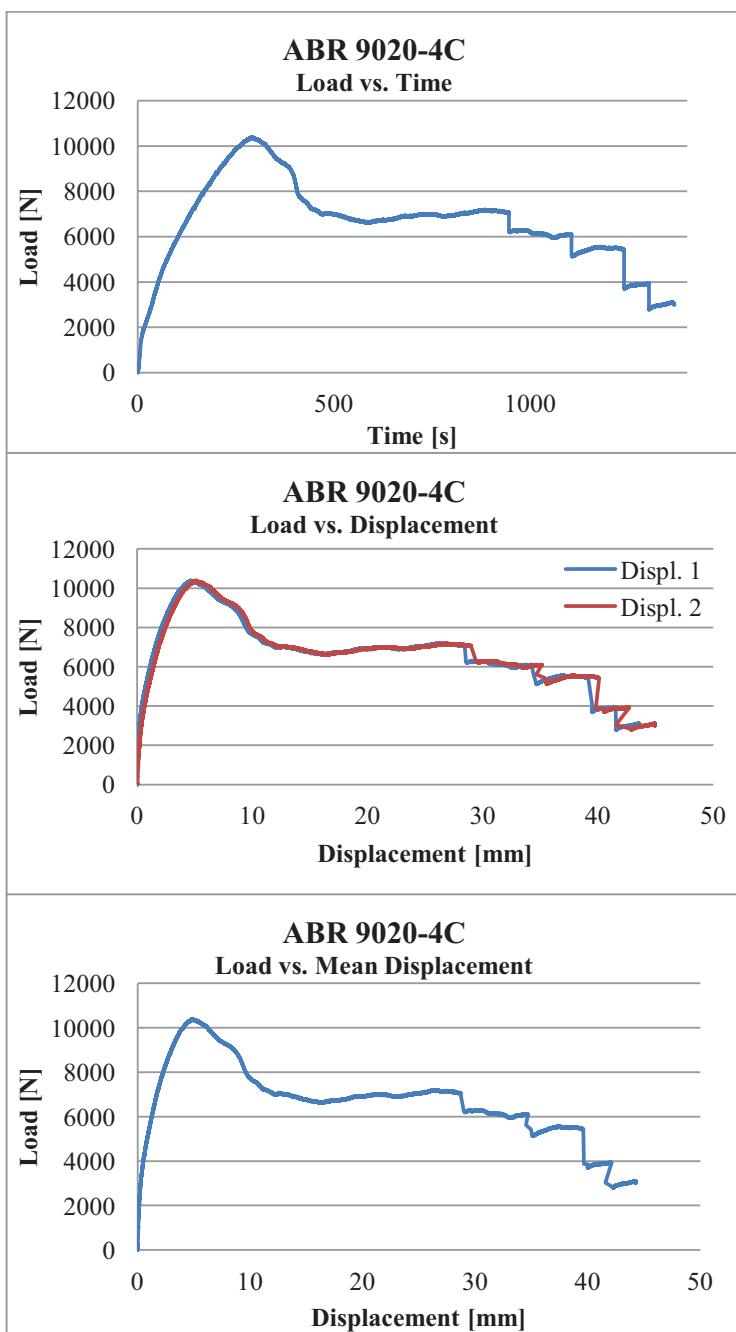
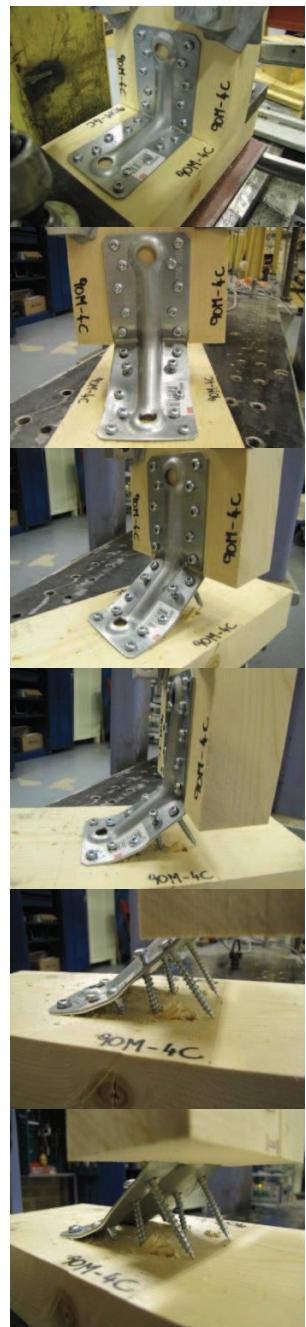
Failure	2
Failure load [N]	10397
Displacement 1 [mm]	-
Displacement 2 [mm]	4.30
Mean Displacement [mm]	-
Moisture [%]	8.94
Density [kg/m ³]	377

The LVDT number 1 did not work.

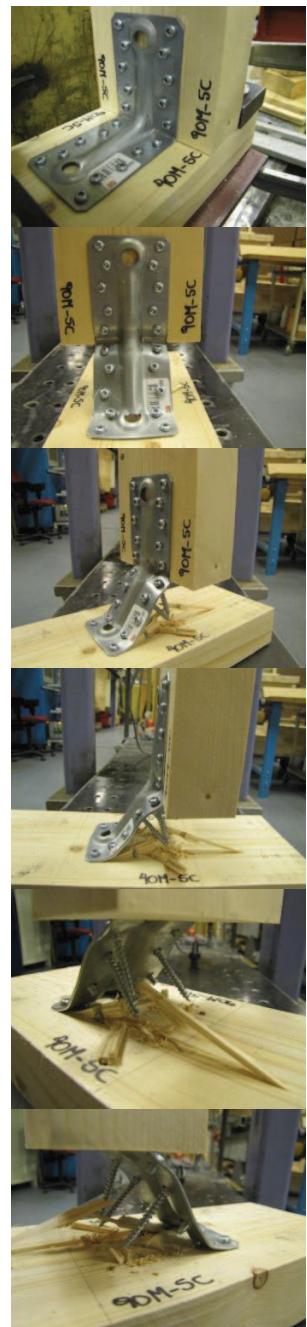
Failure	2
Failure load [N]	10396
Displacement 1 [mm]	4.67
Displacement 2 [mm]	5.09
Mean Displacement [mm]	4.88
Moisture [%]	8.41
Density [kg/m ³]	3.74

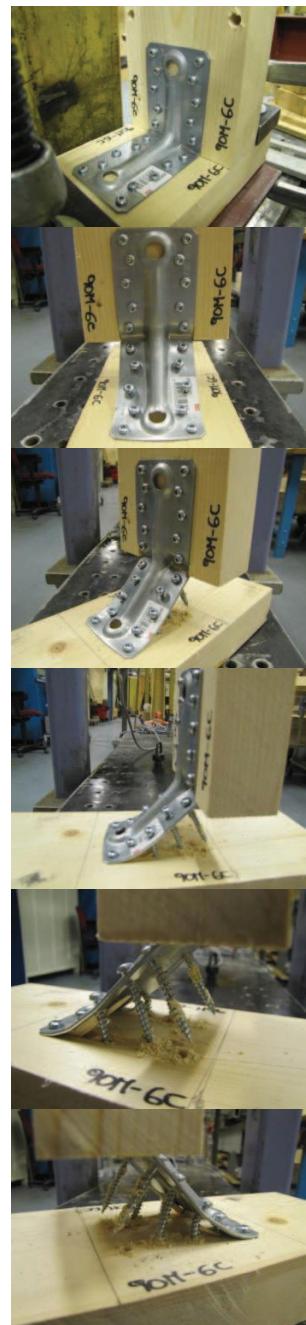
Failure	2
Failure load [N]	9834
Displacement 1 [mm]	3.50
Displacement 2 [mm]	3.44
Mean Displacement [mm]	3.47
Moisture [%]	8.97
Density [kg/m ³]	398
