Experimental Testing of Hold Down Devices for Timber Frame Shear Walls

Giuseppe Caprolu

ISSN: 1402-1536
ISBN 978-91-7439-386-6

Luleå 2012

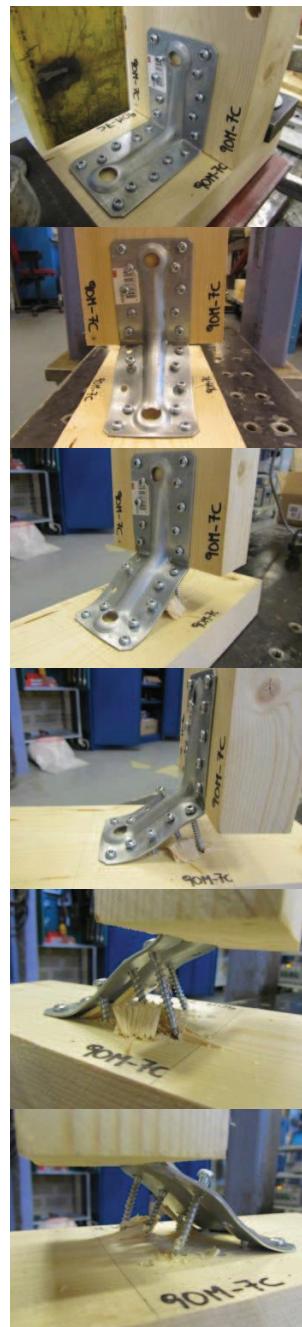
Failure	2
Failure load [N]	11560
Displacement 1 [mm]	6.29
Displacement 2 [mm]	6.05
Mean Displacement [mm]	6.17
Moisture [%]	8.60
Density [kg/m ³]	481

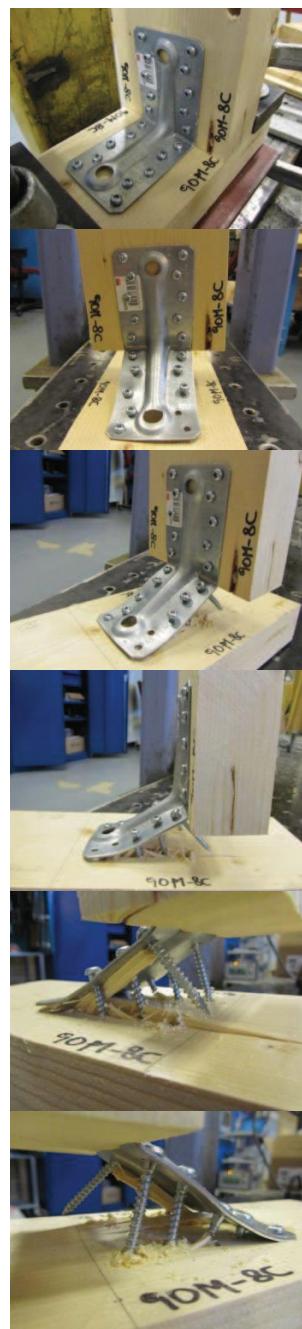
Failure	2
Failure load [N]	8643
Displacement 1 [mm]	2.17
Displacement 2 [mm]	2.76
Mean Displacement [mm]	2.47
Moisture [%]	8.80
Density [kg/m ³]	367

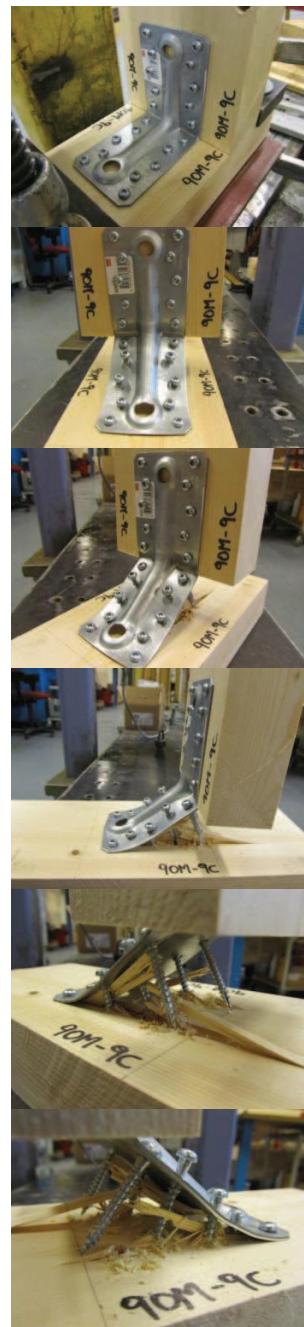
Failure	2
Failure load [N]	9088
Displacement 1 [mm]	4.09
Displacement 2 [mm]	5.36
Mean Displacement [mm]	4.73
Moisture [%]	9.51
Density [kg/m ³]	372

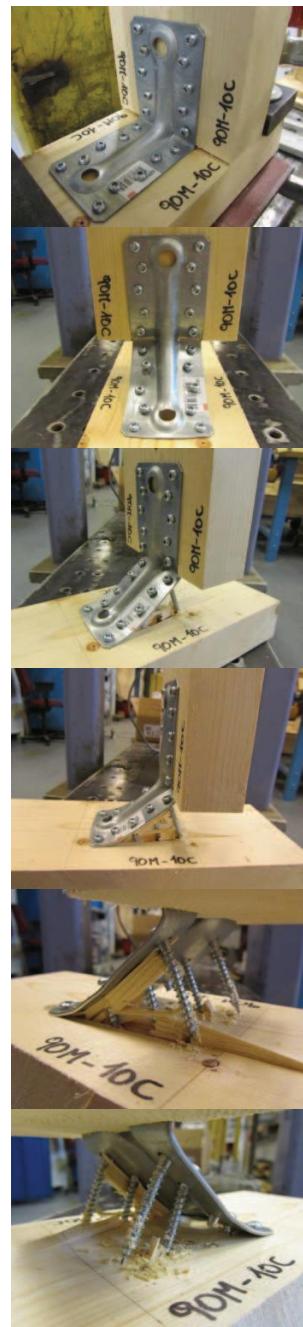
Failure	2
Failure load [N]	11508
Displacement 1 [mm]	4.72
Displacement 2 [mm]	5.03
Mean Displacement [mm]	4.88
Moisture [%]	10.2
Density [kg/m ³]	467

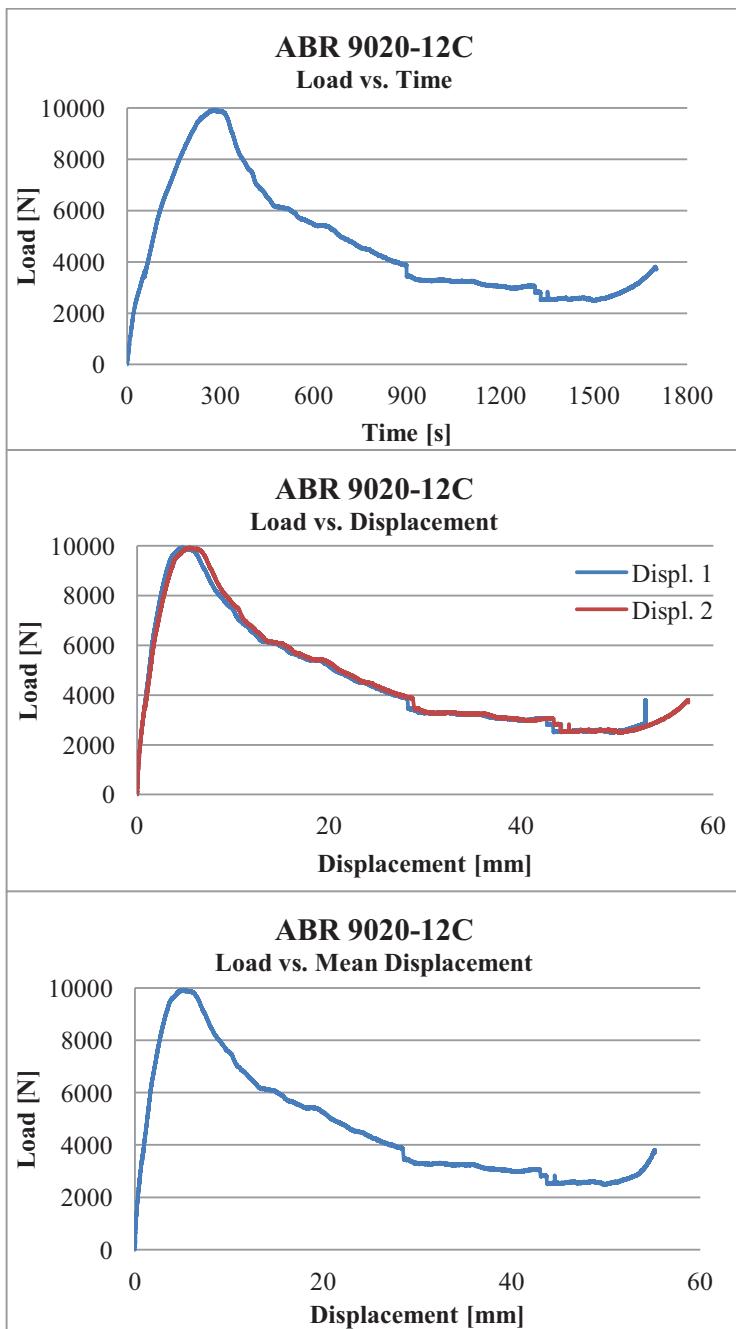
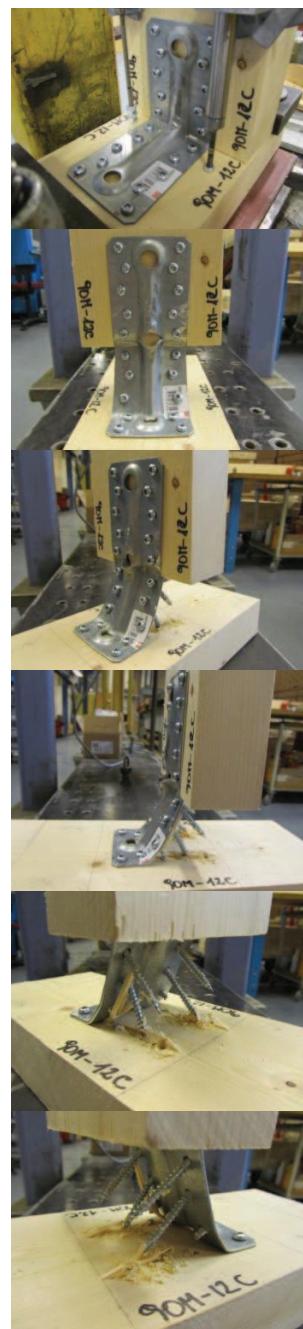
Failure	2
Failure load [N]	9994
Displacement 1 [mm]	5.55
Displacement 2 [mm]	4.48
Mean Displacement [mm]	5.01
Moisture [%]	8.77
Density [kg/m ³]	410

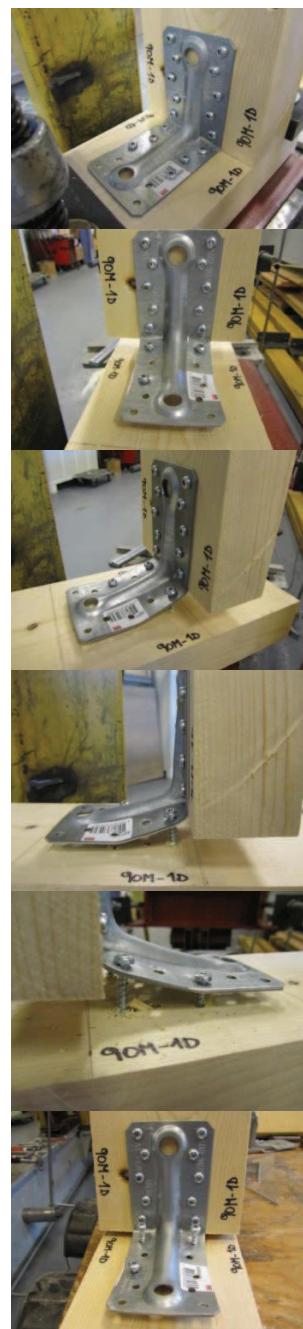
Failure	2
Failure load [N]	9938
Displacement 1 [mm]	4.77
Displacement 2 [mm]	5.49
Mean Displacement [mm]	5.13
Moisture [%]	9.67
Density [kg/m ³]	413

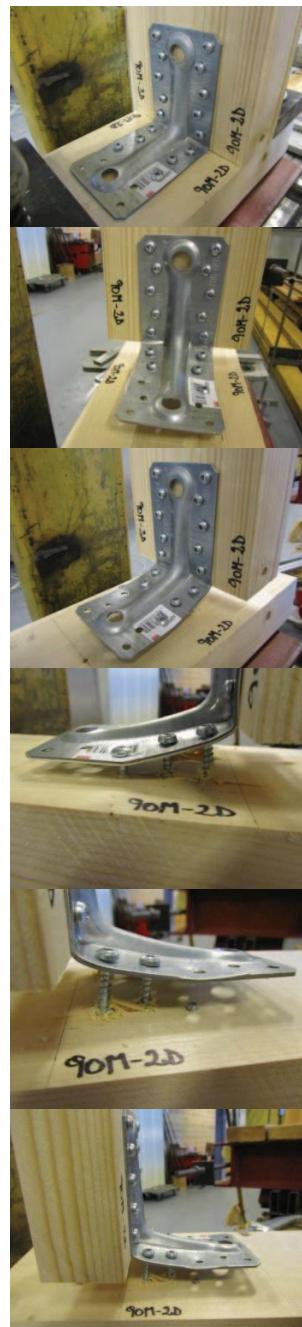
Failure	2
Failure load [N]	12458
Displacement 1 [mm]	5.74
Displacement 2 [mm]	7.07
Mean Displacement [mm]	6.41
Moisture [%]	10.6
Density [kg/m ³]	480

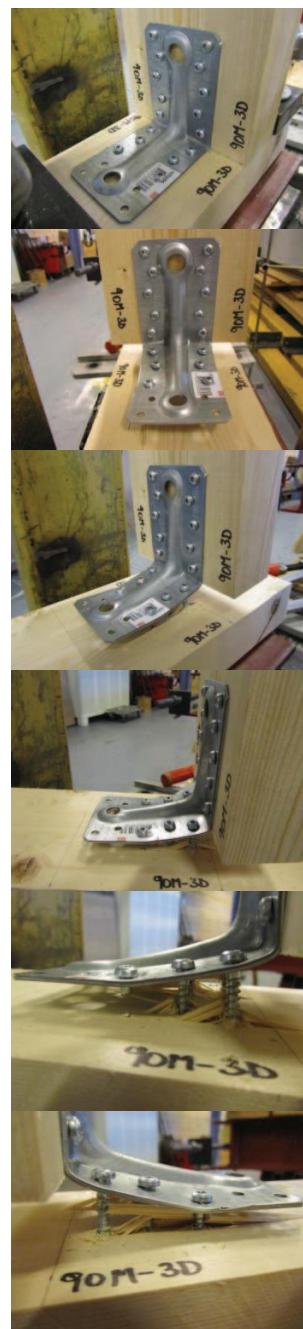
Failure	2
Failure load [N]	11958
Displacement 1 [mm]	-
Displacement 2 [mm]	7.51
Mean Displacement [mm]	-
Moisture [%]	9.36
Density [kg/m ³]	466

The LVDT number 1 did not work.

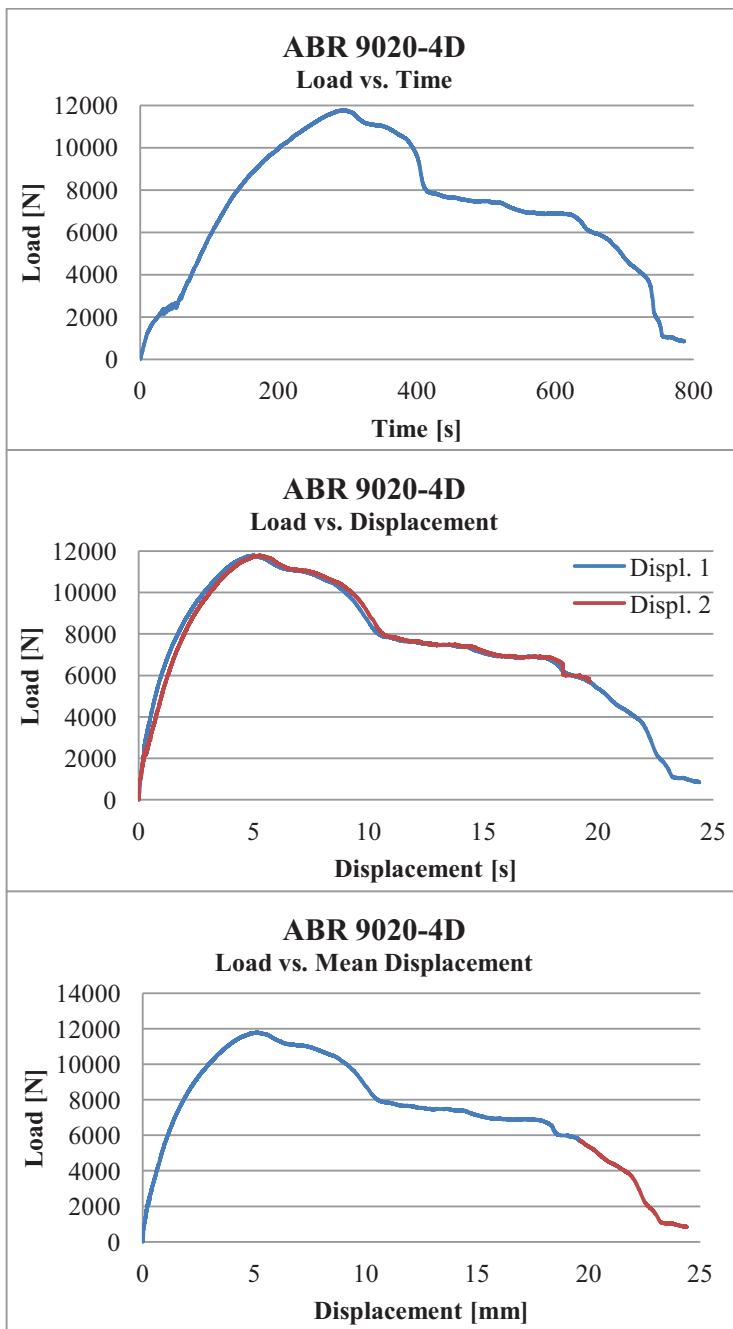
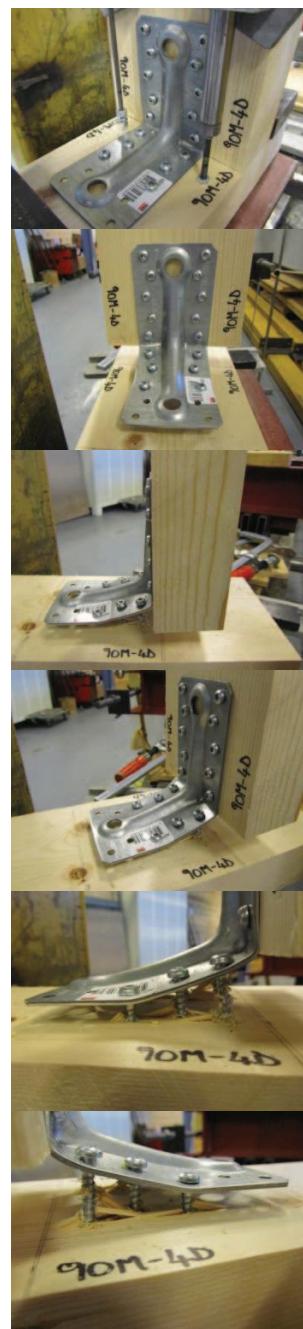
Failure	2
Failure load [N]	11453
Displacement 1 [mm]	4.75
Displacement 2 [mm]	5.20
Mean Displacement [mm]	4.97
Moisture [%]	9.36
Density [kg/m ³]	477

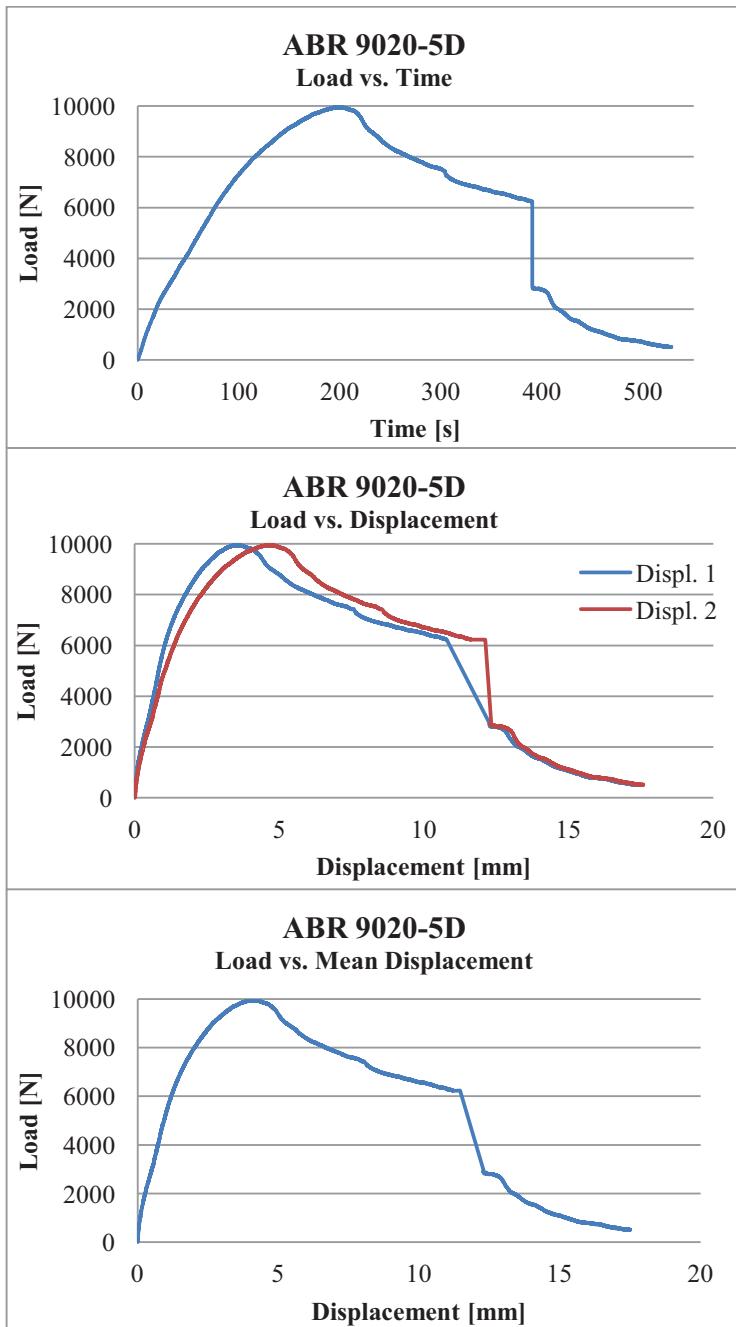
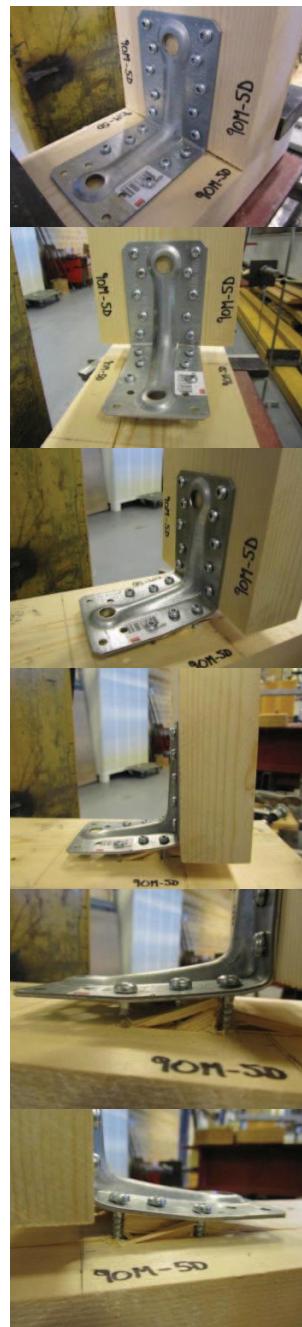
Failure	2
Failure load [N]	9955
Displacement 1 [mm]	3.60
Displacement 2 [mm]	4.73
Mean Displacement [mm]	4.17
Moisture [%]	7.64
Density [kg/m ³]	413

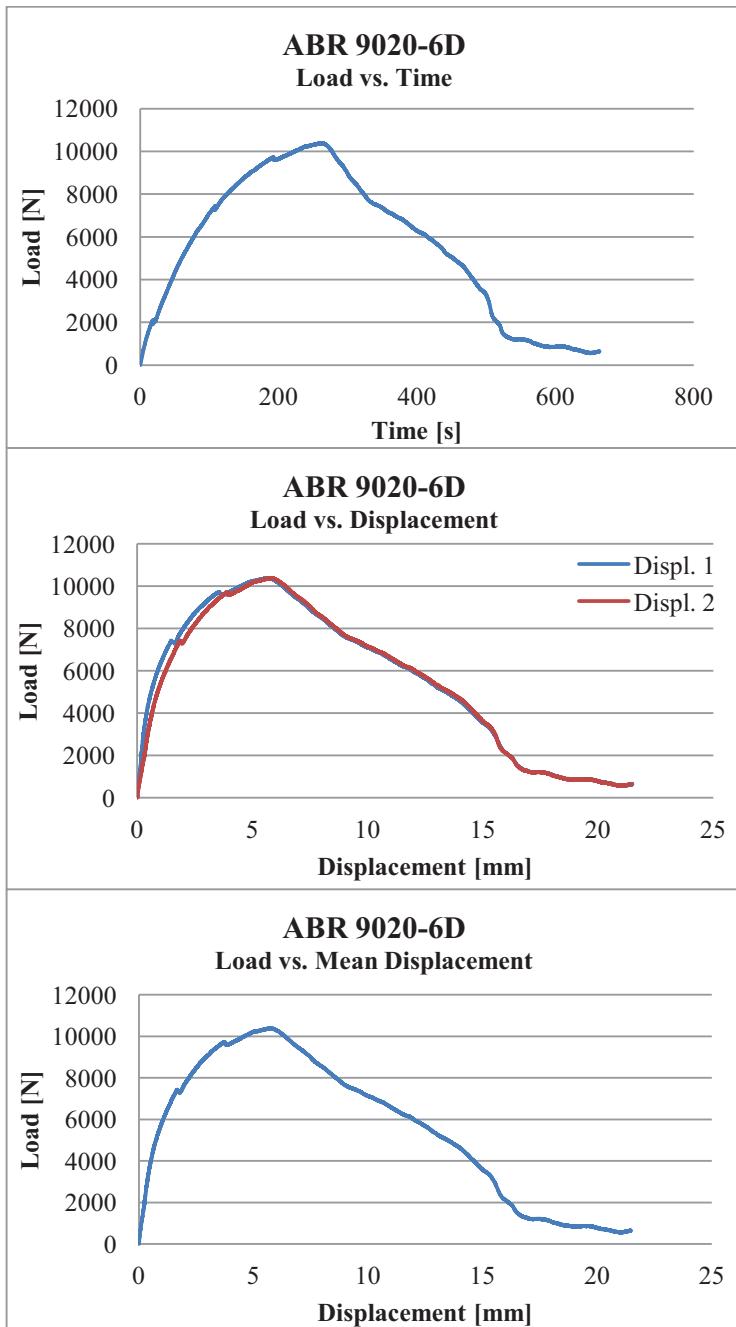
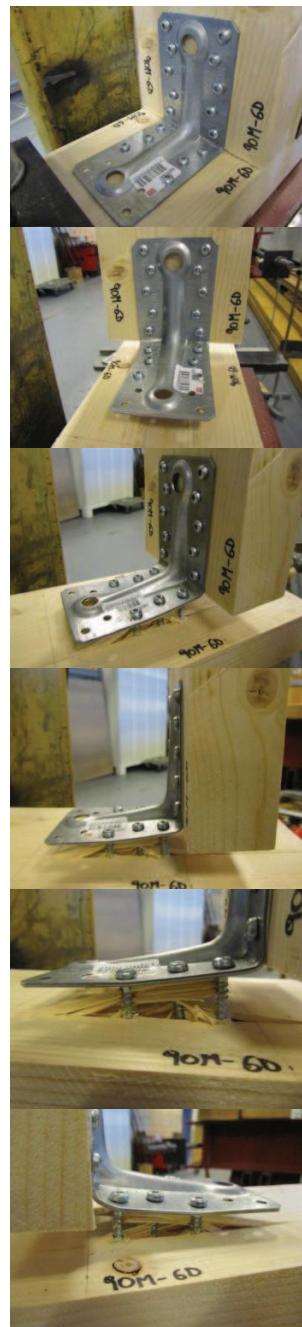
Failure	2
Failure load [N]	10388
Displacement 1 [mm]	5.65
Displacement 2 [mm]	5.77
Mean Displacement [mm]	5.71
Moisture [%]	11.0
Density [kg/m ³]	407

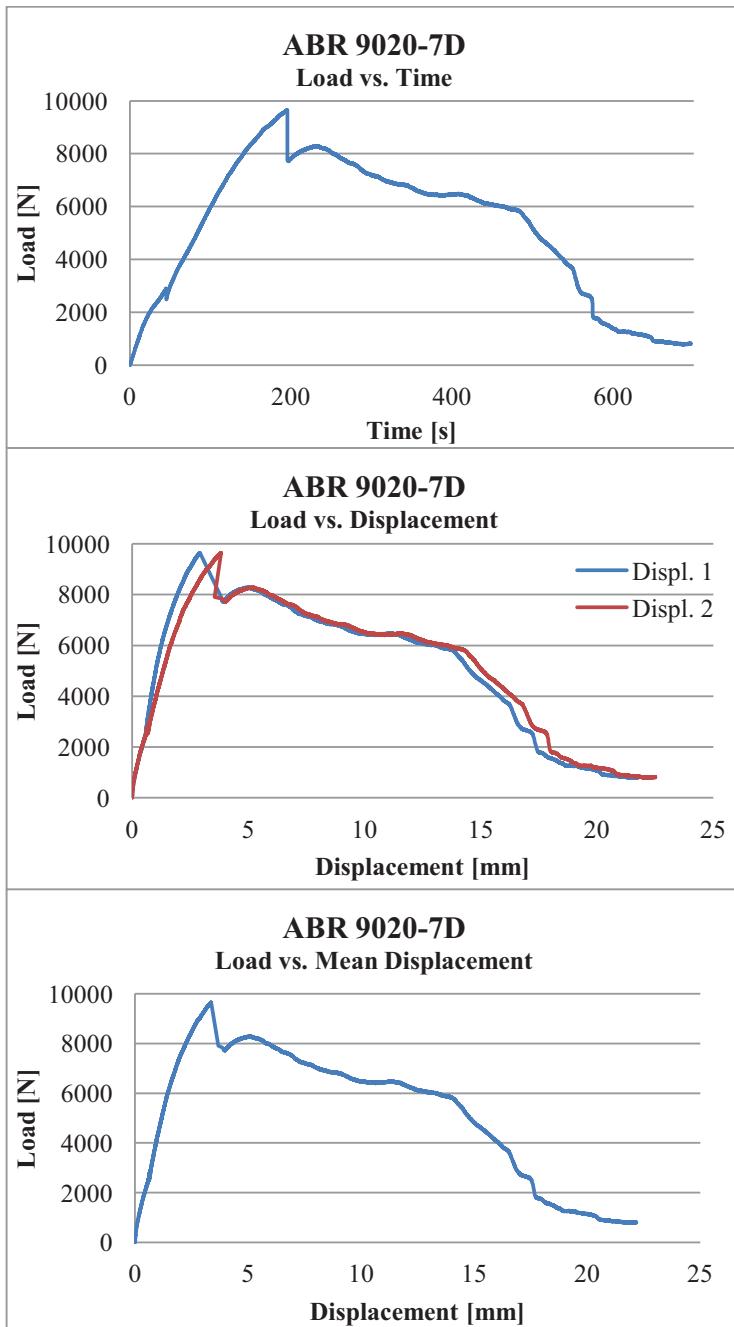
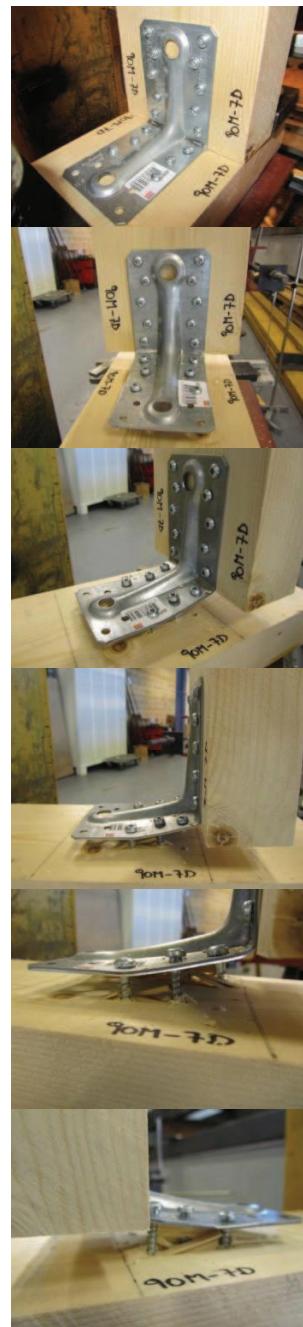
Failure	2
Failure load [N]	9650
Displacement 1 [mm]	2.92
Displacement 2 [mm]	3.83
Mean Displacement [mm]	3.37
Moisture [%]	7.54
Density [kg/m ³]	402

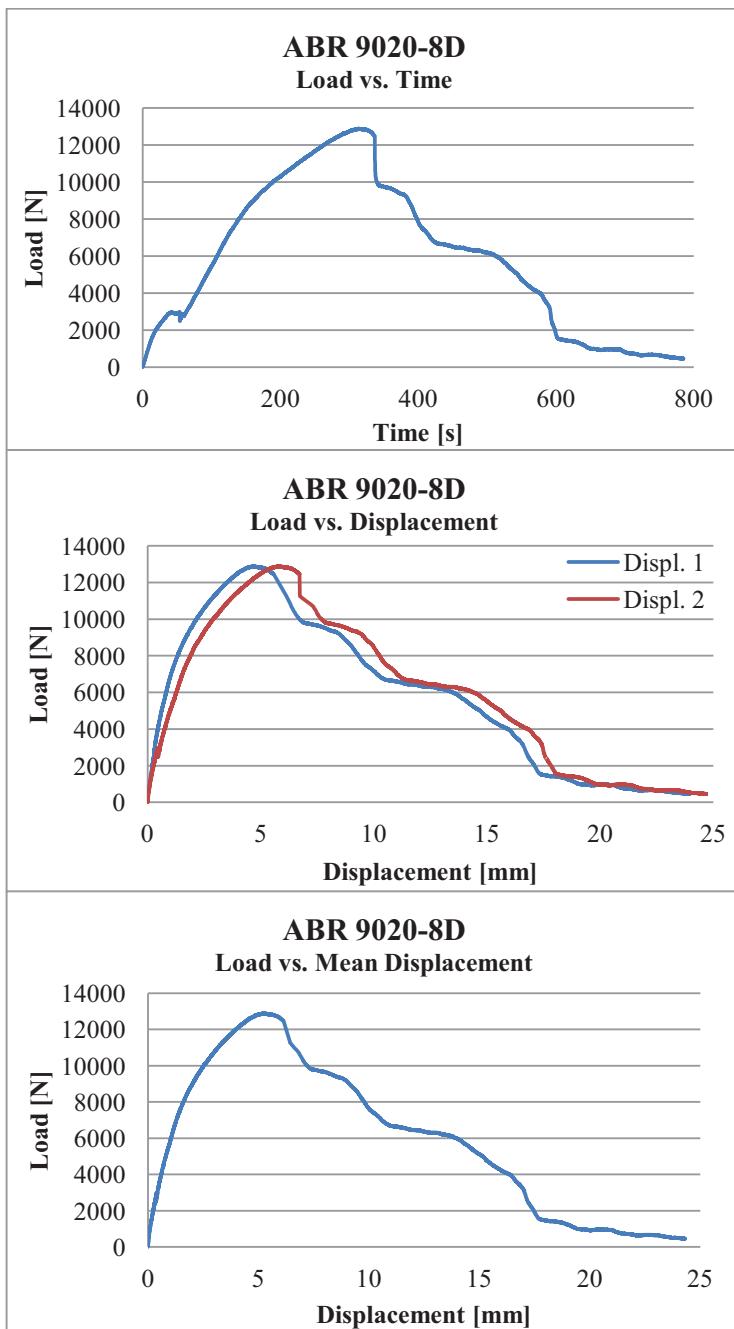
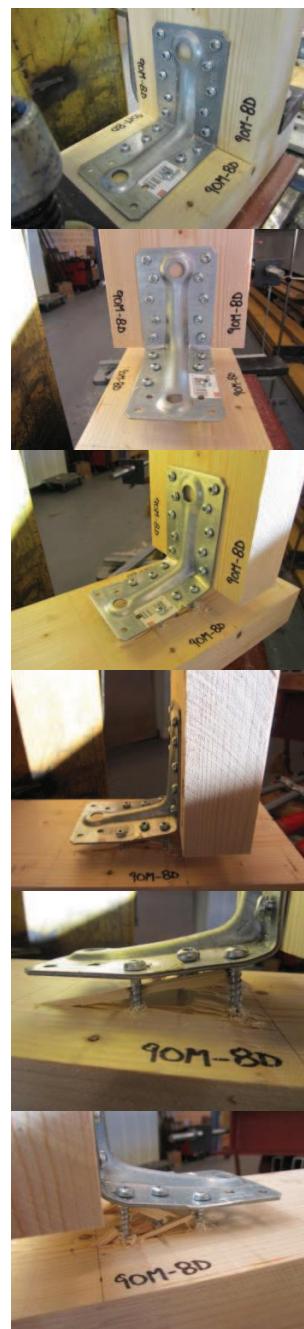
Failure	2
Failure load [N]	12886
Displacement 1 [mm]	4.66
Displacement 2 [mm]	5.79
Mean Displacement [mm]	5.23
Moisture [%]	8.11
Density [kg/m ³]	404

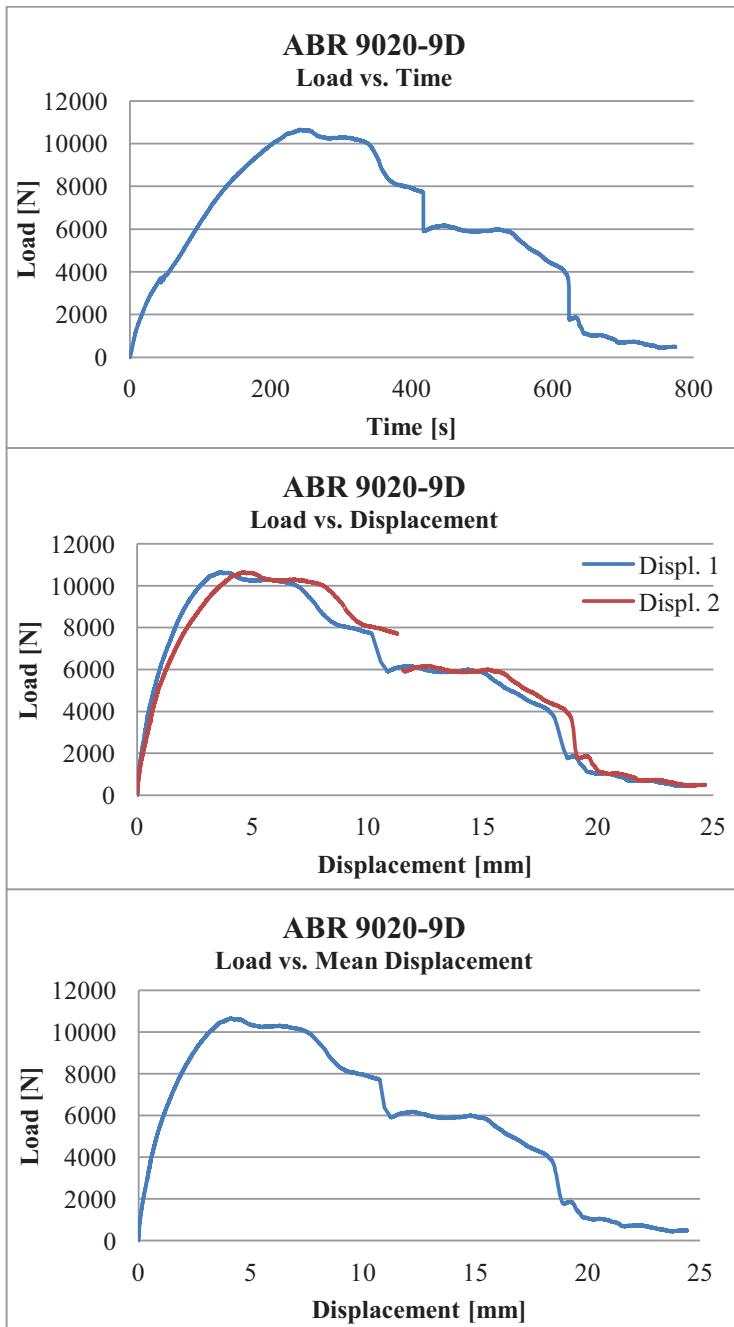
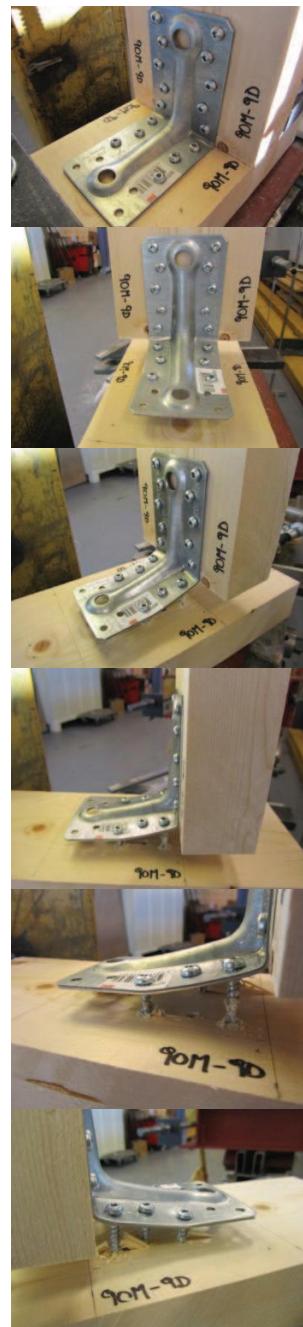
Failure	2
Failure load [N]	10650
Displacement 1 [mm]	3.58
Displacement 2 [mm]	4.58
Mean Displacement [mm]	4.08
Moisture [%]	8.97
Density [kg/m ³]	465

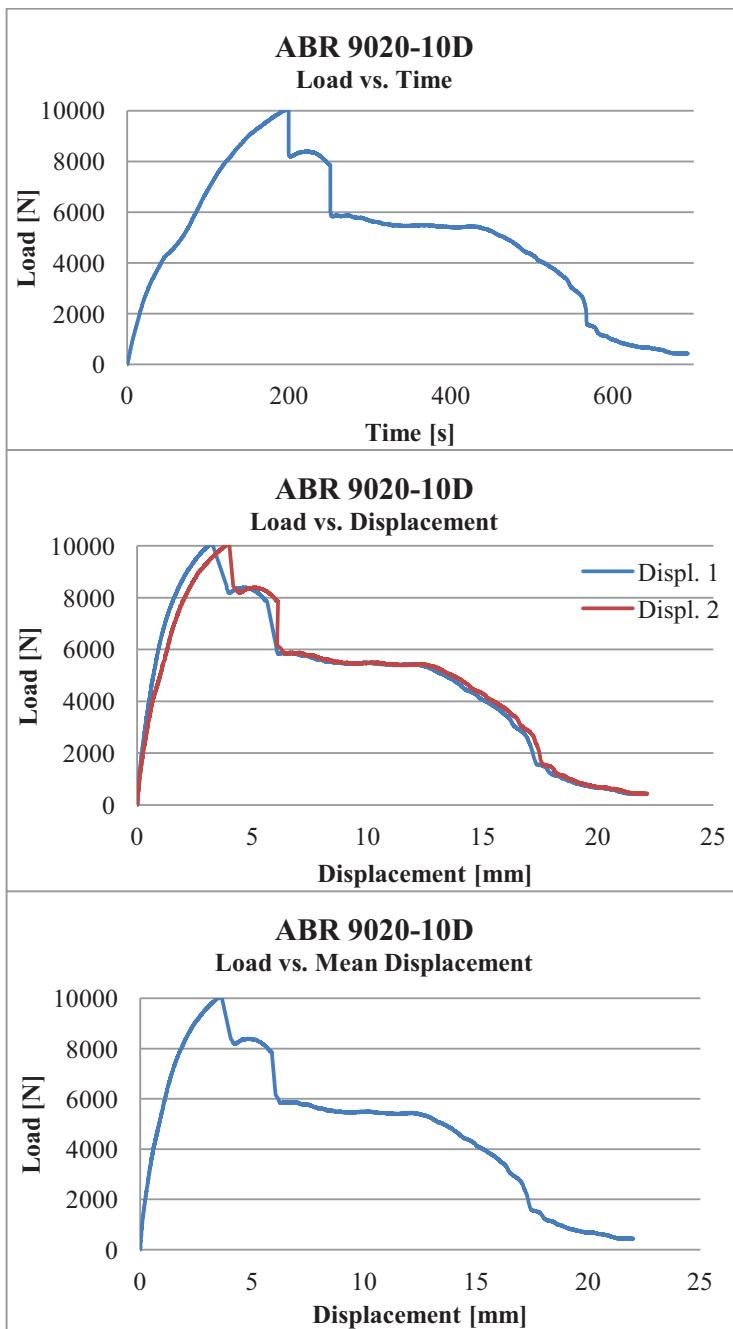
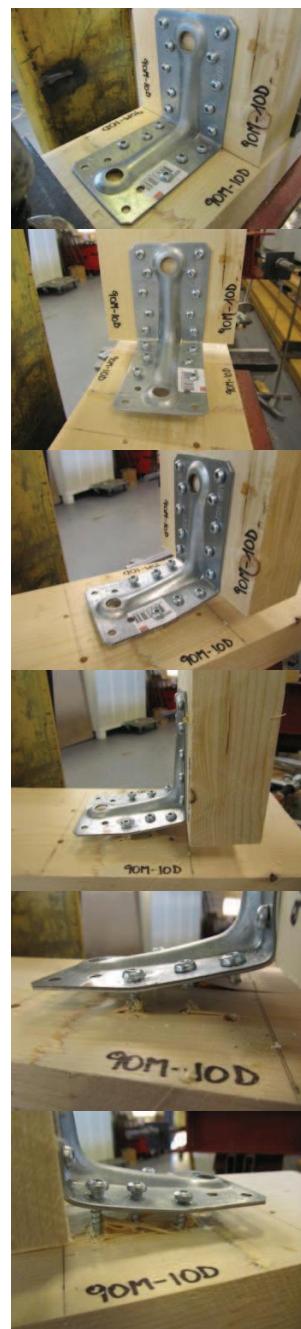
Failure	2
Failure load [N]	10096
Displacement 1 [mm]	3.25
Displacement 2 [mm]	4.00
Mean Displacement [mm]	3.62
Moisture [%]	9.08
Density [kg/m ³]	406

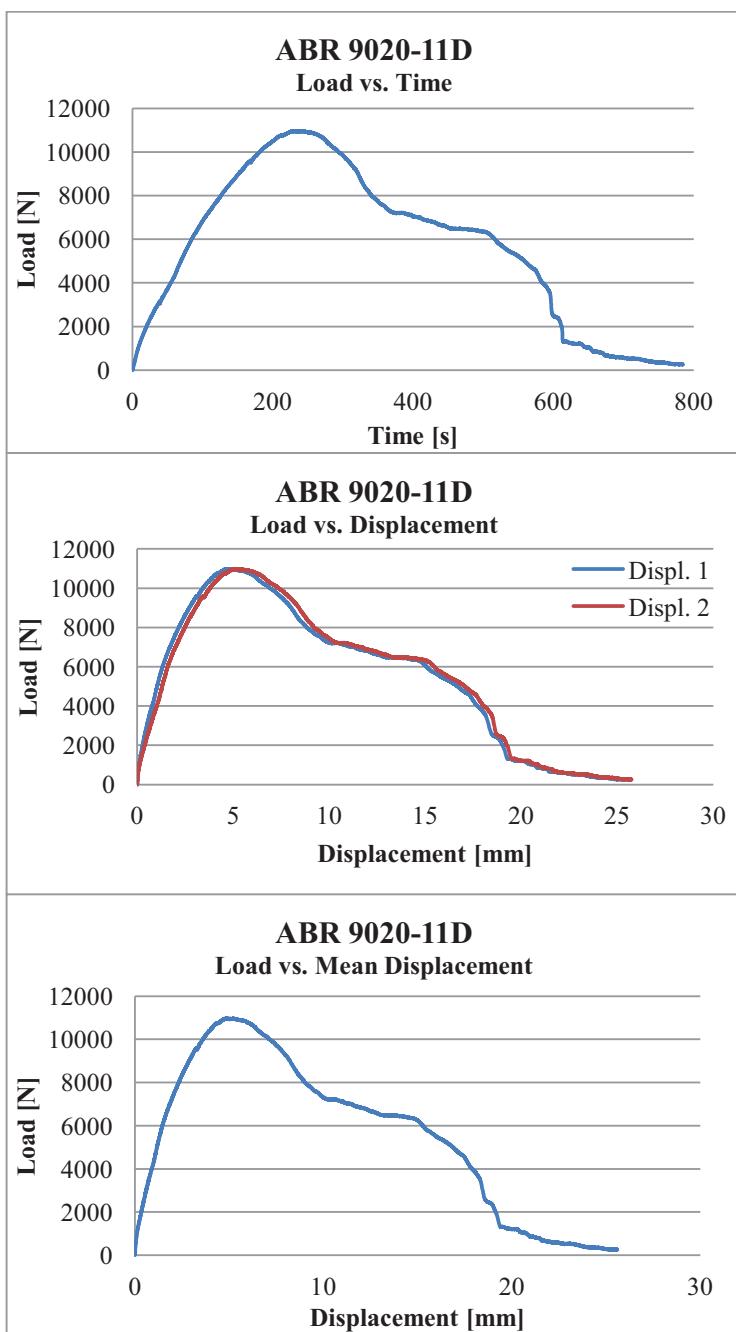
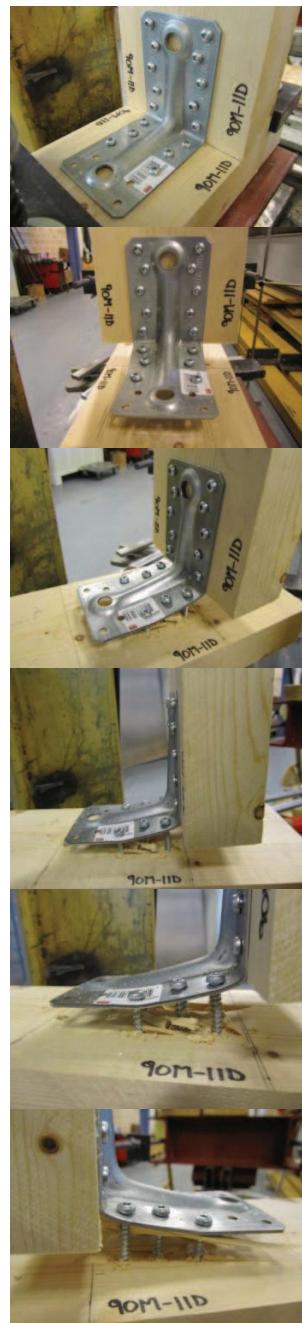
Failure	2
Failure load [N]	10967
Displacement 1 [mm]	4.65
Displacement 2 [mm]	5.03
Mean Displacement [mm]	4.84
Moisture [%]	9.78
Density [kg/m ³]	430

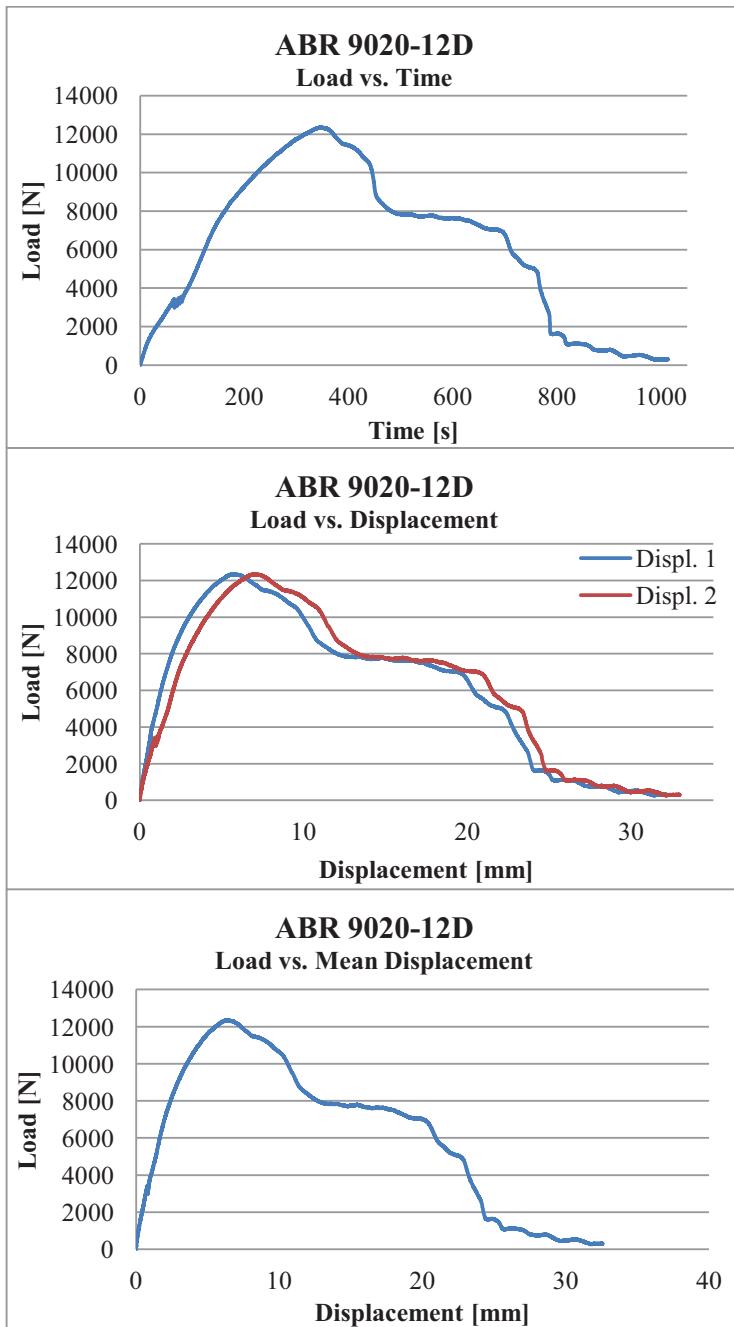
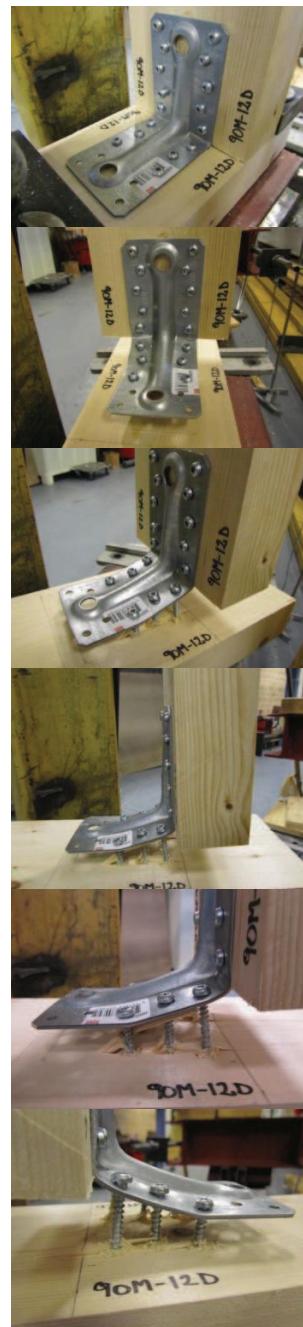
Failure	2
Failure load [N]	12363
Displacement 1 [mm]	5.74
Displacement 2 [mm]	7.02
Mean Displacement [mm]	6.38
Moisture [%]	8.54
Density [kg/m ³]	496

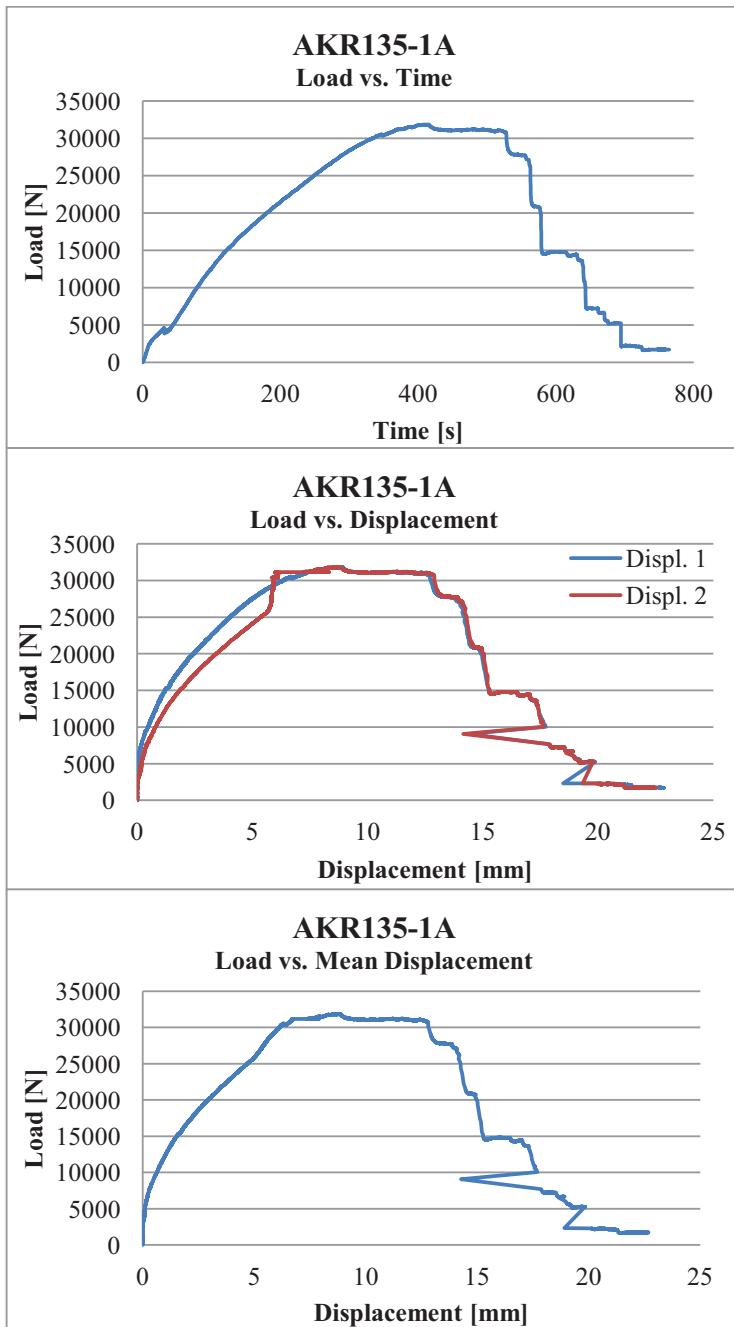
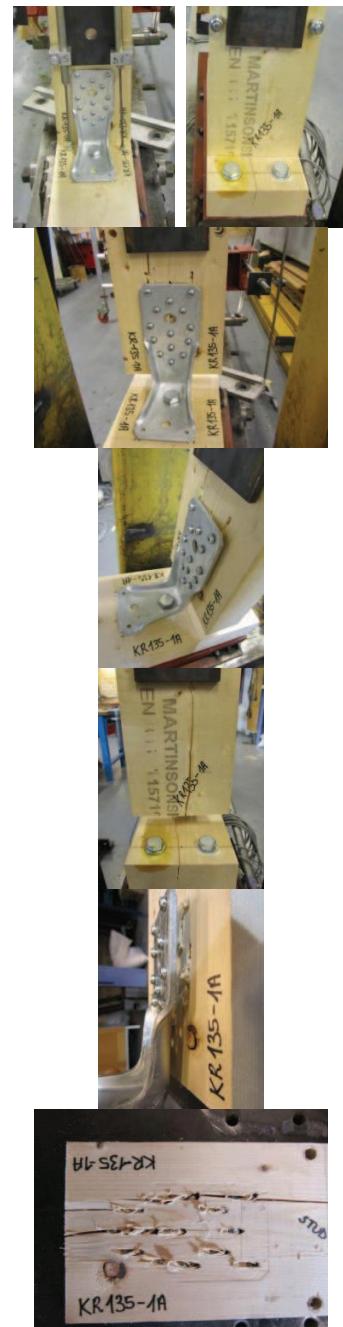
Series 3 – Angle connector AKR 135

Set 1 – 14 wooden screws 5x40 on the stud and 1 bolt M12 on the rail

Failure	3a
Failure load [N]	31836
Displacement 1 [mm]	8.86
Displacement 2 [mm]	8.76
Mean Displacement [mm]	8.81
Moisture [%]	9.97
Density [kg/m ³]	405

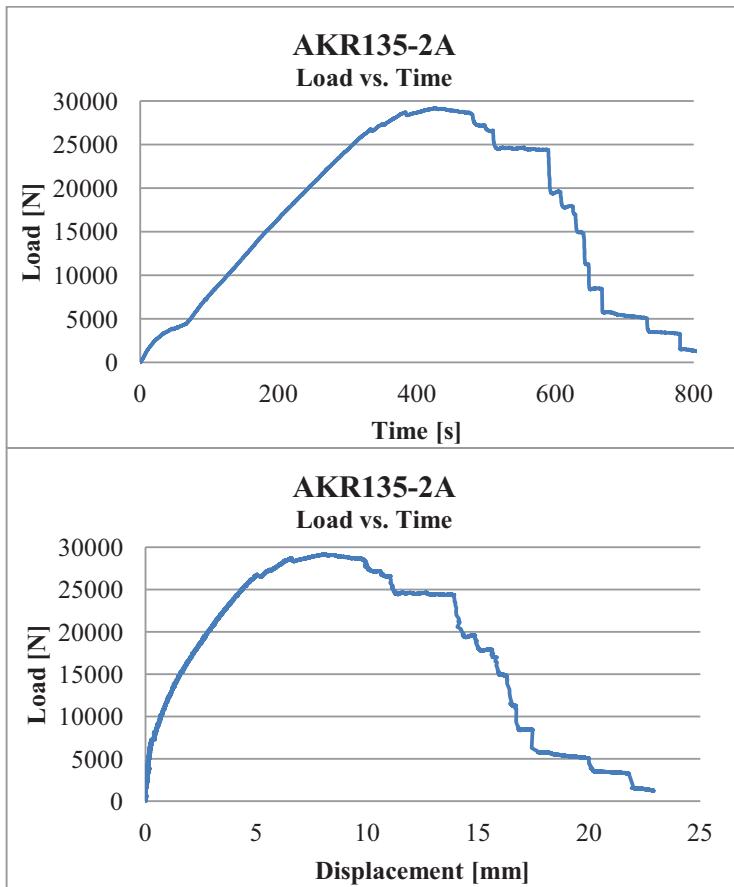
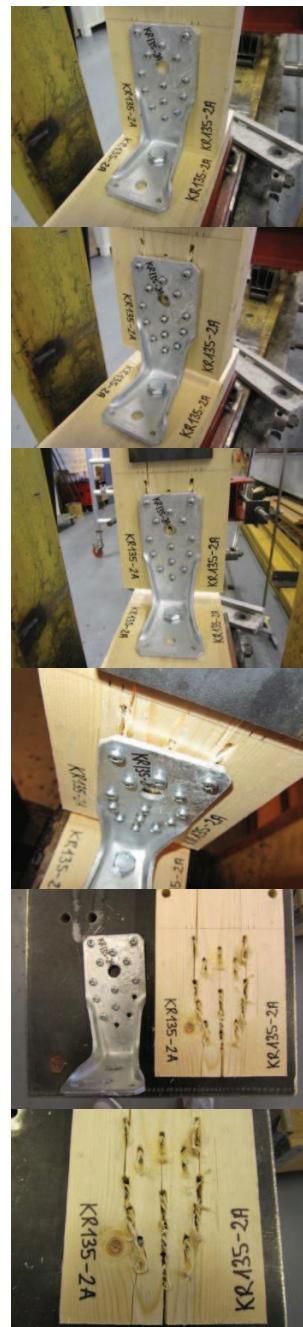
Failure	3a
Failure load [N]	29185
Displacement 1 [mm]	-
Displacement 2 [mm]	8.02
Mean Displacement [mm]	-
Moisture [%]	9.45
Density [kg/m ³]	410

The LVDT number 1 did not work.

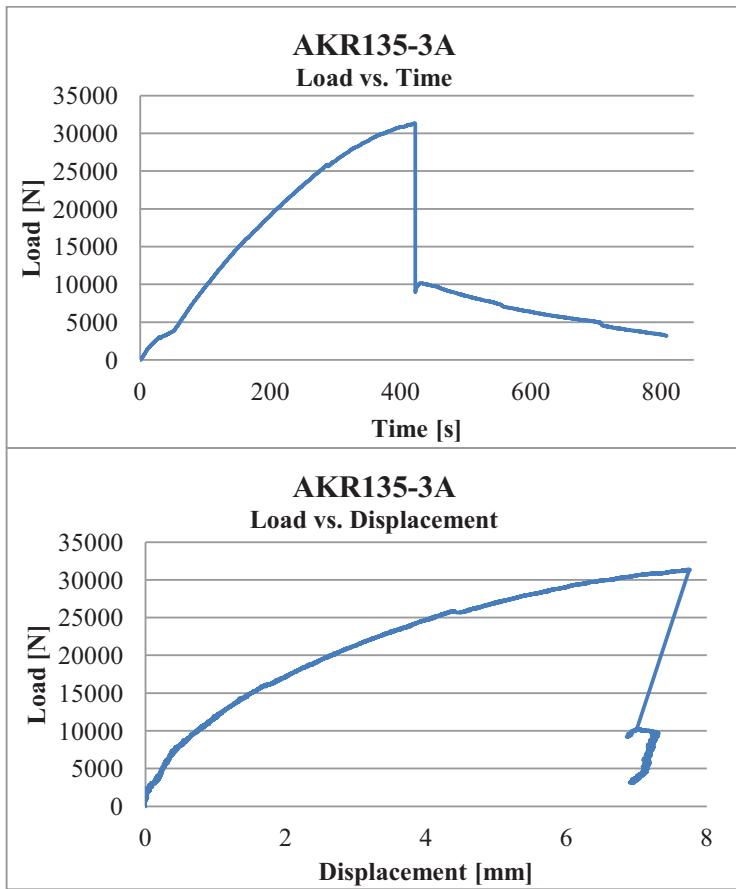
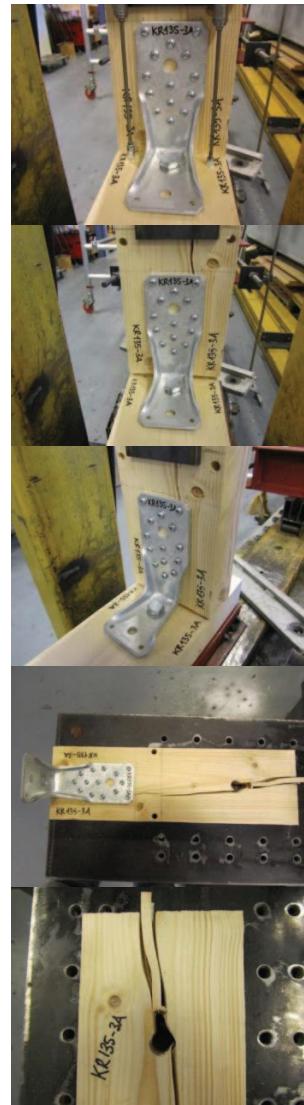
Failure	3b
Failure load [N]	31339
Displacement 1 [mm]	-
Displacement 2 [mm]	7.74
Mean Displacement [mm]	-
Moisture [%]	-
Density [kg/m ³]	392

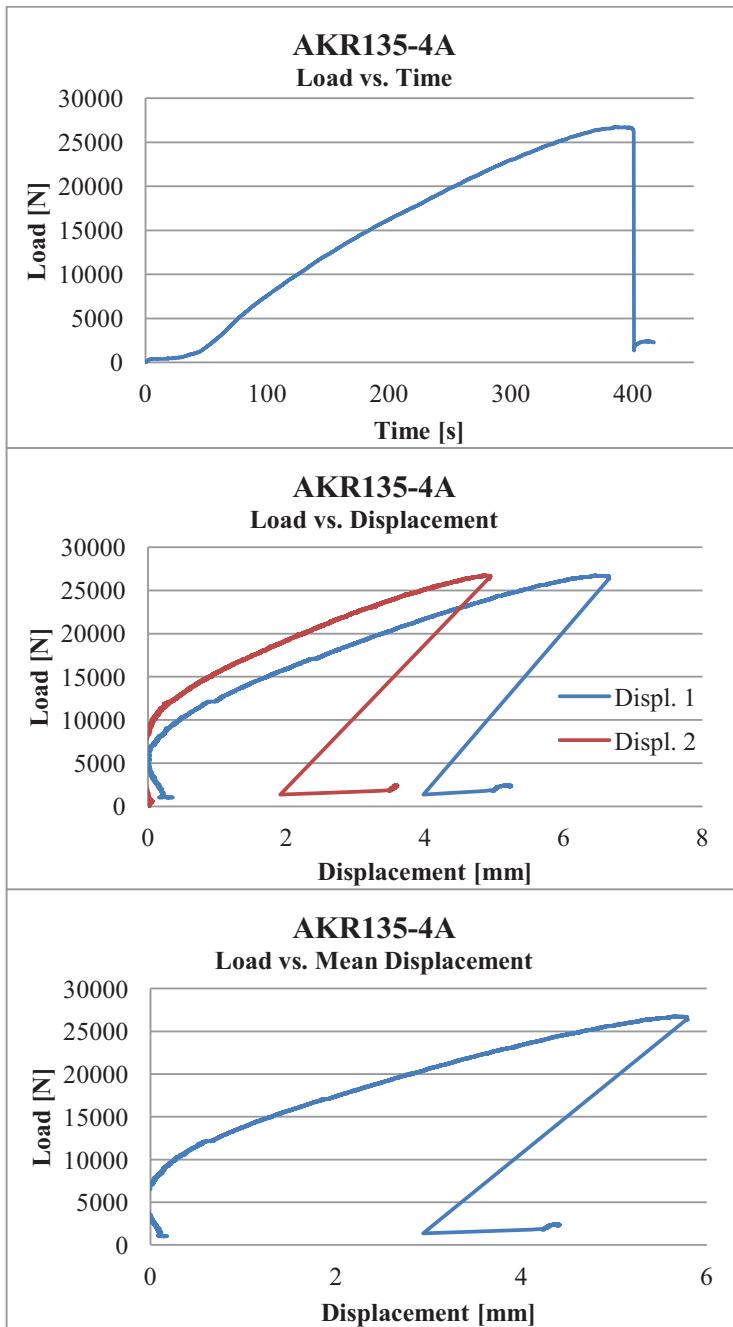
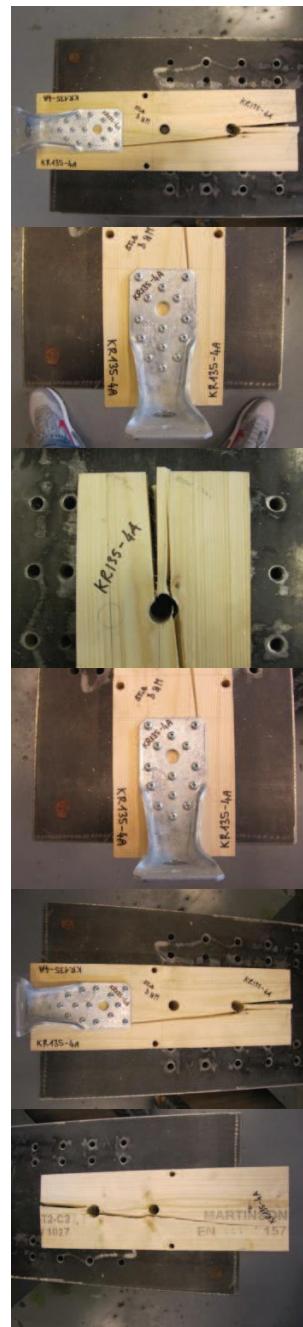
Failure	3b
Failure load [N]	26732
Displacement 1 [mm]	6.45
Displacement 2 [mm]	4.84
Mean Displacement [mm]	5.65
Moisture [%]	10.5
Density [kg/m ³]	378
