Experimental Testing of Hold Down Devices for Timber Frame Shear Walls

Giuseppe Caprolu

ISSN: 1402-1536
ISBN 978-91-7439-386-6

Luleå 2012

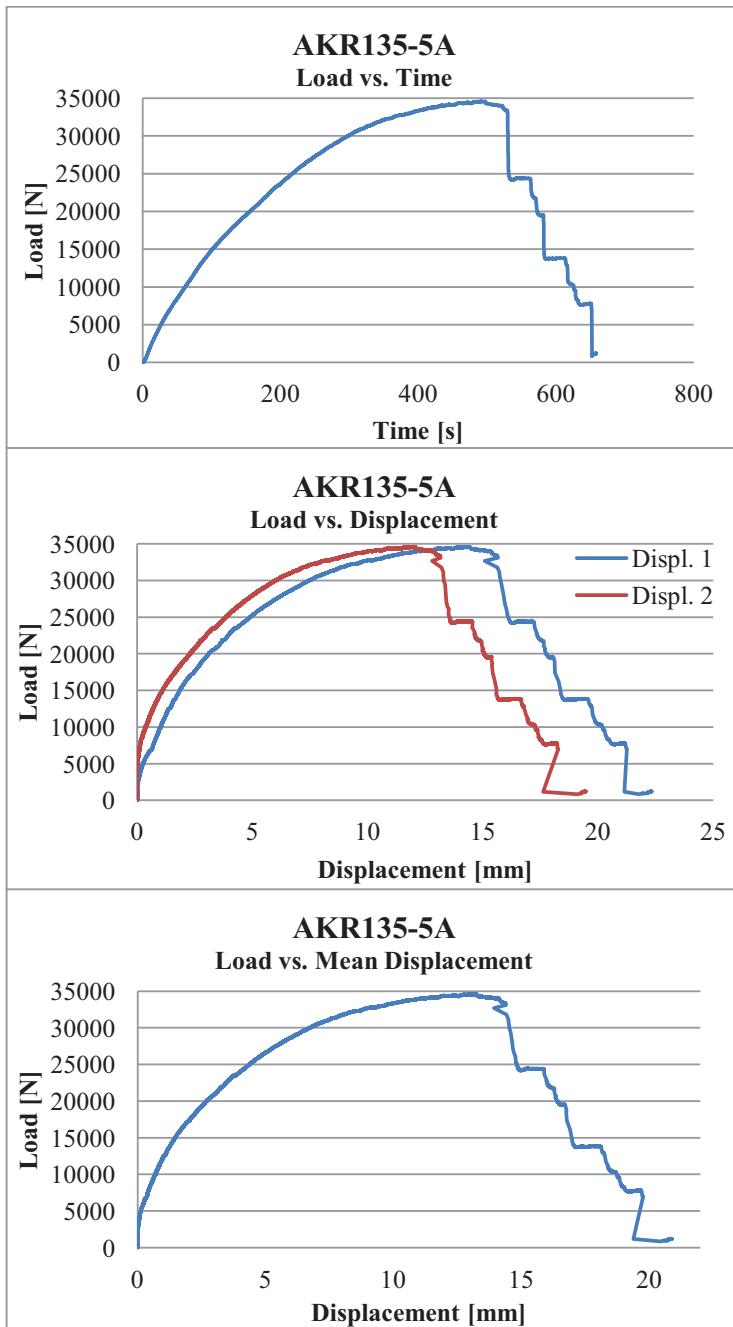
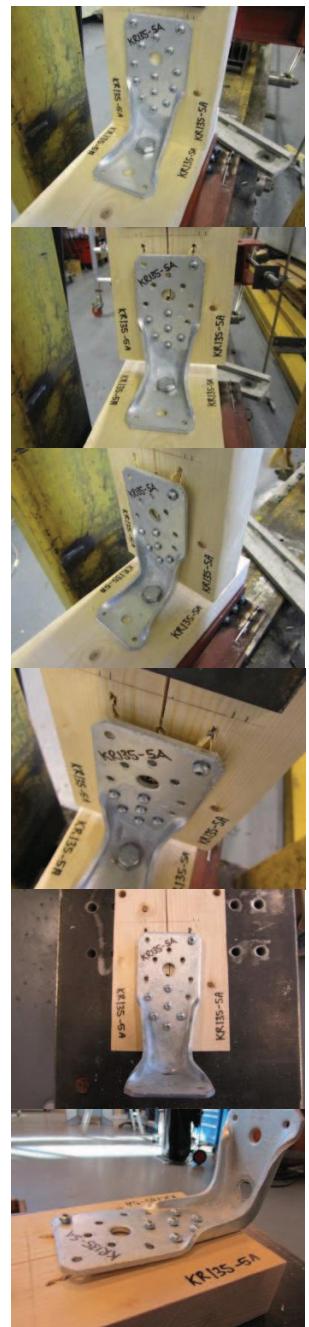
Failure	3a
Failure load [N]	34586
Displacement 1 [mm]	14.4
Displacement 2 [mm]	12.1
Mean Displacement [mm]	13.2
Moisture [%]	9.23
Density [kg/m ³]	419

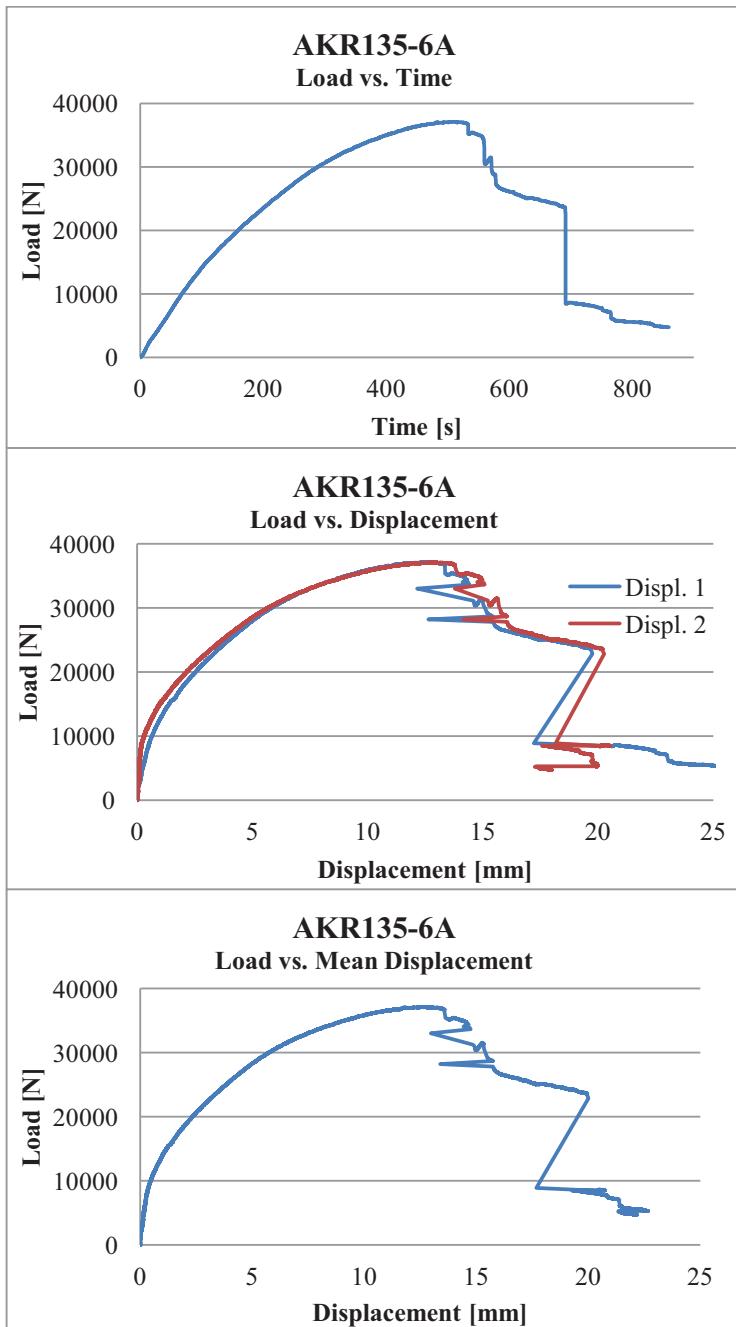
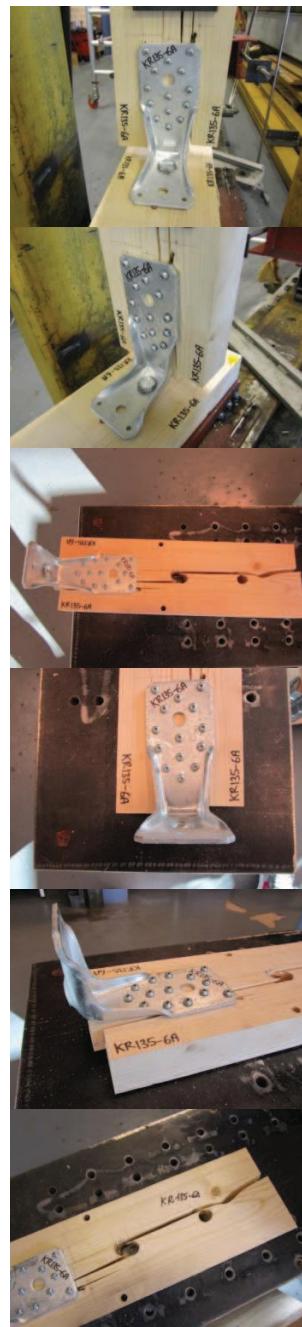
Failure	3a
Failure load [N]	37123
Displacement 1 [mm]	12.6
Displacement 2 [mm]	12.9
Mean Displacement [mm]	12.8
Moisture [%]	10.2
Density [kg/m ³]	376

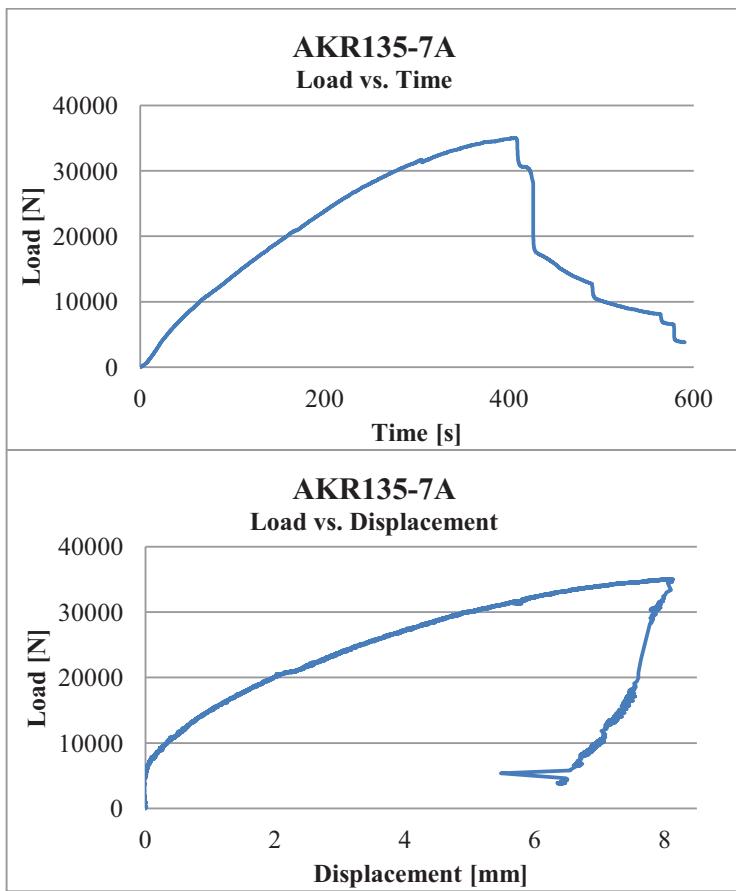
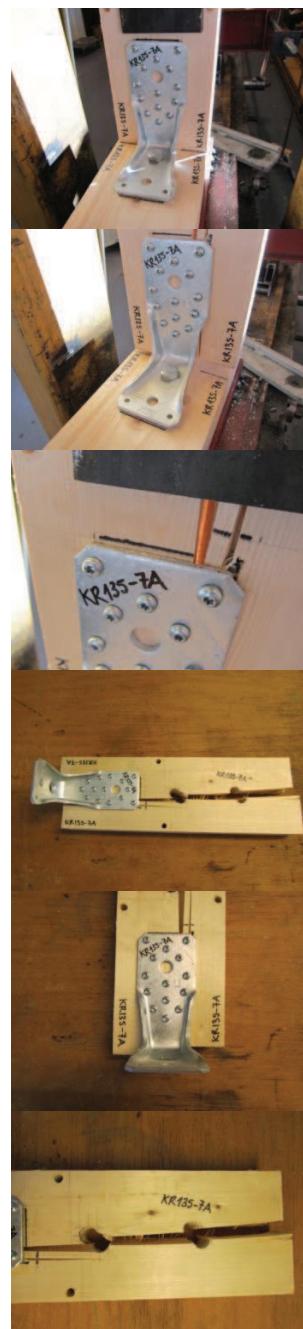
Failure	3b
Failure load [N]	35045
Displacement 1 [mm]	-
Displacement 2 [mm]	8.04
Mean Displacement [mm]	-
Moisture [%]	10.0
Density [kg/m ³]	481

The LVDT number 1 did not work.

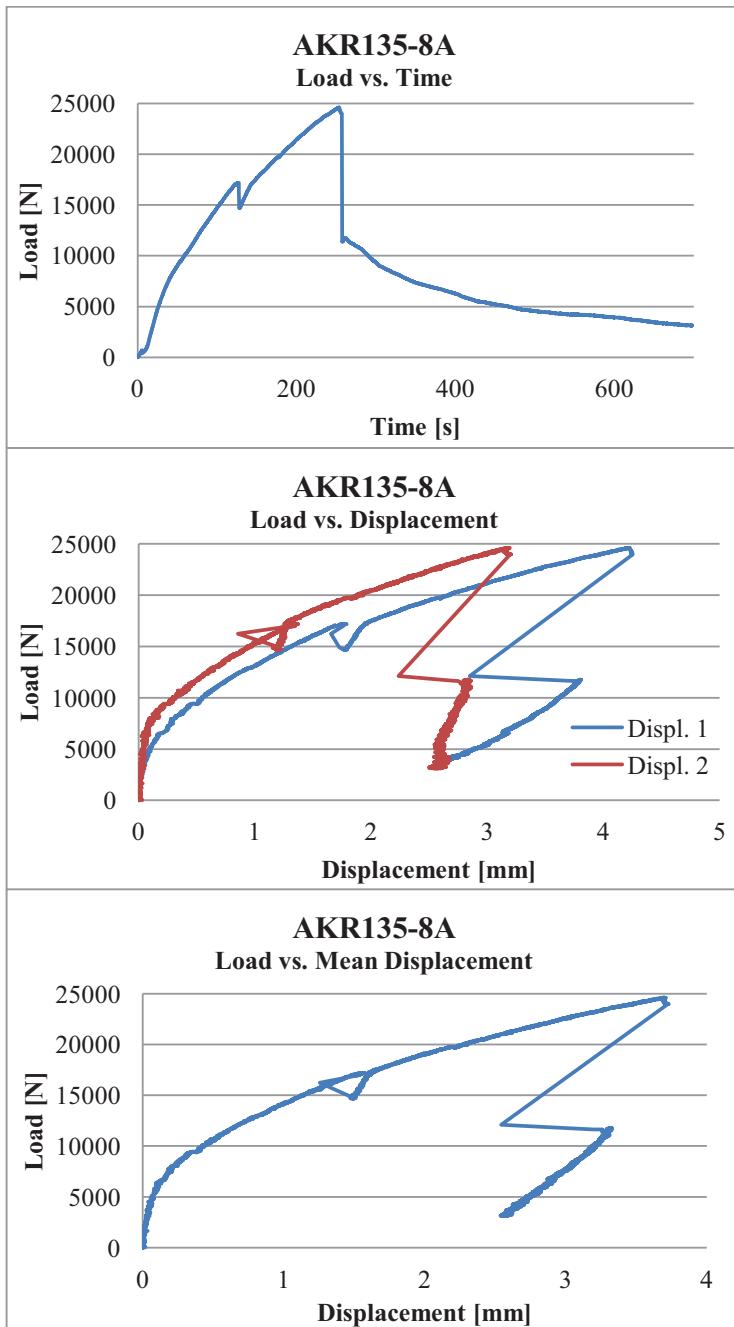
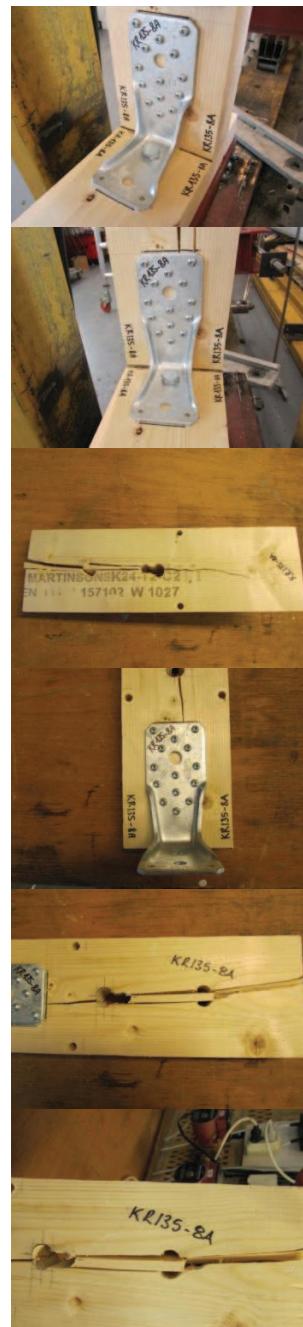
Failure	3b
Failure load [N]	24613
Displacement 1 [mm]	4.22
Displacement 2 [mm]	3.17
Mean Displacement [mm]	3.69
Moisture [%]	9.79
Density [kg/m ³]	357

The failure load is less than other tests, probably there was some problem in the specimen.

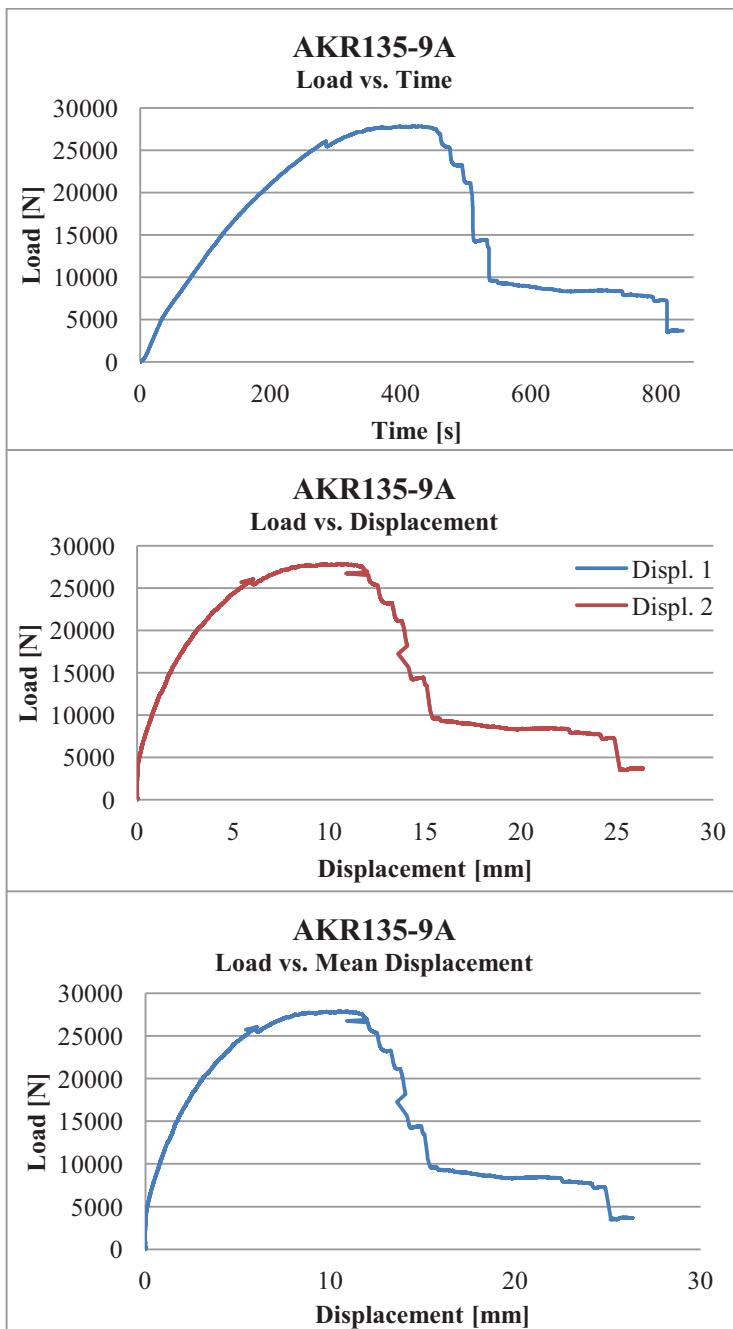
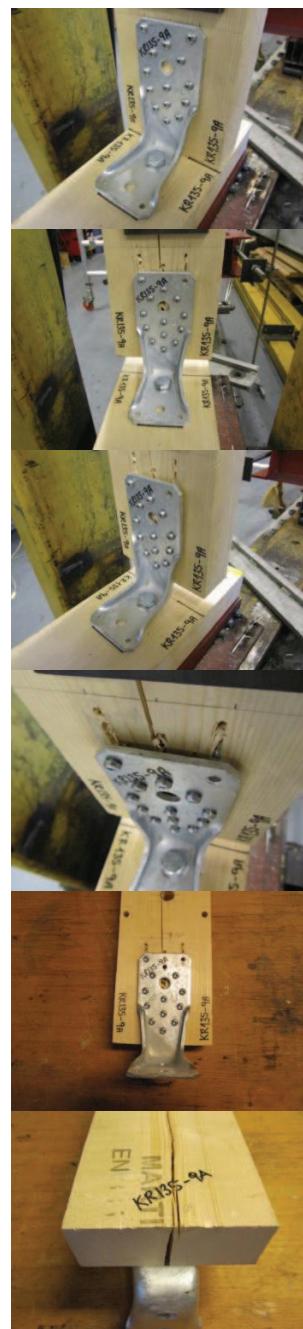
Failure	3a
Failure load [N]	27883
Displacement 1 [mm]	10.5
Displacement 2 [mm]	10.5
Mean Displacement [mm]	10.5
Moisture [%]	9.62
Density [kg/m ³]	357

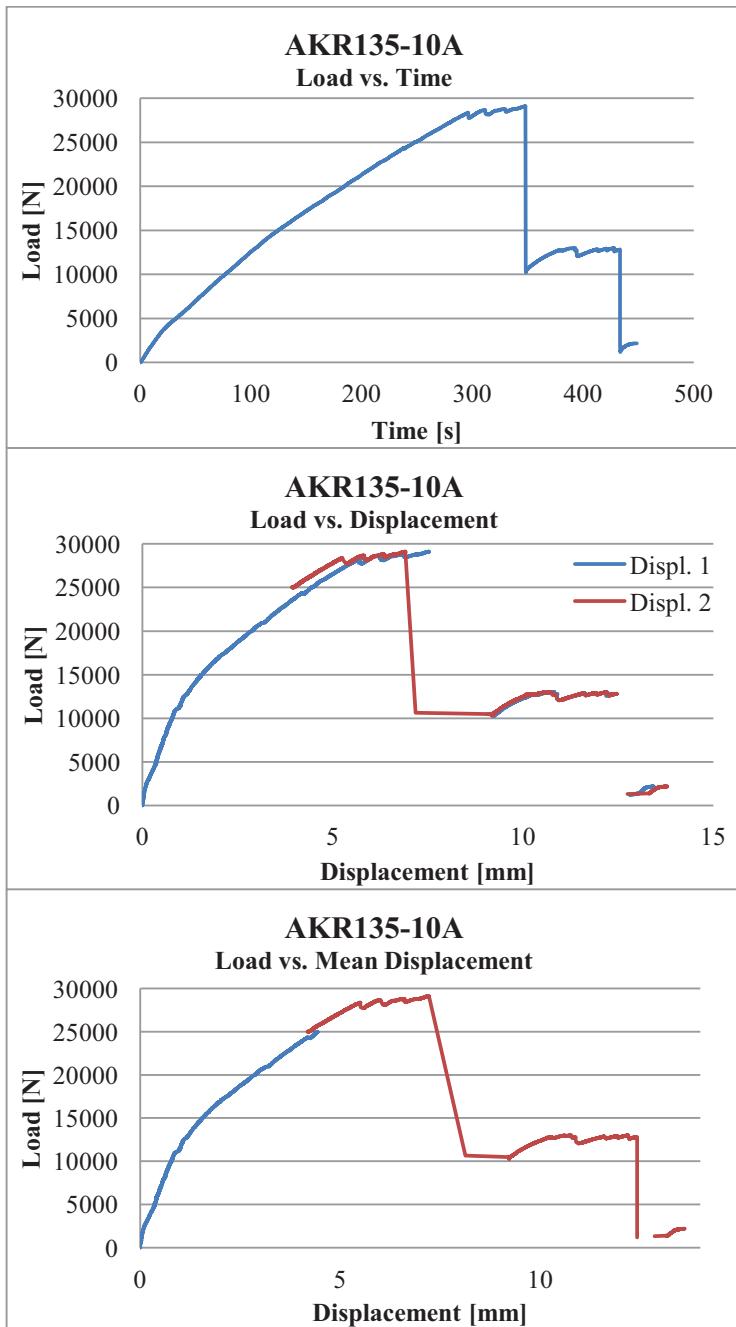
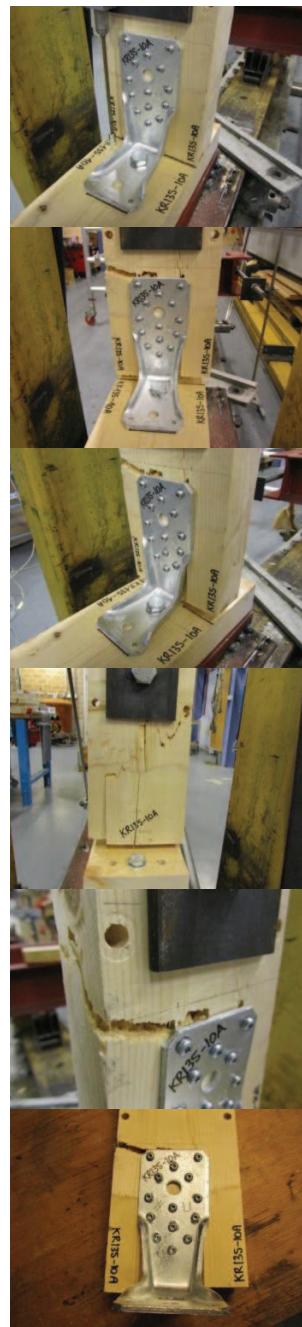
Failure	3b
Failure load [N]	29111
Displacement 1 [mm]	7.53
Displacement 2 [mm]	6.91
Mean Displacement [mm]	7.22
Moisture [%]	10.9
Density [kg/m ³]	367

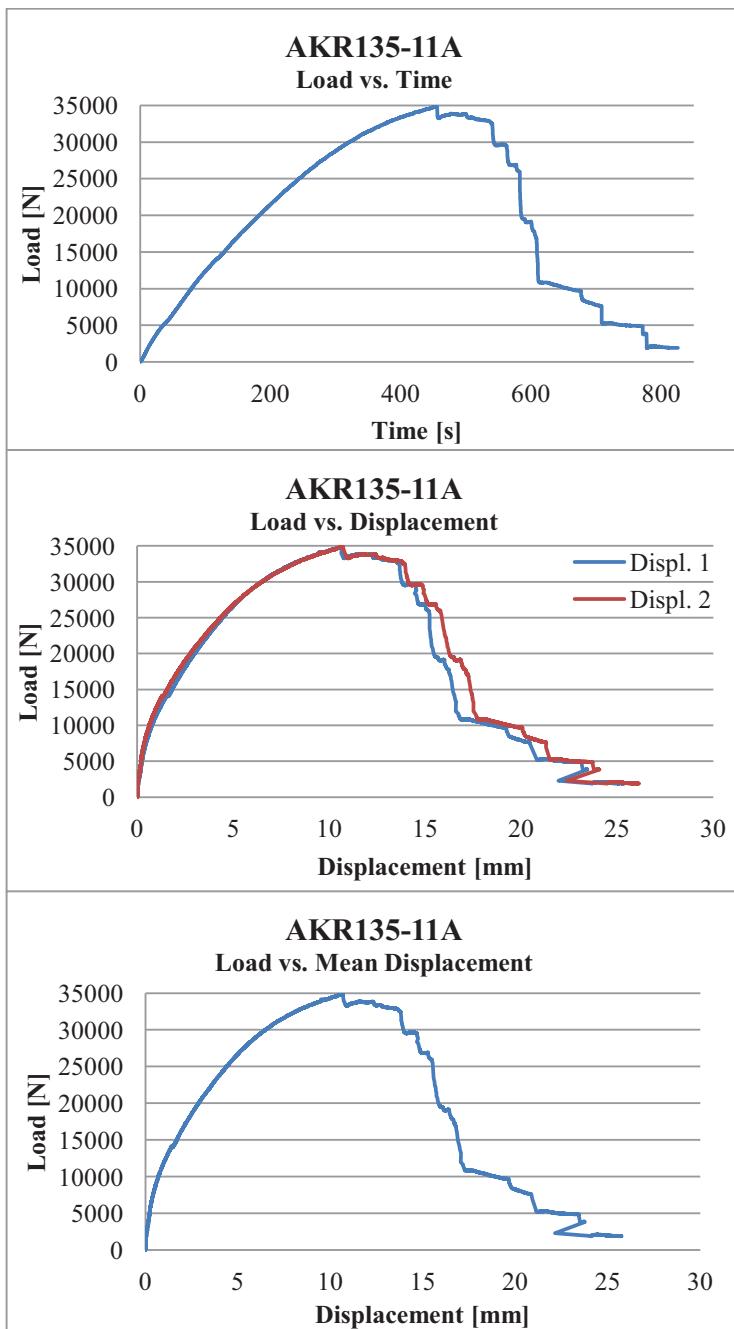
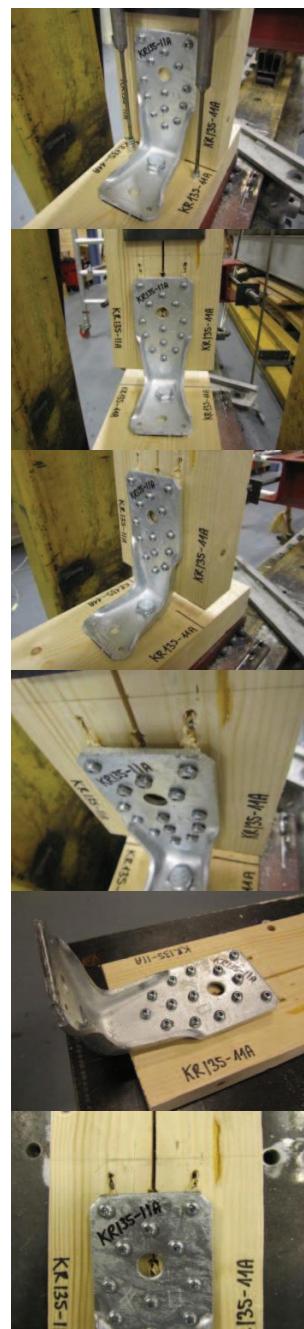
Failure	3a
Failure load [N]	34865
Displacement 1 [mm]	10.7
Displacement 2 [mm]	10.7
Mean Displacement [mm]	10.7
Moisture [%]	8.72
Density [kg/m ³]	375

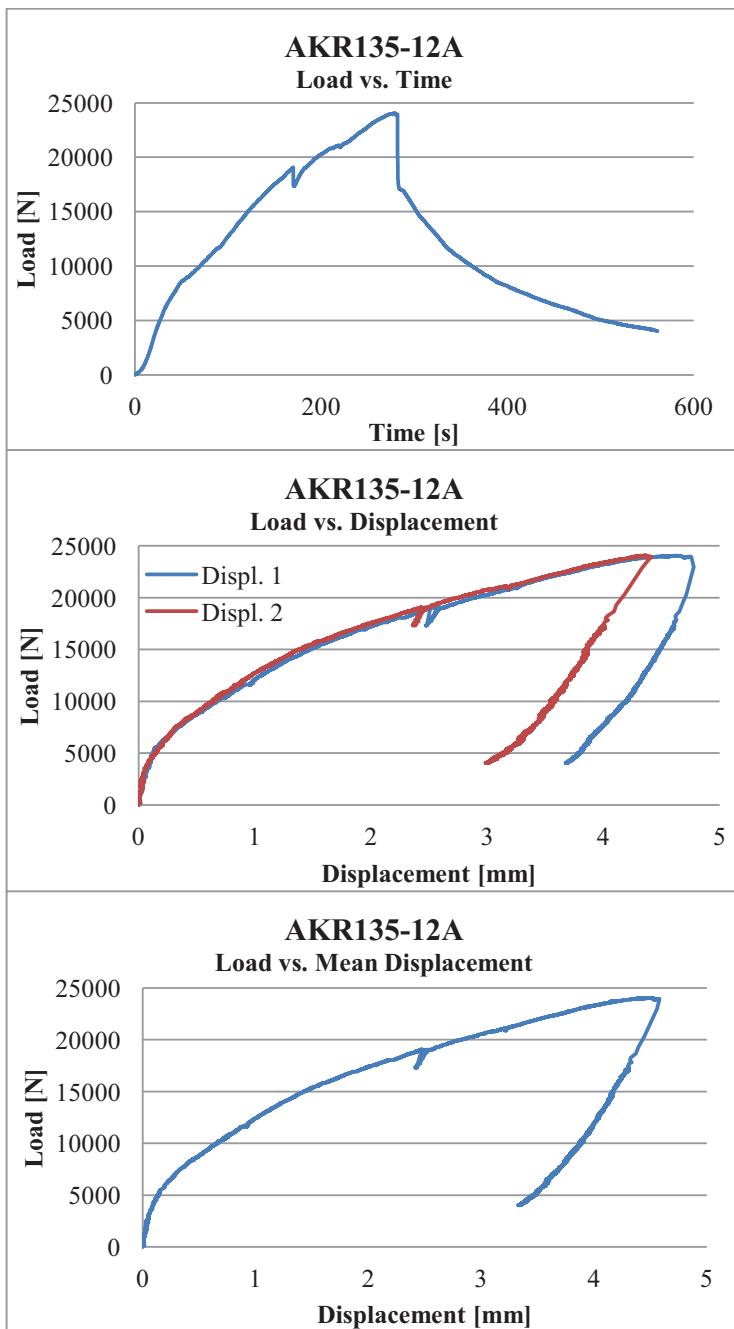
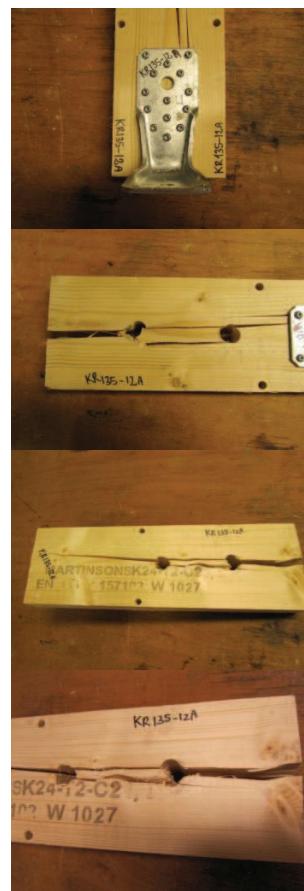
Failure	3a
Failure load [N]	24044
Displacement 1 [mm]	4.63
Displacement 2 [mm]	4.34
Mean Displacement [mm]	4.49
Moisture [%]	9.96
Density [kg/m ³]	431

The LVDT number 1 after failure did not work well.

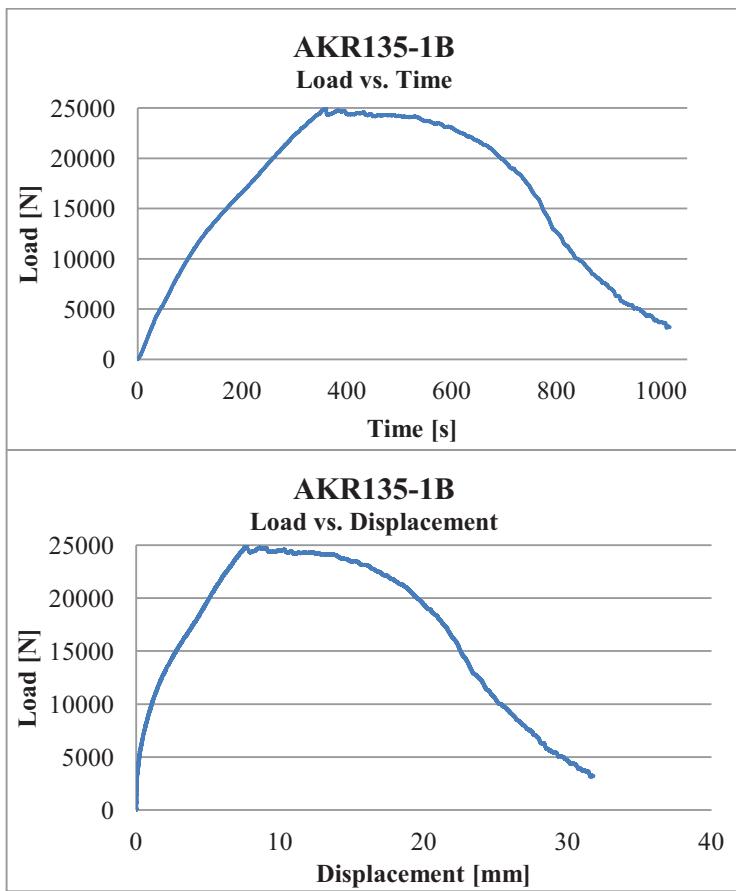
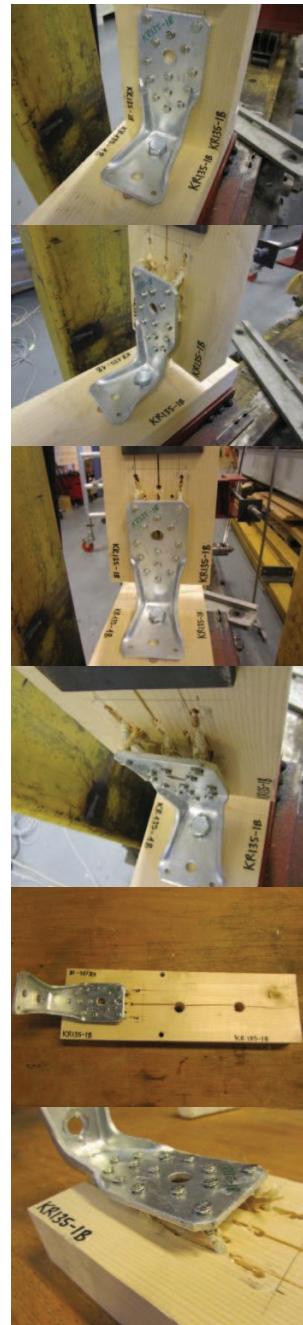
Failure	3a
Failure load [N]	25043
Displacement 1 [mm]	-
Displacement 2 [mm]	7.73
Mean Displacement [mm]	-
Moisture [%]	9.84
Density [kg/m ³]	357

The LDVT number 1 did not work.

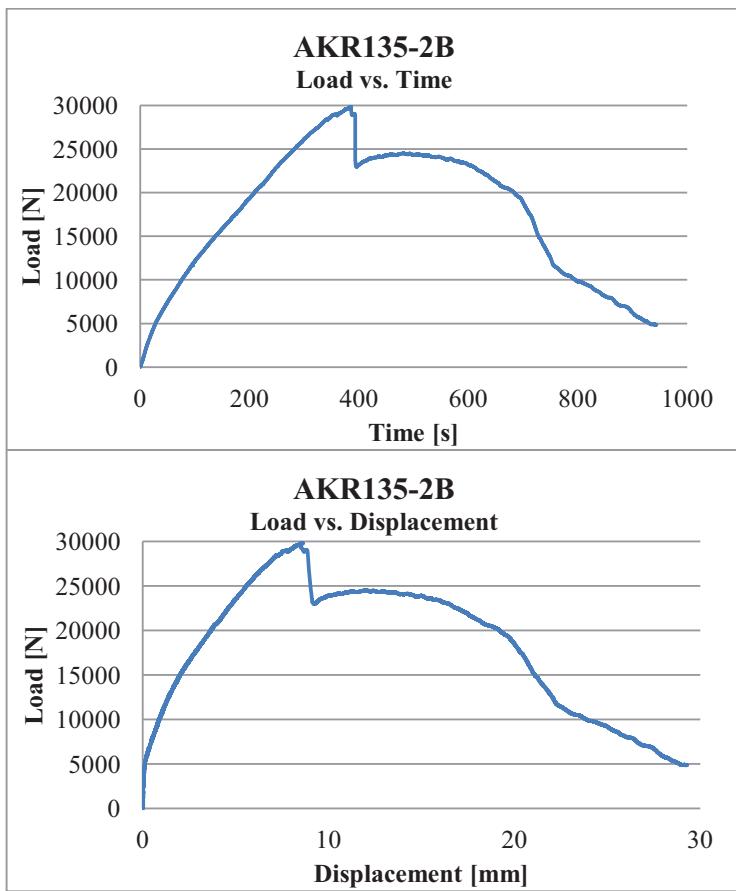
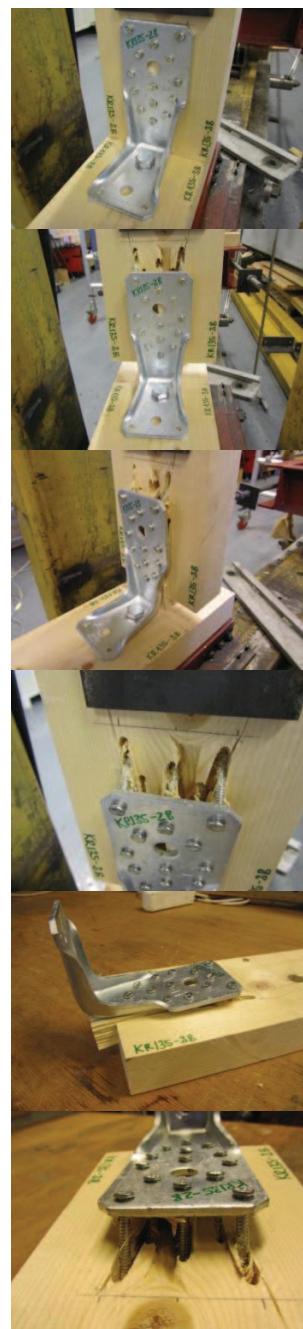
Failure	3a
Failure load [N]	29805
Displacement 1 [mm]	-
Displacement 2 [mm]	8.62
Mean Displacement [mm]	-
Moisture [%]	9.87
Density [kg/m ³]	389

The LVDT number 1 did not work.

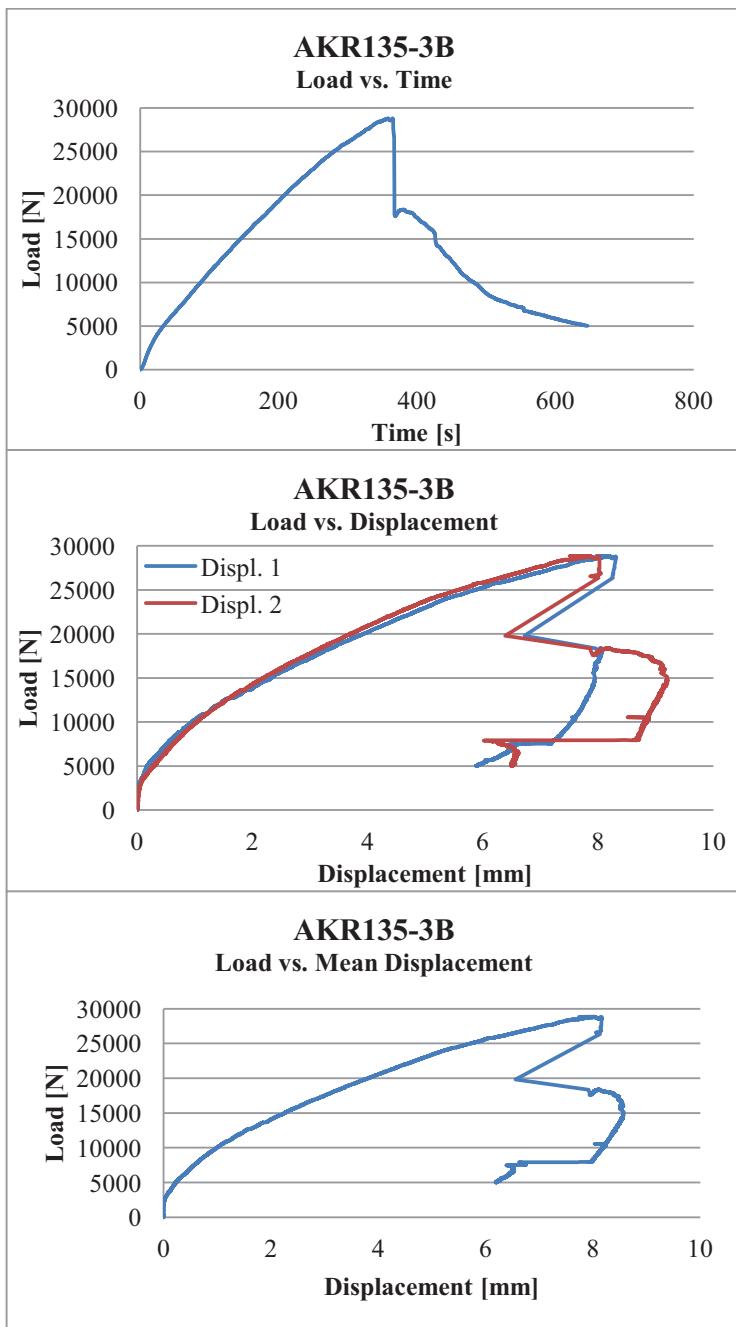
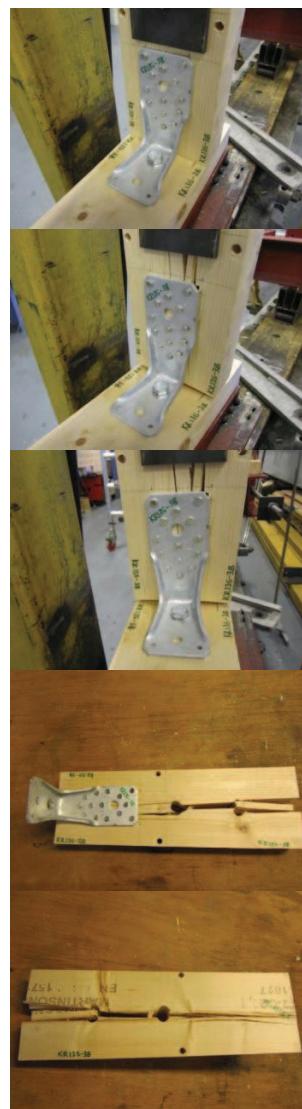
Failure	3b
Failure load [N]	28842
Displacement 1 [mm]	8.21
Displacement 2 [mm]	7.87
Mean Displacement [mm]	8.04
Moisture [%]	8.53
Density [kg/m ³]	452

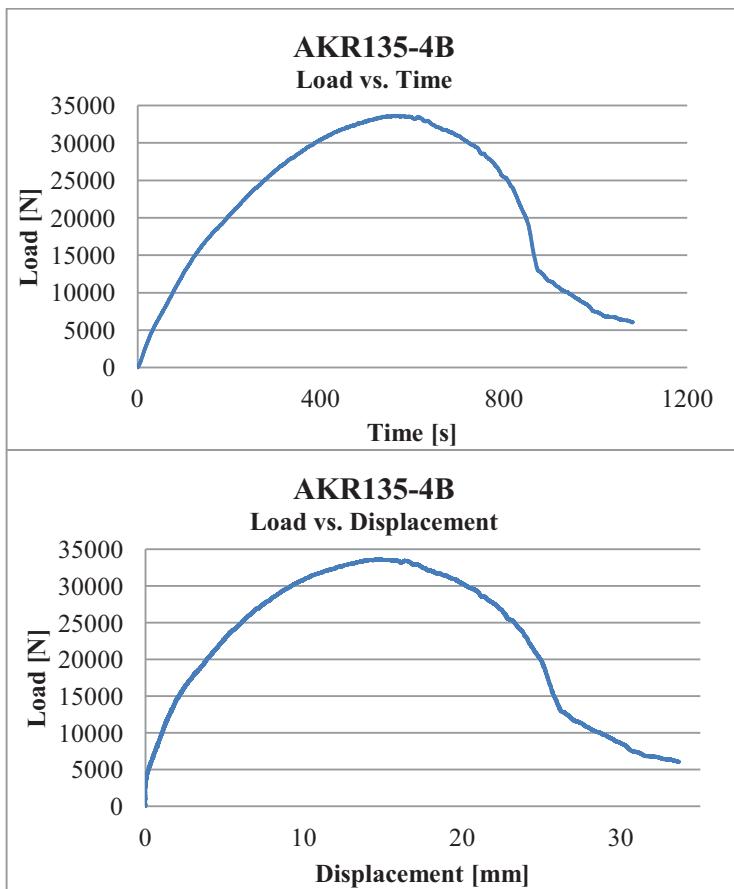
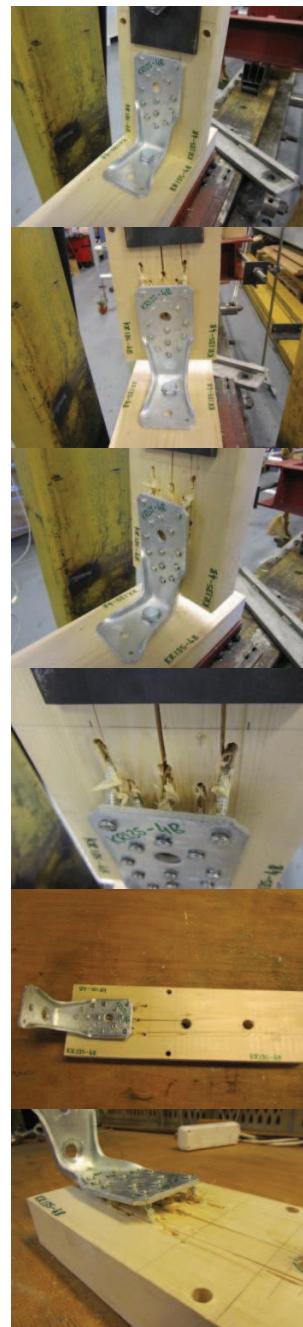
Failure	3a
Failure load [N]	33620
Displacement 1 [mm]	-
Displacement 2 [mm]	14.6
Mean Displacement [mm]	-
Moisture [%]	12.8
Density [kg/m ³]	483

The LVDT number 1 did not work.

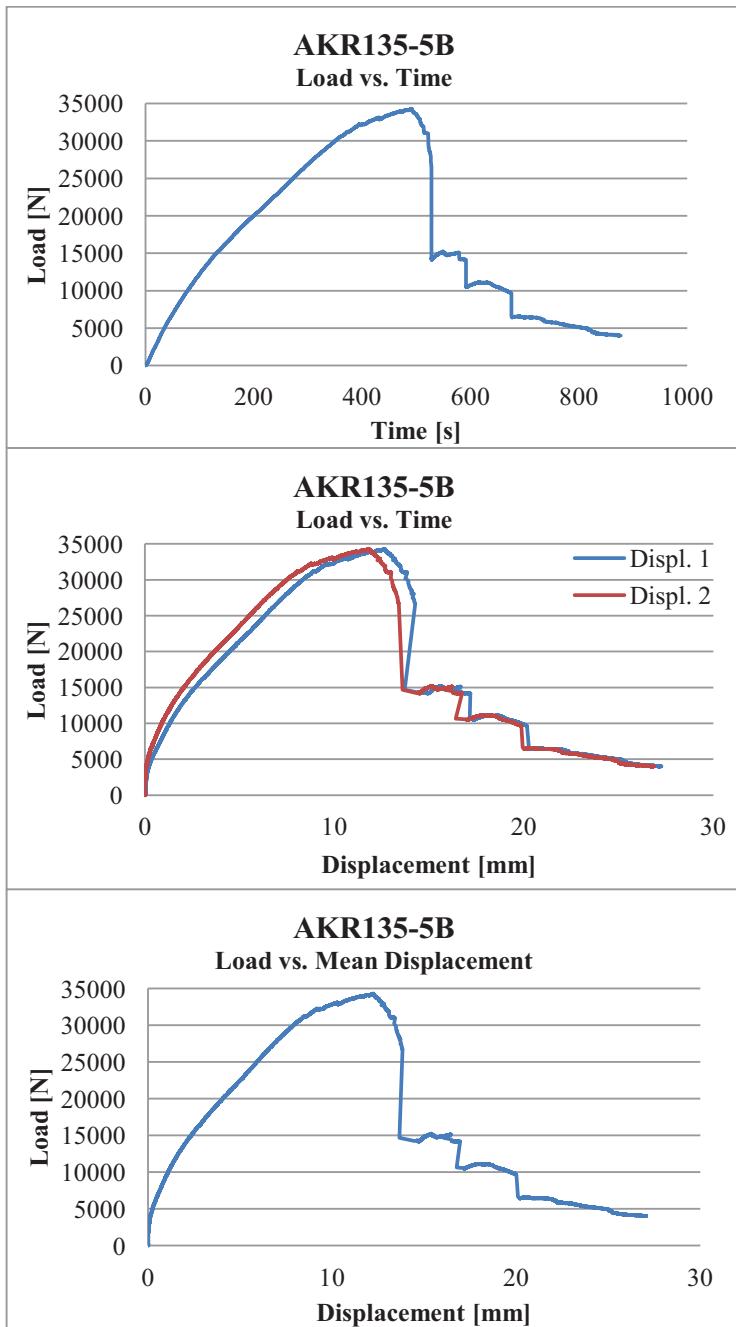
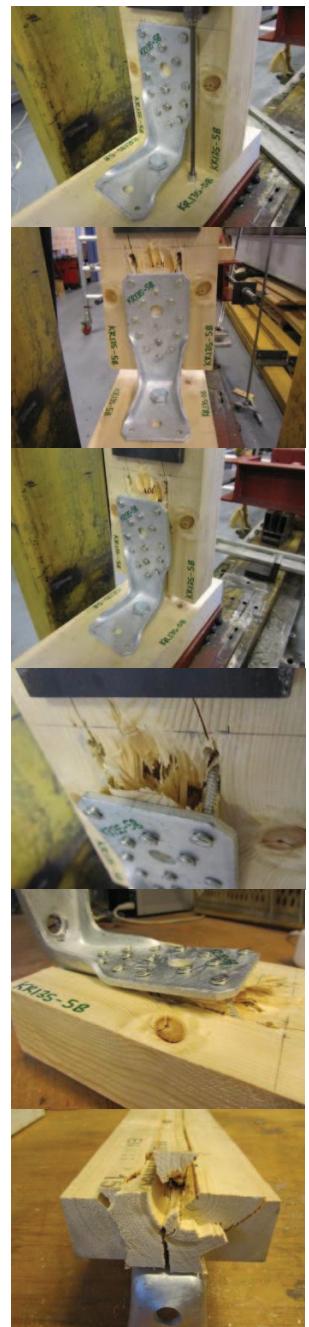
Failure	3a
Failure load [N]	34296
Displacement 1 [mm]	12.6
Displacement 2 [mm]	11.8
Mean Displacement [mm]	12.2
Moisture [%]	9.23
Density [kg/m ³]	444

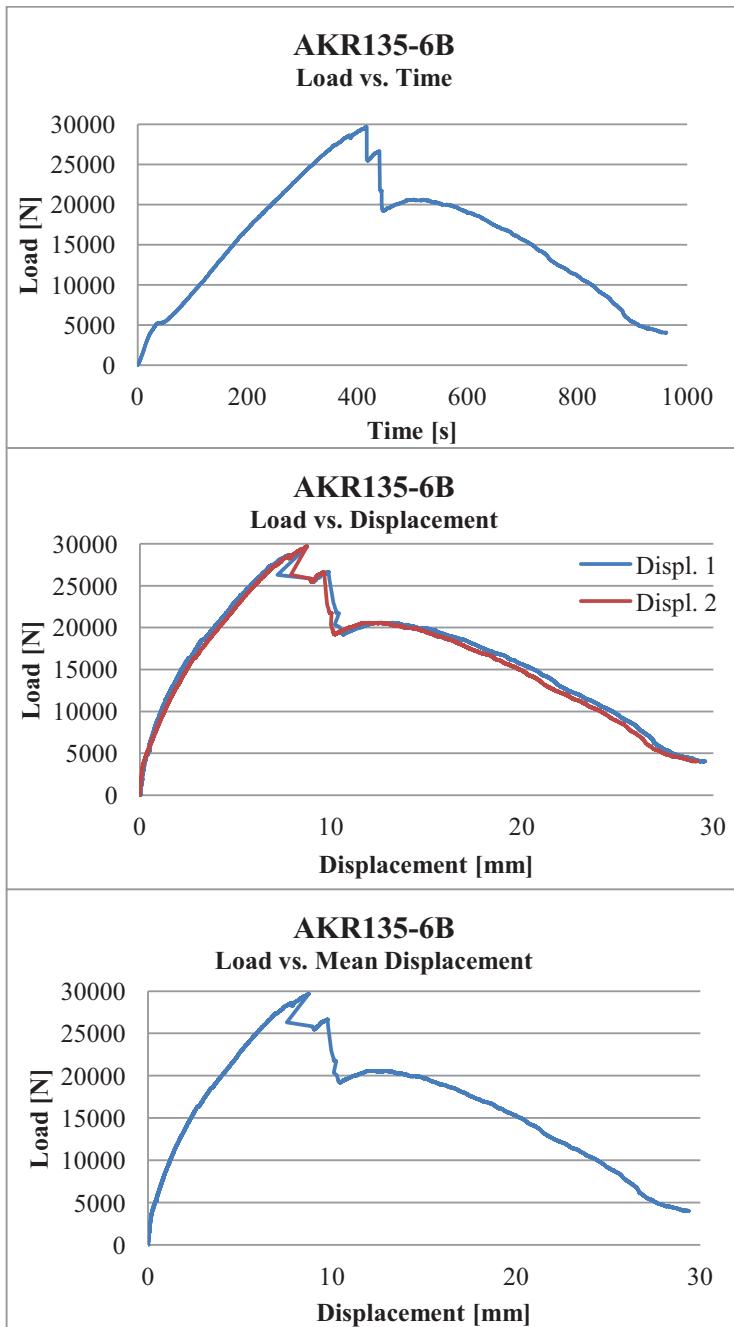
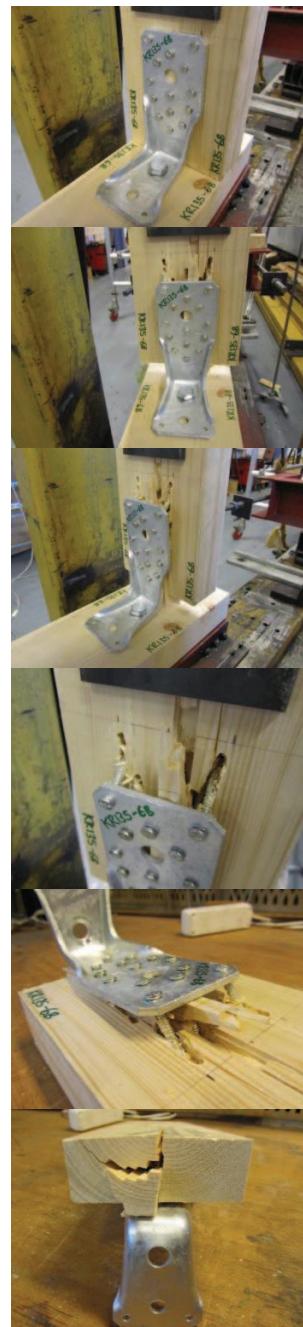
Failure	3a
Failure load [N]	29675
Displacement 1 [mm]	8.73
Displacement 2 [mm]	8.71
Mean Displacement [mm]	8.72
Moisture [%]	8.97
Density [kg/m ³]	367

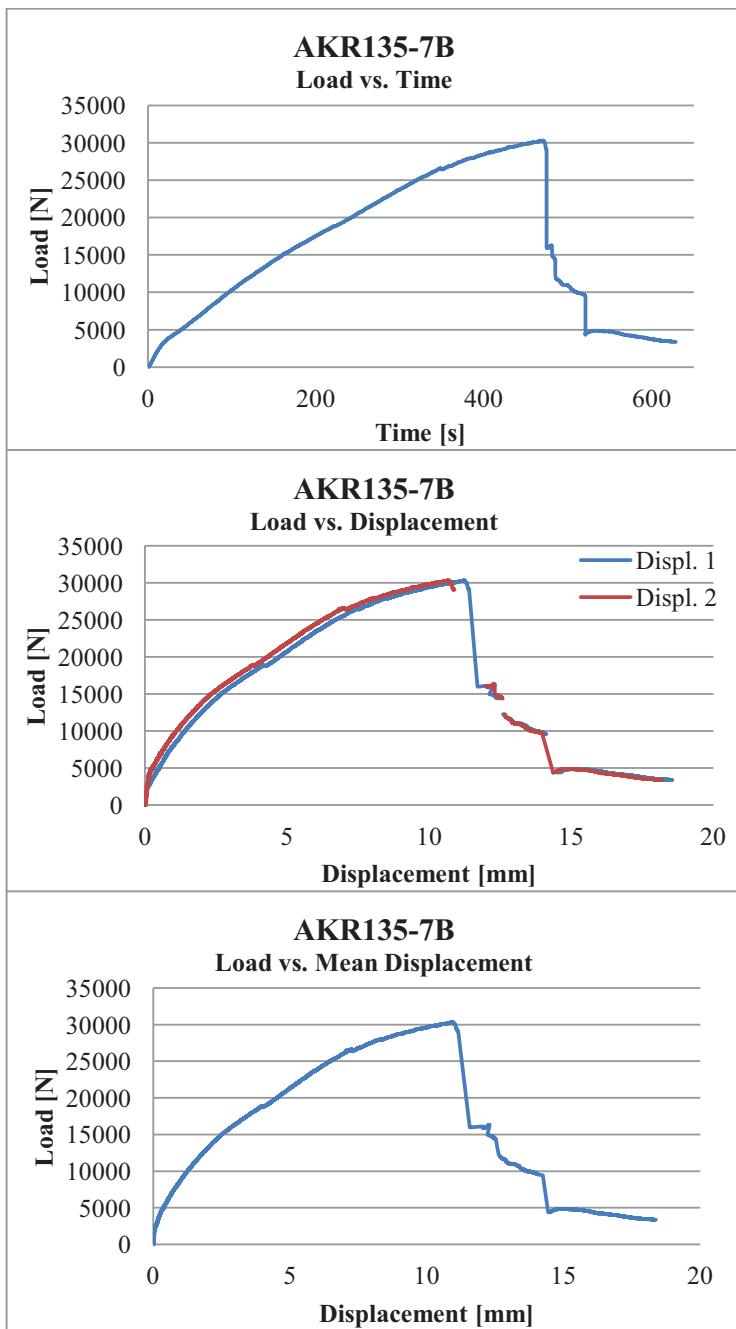
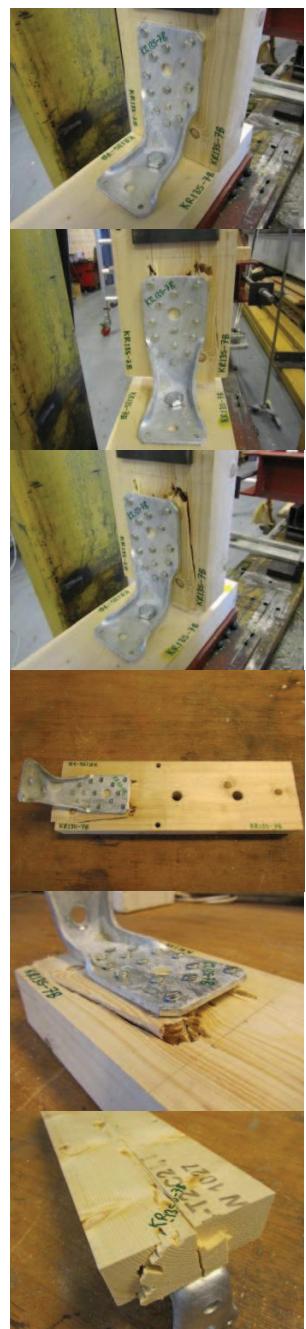
Failure	3b
Failure load [N]	30309
Displacement 1 [mm]	11.2
Displacement 2 [mm]	10.7
Mean Displacement [mm]	10.9
Moisture [%]	12.6
Density [kg/m ³]	382

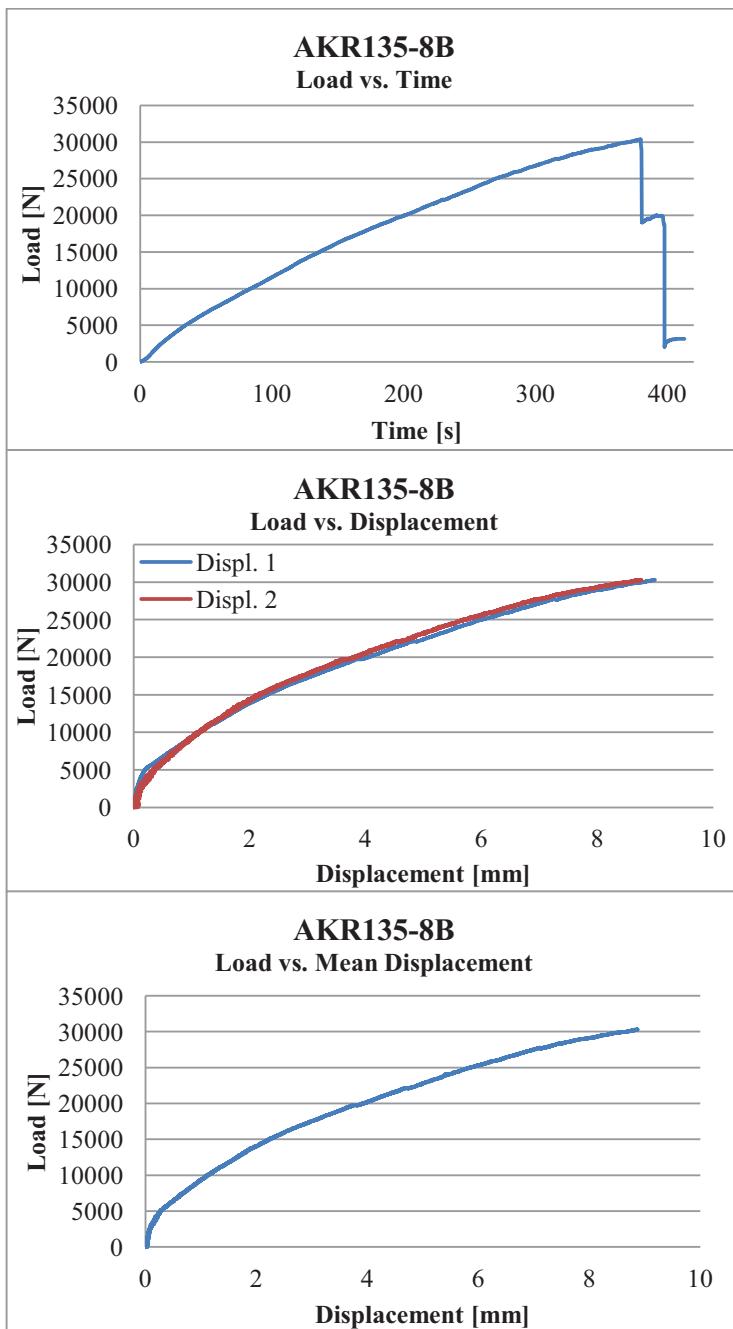
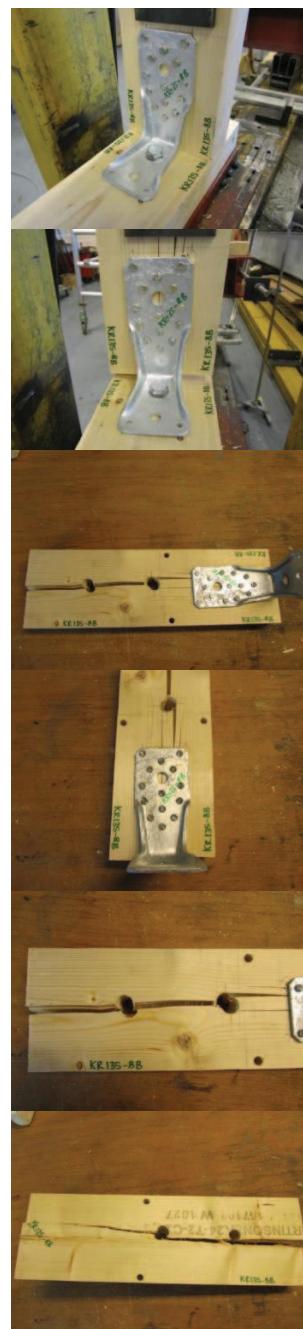
Failure	3b
Failure load [N]	30363
Displacement 1 [mm]	9.05
Displacement 2 [mm]	8.83
Mean Displacement [mm]	8.94
Moisture [%]	9.23
Density [kg/m ³]	530

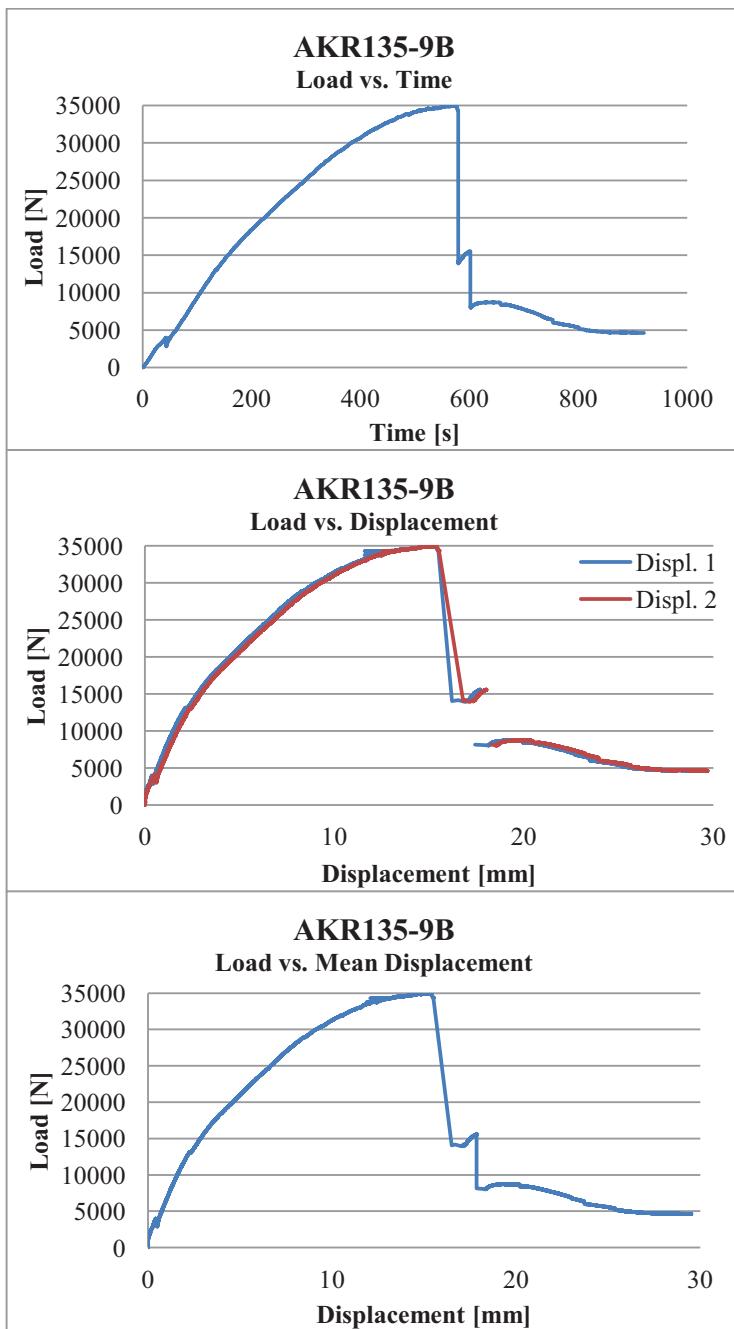
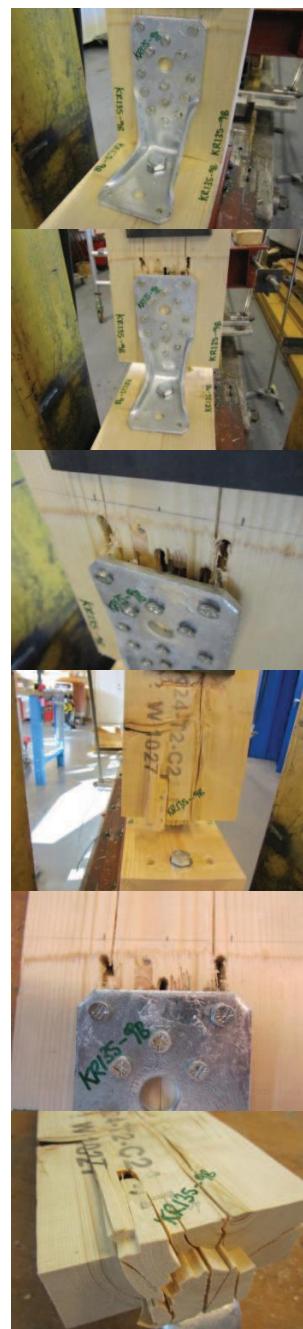
Failure	3b
Failure load [N]	34980
Displacement 1 [mm]	15.2
Displacement 2 [mm]	15.2
Mean Displacement [mm]	15.2
Moisture [%]	11.4
Density [kg/m ³]	438
