Experimental Testing of Hold Down Devices for Timber Frame Shear Walls

Giuseppe Caprolu

ISSN: 1402-1536
ISBN 978-91-7439-386-6

Luleå 2012

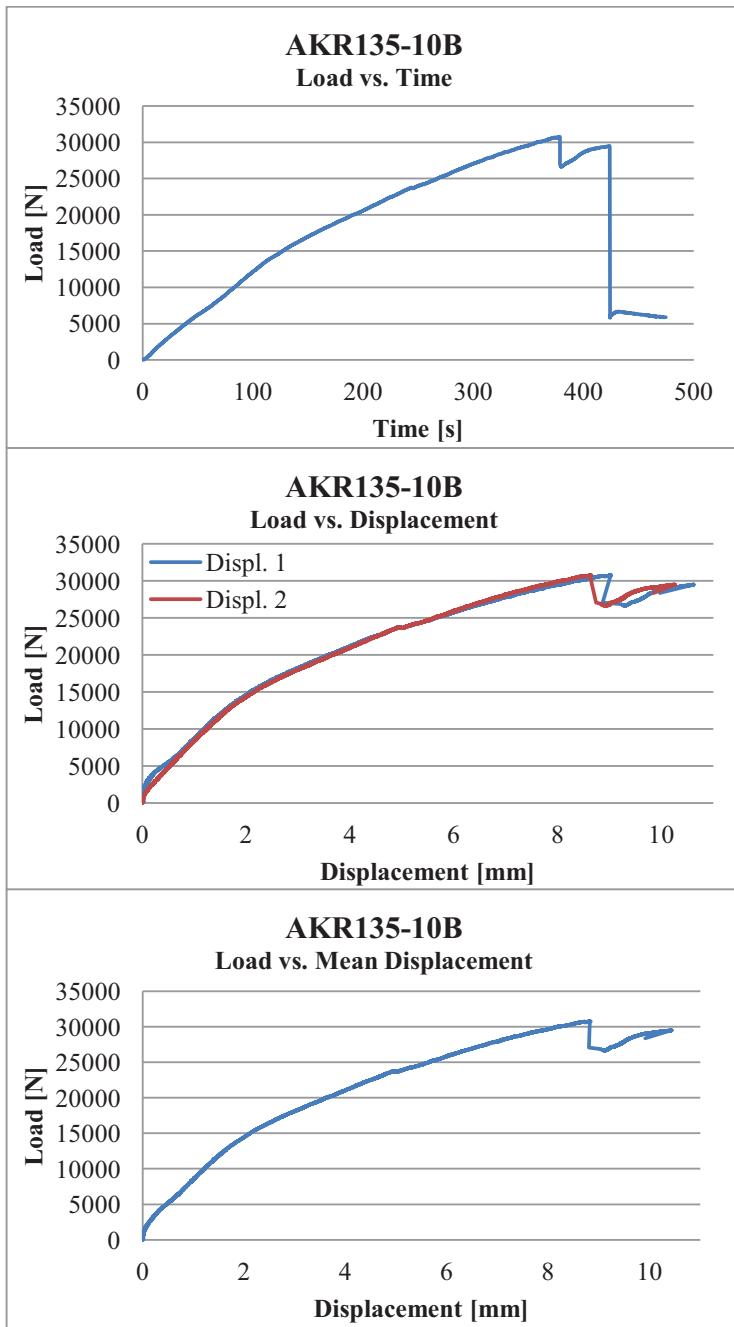
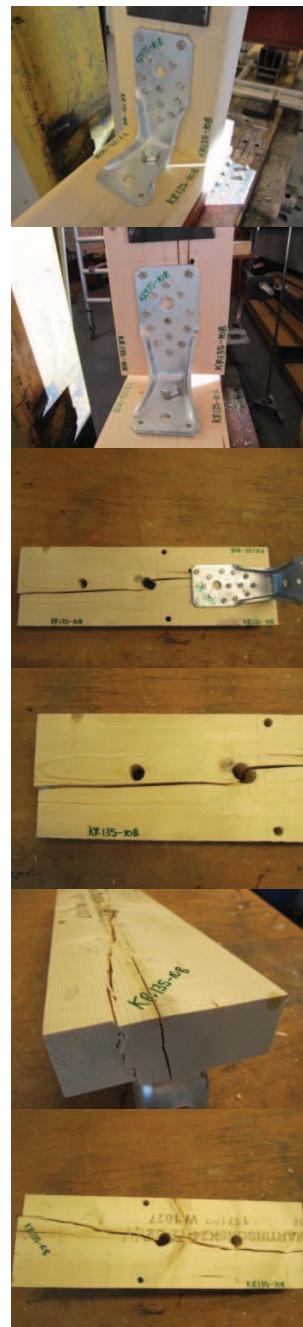
Failure	3b
Failure load [N]	30771
Displacement 1 [mm]	9.02
Displacement 2 [mm]	8.62
Mean Displacement [mm]	8.82
Moisture [%]	8.58
Density [kg/m ³]	381

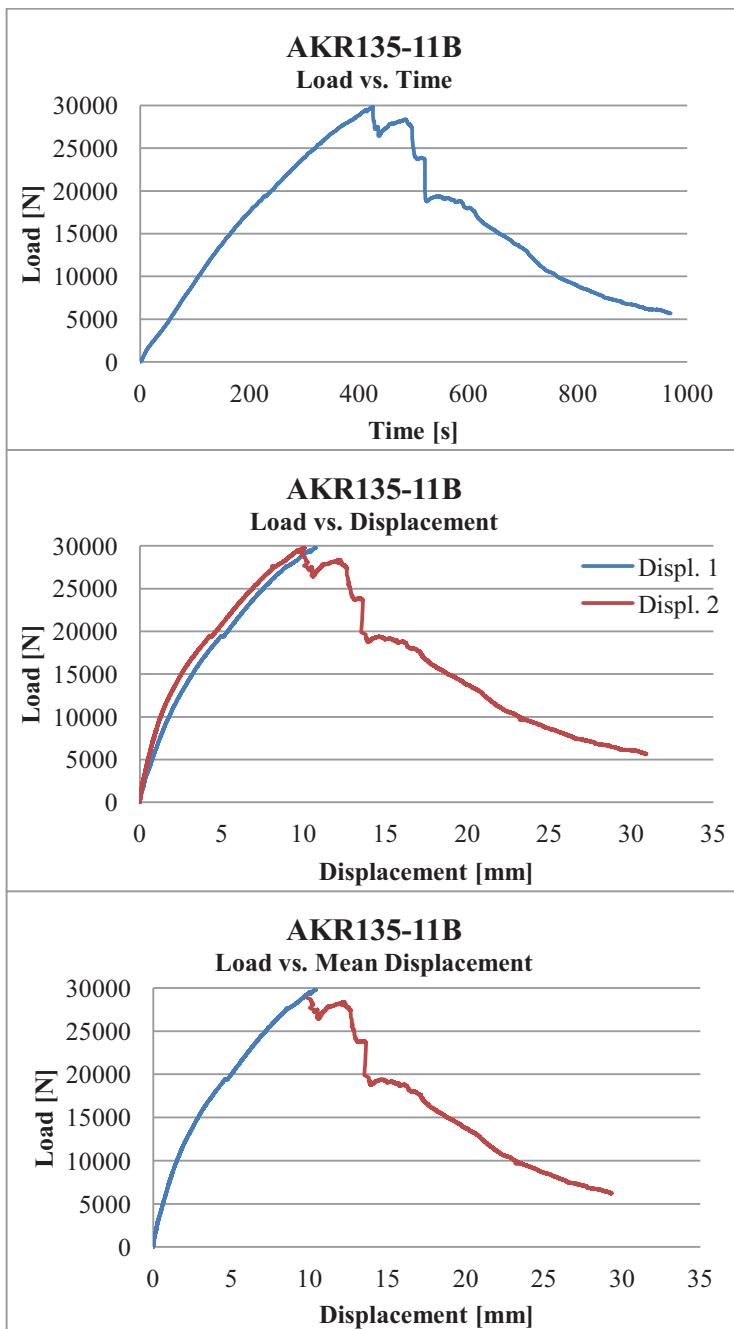
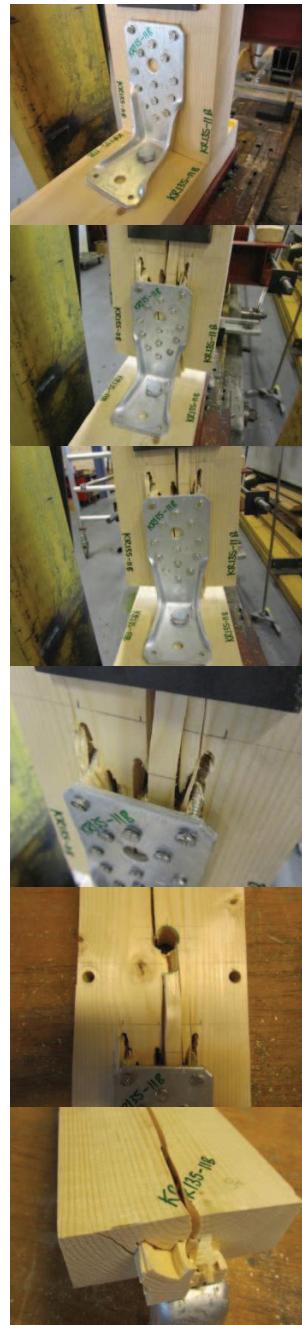
Failure	3b
Failure load [N]	29782
Displacement 1 [mm]	10.7
Displacement 2 [mm]	10.0
Mean Displacement [mm]	10.4
Moisture [%]	9.70
Density [kg/m ³]	361

The LVDT number 1 did not work after failure.

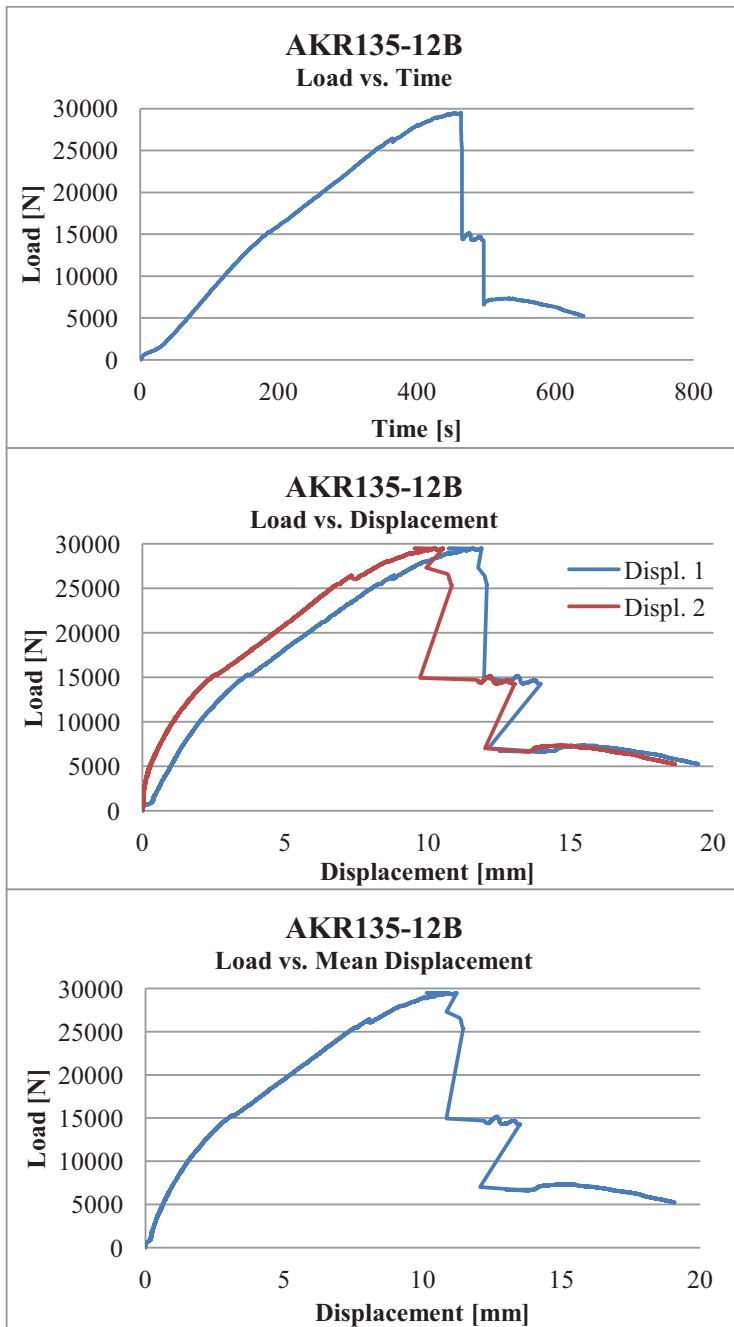
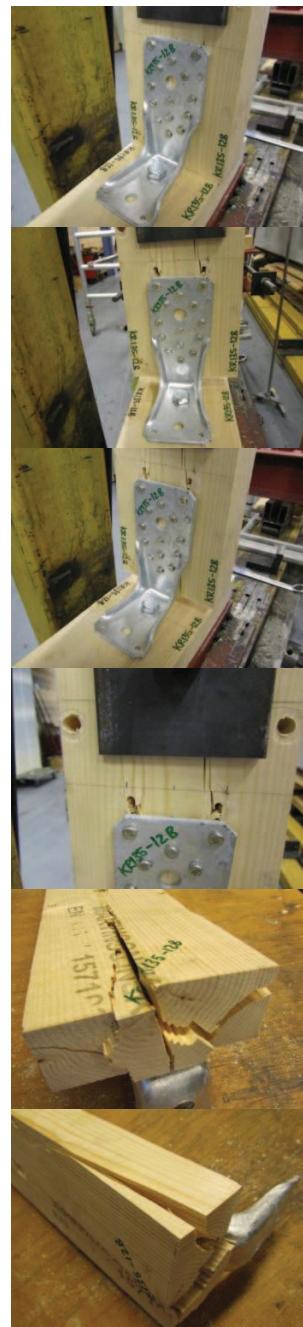
Failure	3b
Failure load [N]	29496
Displacement 1 [mm]	11.6
Displacement 2 [mm]	10.3
Mean Displacement [mm]	10.9
Moisture [%]	9.44
Density [kg/m ³]	372

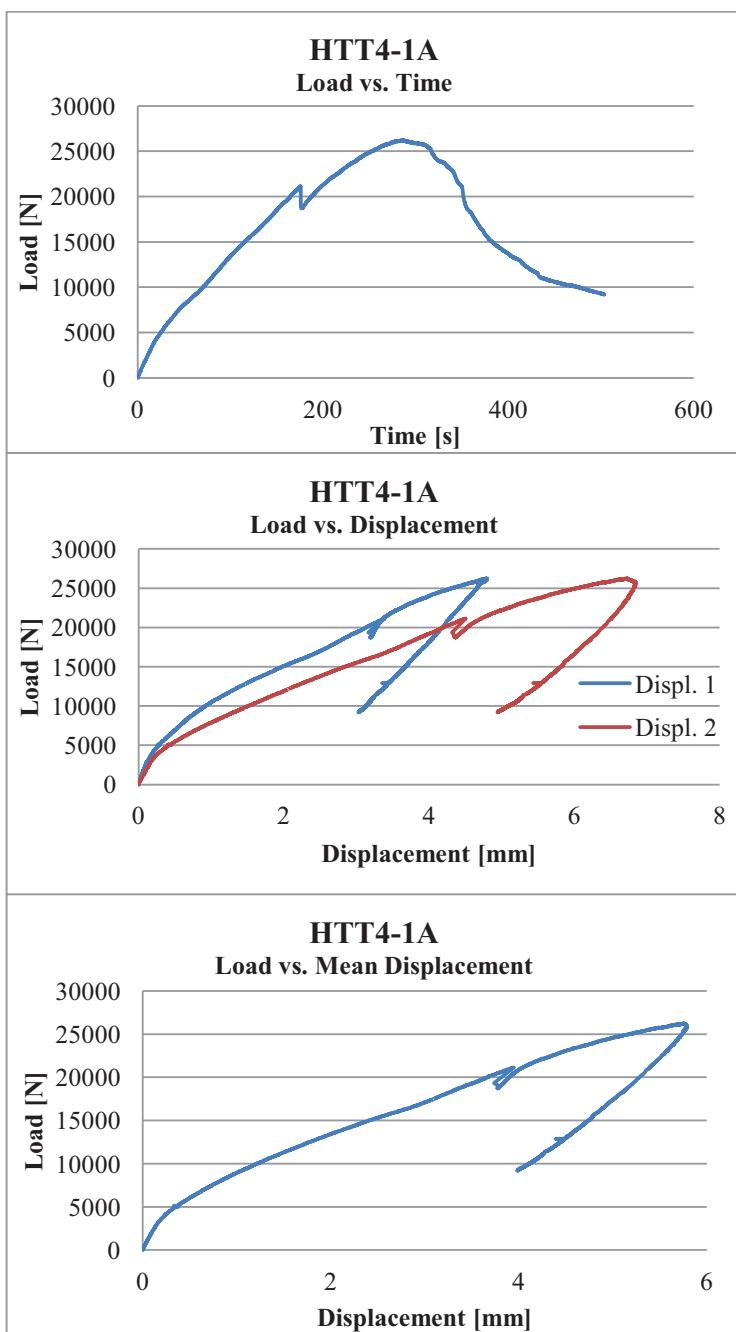
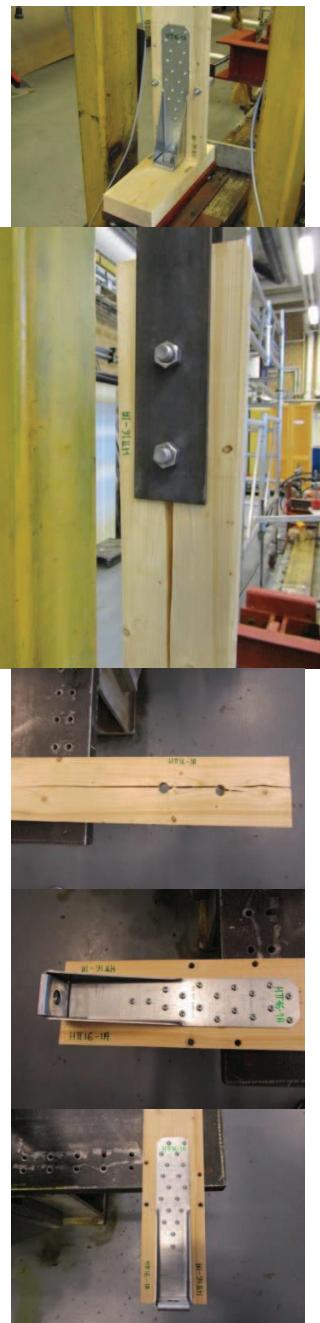
Failure	3b
Failure load [N]	26232
Displacement 1 [mm]	4.79
Displacement 2 [mm]	6.71
Mean Displacement [mm]	5.75
Moisture [%]	7.91
Density [kg/m ³]	387

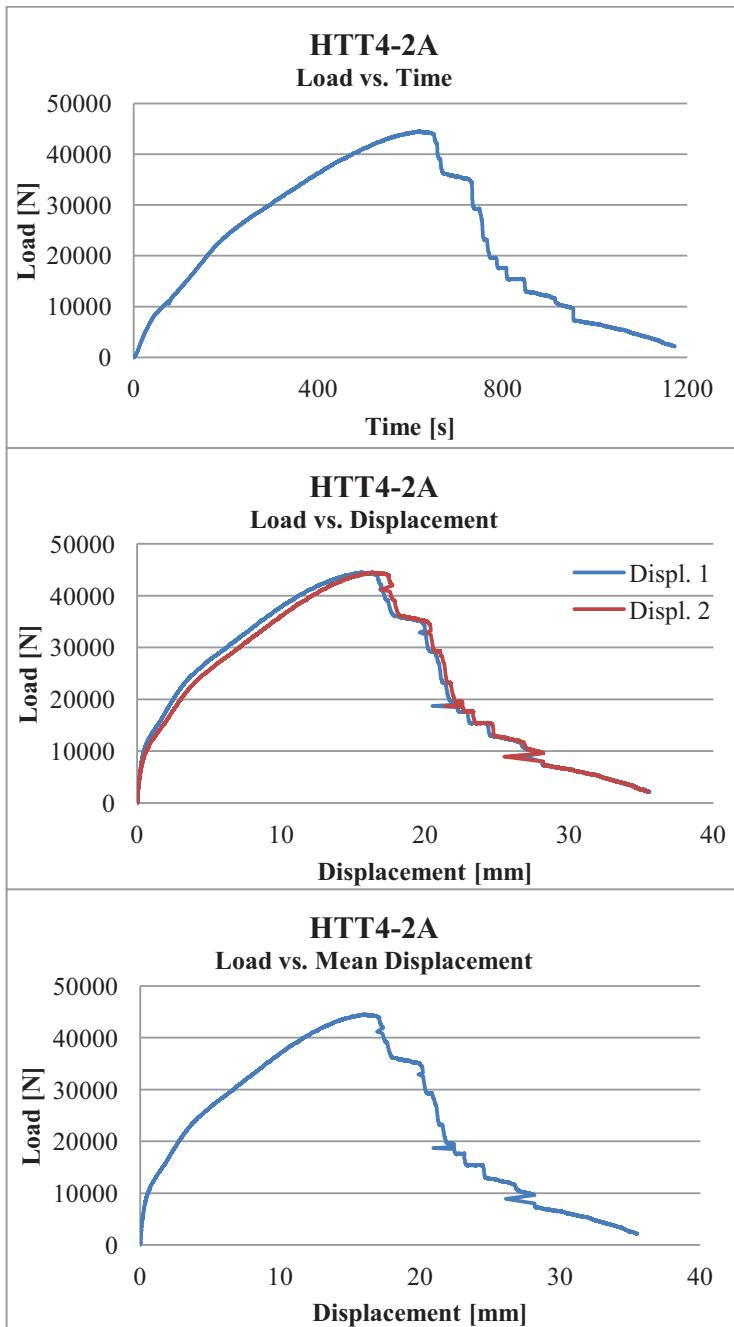
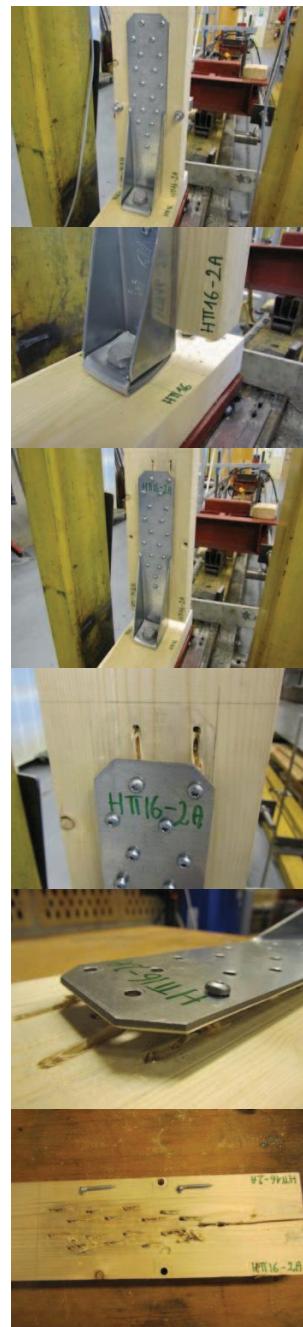
Failure	3a
Failure load [N]	44515
Displacement 1 [mm]	15.6
Displacement 2 [mm]	16.4
Mean Displacement [mm]	16.0
Moisture [%]	8.11
Density [kg/m ³]	327

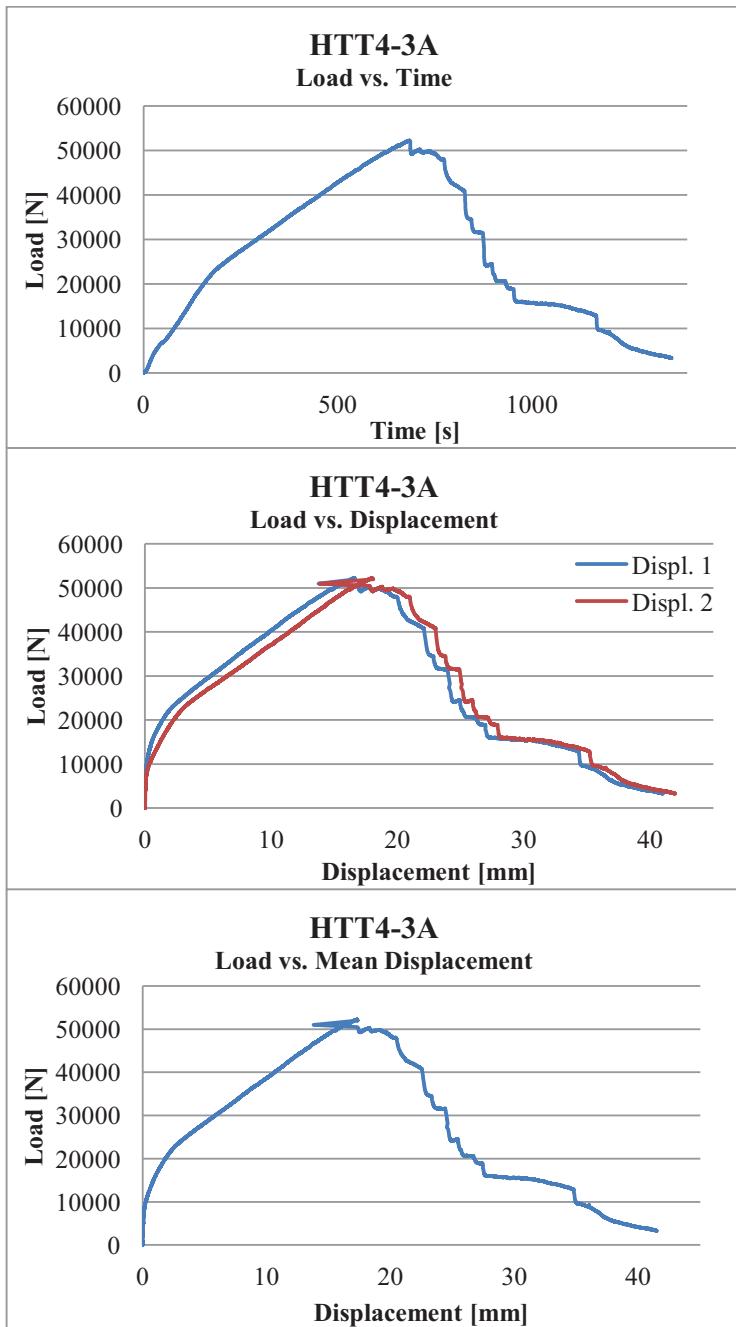
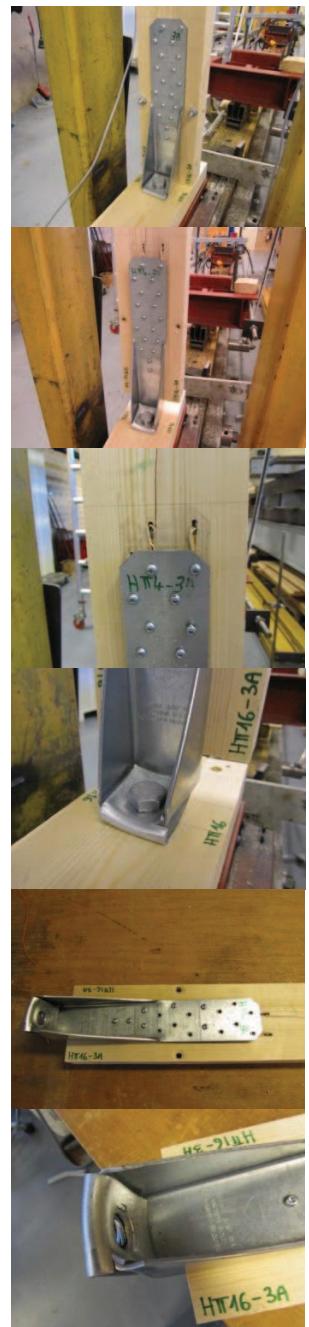
Failure	3a
Failure load [N]	52241
Displacement 1 [mm]	16.6
Displacement 2 [mm]	18.0
Mean Displacement [mm]	13.3
Moisture [%]	8.50
Density [kg/m ³]	414

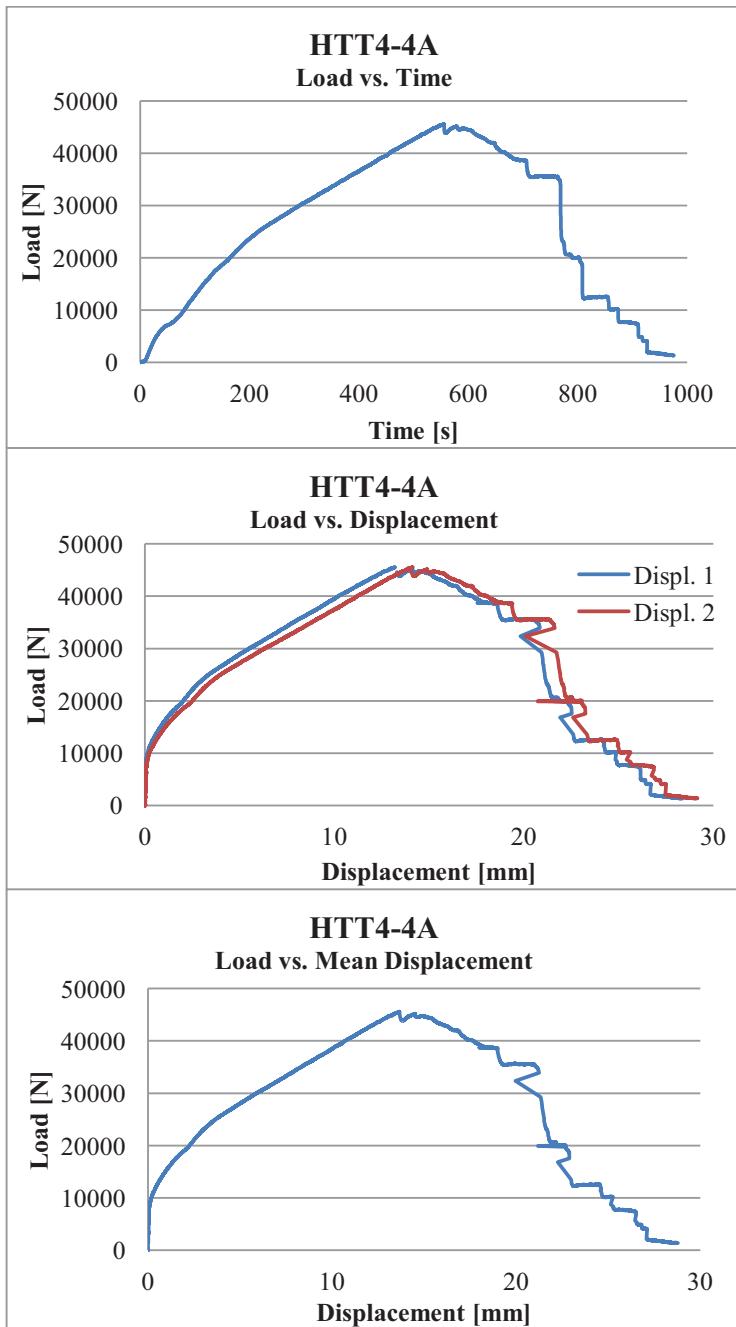
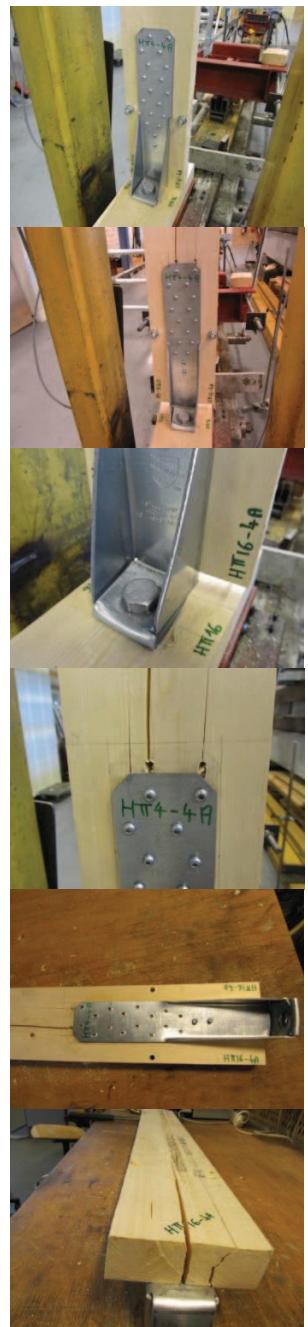
Failure	3a
Failure load [N]	45584
Displacement 1 [mm]	13.2
Displacement 2 [mm]	14.1
Mean Displacement [mm]	13.7
Moisture [%]	9.18
Density [kg/m ³]	433

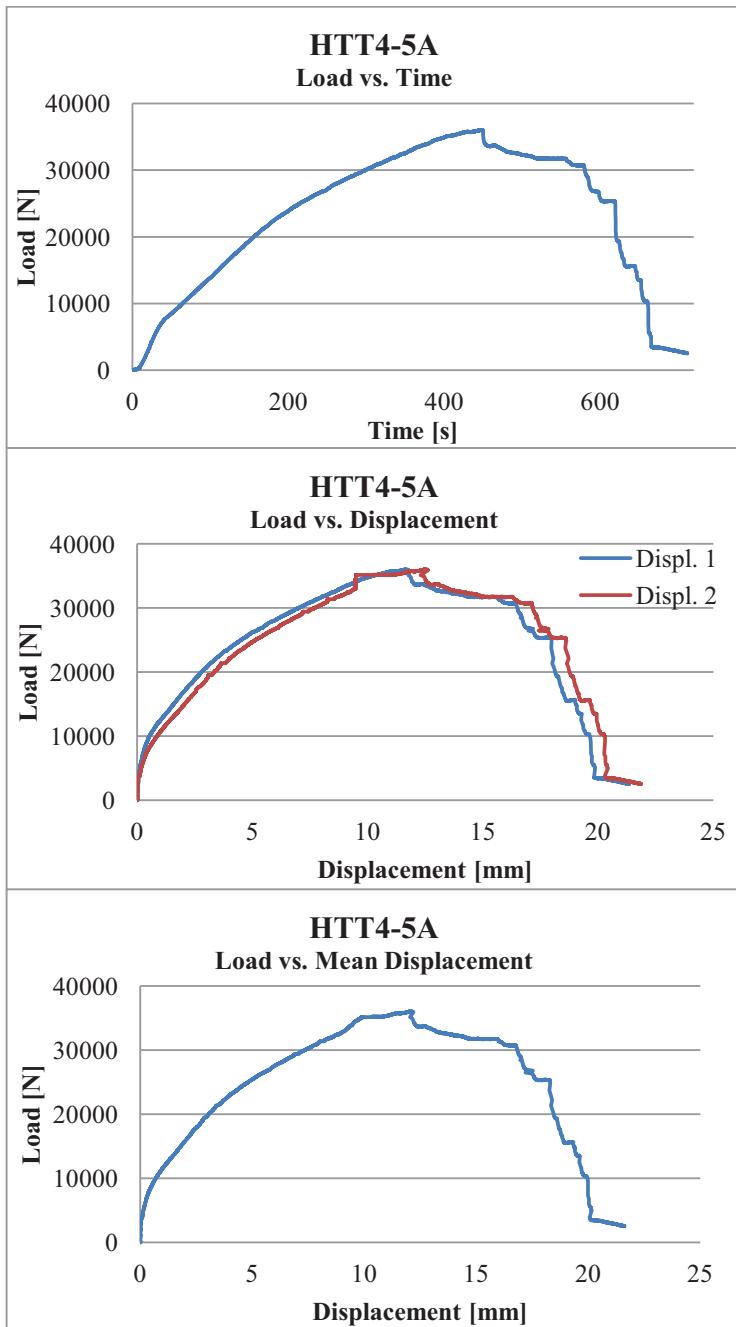
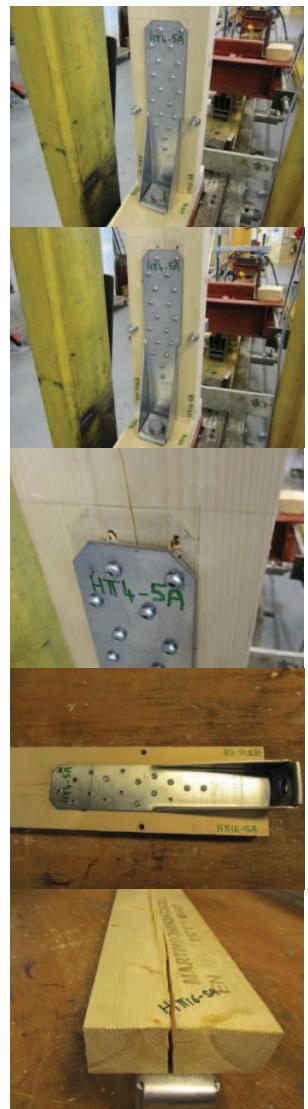
Failure	3a
Failure load [N]	36034
Displacement 1 [mm]	11.6
Displacement 2 [mm]	12.5
Mean Displacement [mm]	12.1
Moisture [%]	7.24
Density [kg/m ³]	327

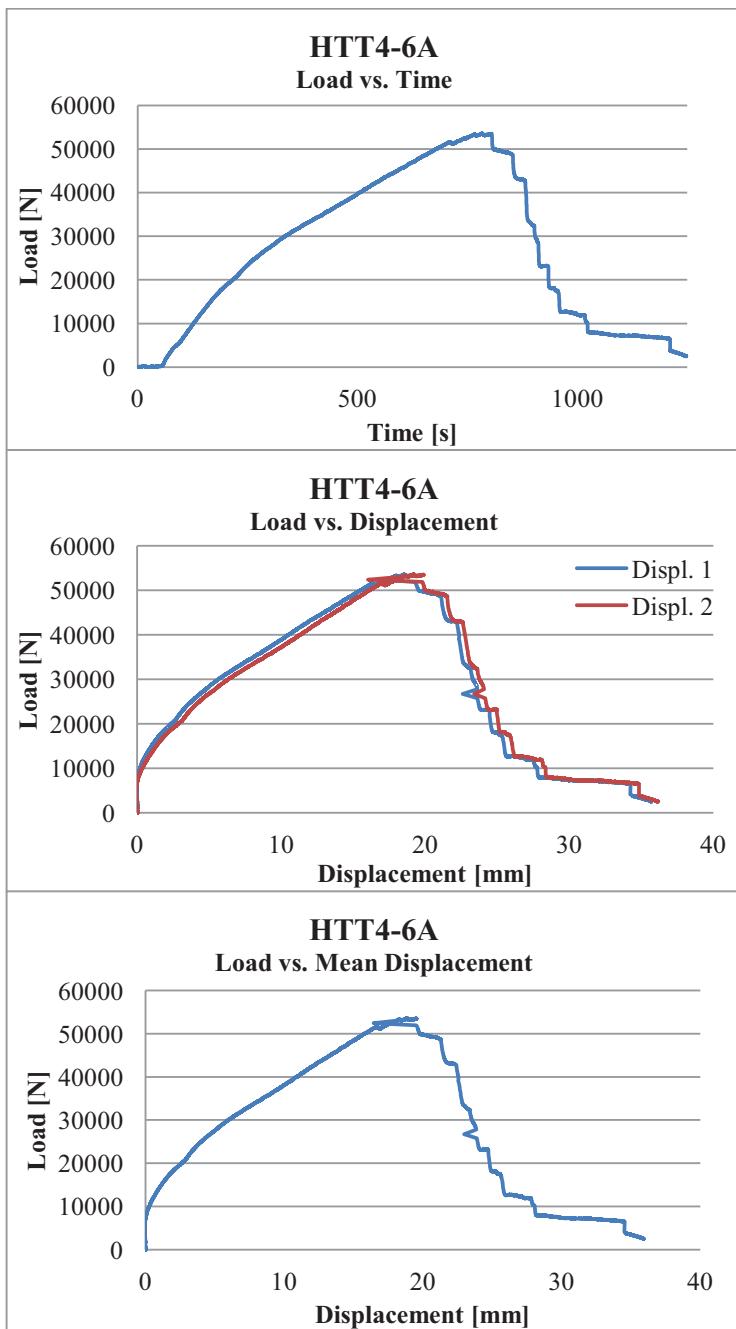
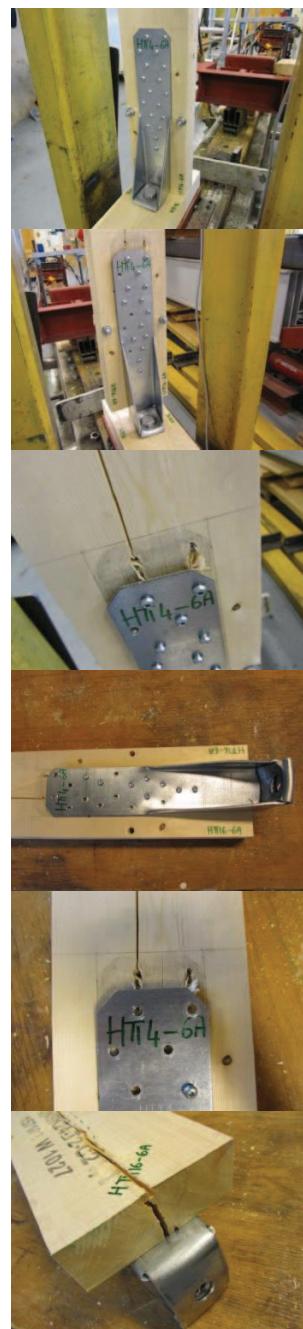
Failure	3a
Failure load [N]	53590
Displacement 1 [mm]	18.6
Displacement 2 [mm]	19.2
Mean Displacement [mm]	18.9
Moisture [%]	9.76
Density [kg/m ³]	456

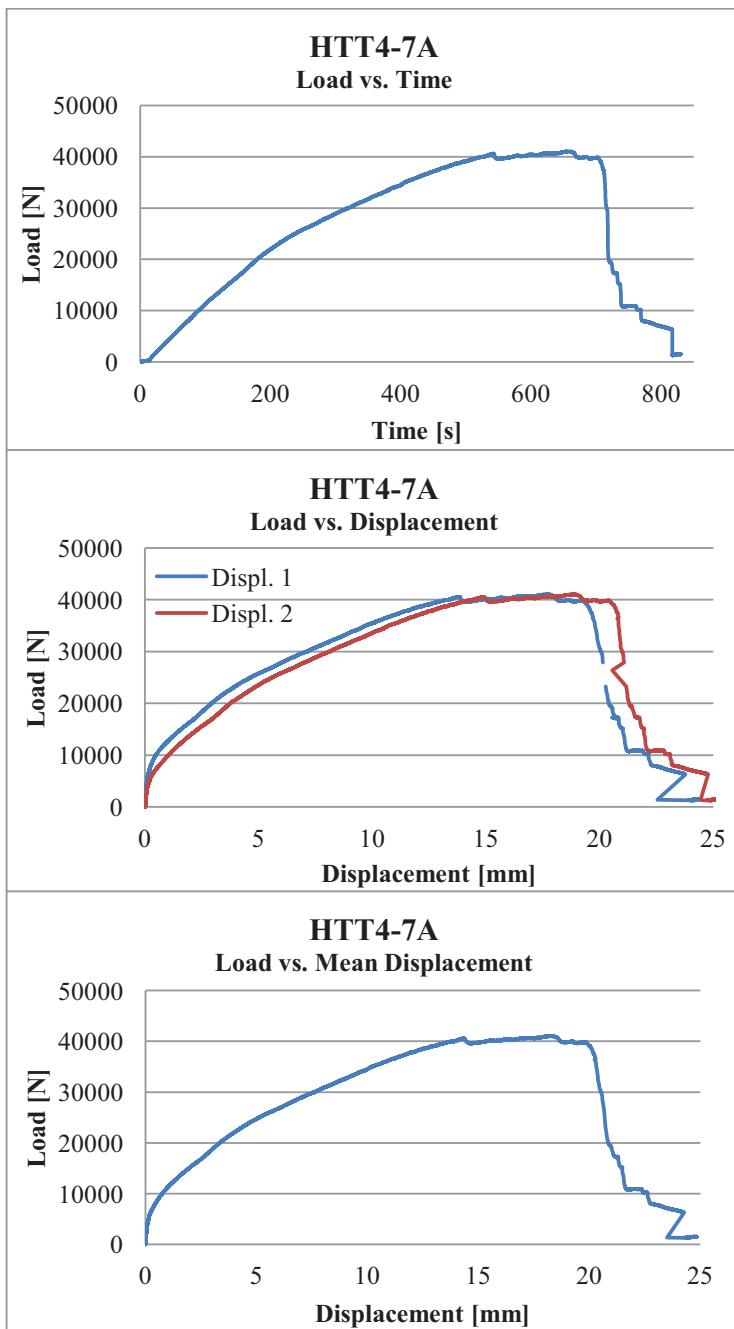
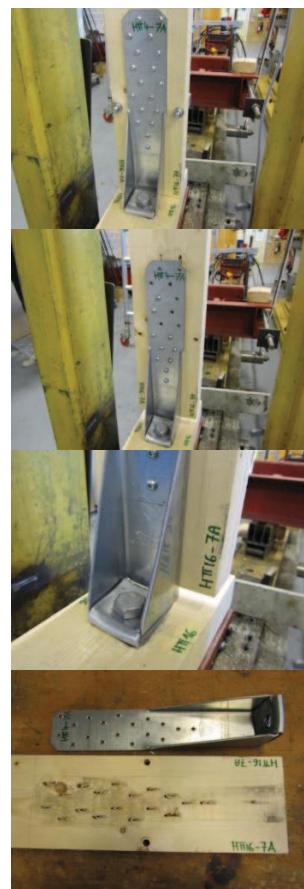
Failure	3a
Failure load [N]	41046
Displacement 1 [mm]	17.7
Displacement 2 [mm]	18.9
Mean Displacement [mm]	18.3
Moisture [%]	9.48
Density [kg/m ³]	440

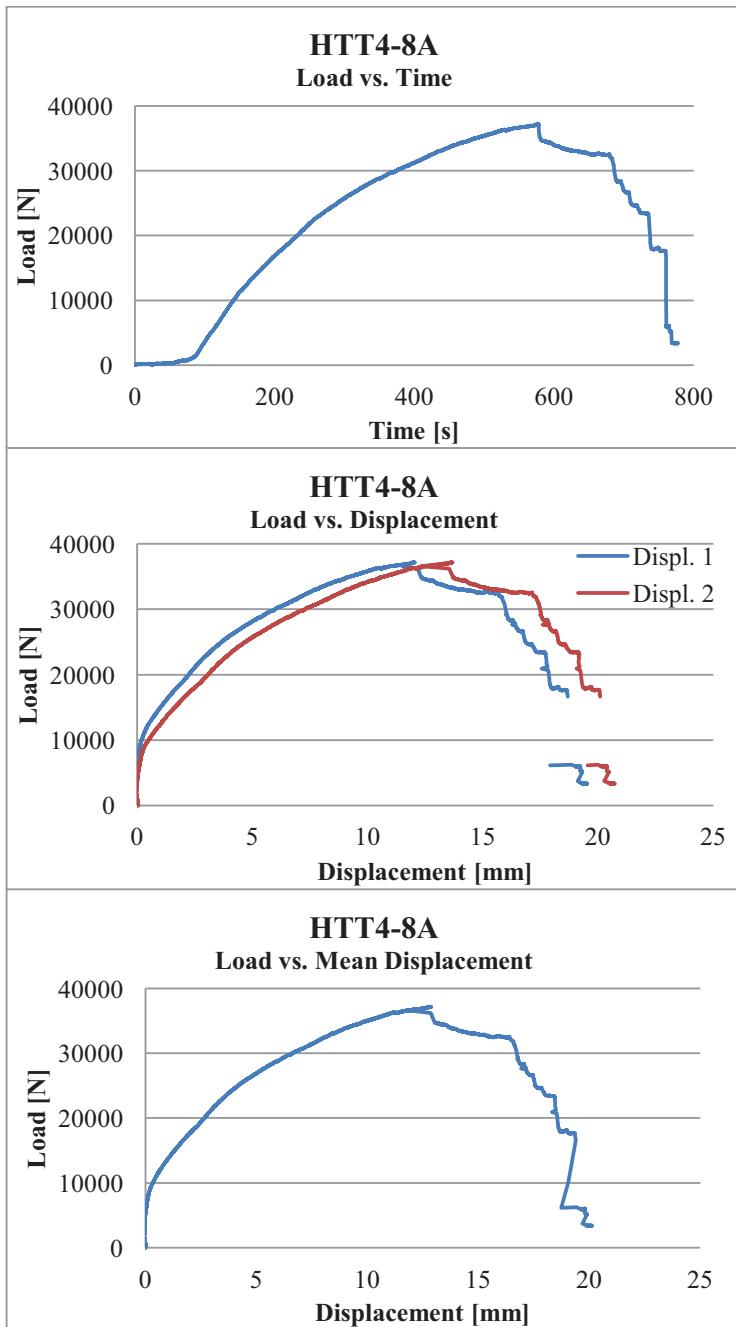
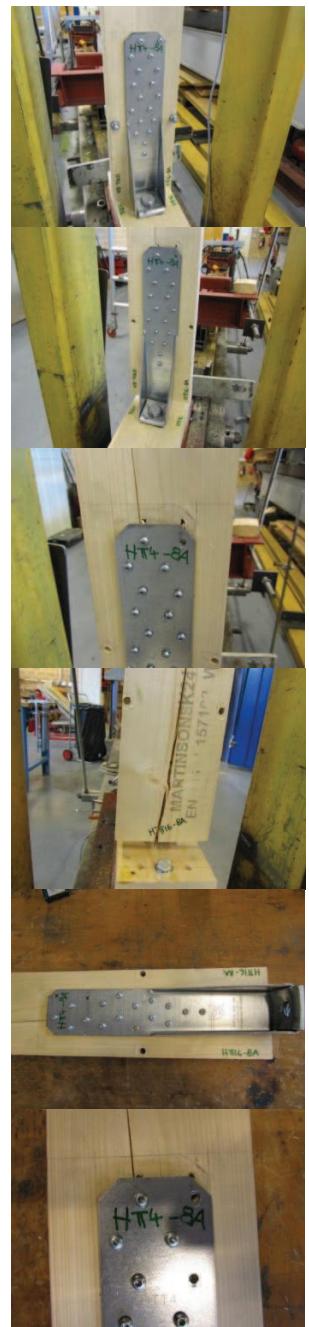
Failure	3a
Failure load [N]	37198
Displacement 1 [mm]	12.0
Displacement 2 [mm]	13.7
Mean Displacement [mm]	12.8
Moisture [%]	7.58
Density [kg/m ³]	336

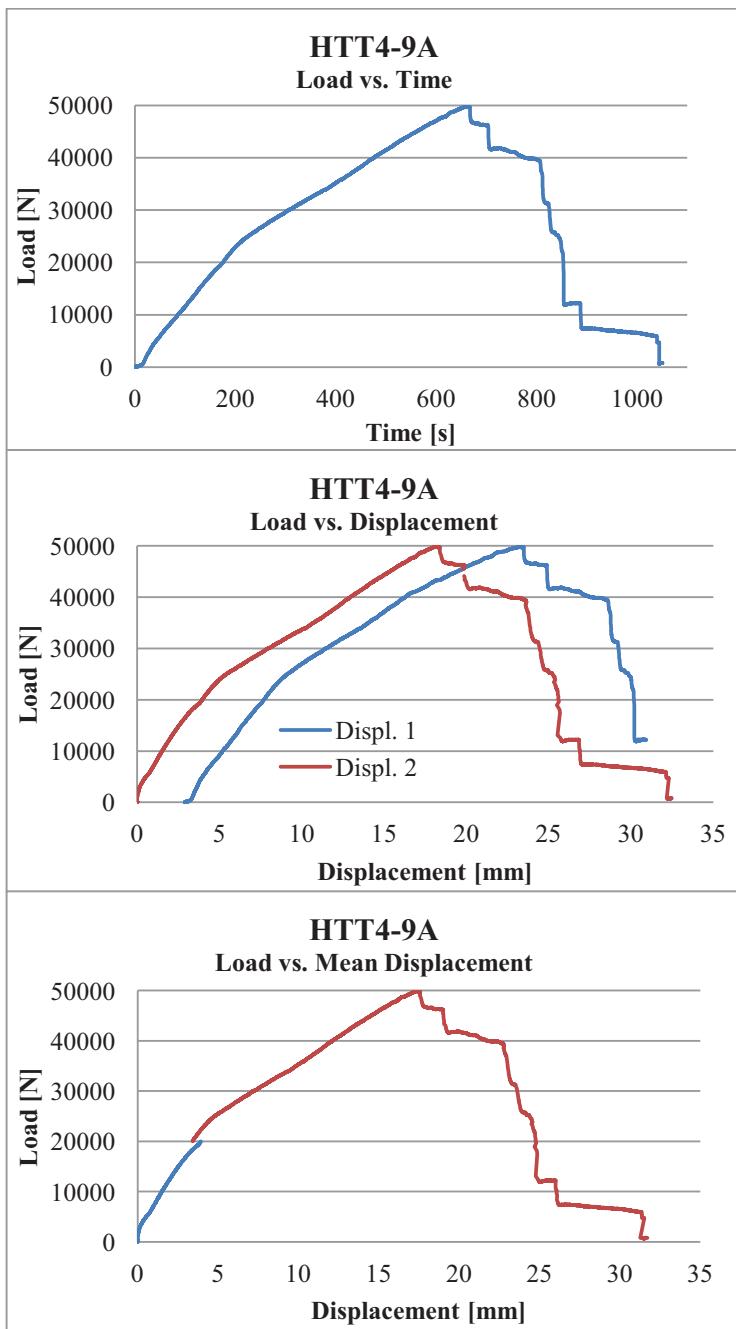
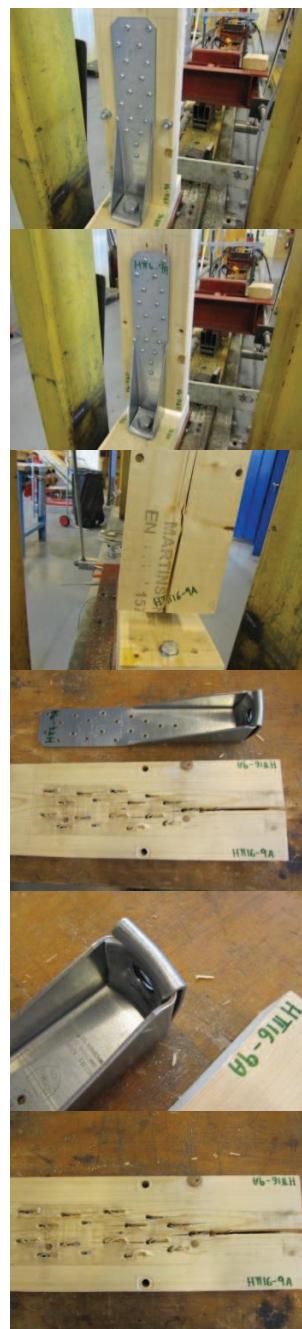
Failure	3a
Failure load [N]	49921
Displacement 1 [mm]	16.6
Displacement 2 [mm]	18.2
Mean Displacement [mm]	17.4
Moisture [%]	8.56
Density [kg/m ³]	409

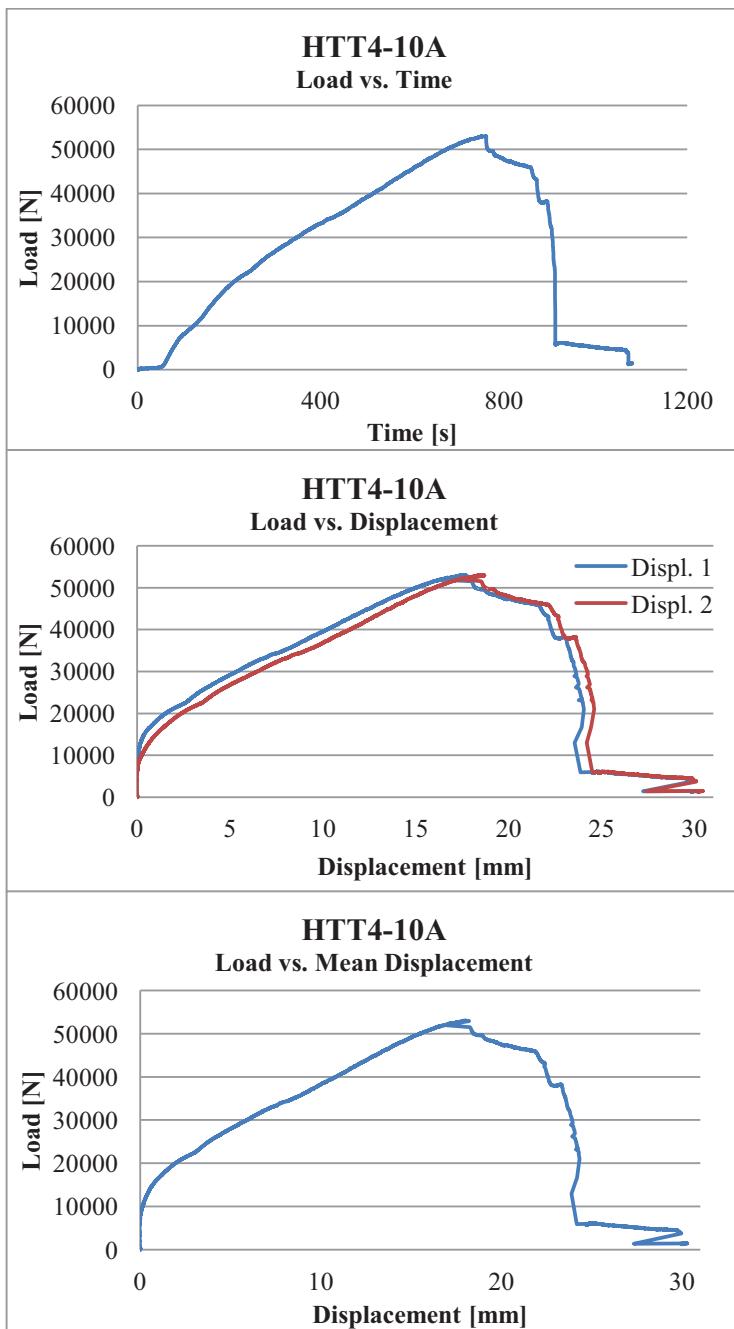
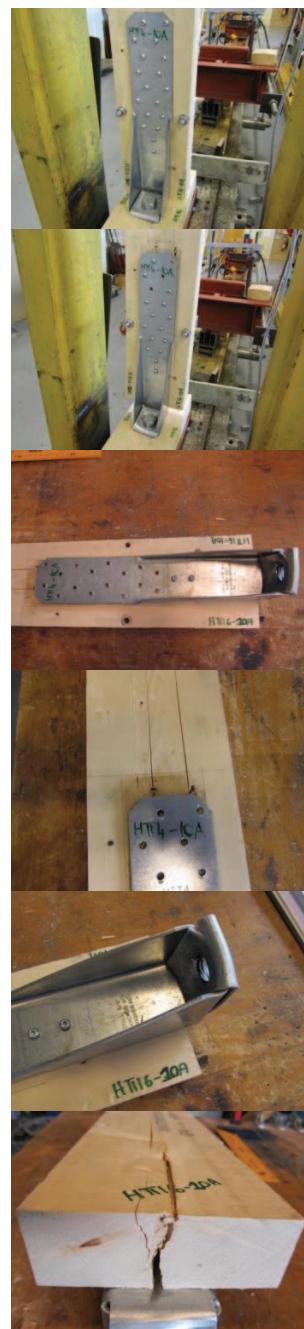
Failure	3a
Failure load [N]	53022
Displacement 1 [mm]	17.5
Displacement 2 [mm]	18.4
Mean Displacement [mm]	18.0
Moisture [%]	9.57
Density [kg/m ³]	444

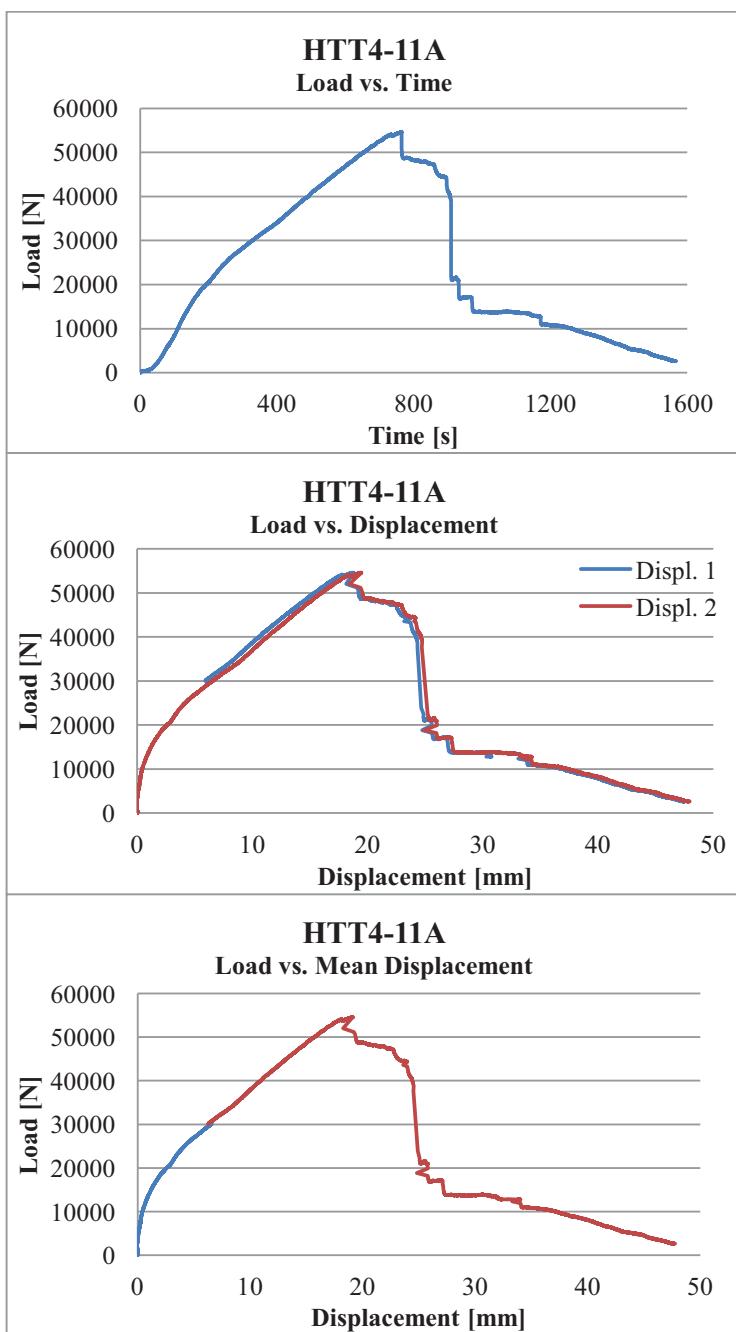
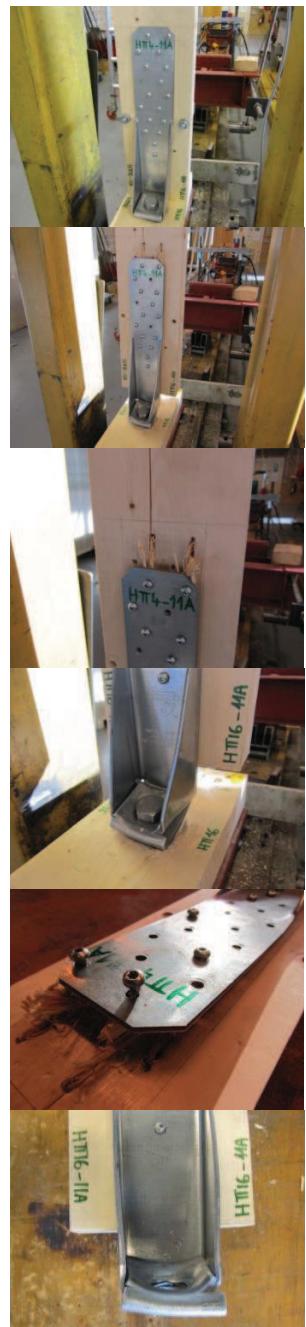
Failure	3a
Failure load [N]	54604
Displacement 1 [mm]	18.8
Displacement 2 [mm]	19.5
Mean Displacement [mm]	19.1
Moisture [%]	8.98
Density [kg/m ³]	458

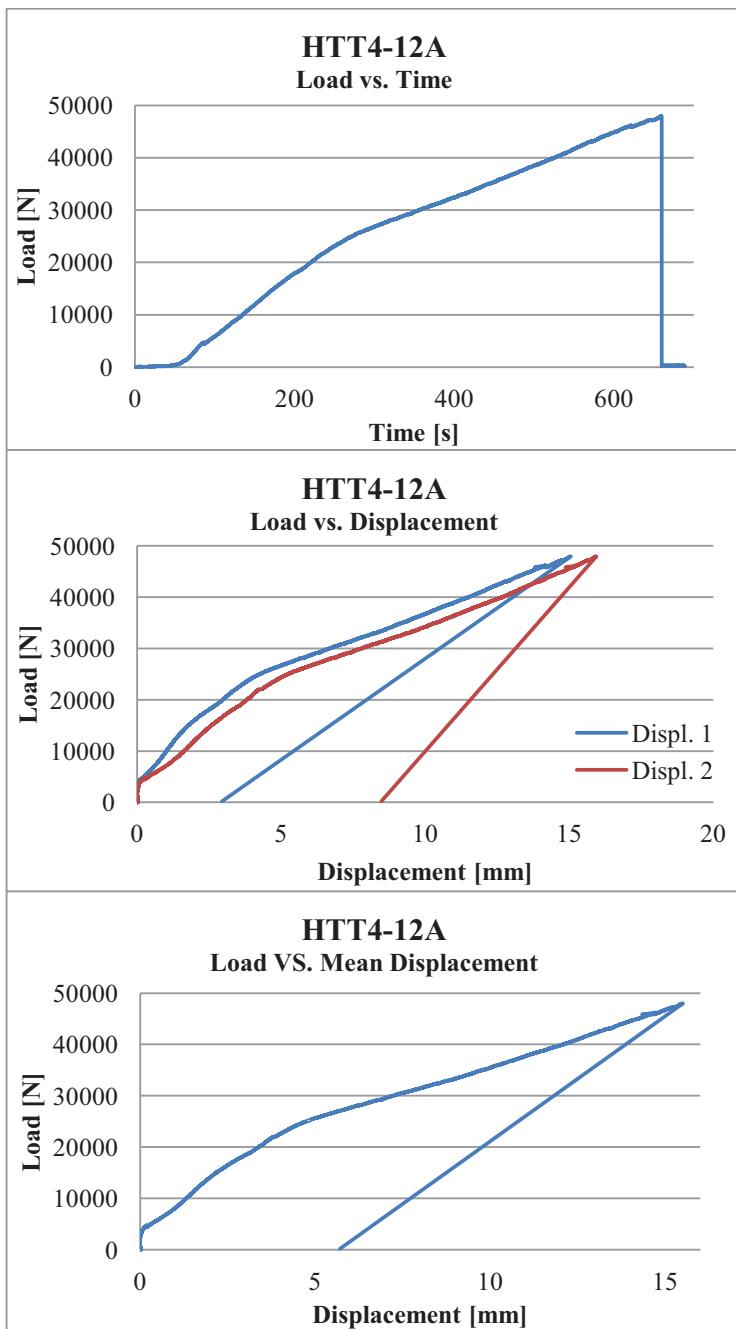
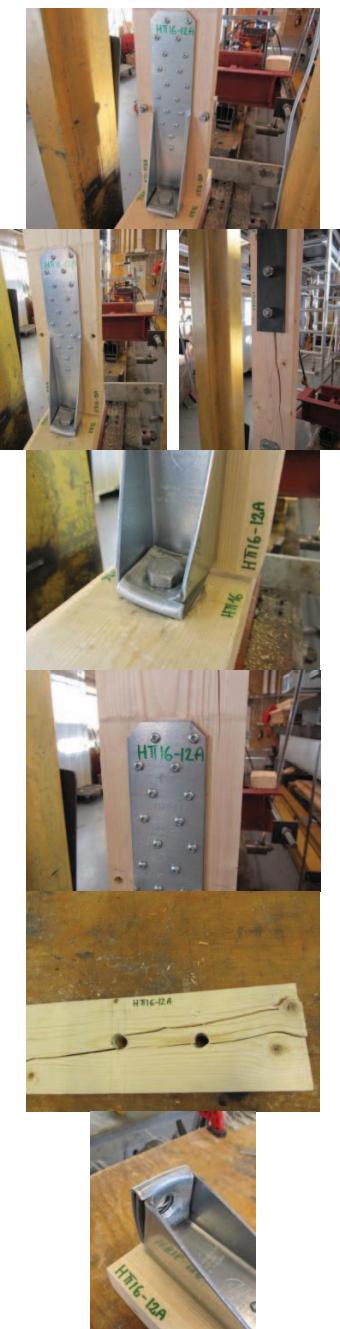
Failure	3b
Failure load [N]	47979
Displacement 1 [mm]	15.1
Displacement 2 [mm]	15.9
Mean Displacement [mm]	15.5
Moisture [%]	8.44
Density [kg/m ³]	369

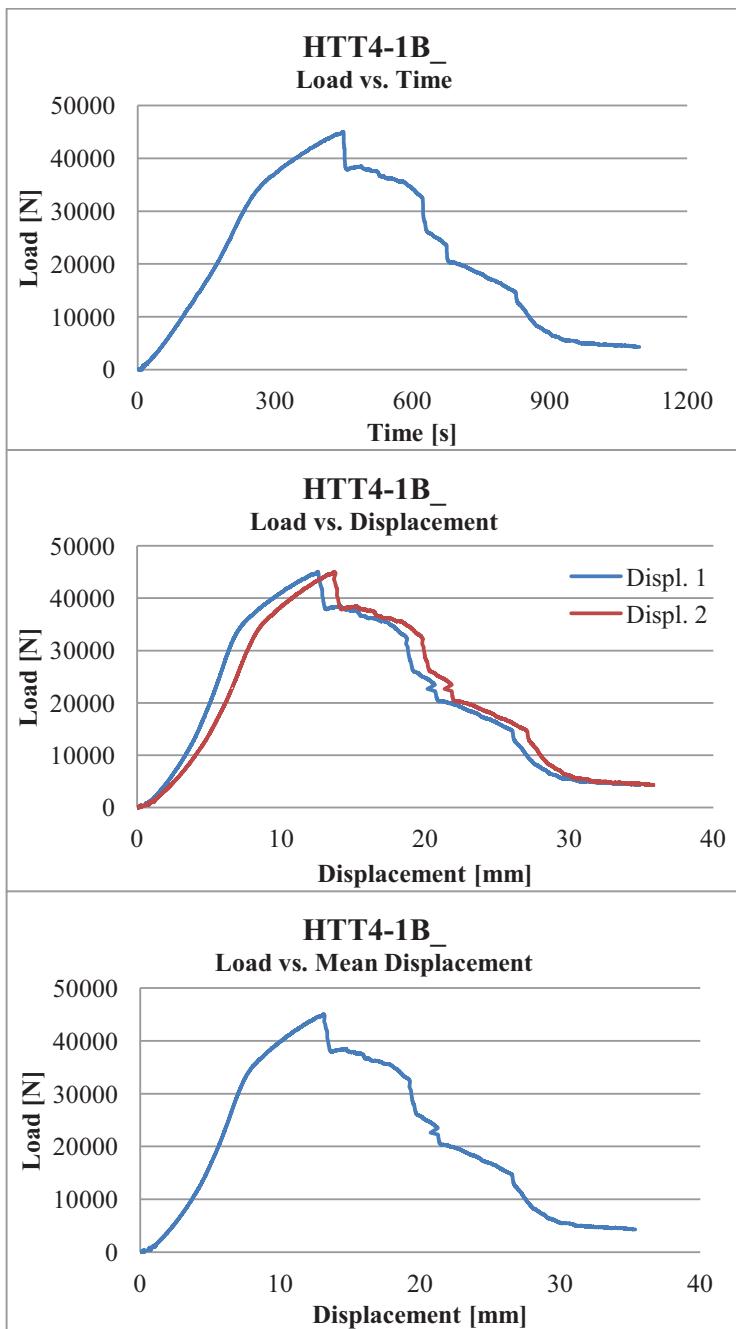
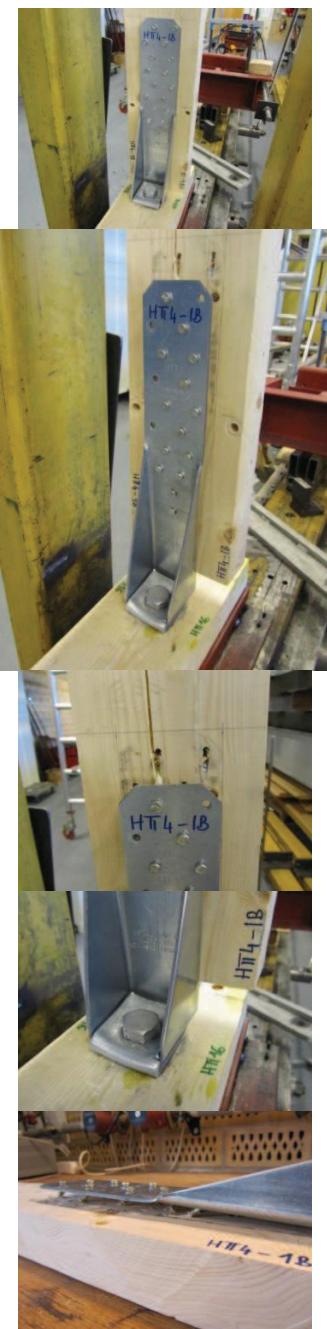
Set 2 – 18 annular ringed shank nails 4x40 on the stud and 1 bolt M16

Failure	3a
Failure load [N]	45067
Displacement 1 [mm]	12.6
Displacement 2 [mm]	13.7
Mean Displacement [mm]	13.1
Moisture [%]	8.81
Density [kg/m ³]	383
