Experimental Testing of Hold Down Devices for Timber Frame Shear Walls

Giuseppe Caprolu

ISSN: 1402-1536
ISBN 978-91-7439-386-6

Luleå 2012

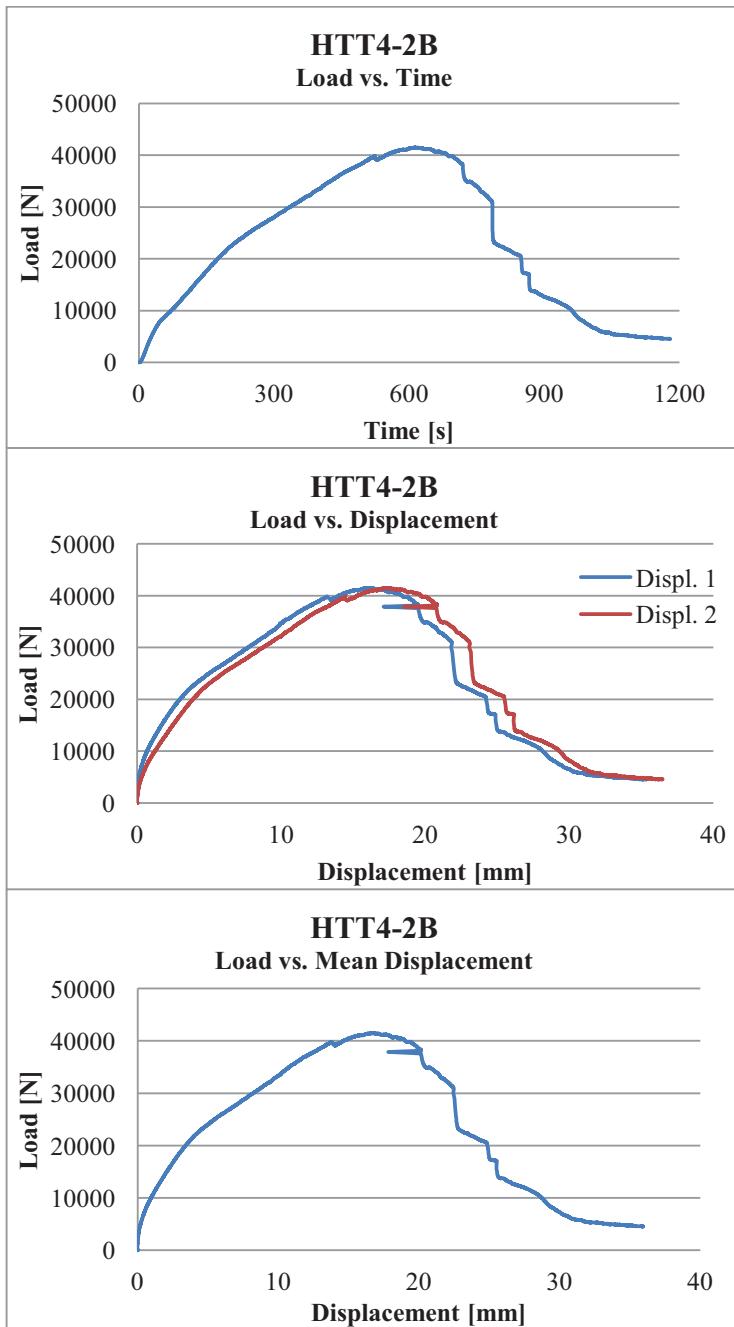
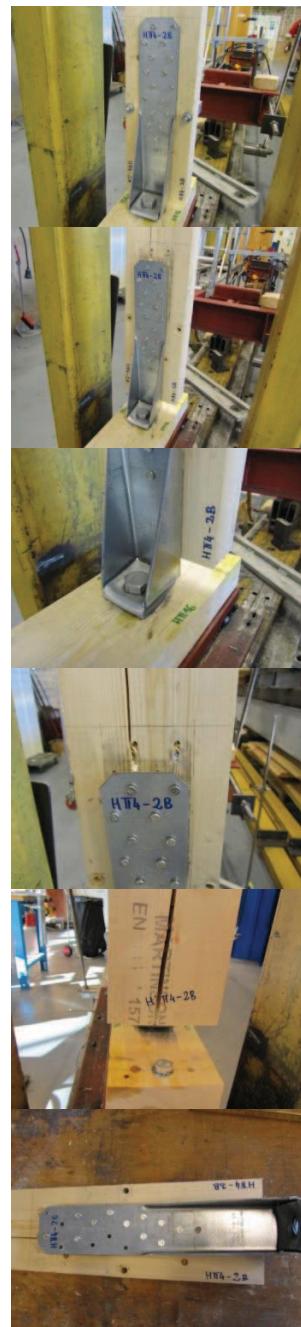
Failure	3a
Failure load [N]	41494
Displacement 1 [mm]	16.0
Displacement 2 [mm]	17.3
Mean Displacement [mm]	16.7
Moisture [%]	8.53
Density [kg/m ³]	400

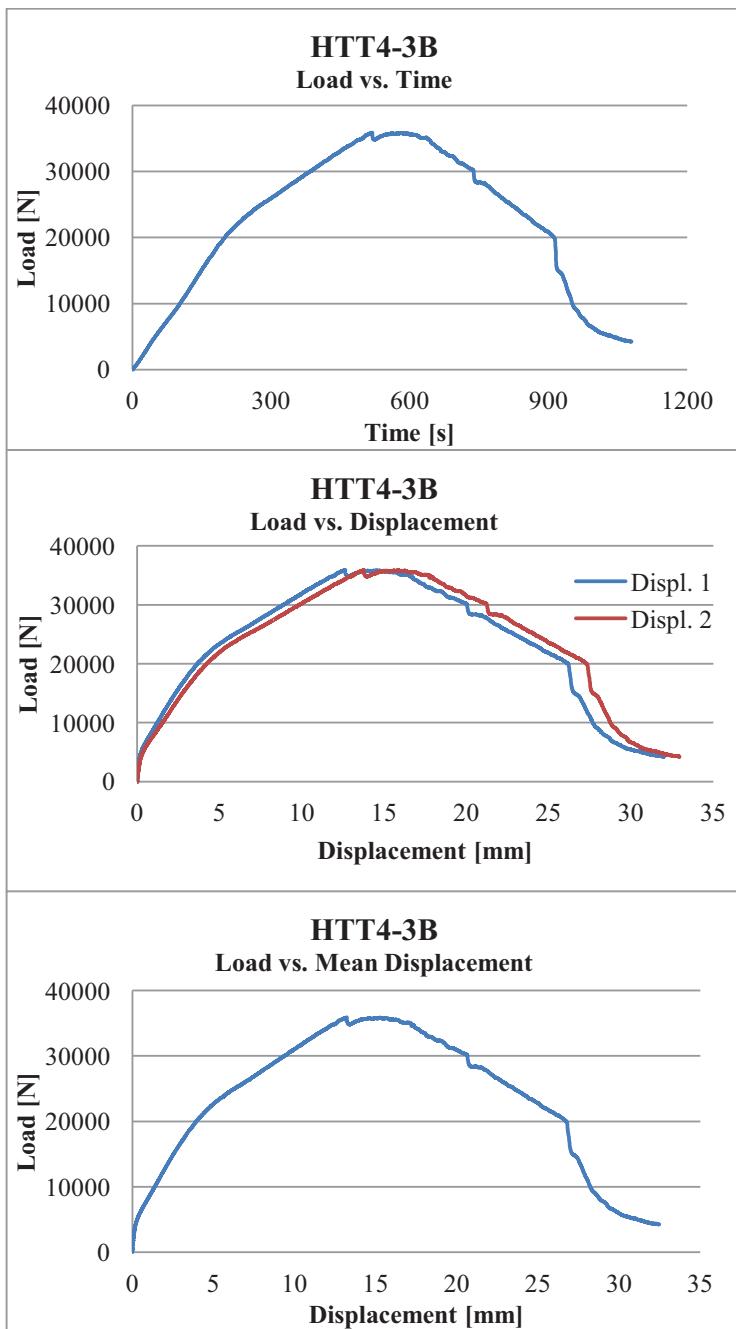
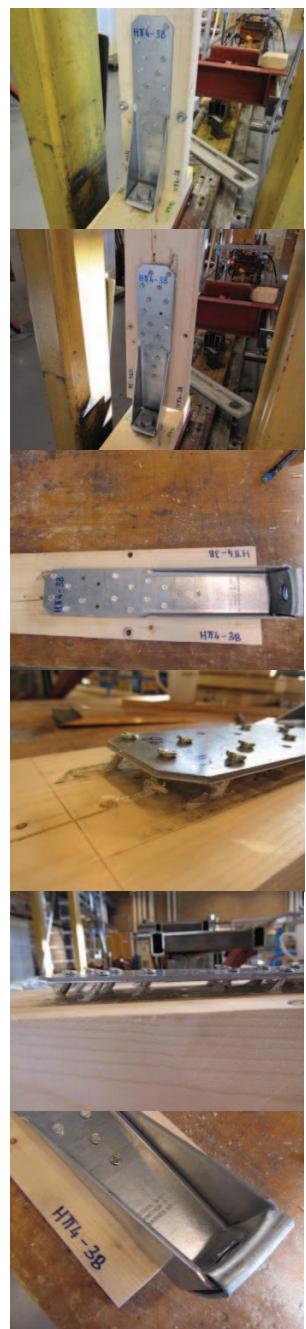
Failure	3a
Failure load [N]	35909
Displacement 1 [mm]	12.6
Displacement 2 [mm]	13.8
Mean Displacement [mm]	13.2
Moisture [%]	7.96
Density [kg/m ³]	330

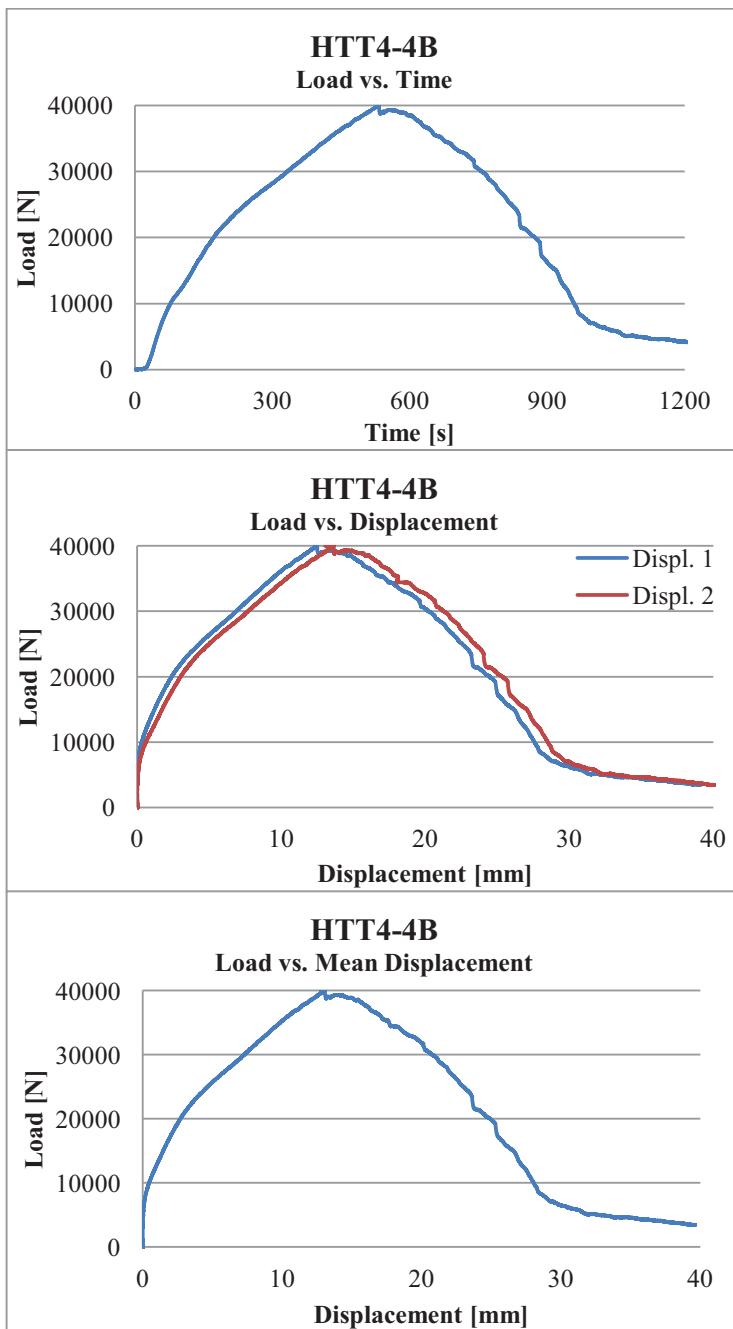
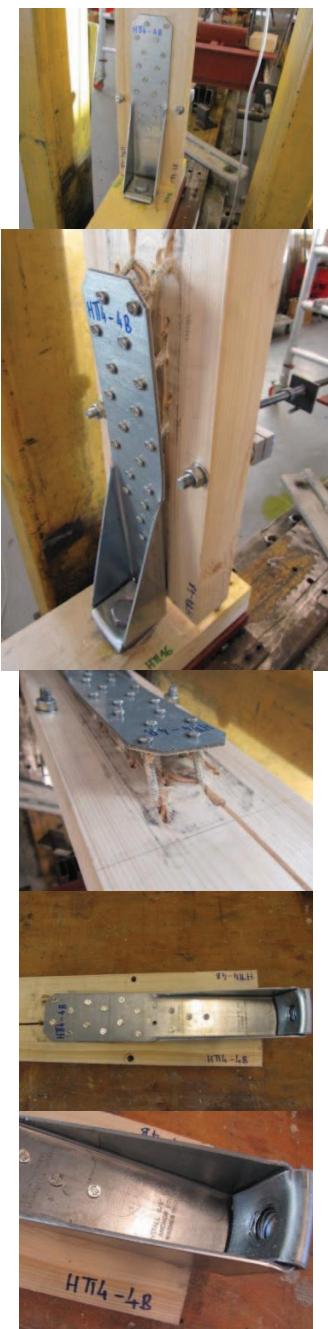
Failure	3a
Failure load [N]	40024
Displacement 1 [mm]	12.5
Displacement 2 [mm]	13.0
Mean Displacement [mm]	12.8
Moisture [%]	8.68
Density [kg/m ³]	379

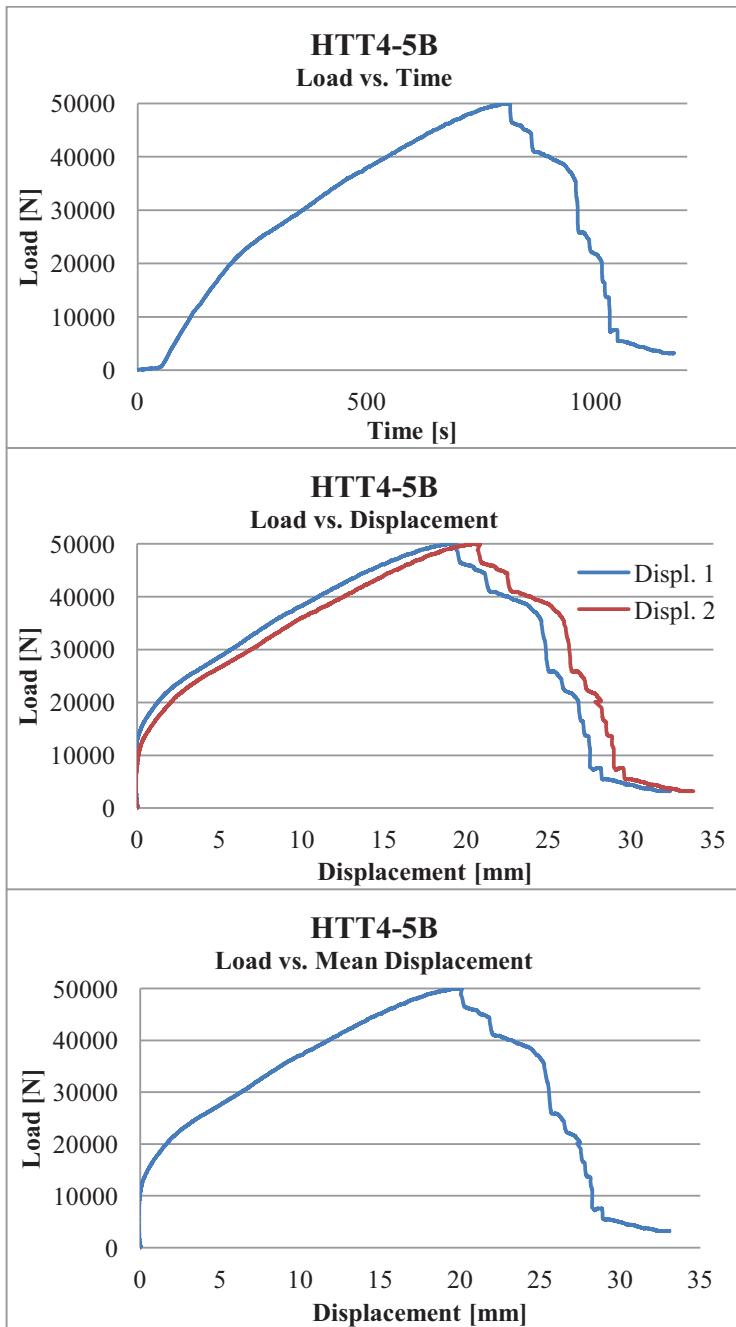
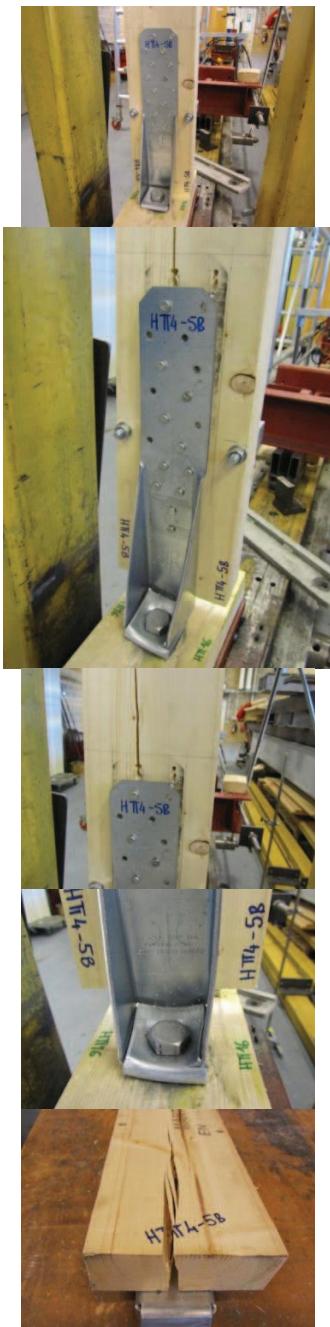
Failure	3a
Failure load [N]	50039
Displacement 1 [mm]	18.9
Displacement 2 [mm]	20.4
Mean Displacement [mm]	19.7
Moisture [%]	8.74
Density [kg/m ³]	396

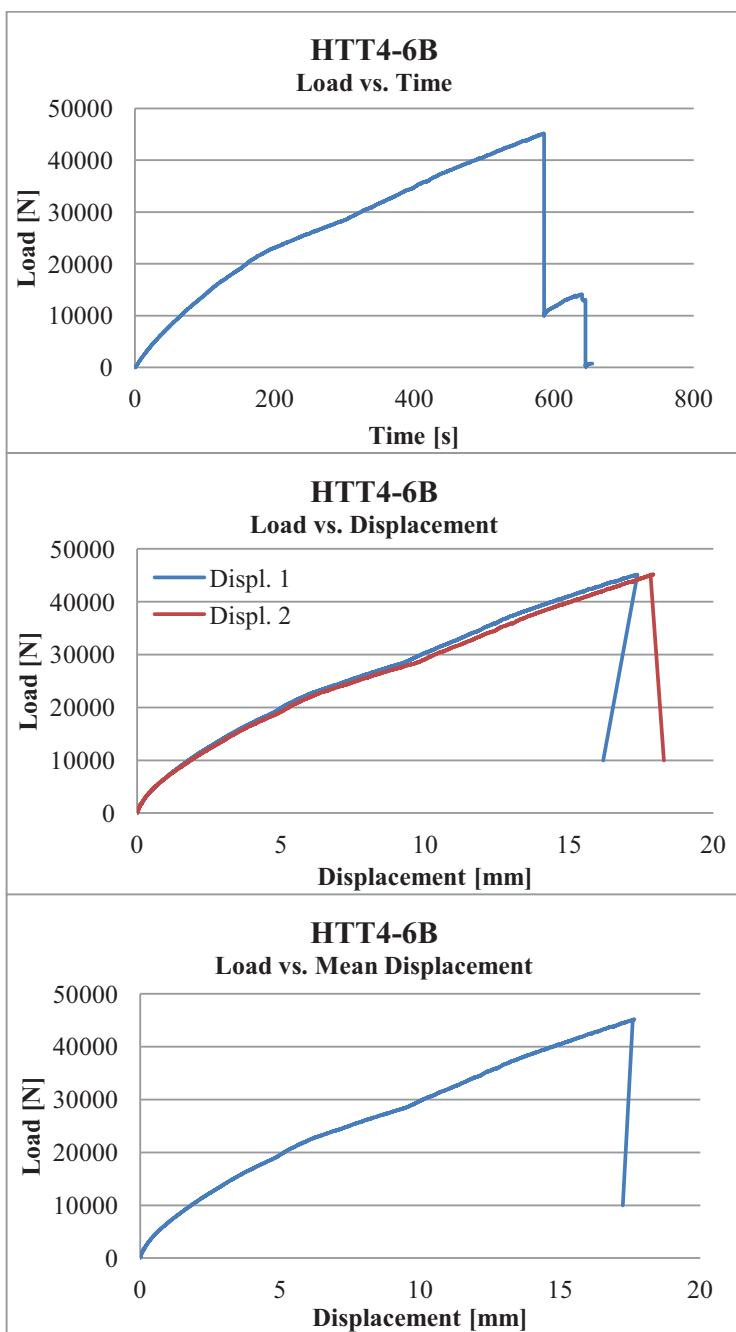
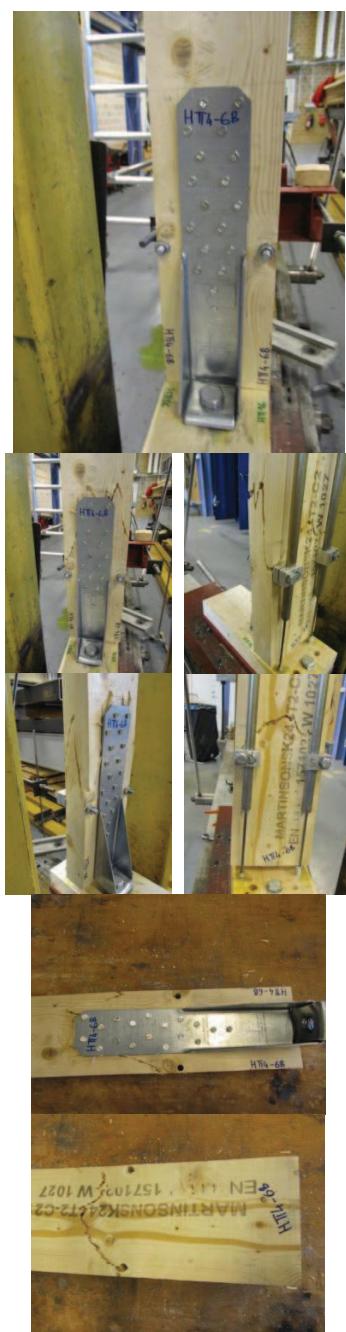
Failure	3b
Failure load [N]	45158
Displacement 1 [mm]	17.4
Displacement 2 [mm]	17.9
Mean Displacement [mm]	17.7
Moisture [%]	7.66
Density [kg/m ³]	385

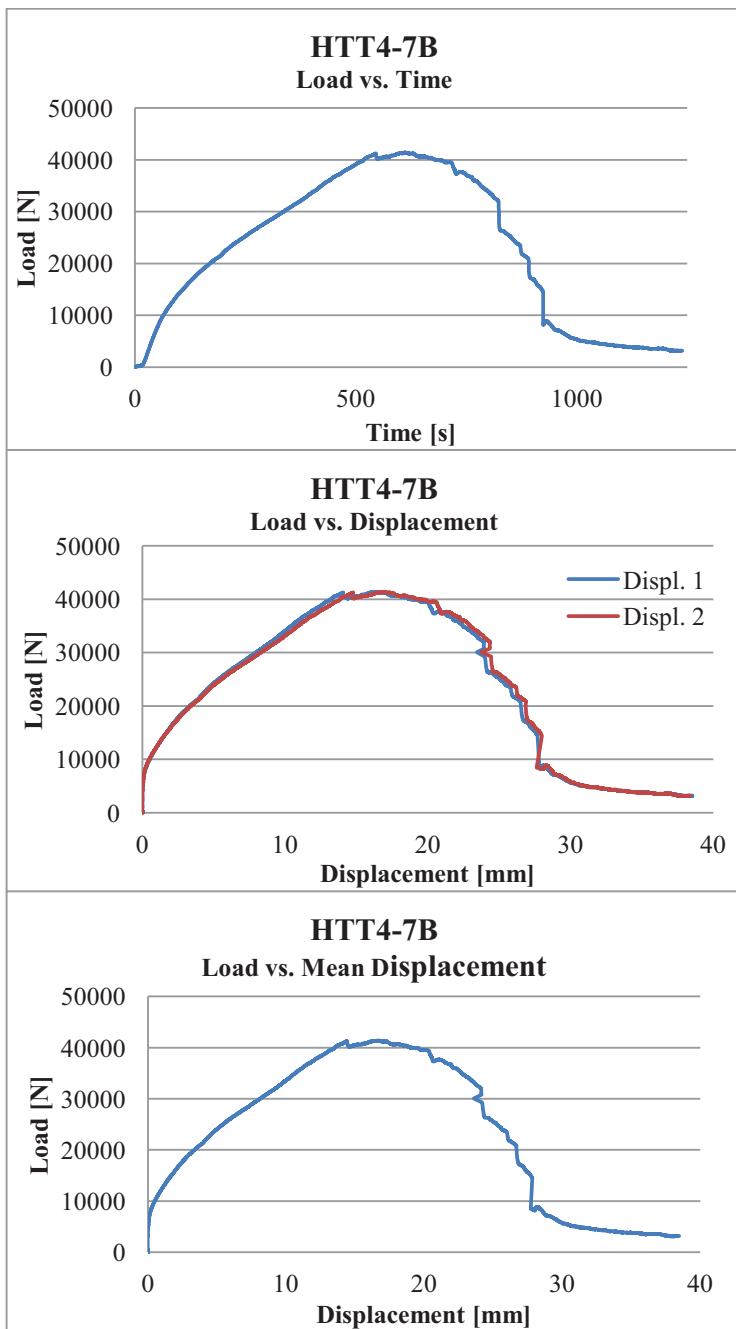
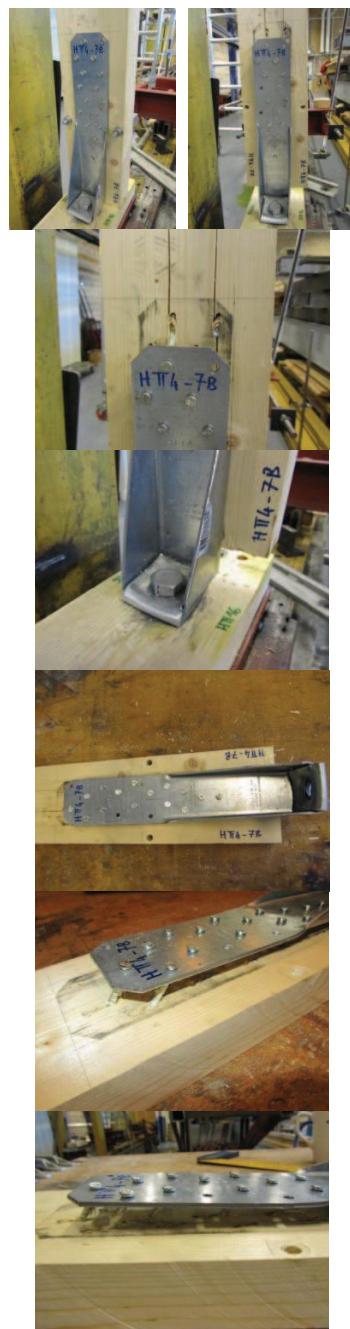
Failure	3a
Failure load [N]	41398
Displacement 1 [mm]	16.4
Displacement 2 [mm]	16.9
Mean Displacement [mm]	16.7
Moisture [%]	9.11
Density [kg/m ³]	450

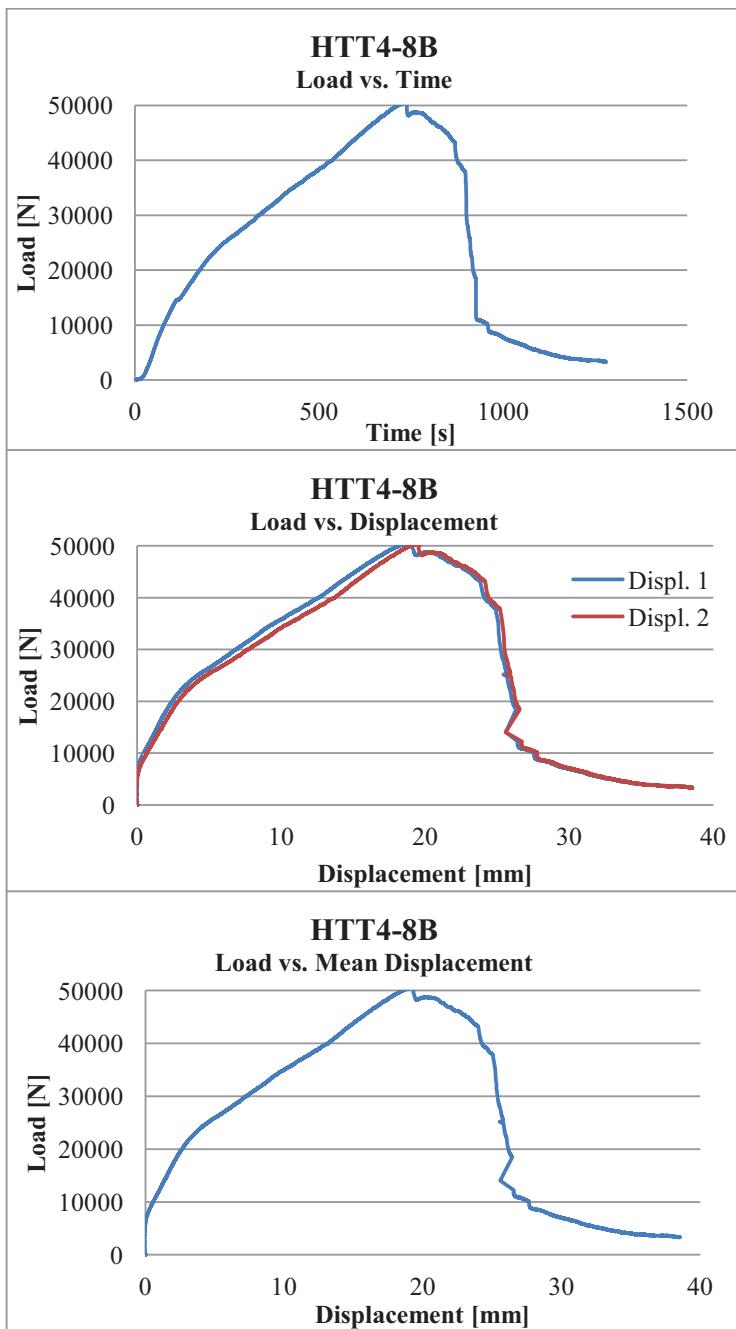
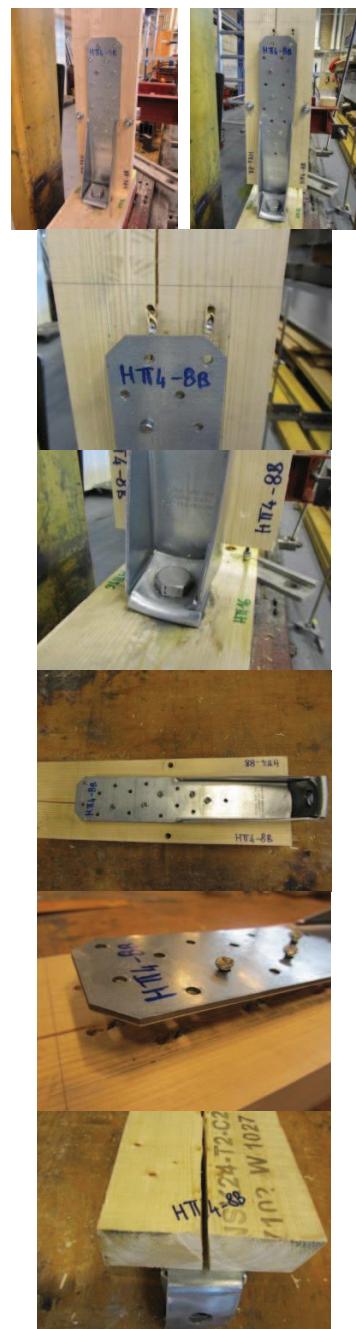
Failure	3a
Failure load [N]	50720
Displacement 1 [mm]	18.9
Displacement 2 [mm]	19.7
Mean Displacement [mm]	19.3
Moisture [%]	9.30
Density [kg/m ³]	425

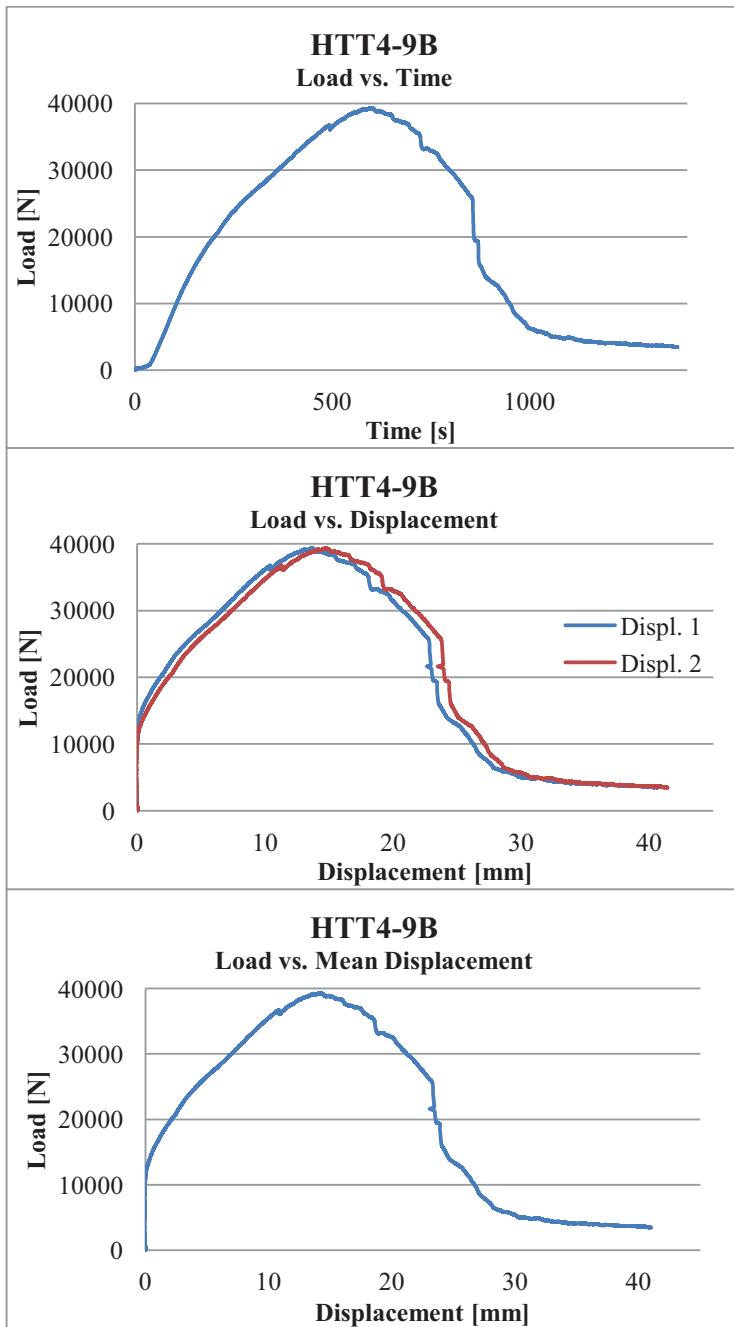
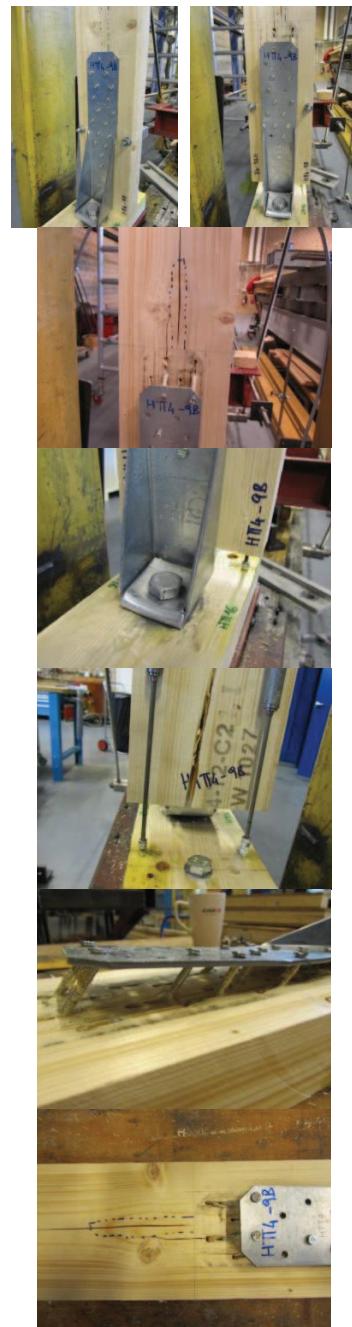
Failure	3a
Failure load [N]	39319
Displacement 1 [mm]	13.6
Displacement 2 [mm]	14.7
Mean Displacement [mm]	14.1
Moisture [%]	8.45
Density [kg/m ³]	395

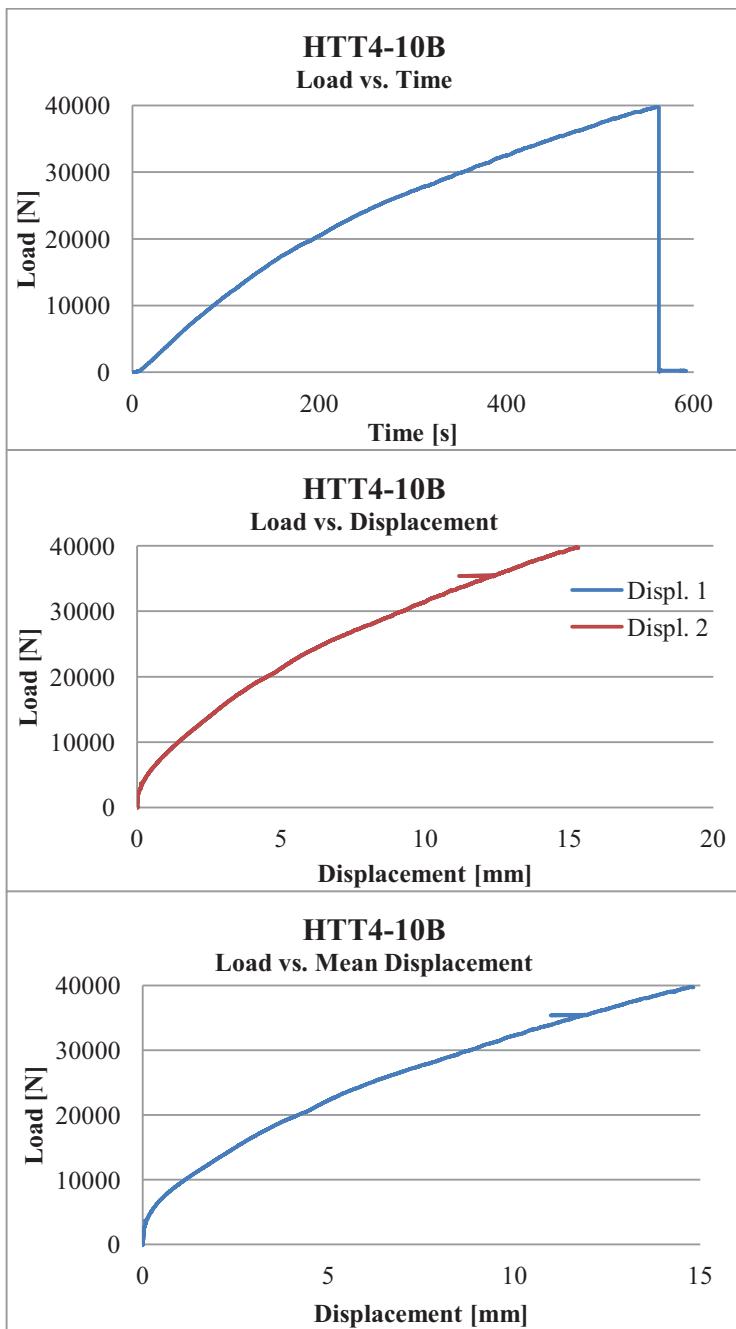
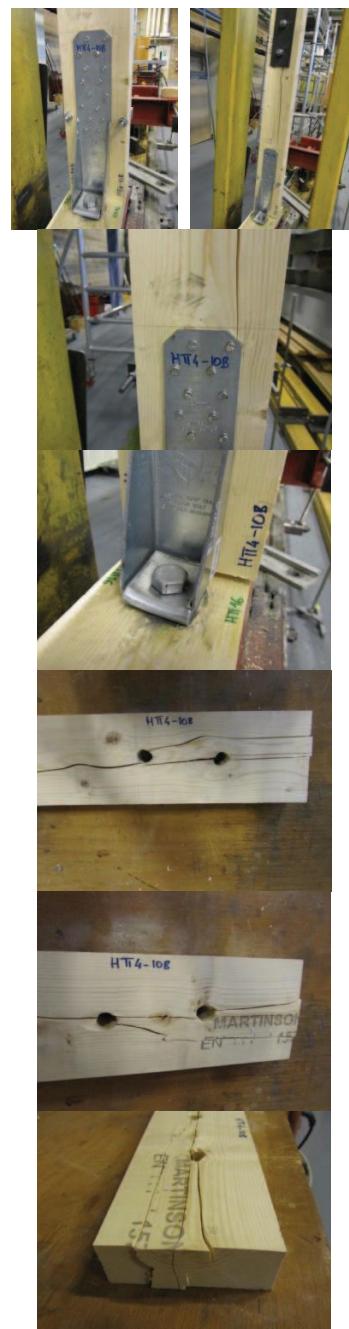
Failure	3b
Failure load [N]	39760
Displacement 1 [mm]	14.3
Displacement 2 [mm]	15.3
Mean Displacement [mm]	14.8
Moisture [%]	8.81
Density [kg/m ³]	361

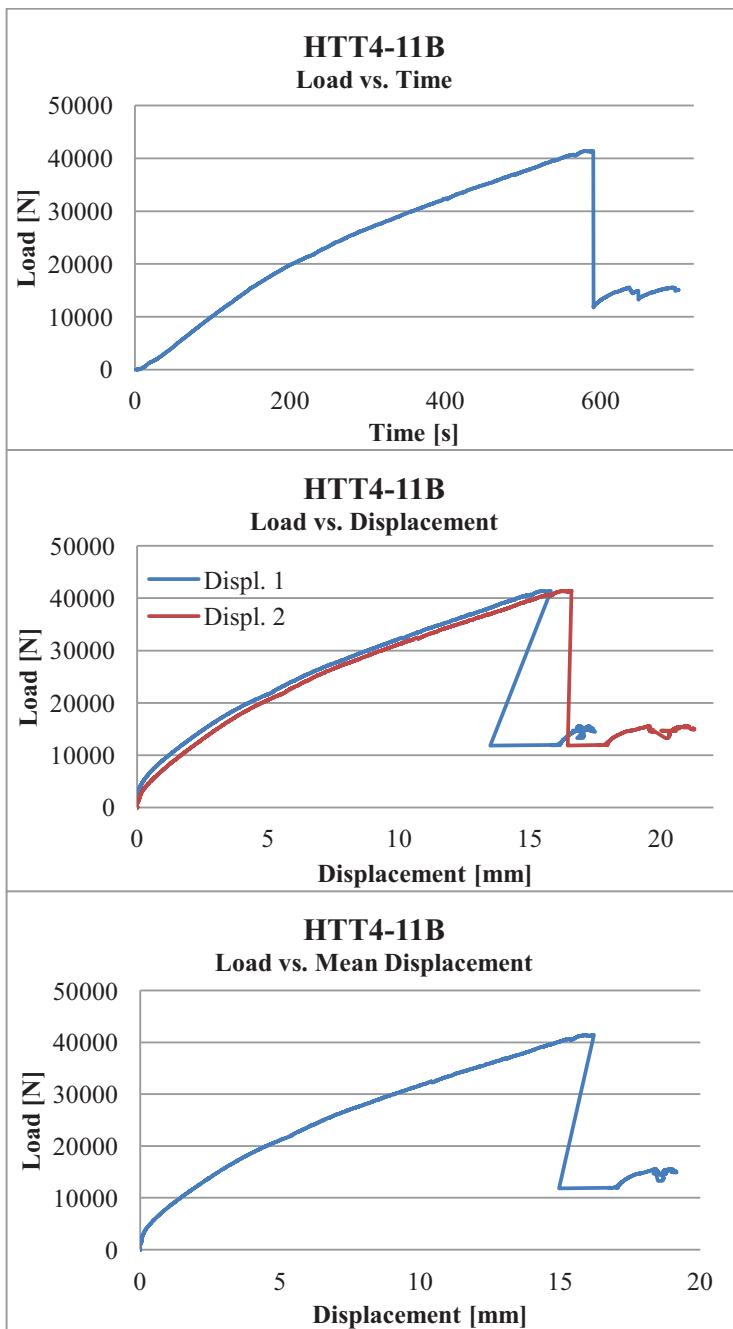
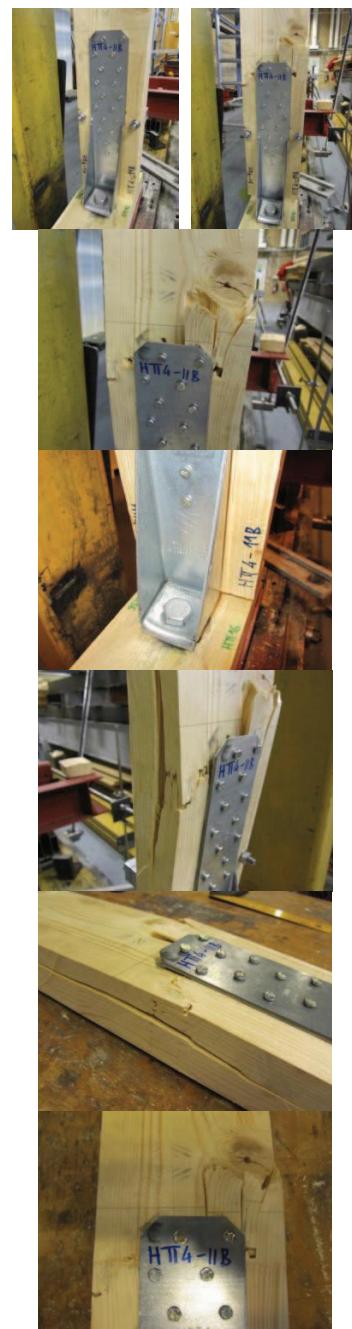
Failure	3b
Failure load [N]	41399
Displacement 1 [mm]	15.8
Displacement 2 [mm]	16.6
Mean Displacement [mm]	16.2
Moisture [%]	7.80
Density [kg/m ³]	387

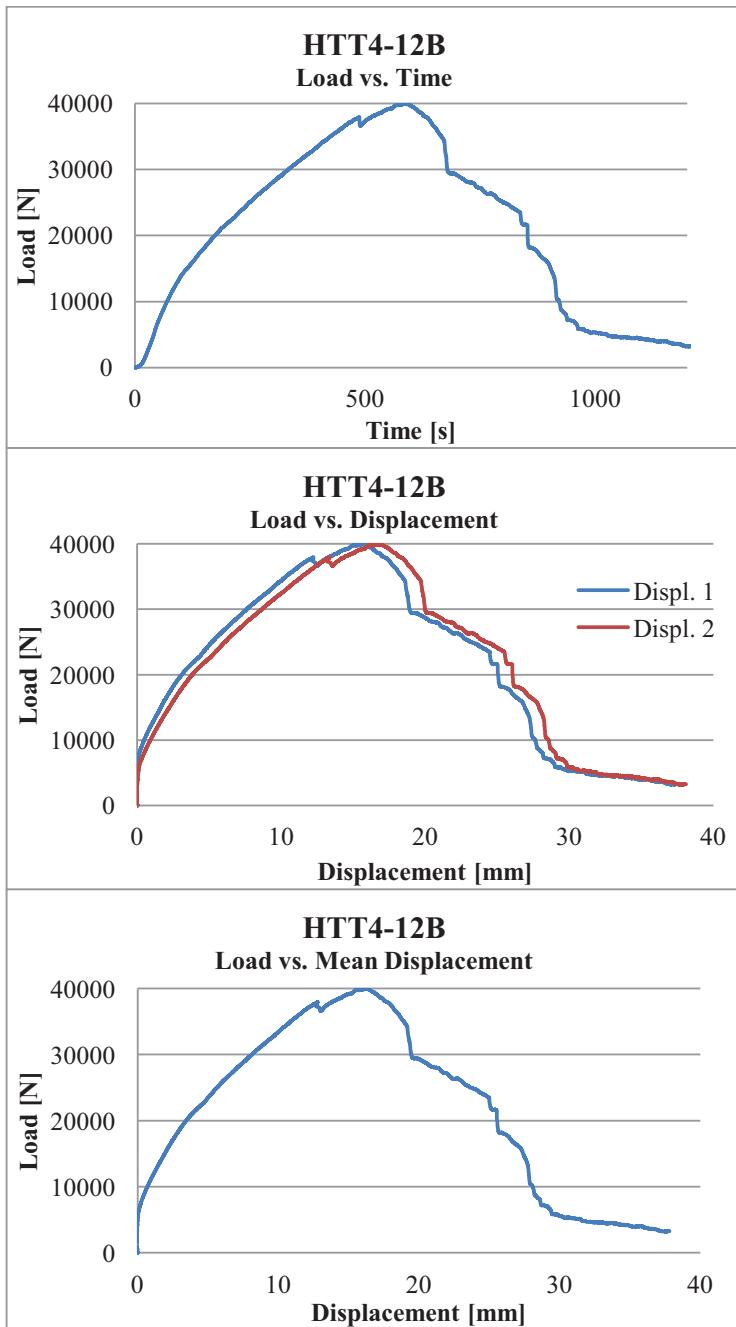
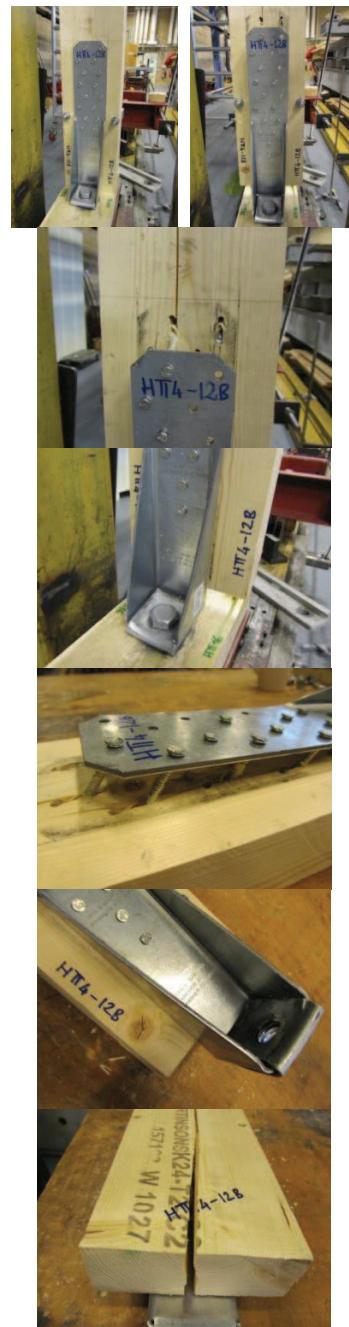
Failure	3a
Failure load [N]	39979
Displacement 1 [mm]	15.8
Displacement 2 [mm]	16.9
Mean Displacement [mm]	16.3
Moisture [%]	8.68
Density [kg/m ³]	425

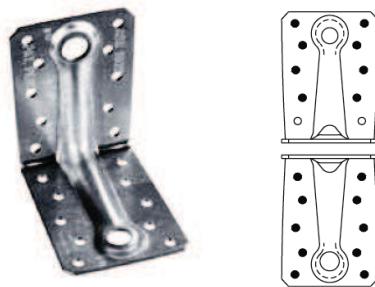
- 2) Connector Simpson strong-tie ABR 9020: steel angle connector (*Steel S250GD*) is used for joints in load bearing timber structures. For fastening of timber used annular ringed shank nails CAN 4.0x40 mm or wooden screws CSA 5.0x40 mm. For fixing in concrete used a bolt M10.

Dimension [mm]				Holes	
A	B	C	Thickness	\varnothing	Number
90	90	65	2.5	5 11	10+10 1+1

Connector ABR 9020 has been used in Series 2.
