# Potential Sources of Stormwater Pollutants

*Leaching of Metals and Organic Compounds from Roofing Materials*

Master of Science in Engineering Technology  
Natural Resources Engineering

Luleå University of Technology  
Department of Civil, Environmental and Natural Resources Engineering

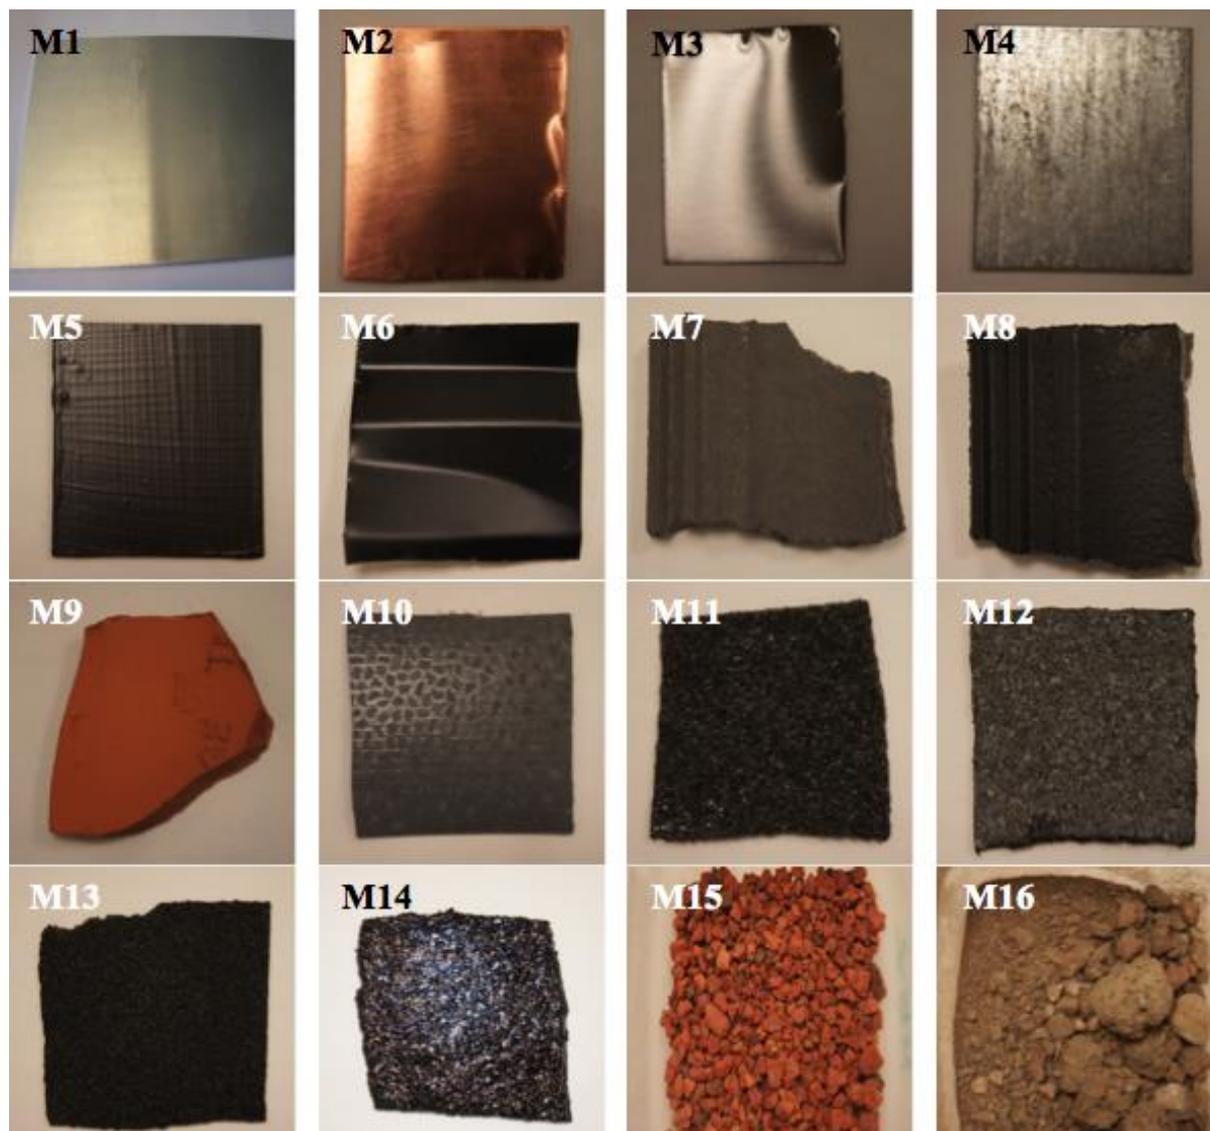
**Figure 1** Photos and labelling of the roofing materials included in the study.

Materials M1 – M4 as well as M9, M15 and M16 were only analysed regarding metals. Nonylphenols and nonylphenol ethoxylates were analysed on nearly all of the materials included in the organic compounds leaching, since the usage of NPEOs is referred to as close to universal (Björklund, 2011). PAHs have been shown to be present in bitumen (Bolliet et al., 2013) and was therefore analysed on the bitumen products (M11 – M14). Phthalates were analysed on the felt roofs and shingle (M11 – M13), since phthalates have previously been reported to be present in SBS-bitumen (Lindström, 2007). The PVC (M10) and the roof paint (M5) were also analysed concerning phthalates, as they are known to be present in PVCs and paints (Björklund et al., 2007). Closer descriptions of the performed analyses are presented in Table 6.

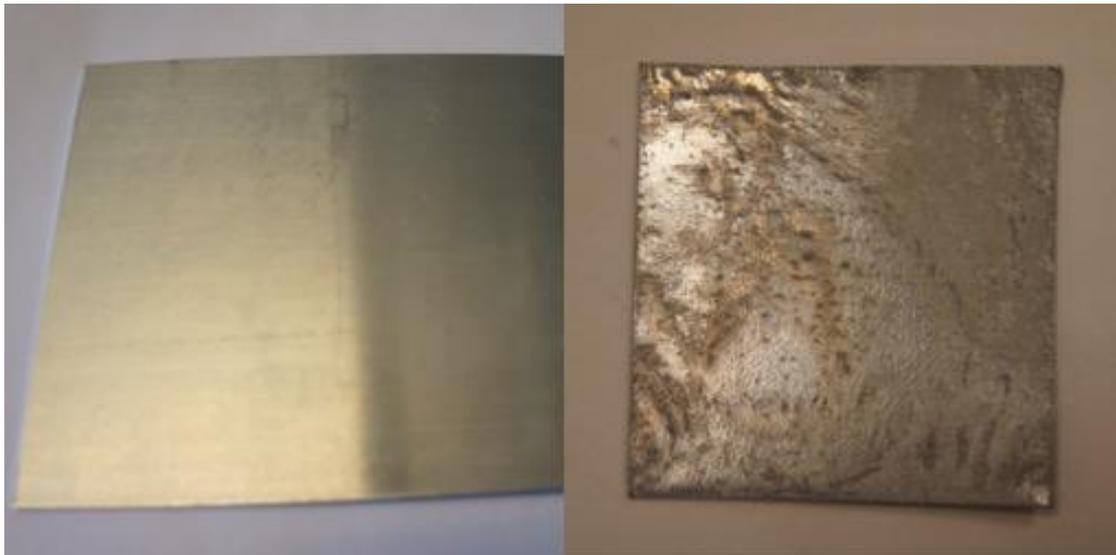
After the leaching experiments, the visual inspection of the materials showed that the surface of zinc sheet was covered with a light coating different from before the leaching, suggesting that some kind of reaction, e.g. oxidation had occurred. This can be seen in Figure 2. A flake-like structure was observed on the surface of the leachate from the galvanised steel when collecting the samples, but the material itself looked similar to before the leaching experiments. The surface structure of the other materials also appeared similar to prior to the leaching experiments.

**Figure 2** The zinc sheet prior to the leaching (left) and after the leaching (right).

before and after the leaching procedure, presented in Figure 2, indicates formation of corrosion products. This may also explain the release of particulate Zn from the zinc sheet and galvanised steel. Bertling et al. (2006) performed outdoor measurements on different types of zinc based material panels and suggested corrosion product formation of basic zinc carbonates and also experienced an increase of pH in runoff from zinc sheets and galvanised steel. Furthermore, the zinc carbonate Hydrozincite is the initial phase of corrosion product and is also the most abundant phase on zinc roofs (He, 2002). Quek & Förster (1993) reported high concentrations of dissolved zinc from a zinc sheet roof, likely due to weathering. The results from this study implied a release of particulate zinc from the zinc sheet instead, but in this case the zinc sheet was not exposed to weathering. The zinc sheet and the galvanised steel were also the materials that exhibited the highest release of Zn. In addition, the coated steel as well as the metal roof paint also showed a significant release of Zn, indicating use of Zn containing additives in the manufacturing process of these products.

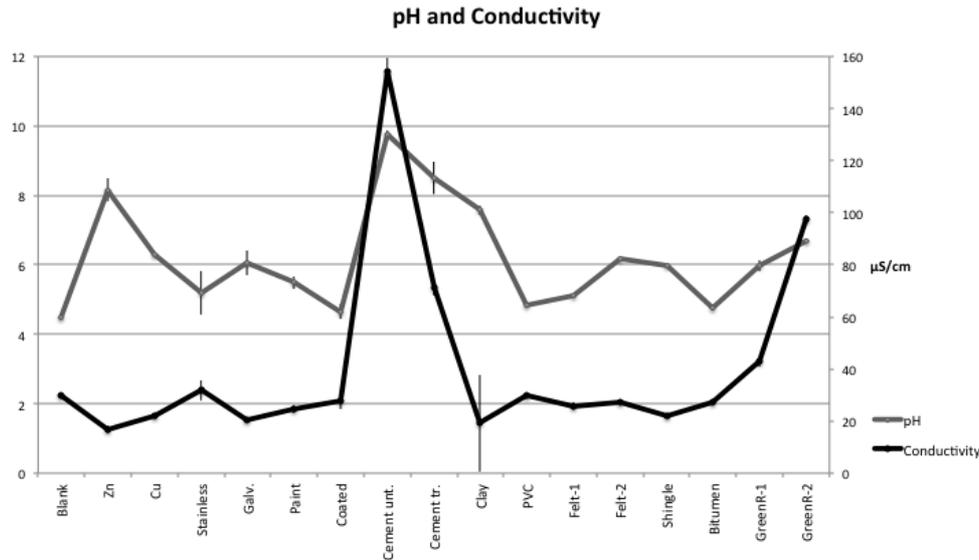
The pH and conductivity were recorded in the leachates from each material duplicates and mean values were calculated. The results are presented in Figure 3 below, where the black line represents conductivity in  $\mu\text{S}/\text{cm}$  with the scale on the right hand axis and the grey line represents pH with the scale on the left hand axis. Prior to the leaching experiments, the pH in the synthetic rainwater was in the range of 4.3 – 4.5 and the conductivity was in the range of 25.1 – 30.3  $\mu\text{S}/\text{cm}$ .

**Figure 3** Mean pH and conductivity in the leachate of each material. The uncertainty bars represent the measured pH/conductivity in each duplicate sample.

Figure 3 shows that the pH and conductivity in the leachate from the blank sample was in the same range as for the synthetic rainwater prior to leaching, mentioned above. The leachates from the stainless steel (M3), the coated steel sheet (M6), the PVC (M10) as well as the bitumen paste (M14) did not show any significant changes in pH or conductivity. The most obvious change in pH was for the untreated cement tile (M7), followed by the zinc sheet (M1) as well as the coated cement tile and the clay tile (M8 – M9). The cement tiles also showed a significant increase in conductivity compared to the synthetic rainwater, as did the green roof substrates. There was a large spread in the conductivity values measured in the leachates from the duplicate clay tiles, which made this result unreliable. This is visible in the long uncertainty bar for the clay tile material in Figure 3. Aside from the clay tile, the zinc sheet and the galvanised steel were the only materials that display notably lower conductivity than the synthetic rainwater.

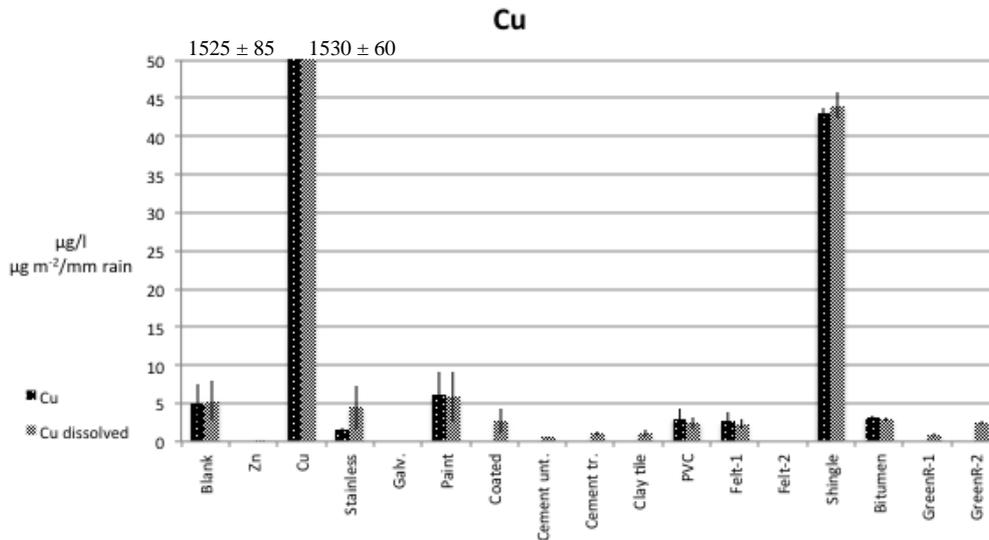
Figure 4 shows the copper concentrations in the leachates from each of the studied materials. The dissolved- and total concentrations were closely conforming to each other for all of the materials. As expected, the Cu concentration in the leachate from the Cu-sheet was significantly higher than concentration in the leachate from any other material. As the entire bar for the Cu-sheet is not visible in the scale for Figure 4, the analysed mean concentrations are presented in the numbers above the bars. Aside from the Cu-sheet, the shingle material

showed high Cu concentrations. None of the other materials showed higher concentrations of copper than the blank sample.

**Figure 4** Mean Cu concentrations in the leachates from each roofing material. The uncertainty bars represent the concentration in each duplicate sample.

Table 7 below displays the estimated potential release of Cu in one year from 100 m<sup>2</sup> roof surface of copper sheet and shingle. The release from both materials was mainly in dissolved form and amount to 110 grams and ca. 3 grams respectively.

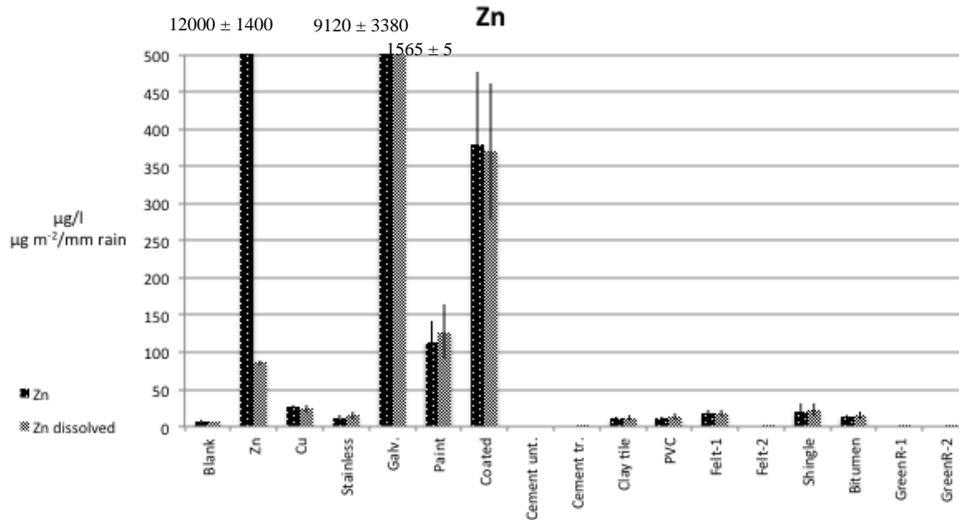
In Figure 5 below, the zinc concentrations for each leachate are presented. There was a strong difference in the total- and dissolved concentrations for the Zn sheet and the galvanised steel, which implied that particulate Zn was released from the materials. The highest concentrations of zinc were found in the leachates from the zinc sheet as well as the galvanised steel. More surprisingly, high concentrations of Zn were also found in the leachate from the metal roof paint and the coated steel. The spread of the concentrations of the duplicate samples concerning the coated steel was relatively high, corresponding to ca. ± 25 % of the mean total and dissolved concentrations.

**Figure 5** Mean Zn concentrations in the leachates from each roofing material. The uncertainty bars represent the concentration in each duplicate sample.

The potential annual release of zinc from chosen roofing materials is presented in Table 8 below. The zinc sheet showed a potential release of almost 900 g zinc per 100 m<sup>2</sup> and year, of which a large part was in particulate form. The galvanised steel showed a significant release of both dissolved and particulate zinc. The roof paint as well as the coated steel seemed to mainly release zinc in dissolved form.

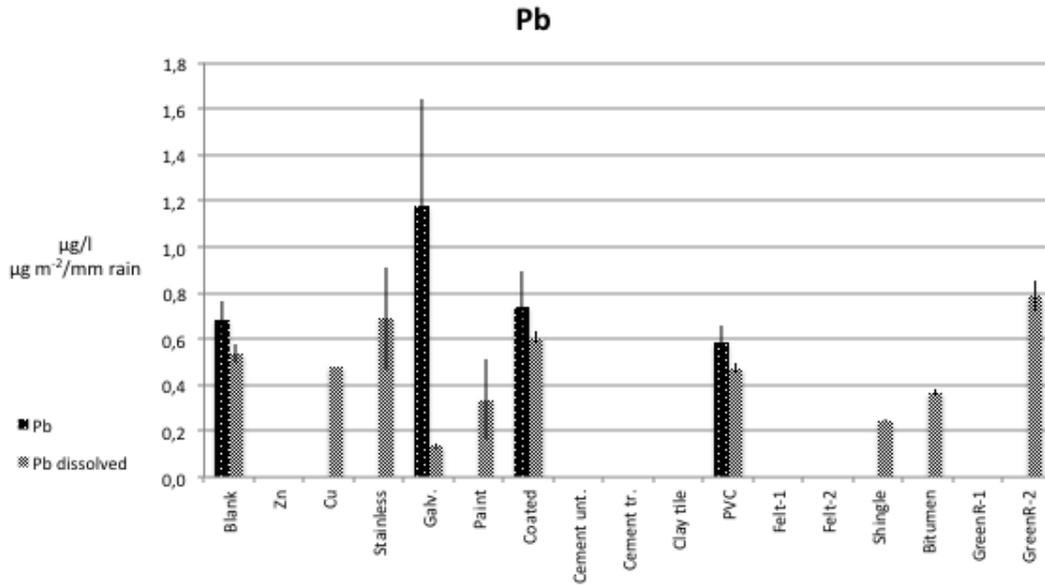
The concentrations of lead in the leachates are presented in Figure 6. Relatively equal lead concentrations were observed for the materials that seemed to release lead. Lead was not found in concentrations that were significantly higher than the blank sample in any of the materials. Excluding the galvanised steel, the total- and dissolved concentrations were similar to each other. The result for the galvanised steel showed that the release of Pb was primarily in particulate form. The soil used as a green roof substrate showed the highest release of dissolved Pb. The absence of the total Pb concentrations for many materials was most likely correlated to the higher report limit for the V-3b analysis (0.5 µg/L) than the report limit for V-2 (0.01 µg/L).

**Figure 6** Mean Pb concentrations in the leachates from each roofing material. The uncertainty bars represent the concentration in each duplicate sample.

The potential annual lead release was only calculated for materials with concentrations that were notably higher than the blank sample, i.e. the galvanised steel and the green roof substrate. The results showed a potential annual release of 84.6 mg total Pb/100 m<sup>2</sup> and 56.6 mg dissolved Pb/100 m<sup>2</sup> respectively.

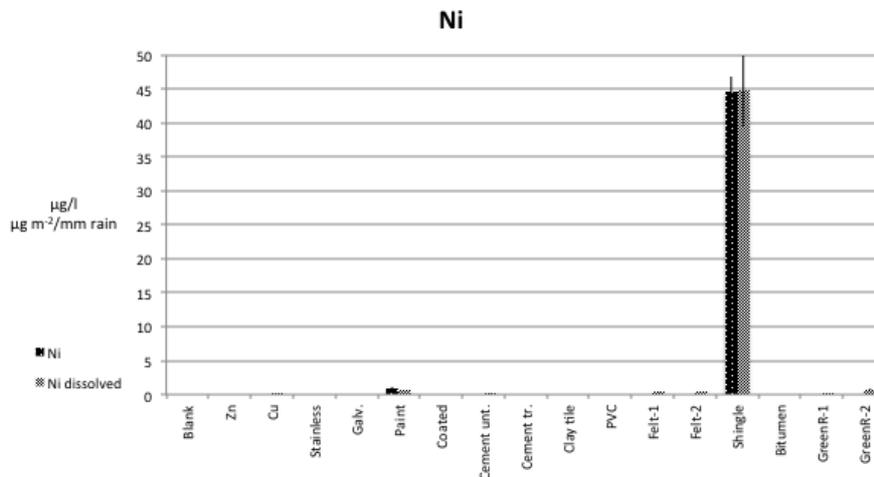
The Ni concentrations in the leachates, presented in Figure 7, were below reporting limit for most materials. Small amounts of Ni were released from the roof paint as well as the felt roof materials, while the Ni release from the Shingle was significantly higher. The release of Ni from the shingle was in the same order of magnitude as the release of copper from the same material.

**Figure 7** Mean Ni concentrations in the leachates from each roofing material. The uncertainty bars represent the concentration in each duplicate sample.

The potential annual release of dissolved Ni from 100 m<sup>2</sup> shingle roofing was determined to 3200 mg. Correspondingly, 43.6 mg dissolved Ni could potentially be released from 100 m<sup>2</sup> painted metal roof in one year's amount of precipitation.

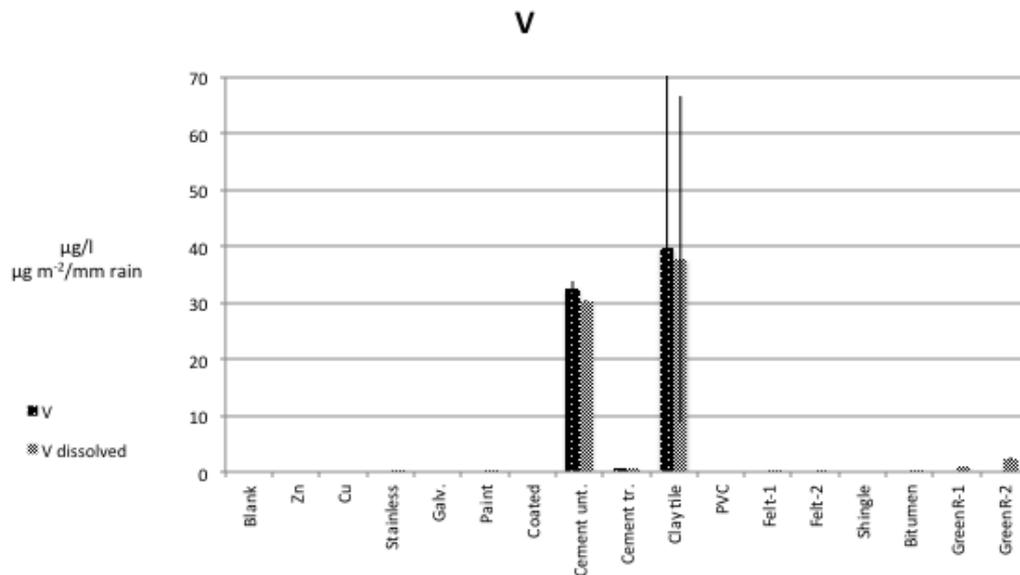
From Figure 8 it can be seen that vanadium was mainly released from the untreated cement tile and the clay tile. There was a significant difference in the release of V from the treated- and the untreated cement tile, which implies that the coating on the treated cement tile somehow hindered the surface from releasing V. The conformity between total- and dissolved concentrations was clear concerning the cement tiles as well as the clay tile. There was a large nonconformity both in total- and dissolved concentrations concerning the clay tile duplicates.

**Figure 8** Mean V concentrations in the leachates from each roofing material. The uncertainty bars represent the concentration in each duplicate sample.

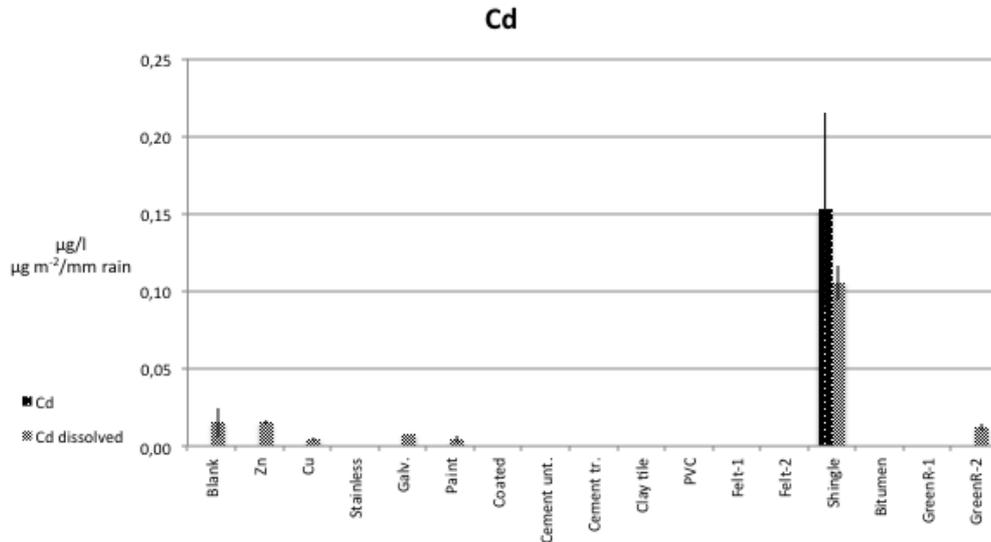
The release of Cadmium from the different roofing materials is presented in Figure 9. The highest concentrations were found in the leachate from the shingle, both concerning particulate and dissolved concentrations. Dissolved Cd was also reported in the leachates from the zinc sheet, the galvanised steel, the copper sheet, the metal roof paint and even the blank sample.

**Figure 9** Mean Cd concentrations in the leachates from each roofing material. The uncertainty bars represent the concentration in each duplicate sample.

The potential annual emissions of Cd from a 100 m<sup>2</sup> shingle roof was calculated to approximately 11.0 mg Cd, of which ca. 7.6 mg is in dissolved form.

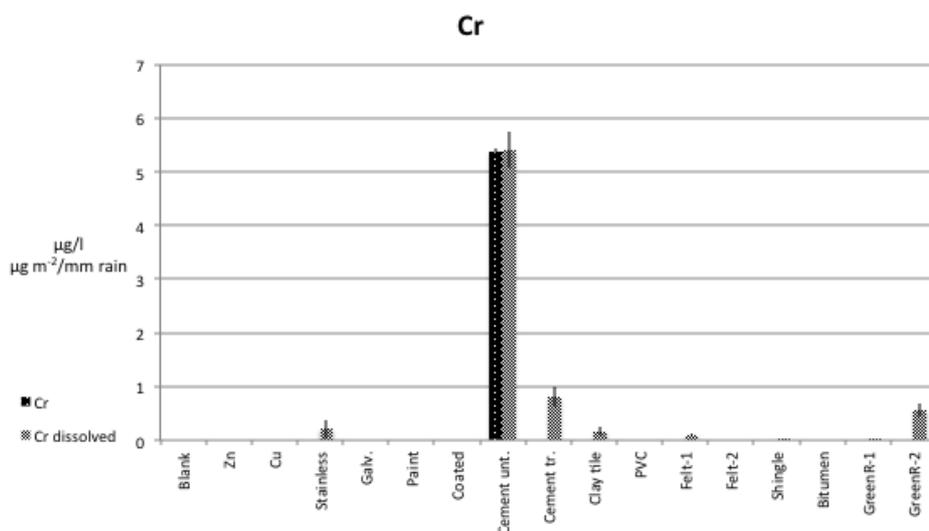
The release of chromium from each material is presented in Figure 10. Significant concentrations of Cr were present in the leachates from the untreated cement tile. The dissolved- and total concentrations were equivalent, indicating that the release of Cr is almost exclusively in dissolved form. Noteworthy is also that the Cr release from the treated cement tile was many orders of magnitudes smaller compared to the untreated cement tile. This suggests that the surface treatment on the treated cement tile somehow hindered the release of chromium. Chromium was also present in the leachates from the stainless steel, the clay tile, one felt roof (M11), the shingle and the second green roof substrate (M16).

**Figure 10** Mean Cr concentrations in the leachates from each roofing material. The uncertainty bars represent the concentration in each duplicate sample.

The results correspond to an annual release of ca. 390 mg dissolved Cr from 100 m<sup>2</sup> roofing of untreated cement tiles and correspondingly ca. 58.1 mg dissolved Cr from the surface treated cement tile.

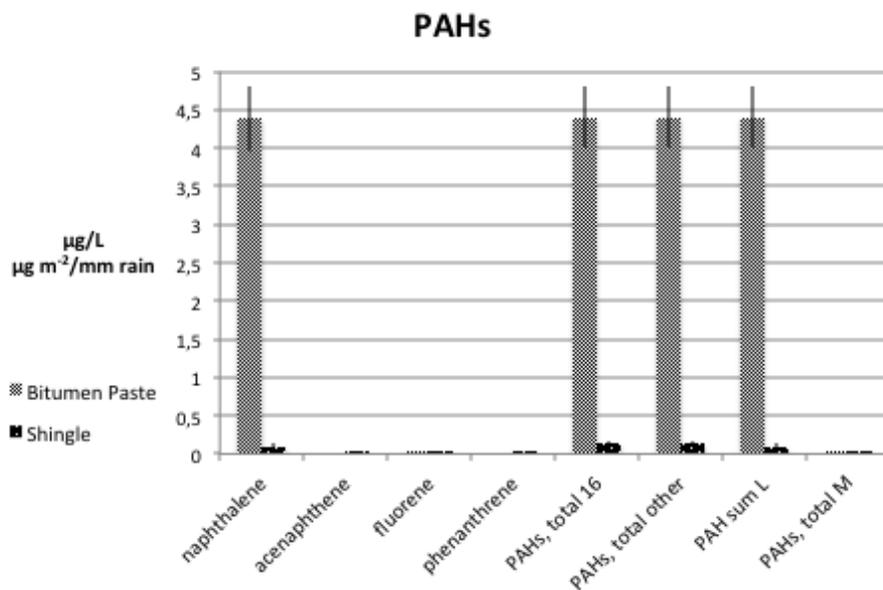
The release of PAHs was analysed in the felt roof materials, the shingle and the bitumen paste used for maintenance of felt roofs. 16 common PAHs of low, medium and high molecular weight were analysed. No PAHs were reported in any of the two felt roofs. Figure 11 shows the concentrations of PAHs in the shingle and the bitumen paste. Only the PAHs that were present in the leachates in concentrations above reporting limits was included in the figure. The release of PAHs was significantly larger from the bitumen paste than the shingle. For both materials naphthalene was predominantly released and thus the sum of released PAHs were mainly PAHs of low molecular weight (PAH sum L).

**Figure 11** Mean concentrations of reported PAHs in shingle and bitumen paste. The uncertainty bars represent the concentration in each duplicate sample.

Table 9 below displays the estimated annual release of PAHs from 100 m<sup>2</sup> roof surface concerning shingle- and bitumen paste covered roofing. According to this approximation, more than 300 mg naphthalene could be released from 100 m<sup>2</sup> bitumen paste-covered roof in one year's amount of precipitation.

PAHs were released from two of the four analysed materials. All of the PAHs that were found in this study are of low molecular weight with 2-3 aromatic rings. The smaller PAHs are generally more volatile and soluble (Naturvårdsverket, 2007), which may explain why these seemed to be released from the investigated materials. None of the felt roofs seemed to release PAHs, while the shingle roofing released reportable levels of PAHs. This was an interesting discovery, since these three materials are similar in their composition, but from different manufacturers. The concentrations of PAHs in the leachate from the shingle correspond to ca. 7 – 19 % of the measured concentrations of PAHs in stormwater that are presented in Table 2. Correspondingly, the concentrations of PAHs in the leachate from the bitumen paste were ca. 260 – 494 % of the measured concentrations in the stormwater. One has to keep in mind that the bitumen paste is used for maintenance of older roofs and the usage of the product and thus the potential release may therefore be limited to areas where these types of roofs are common. Due to this, the bitumen paste may only influence stormwater quality locally. It is important to recognise that the measured concentrations of PAHs in stormwater are derived from various sources of pollution, such as traffic, and will also be diluted with runoff that does not contain PAHs. The potential long-term release of PAHs from the bitumen paste has not been evaluated in this study and it is therefore not feasible to conclude if the potential annual release of about 316 mg PAHs per 100 m<sup>2</sup> roof surface, calculated in section 5.4.1, is relevant a few years after applying the bitumen paste to the roof.

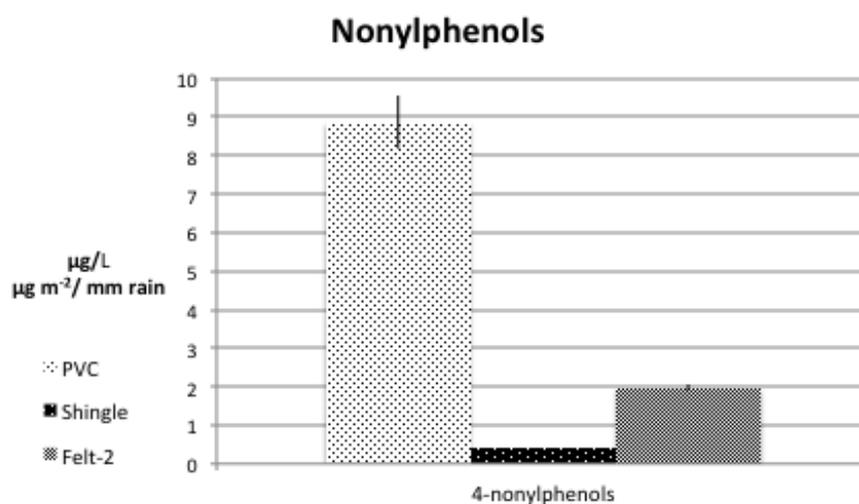
In the leachates from the PVC sheet, the shingle roof and one of the felt roof materials (M12), 4-nonylphenols were reported in concentrations above report limits, see Figure 12. The largest release of NPs was from the PVC sheet. NPs and NPEOs were analysed on most materials included in the organic screening (the metal roof paint, the coated steel, both cement tiles, the PVC, both felt roofs and the shingle). No NPs were reported in the other materials. The NPEO-concentrations were below report limits for all materials.

**Figure 12** Mean concentrations of nonylphenols in PVC, shingle and one felt roof (M12). The uncertainty bars represent the concentration in each duplicate sample.

The annual release of 4-nonylphenols was approximated, considering the annual mean precipitation in Sweden of 720 mm. The approximation is presented in Table 10 below. This approximation suggested that 100 m<sup>2</sup> of the PVC roofing, which released the largest amount of NPs, would release near 640 mg per year. The release of NPs from the felt roof seemed to be around 140 mg /100 m<sup>2</sup> in one year's precipitation and the corresponding release from the shingle roofing is near 30 mg / 100 m<sup>2</sup>.

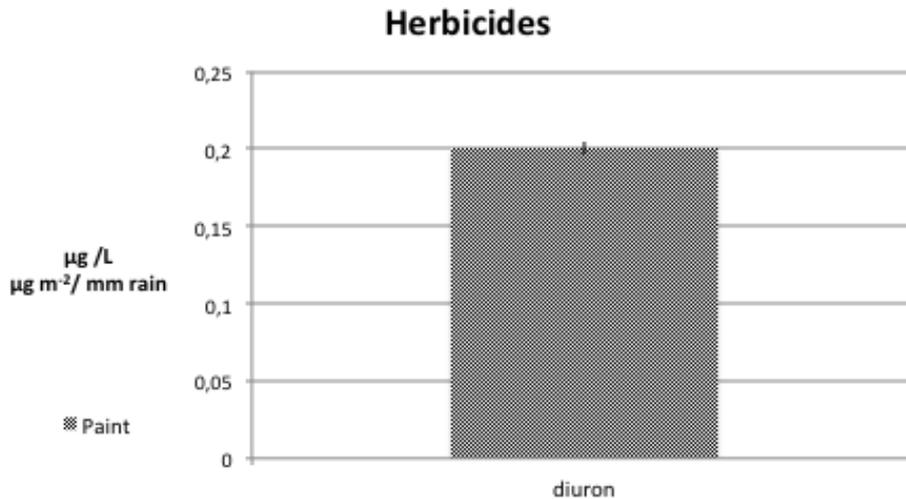
The leachates from the metal roof paint as well as the bitumen paste were analysed with respect to urea-based herbicides. In the leachate from the bitumen paste, no herbicides were reported. The result for the metal roof paint is displayed in Figure 13 below. About 0.2  $\mu\text{g/L}$  of diuron was found in the leachate from the paint. Diuron was the only herbicide reported in the leachate and thus the other herbicides are not presented in the figure.

**Figure 13** Mean concentration of diuron in the metal roof paint. The uncertainty bar represents the concentration in each duplicate sample.

Considering the annual mean precipitation in Sweden of 720 mm, this corresponded to a release of about 14.4 mg diuron per year for a painted roof surface of 100  $\text{m}^2$ .

The herbicide diuron was found in the leachate from the metal roof paint, but in significantly lower concentrations than previous measurements from stormwater presented in Table 2. The concentration of diuron in the leachate corresponded to about 16 % of the concentration measured in stormwater by Gasperi et al. (2014). The stormwater concentration obviously includes other sources of pesticides than one single roofing material and therefore this does not necessarily mean that the contribution from the metal roof paint is negligible. The presence of diuron in the leachate from the metal roof paint is also noteworthy, since the use of diuron has been banned in Sweden since the year 1993 (Naturvårdsverket, 2008). As a temperature dependence of pesticide release has previously been reported for pesticides (Wangler et al., 2012), this is also of interest to study further on. It may also be relevant to include other pesticides aside from the urea-based herbicides in further studies.
